# NPS Wildfire Risk Assessments Assessment Locations

# Interpretive Center

## SHIL - Shiloh National Military Park

# NPS Wildland Fire Risk Assessment - Facility Assessment

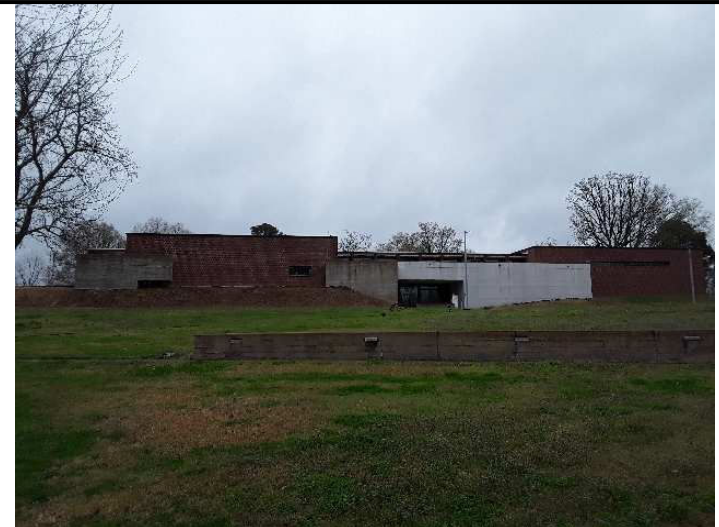
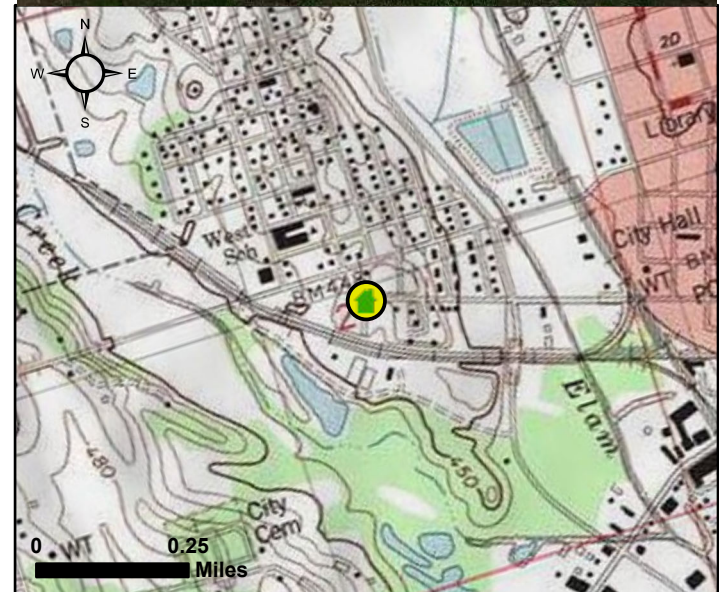
**Facility Name:** Interpretative Center (Corinth)

**Roof Material:** Fire resistant- tar,rubberized

**Siding Material:** Rock, concrete, metal

**Foundation:** Closed, Greater than 30in masonry exposed or N/A
