# NPS Wildfire Risk Assessments Assessment Locations

National Park Service  
U.S. Department of the Interior

## BRCA - Bryce Canyon National Park - Overview

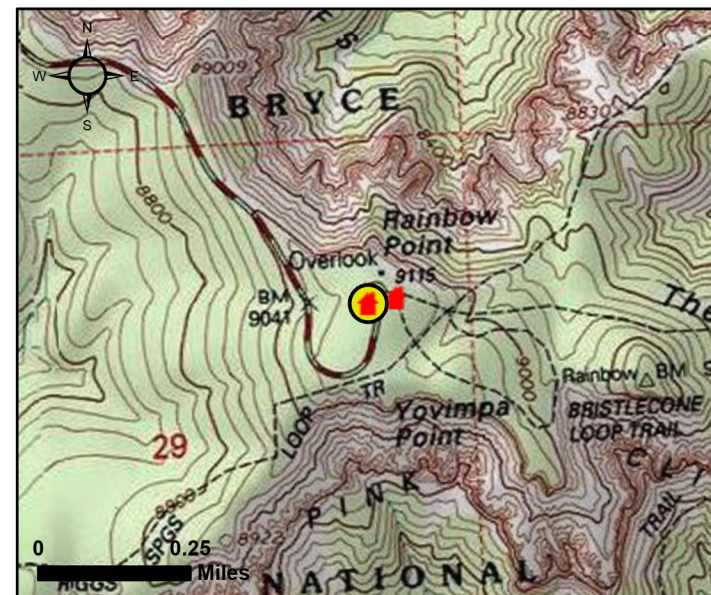
**Facility Name:** Rainbow Dryhead South  
**Unit - Location:** BRCA - Rainbow Point  
**FMSS ID:** 46430, **Local ID:**  
**Structure Type, Use:** Building, Unknown  
**Owner:** National Park Service  
**Field Crew, Visit Date:** Castillo, March 27, 2021  
**Coordinates (DDM):** 37° 28.48900002' N 112° 14.44300002' W

**Rating:** High  
**ProtectionLevel:** Undesignated,  
**Resources of Concern:** Unknown  
**Occupied:** Yes  
**In Community:** No,  
**Revisit Interval:** 8 yrs  
**Map Label:** 96

**Primary Access:** Road  
**Ingress Egress:** 1 road in/out  
**Access Width:** 2 lanes (Greater than 24')  
**Access Condition:** Surfaced-paved, gradeGreater than 5%  
**Bridge Condition:** Less than 300 ft with turnaround  
**Access and Turnarounds:** Less than 300 ft with turnaround  
**Facility Number or Sign:** None or not clearly visible  
**Fuel Type:** Shrub or timber  
**Fuel Load:** Heavy  
**Defensible Space:** Less than 30 ft treated  
**Topography:** Slope 5% to 20%  
**Roof Material:** Noncombustible or not applicable  
**Siding Material:** Wood or open sided  
**Foundation:** Closed, Less than 6in masonry exposed  
**Firewood:** None  
**Water Supply:** No reliable water source nearby  
**Propane:** None  
**Overhead Hazards:** No overhead hazards  
**Comments:**

| Map Label | FMSS ID | Common Name |
|---|---|---|
| 96 | 46430 | Rainbow Dryhead South |

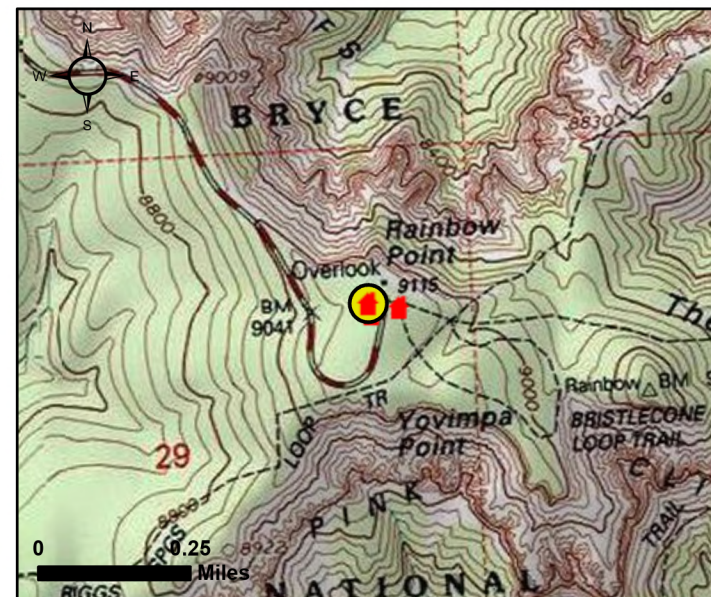
**Facility Name:** Rainbow Dryhead North  
**Unit - Location:** BRCA - Rainbow Point  
**FMSS ID:** 46431, **Local ID:**  
**Structure Type, Use:** Building, Unknown  
**Owner:** National Park Service  
**Field Crew, Visit Date:** Castillo, March 27, 2021  
**Coordinates (DDM):** 37° 28.50300000' N 112° 14.44699998' W

**Rating:** High  
**ProtectionLevel:** Undesignated,  
**Resources of Concern:** Unknown  
**Occupied:** Yes  
**In Community:** No,  
**Revisit Interval:** 8 yrs  
**Map Label:** 95

**Primary Access:** Road  
**Ingress Egress:** 1 road in/out  
**Access Width:** 2 lanes (Greater than 24')  
**Access Condition:** Surfaced-paved, gradeGreater than 5%  
**Bridge Condition:** Less than 300 ft with turnaround  
**Access and Turnarounds:** Less than 300 ft with turnaround  
**Facility Number or Sign:** None or not clearly visible  
**Fuel Type:** Shrub or timber  
**Fuel Load:** Heavy  
**Defensible Space:** Less than 30 ft treated  
**Topography:** Slope 21% to 30%  
**Roof Material:** Noncombustible or not applicable  
**Siding Material:** Wood or open sided  
**Foundation:** Closed, 6in to 30in masonry exposed  
**Firewood:** None  
**Water Supply:** No reliable water source nearby  
**Propane:** None  
**Overhead Hazards:** No overhead hazards  
**Comments:**

| Map Label | FMSS ID | Common Name |
|---|---|---|
| 95 | 46431 | Rainbow Dryhead North |

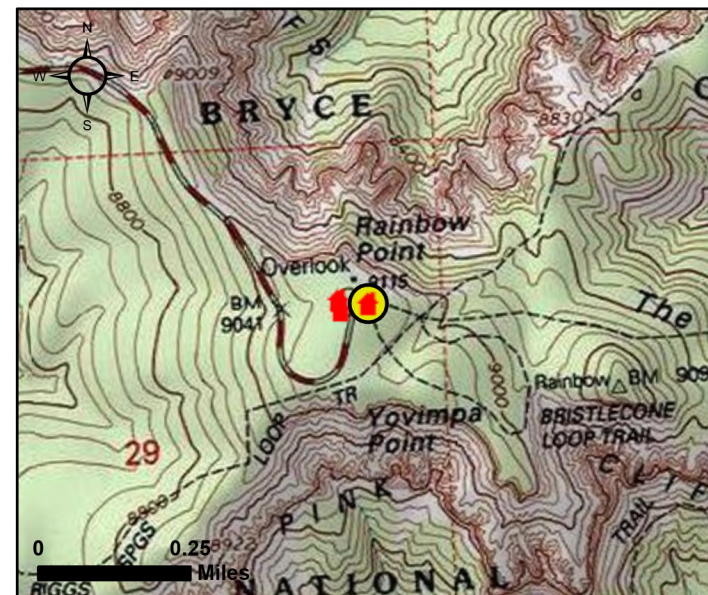
**Facility Name:** Rainbow Comfort Station

**Rating:** High

**Fuel Type:** Shrub or timber

**Fuel Load:** Heavy

**Defensible Space:** Less than 30 ft treated

**Topography:** Slope 21% to 30%

**Roof Material:** Combustible or no roof

**Siding Material:** Wood or open sided

**Foundation:** Closed, 6in to 30in masonry exposed

| Map Label | FMSS ID | Common Name |
|---|---|---|
| 97 | 46424 | Rainbow Comfort Station |
