# NPS Wildfire Risk Assessments Assessment Locations

## ROMO - Rocky Mountain National Park - Overview

## ROMO - Rocky Mountain National Park

# NPS Wildland Fire Risk Assessment - Facility Assessment

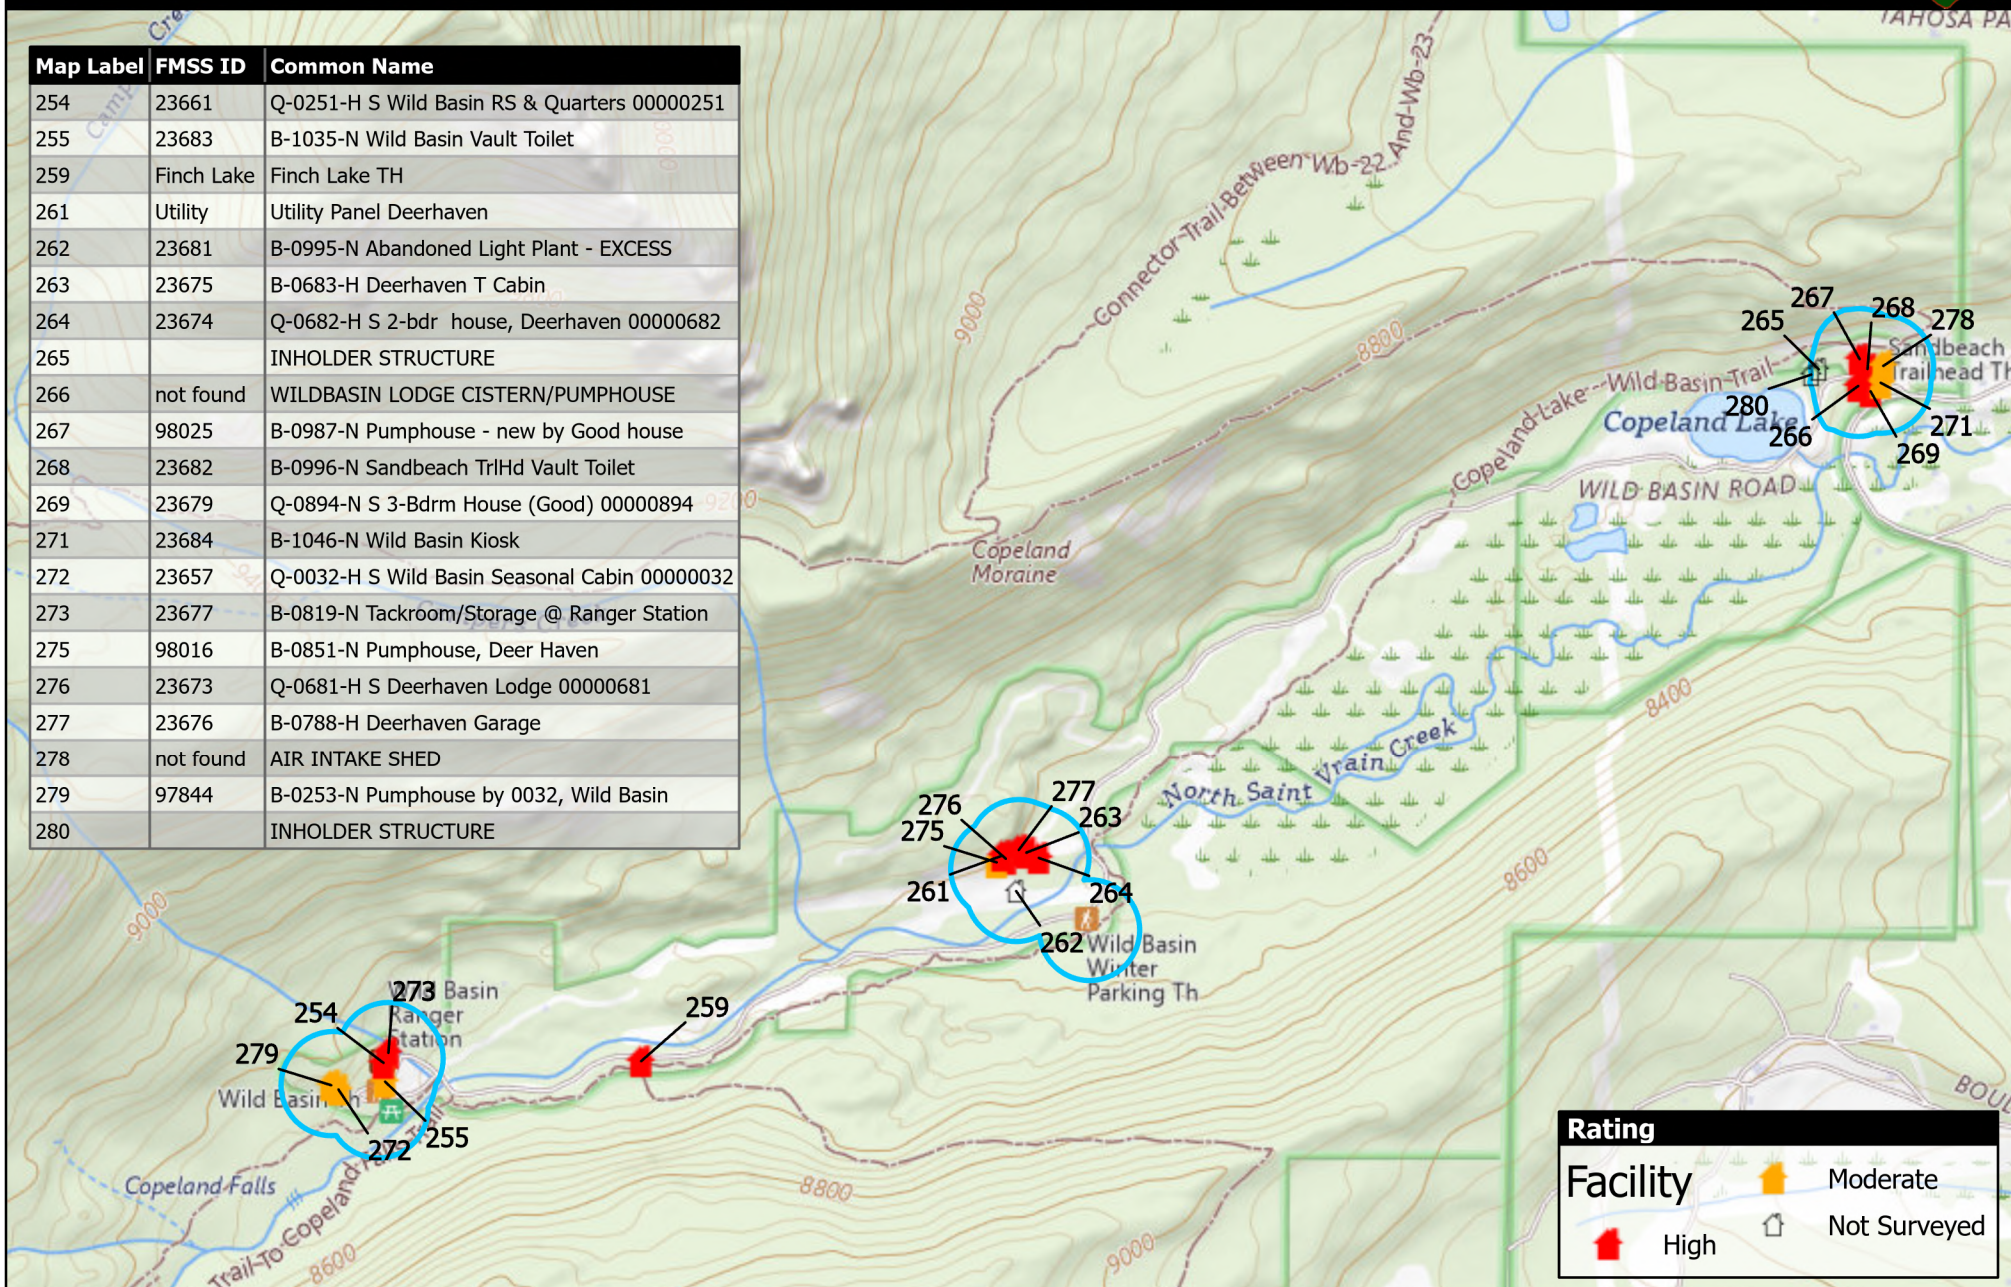
# Wild Basin

| Map Label | FMSS ID | Common Name |

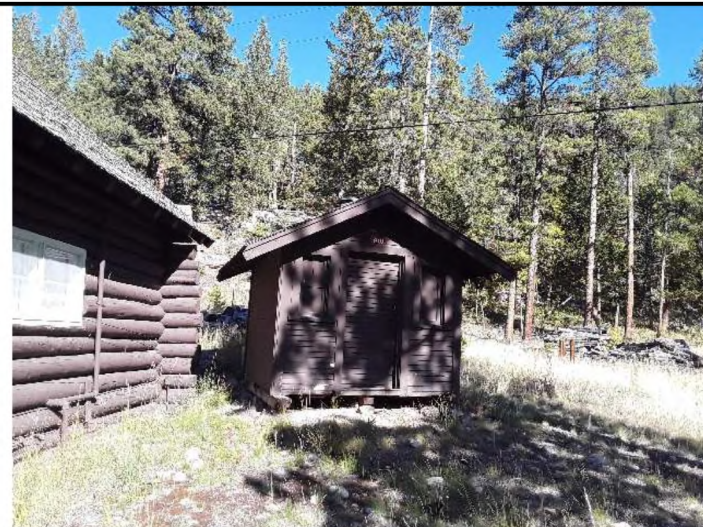
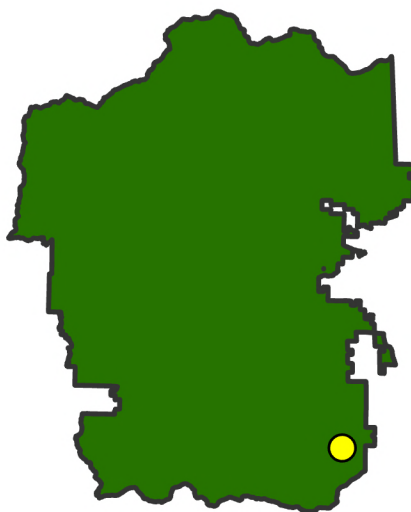
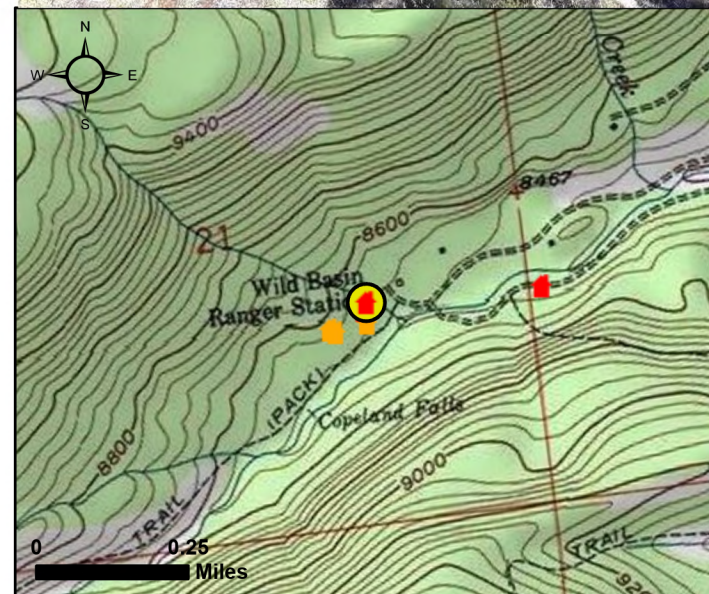
**Facility Name:** B-0819-N Tackroom/Storage @ Ranger Station

**Foundation:** Closed, 6in to 30in masonry exposed
