WATER-RESOURCES INVESTIGATIONS AT  
KATMAI NATIONAL MONUMENT, ALASKA

1968-69

Chester Zenone

Water Resources Division  
Alaska District  
December 1970

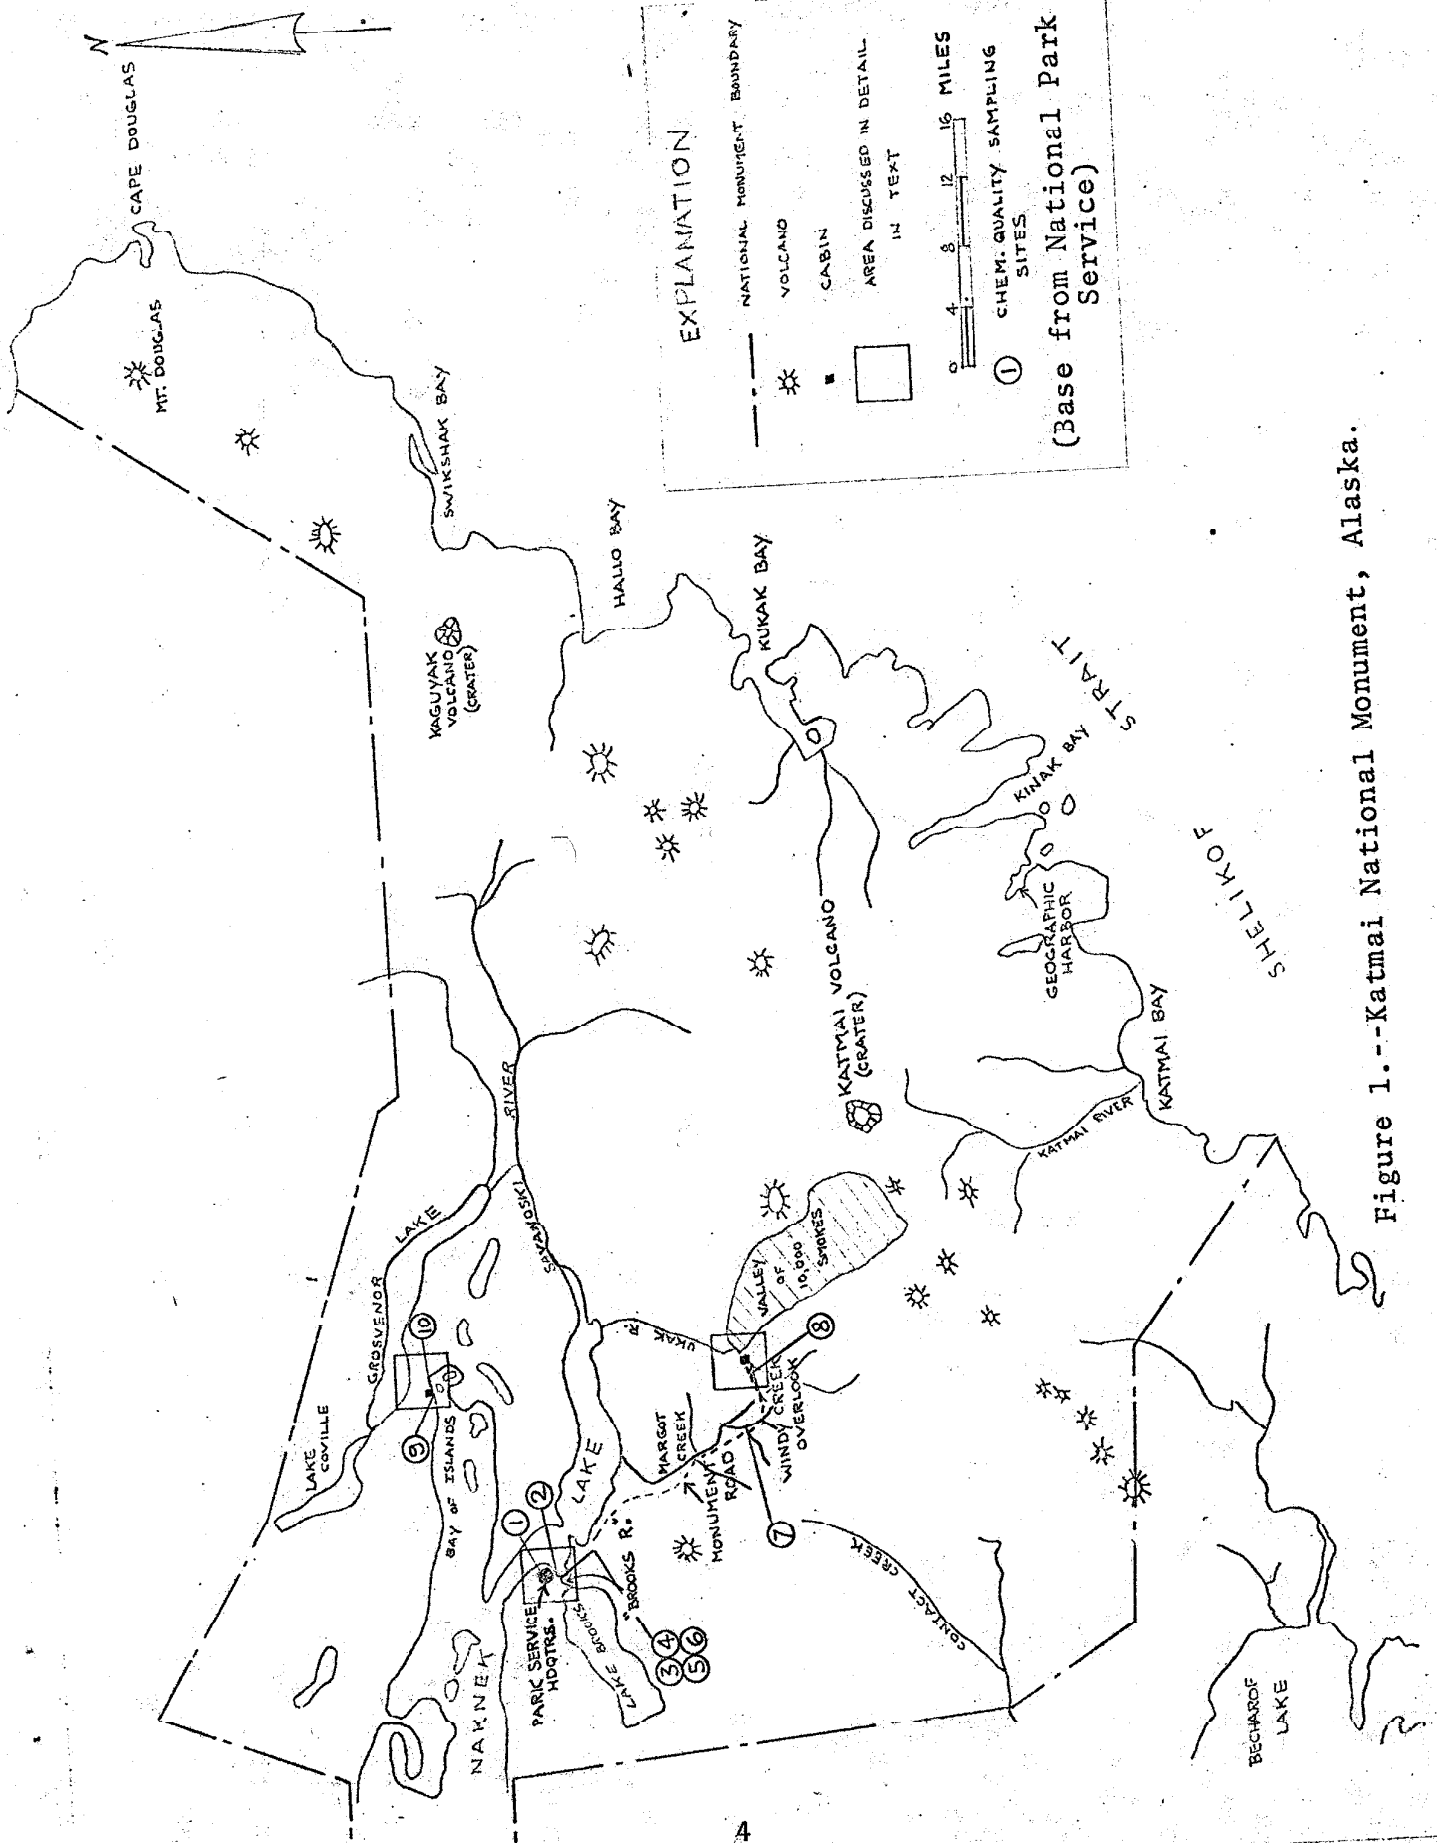
Figure 1.--Katmai National Monument, Alaska.

The Geological Survey was requested to investigate the availability of ground-water and surface-water supplies at specific sites (fig. 1), to appraise the overall water-resources potential at Katmai National Monument, and to make recommendations for the development of those resources. However, a comprehensive areal water-resources report is not feasible with the expenditure of time, personnel, and finances allotted to the present study. A study program leading to such a report might involve installation of stream-gaging stations, extensive test drilling to evaluate ground-water resources, and measurement of precipitation at several sites. Streamflow

The larger streams in the Monument, such as Savanoski (fig. 1), Ukak, and Katmai Rivers, and Margot Creek, are not likely to provide direct use potable water supplies because of their glacial-silt content. Numerous small tributaries to these streams, and small streams entering the bays and inlets along Shelikof Strait, would probably supply adequate water of acceptable quality.

Discharge from a spring crosses the road at mile 16.2, the second ford. The spring water is clear and chemical analysis shows that it is of excellent quality (analysis 8, table 1 and figs. 1 and 3A).

In September 1968 ground observations were made at the Kukak Bay cannery site (fig. 1). A spring that supplied the now abandoned cannery could probably be developed to supply the needs of the area. A small stream in a sheltered bay south of the cannery appears to be a favorable site for a gallery installation.

Chemical analyses of waters from Katmai National Monument are given in table 1 (sampling locations are indicated in figure 1). In 5 of the 6 samples for which iron content was determined, concentrations of iron exceeded the 0.3 mg/l (milligrams per liter) recommended upper limit for drinking water (U.S. Public Health Service, 1962). Sample numbers 4 and 9 contained anomalously high amounts of iron; reanalysis is recommended. The other waters having iron concentrations greater than the 0.3 mg/l limit (sample numbers 2, 5, and 6) would be usable for camp sites if better quality water cannot be found.

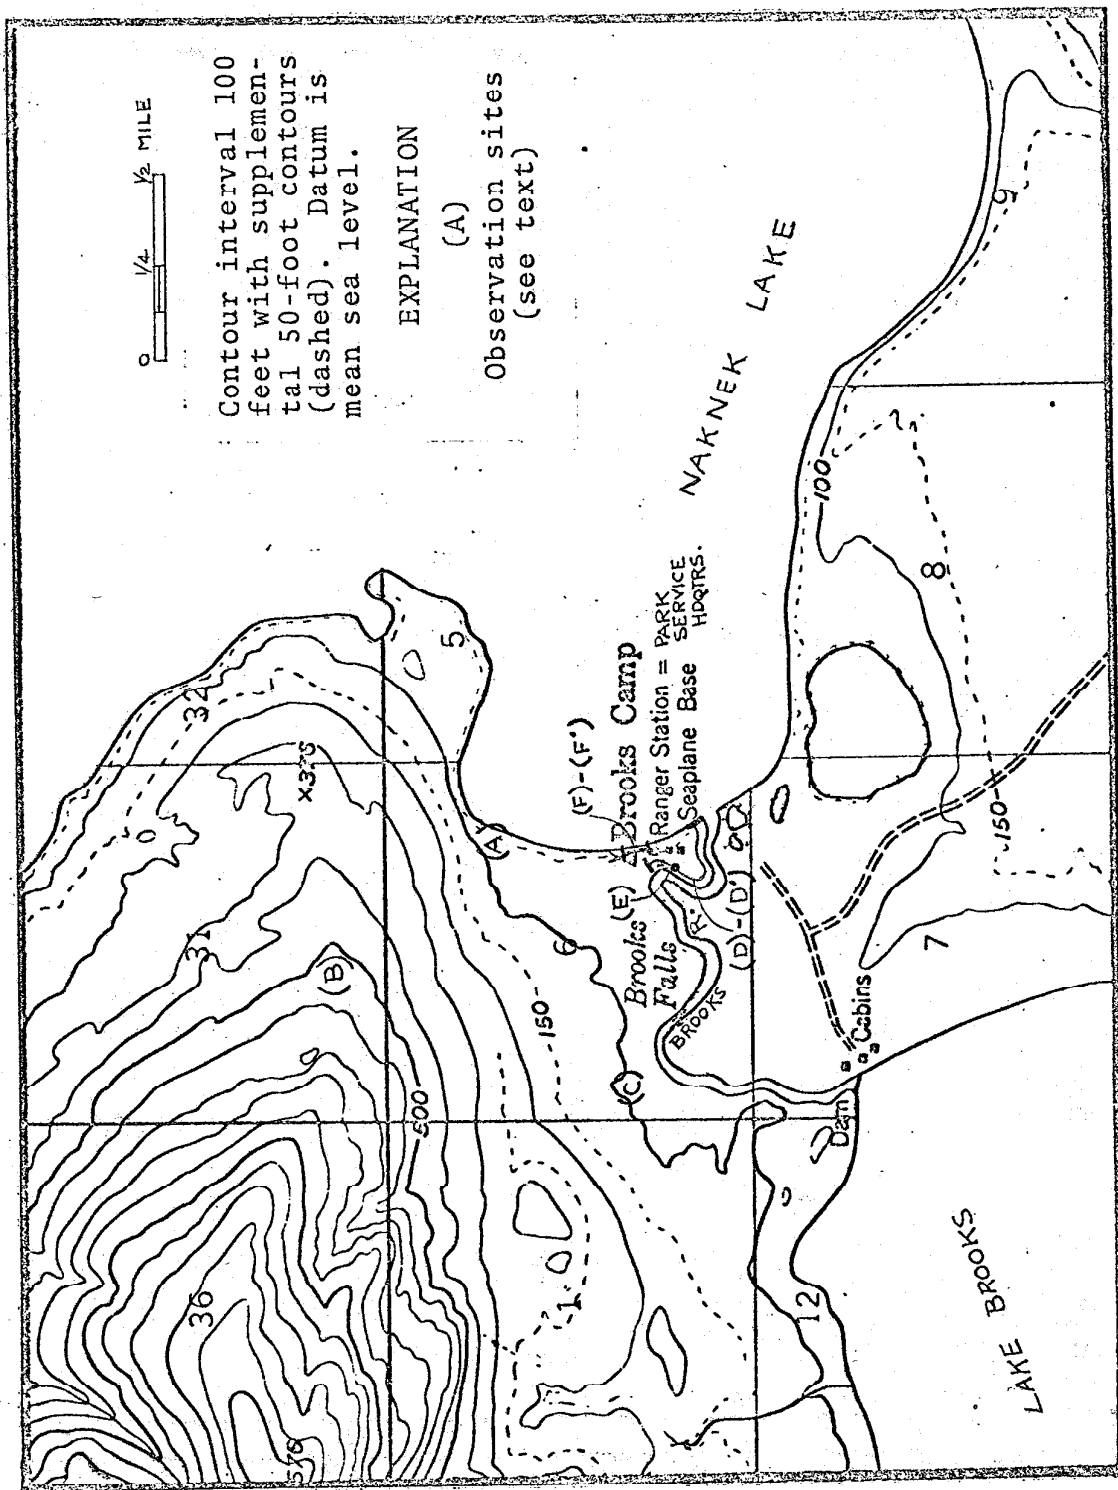
Base from U.S. Geological Survey; Mt. Katmai (C-6) quadrangle; 1:63,360  
Figure 2.--Park Service Headquarters area, Katmai National Monument.

This area was the most intensively studied, because the major development for public use is concentrated at and near the mouth of the stream known locally as Brooks River. Observations on potential water supplies were made at sites designated in figure 2.

A trail between sites (A) and (B) runs through rather dry terrain. The area is underlain by volcanic rocks (Keller and Reiser, 1959), which have only a thin veneer of unconsolidated surficial material. A small water supply might be developed in the spring at one point on the trail. Flow of the spring is approximately 2 gpm (gallons per minute).

Site (C) is in a swampy area; the reddish brown or black color of the water indicates organic matter in solution. This area is unsuitable for development of surface-water or shallow ground-water supplies.

Along the lower reach (D)-(D') of the Brooks River, particularly within 150 yards upstream of the boatdocking area, cutbanks of the river contain mostly sand and gravel overlain by volcanic ash. This area appears the most favorable for a shallow well or gallery installation. Care should be taken to place any such installation upgradient from the pit toilet near the river.

Two test wells were drilled at site (E). Both wells were within 20 feet of the river bank and were approximately 10 feet deep. The materials penetrated in drilling were the same in both wells--1 foot of volcanic ash at the surface and sand and gravel from depths of 1 to 10 feet. Attempts to pump the first well through a 3/4-inch perforated plastic hose were unsuccessful because of mechanical difficulties. The second well, approximately 50 feet downstream from the first, was pumped at 37 gpm through the open end of the 1-1/4-inch drill stem. Pumping was continued for 40 minutes. These results suggest that site (E) would be favorable for the installation of a shallow well or gallery.

Test drilling showed that the Naknek Beach area (F)-(F') is underlain by a thin layer of sand, gravel, volcanic ash, and rounded pumice fragments, which is in turn underlain by consolidated material. The consolidated layer is thought to be weathered bedrock that forms the boundary of the glacially deepened basin of Naknek Lake. Bedrock prevented drilling below depths of 9 feet in holes 1 and 3, and below 6 feet and 5 feet in holes 4 and 5, respectively; but it was not present at a depth of 10 feet in holes 2 and 6 (fig. 3).

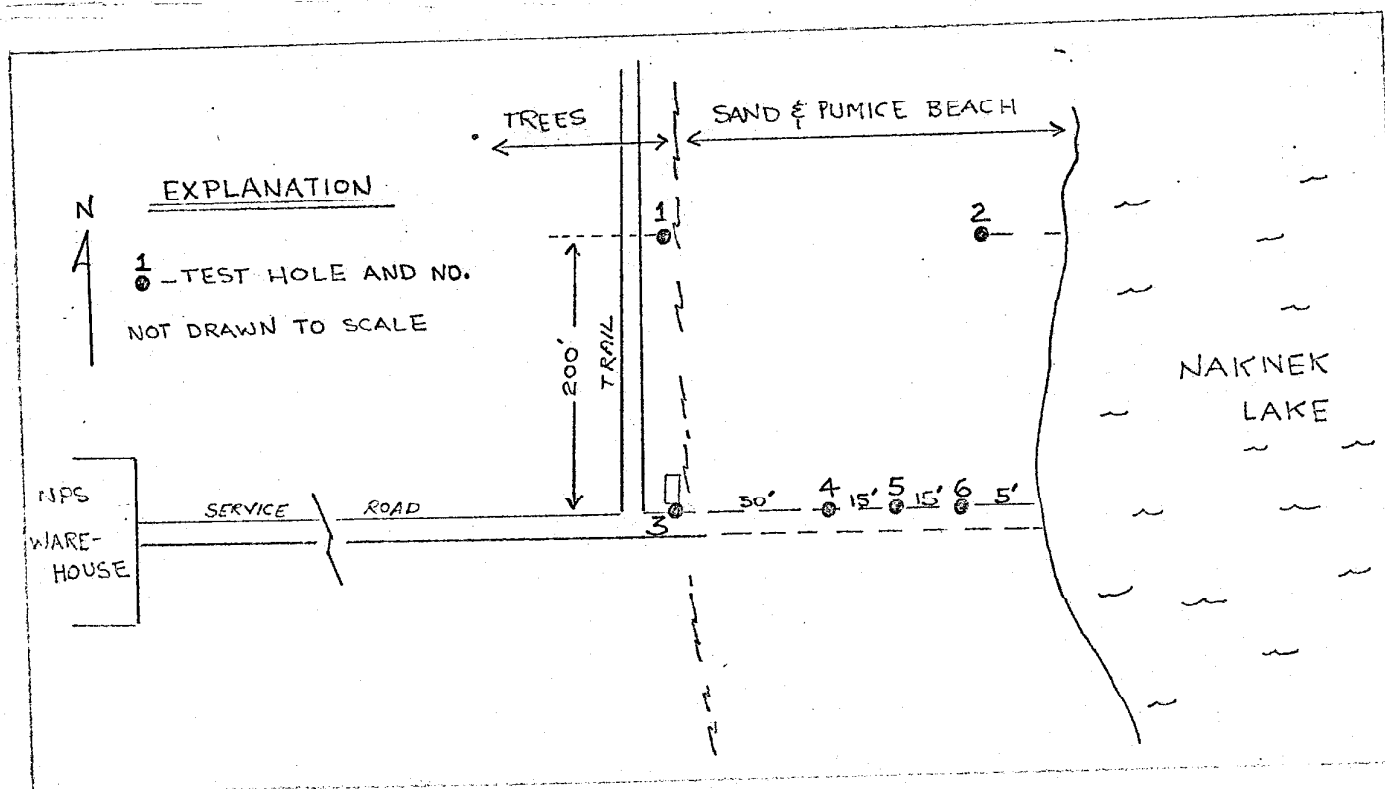
Figure 3.--Schematic diagram of test-hole locations on beach of Naknek Lake (Detail of area (F)-(F') on fig. 2).

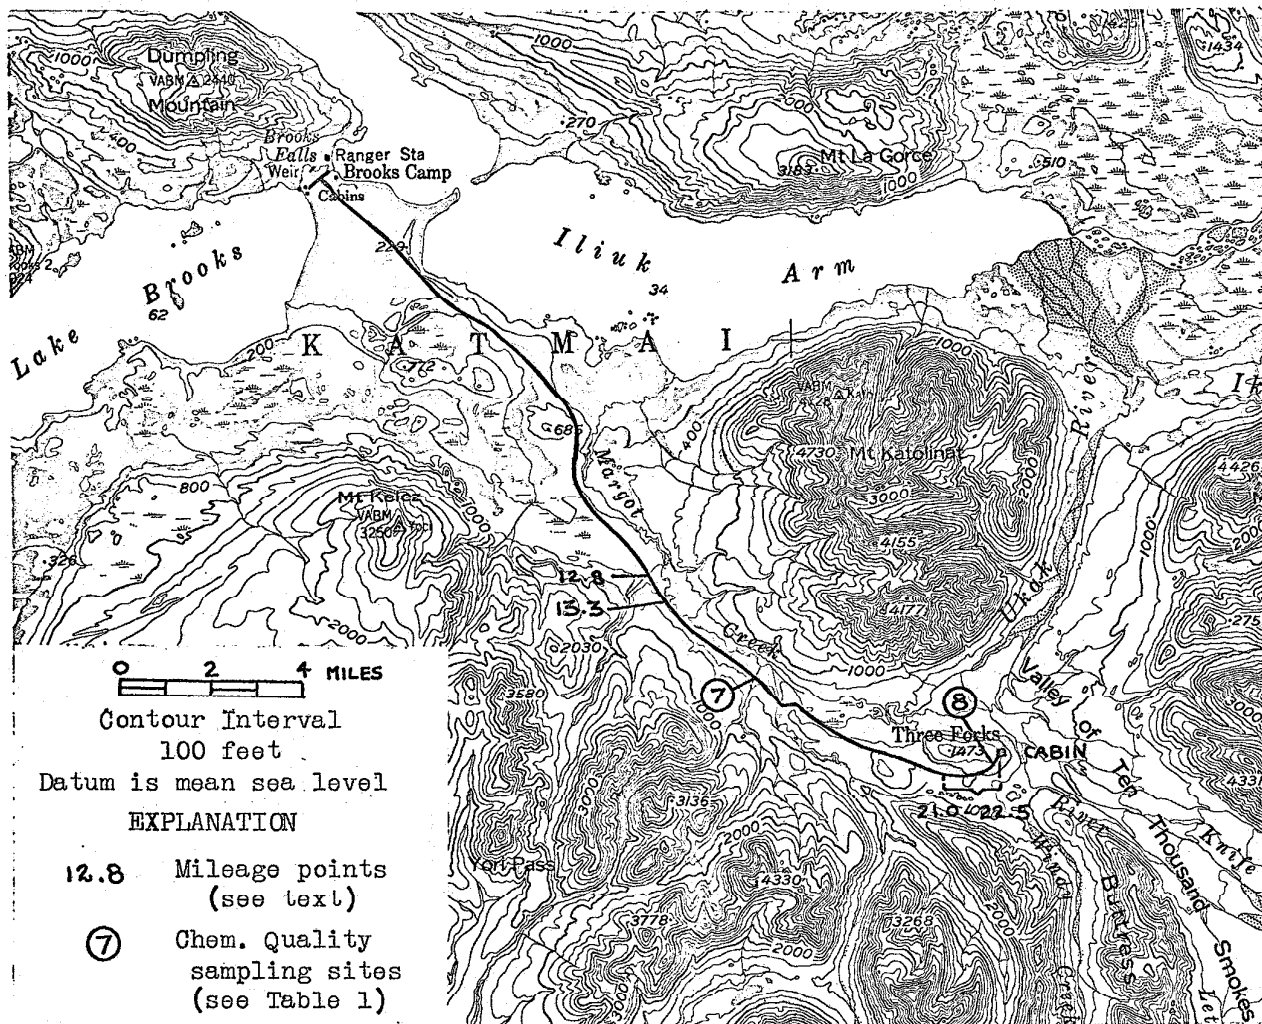
Figure 3A -- Route of Monument Road from Brooks Camp (Headquarters Area) to the Windy Creek Overlook cabin

In traveling the Monument road from Park Service Headquarters to the Windy Creek Overlook, some general observations were made regarding water resources and their potential. These are discussed below (mileage is measured from boat dock at mouth of Brooks River and indicated on fig. 3A).

Between mile 13.3 and 13.4, surface seeps, small runoff channels, and lush vegetation indicate very wet conditions. If a small water source were desired here, a search upgradient might reveal a spring in which the flow is concentrated.

Between mile 21.0 and mile 22.5 several small springs originate in the Windy Creek Overlook area. Flow in the springs ranged from 1 gpm to approximately 5 gpm. In September 1968, D. A. Morris observed no surface flow at any of the springs. However, small seeps and locally greener vegetation suggested underflow at that late-summer period. Subsurface exploration might verify that ground-water development is possible in the area.

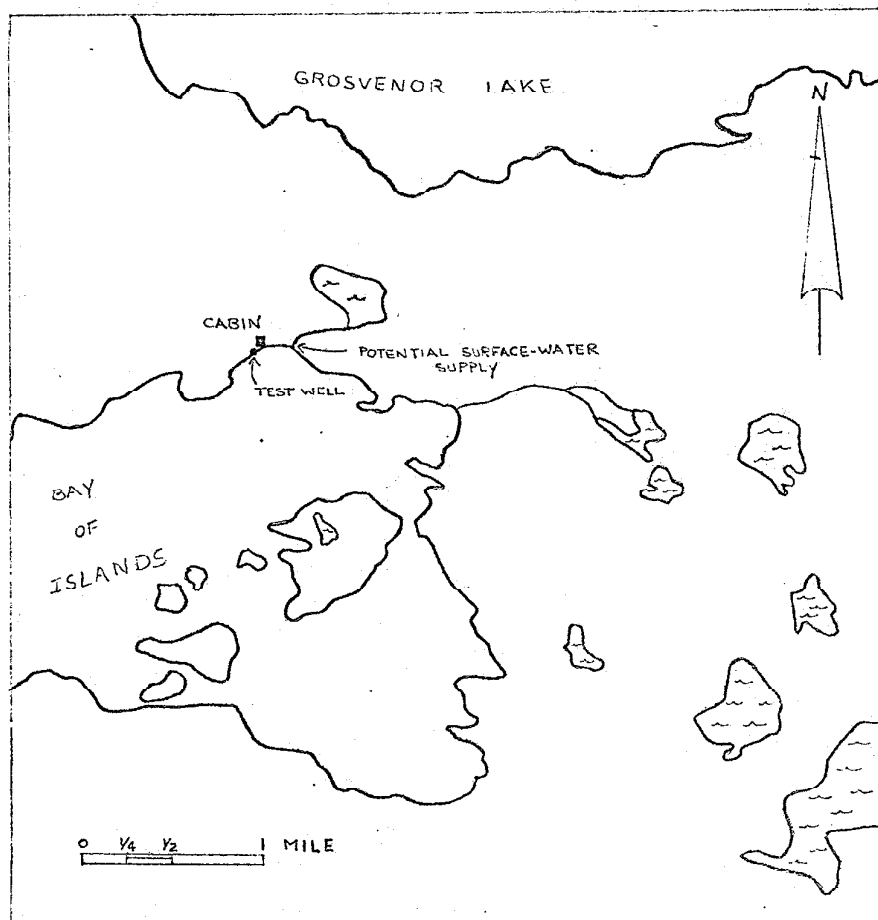
Figure 4.--Bay of Islands patrol cabin area.

Along a short reach of the shore east of the cabin (fig. 4), the rocks are stained a deep rust color. Immediately above this reach is a swampy area containing water that, because of its reddish brown color, appears to have a very high organic or iron content. The area below the swamp would probably not provide a potable surface- or ground-water supply. Further east along this shore a small stream, flowing approximately 25 gpm, enters the Bay of Islands. The stream should provide ample water for anticipated use at this site.

A well was drilled in a small sandy area on the beach just below the cabin. Material present was volcanic ash, clay, sand, and gravel from the surface to the 10-foot total depth. Water pumped from this depth was clouded with fine sediment; a properly screened well would probably eliminate this problem.
