## The Elk Meadow Project

In August 1999, Redwood National and State Parks (RNSP) began a two-year project to construct a new trail system and trailhead through the Davison Ranch. The park acquired the ranch property in 1991 and an adjoining property (the B-Mill Deck) in 1996. In August 1996, RNSP completed a Development Concept Plan (USDI 1996) and was awarded an Intermodal Surface Transportation Efficiency Act (ISTEA) grant for the development of the bike/hike trail and trailhead. On-site surveys and planning were completed by the NPS Denver Service Center in June 1997. Park staff submitted a Biological Assessment for the project to NMFS in July 1999.

This report follows up on the first-year (FY2000) Elk Meadow wetland and riparian revegetation project annual report. It documents the second-year planting and weeding, describes vegetation development the second year (of a two-year project), and it updates the list of vascular plant species found on the Elk Meadow restoration site.

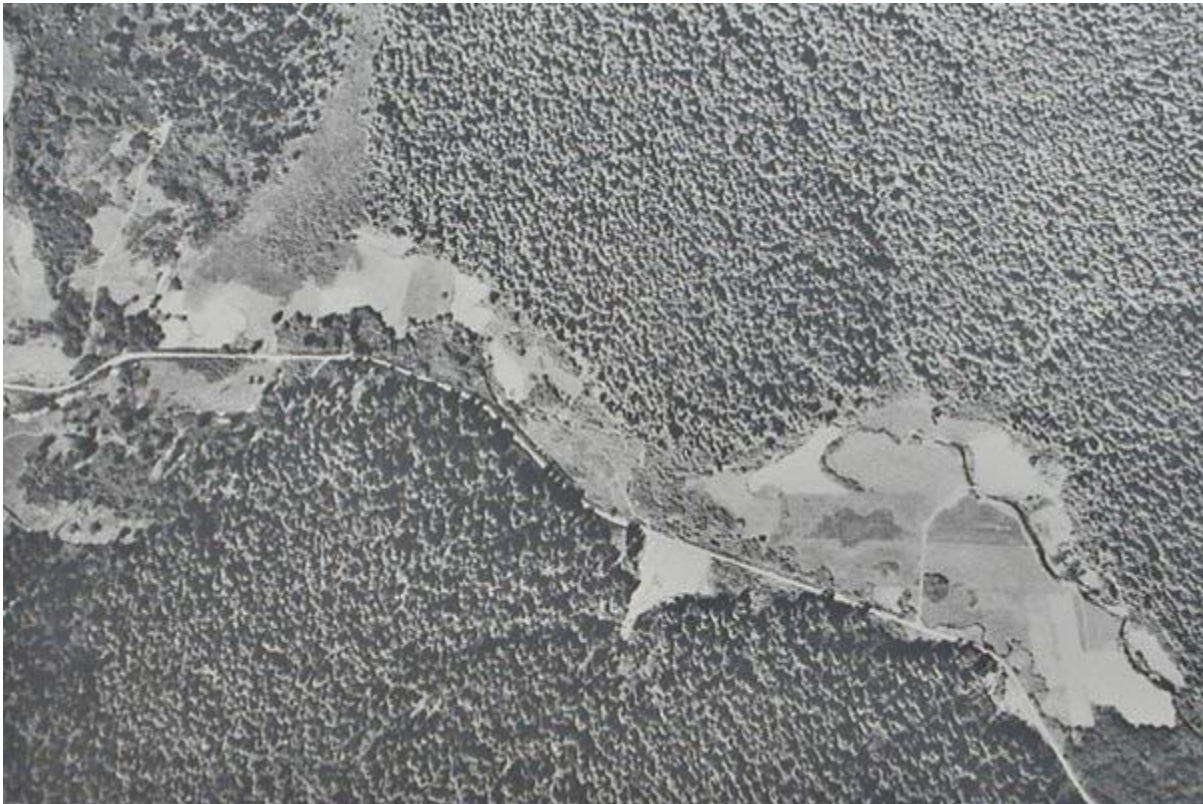
As seen in the photo below, by 1941 the floodplain of lower Prairie Creek watershed had been cleared of much of its natural riparian vegetation. The floodplain was being used for agriculture and as a highway corridor. Pastures appear in uniform light shades. Remnants of the riparian hardwood canopy appear in varied soft gray. Old-growth redwood forest dominated the hillslopes around the Davison Ranch. The huge redwoods and their shadows stand out in great contrast.

View of lower Prairie Creek basin on July 11, 1941 from aerial photograph CVL-6-33.

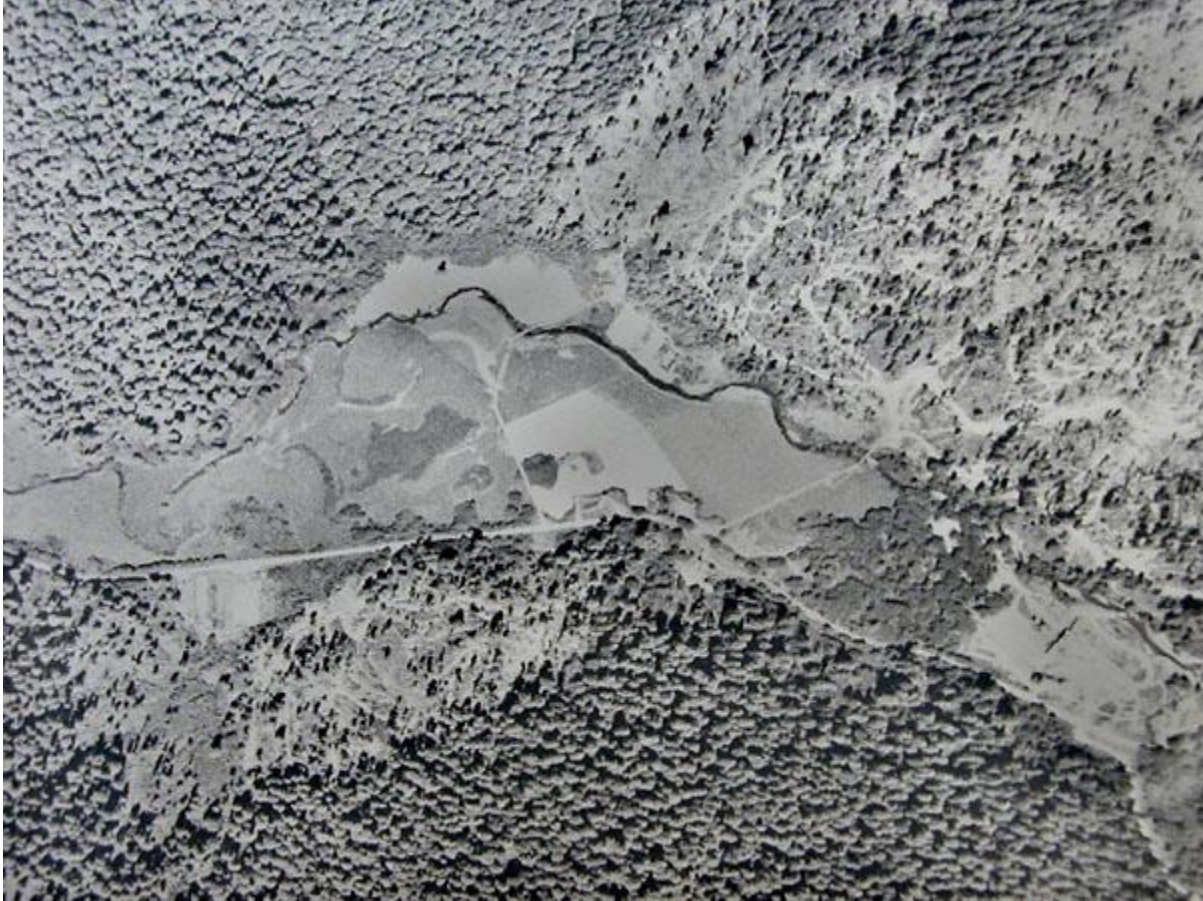
By 1948, the redwoods were being harvested on the slopes around the Davison Ranch. Later, Mill B and its associated log storage deck would be constructed to store and process the harvested timber.

View of Davison Ranch area on June 23, 1948 from aerial photograph CDF2-16-154.

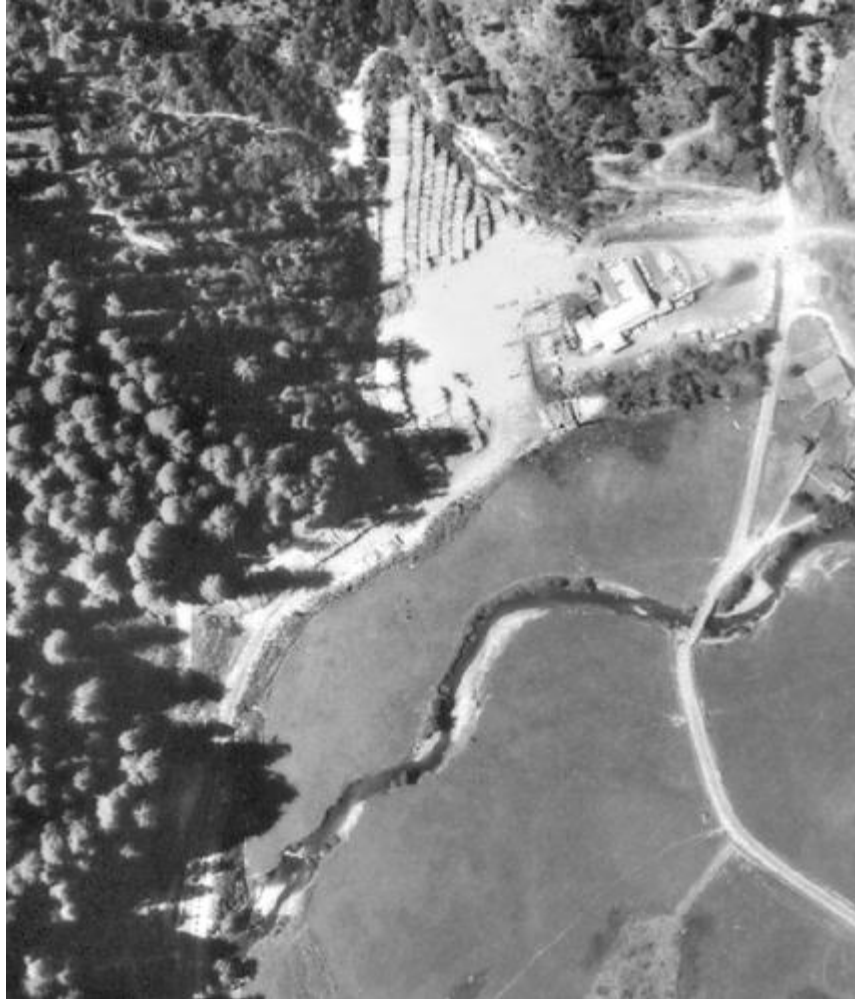
Aerial photograph HCN-1 16-82 for Humboldt County Timber Assessor

The B-Mill Deck grew in stages. An upper deck was built first, partly cut into a spur ridge and partly built on fill pushed into the valley of Davison Creek. Davison Creek was moved into a ditch on its southwest side. The photo below shows the situation in 1962. The upper deck was finished but a lower deck was not yet started. Drainages are clearly visible on the floodplain because it was still open pasture. Stream reaches on the floodplain were affected by a portion of the "200 Road", a new haul road west of Prairie Creek. The haul road was elevated on fill above the floodplain surface. The fill encroached into floodplain backwaters, displacing and elevating the creek beds. It looks like someone dug ditches next to the elevated 200 Road, probably to facilitate drainage of the pasture and wetland. The ditches appearing in 1962 just north of the large tree shadow look like what exists at the confluence of the main stem and south fork today.

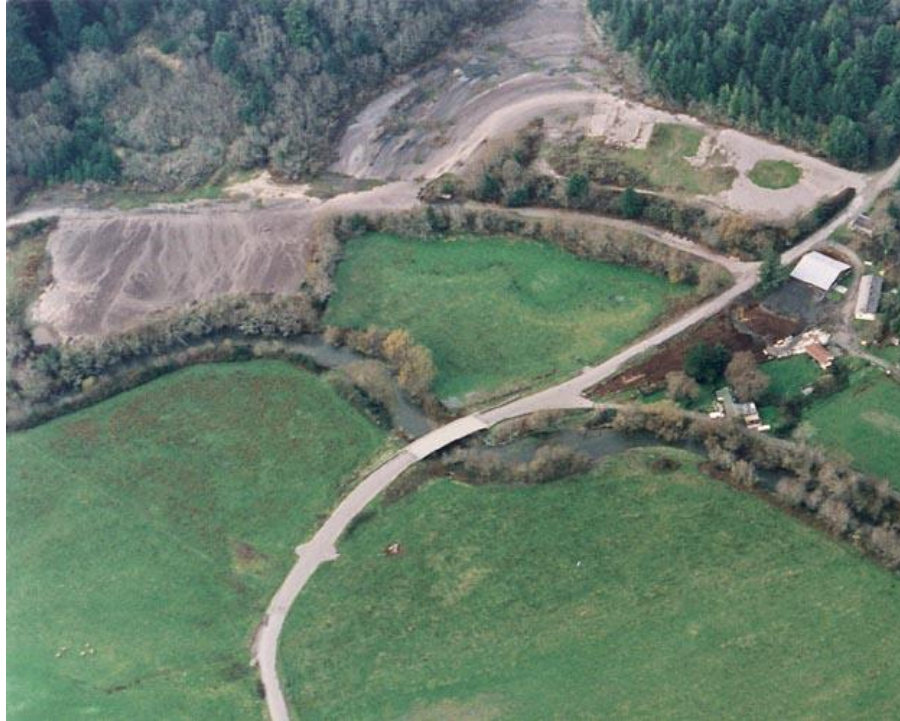
B-Mill Deck, December 14, 1992

In 1967, a lower deck was constructed. The main stem of Davison Creek was diverted through a culvert and ditch north of the lower deck into Prairie Creek (Please click [here](#) for details). By itself, the south fork of Davison Creek had only 27 percent of the combined drainage area to supply the lower reach. From 1967 to 1999 the main stem and south fork emptied separately into Prairie Creek. Successfully re-connecting them would restore and normalize both the winter peak flows and the summer base flow in the lower reach of Davison Creek.

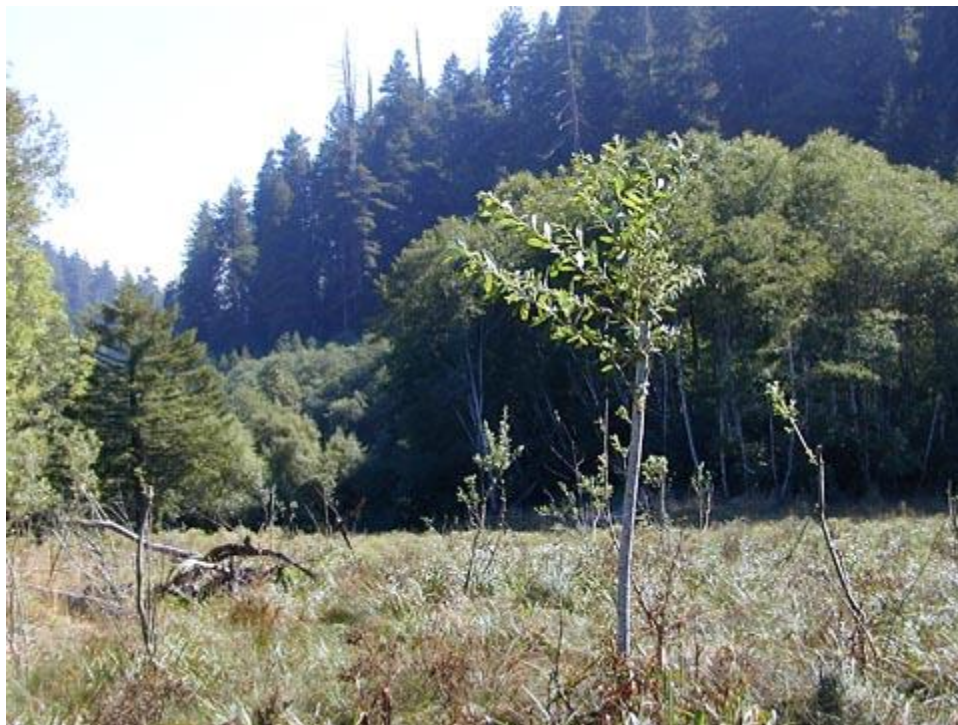
I took notes and photographs to track the fate of the plantings and the overall development of vegetation on the restoration site. On March 6, soon after planting, four of the willow pole clusters had been heavily rubbed and broken, apparently by bull elk. These particular willow clusters were on the floodplain in the small pasture between the restoration site and Davison Road west of Prairie Creek. On March 19, four more clusters had breakage, this time inside the restoration site itself, but the breakage was less severe. In addition, three big poles were entirely girdled between 3 and 4 ft. above ground by antler rubbing. Soon after March 19 the bull elk dropped their antlers, and the girdling and breakage ceased. The willow poles began to sprout in April. By May, all of the willow clusters had vigorous sprouts. The willow tops grew bushier through July, although foliage and side branches less than 7 ft. above ground were heavily browsed (Figure 1). By the middle of August, the bull elk had grown new antlers and lost their velvet. When observed again on September 6th, many more of the willow poles were girdled by bull elk. In addition, the bulls had twisted and broken many more small branches. The breakage reduced some of the willow cluster plantings to single stems, which made them more vulnerable to subsequent rubbing. By September 19th, 37 of the 47 willow poles were girdled to a height of 6.5 ft. and had dead tops.

Figure 1. Willow pole clusters, August 1, 2001.

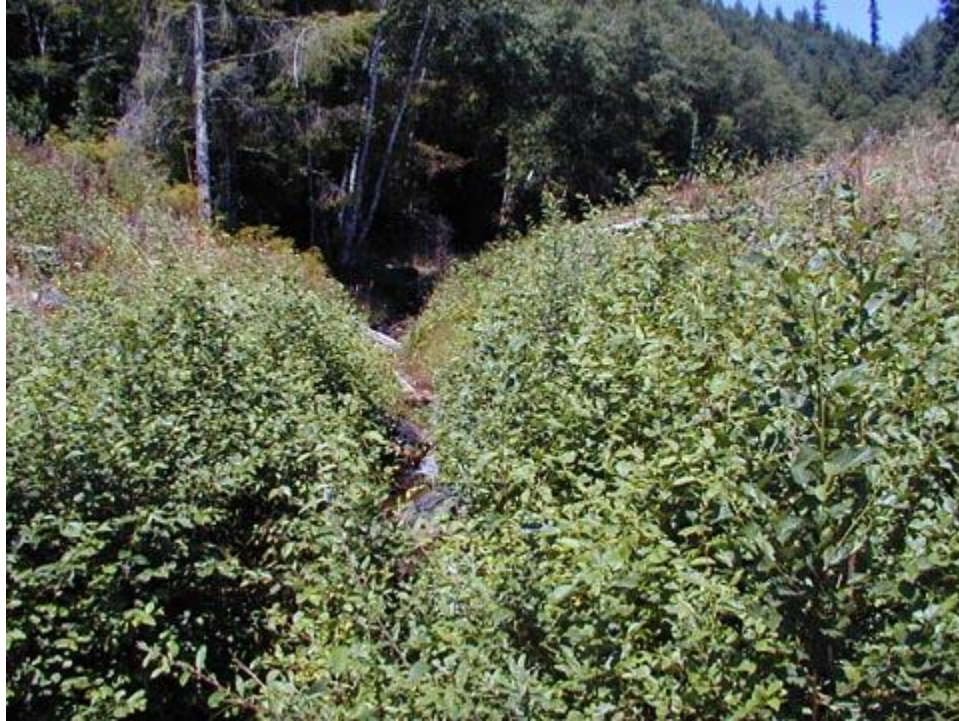
Trees grew rapidly near the culvert inlet on Davison Creek and near the pond where there was plentiful moisture (Figure 2). By the end of September 2001, trees in these locations were 10 to 13 feet tall. Nearly every one-year-old big-leaf maple planted in February 2001 along Davison Creek and along Prairie Creek was heavily browsed.

Figure 2. Alders along Davison Creek, August 1, 2001.
