Summary Report

WATERSHED RESTORATION UNIT 00-1

A100 and A200

Redwood National Park

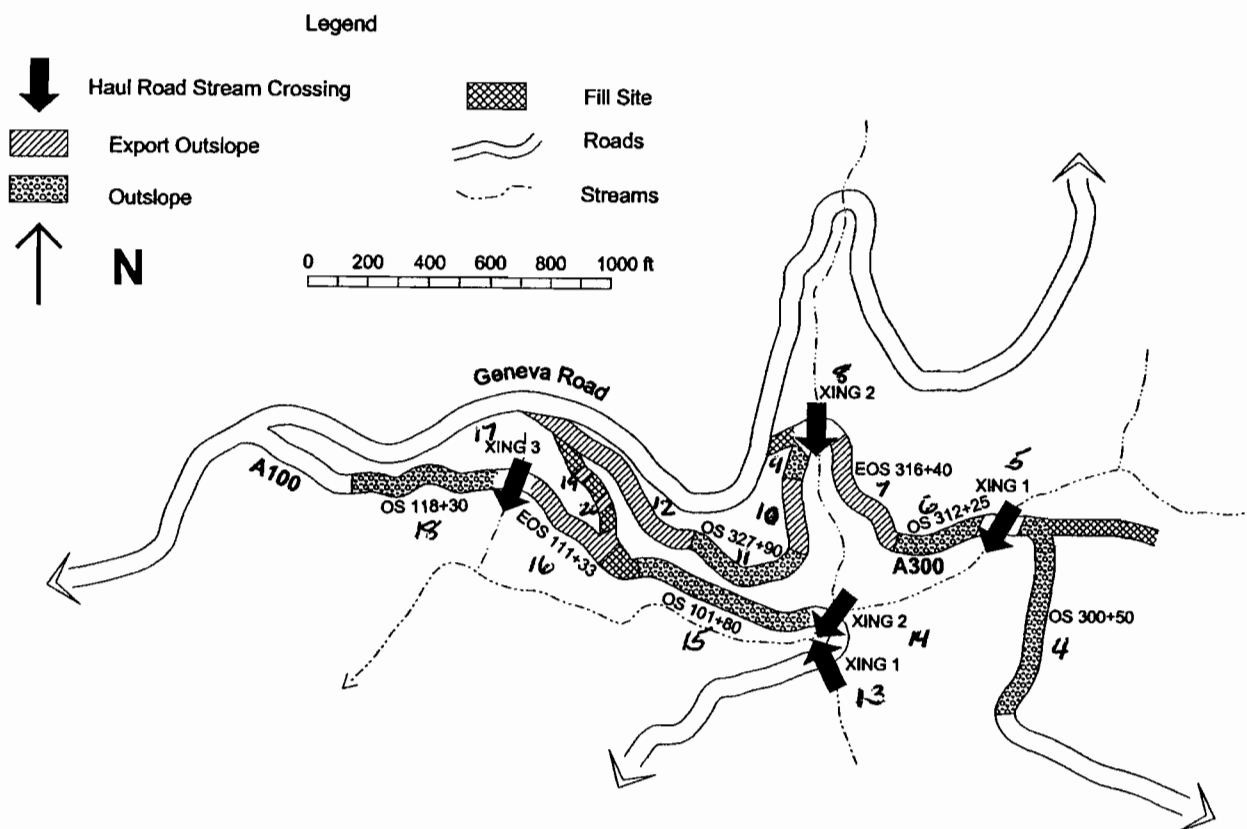
Figure 3: Location of Treatment Types on the A100 and A300. Work on the A300 was not done in 2000.

The heavy equipment phase included completion of all primary restoration treatments. A total of 0.5 mile of the A100 and 0.9 mile of the A200 were removed at a total heavy equipment cost of \$219,586. A total of 47,184 yds<sup>3</sup> of material was excavated from 7 haul road stream crossings (19,510 yds<sup>3</sup>), 9 skid road stream crossings (2,931 yds<sup>3</sup>), 1613 feet of haul road export outslope (6,892 yds<sup>3</sup>), 150 feet of skid road export outslope (1,914 yds<sup>3</sup>), 3738 feet of haul road outslope (14,727 yds<sup>3</sup>), and 780 feet of skid road outslope (1,210 yds<sup>3</sup>). The haul road surface was ripped prior to placement of fill on fillsites.

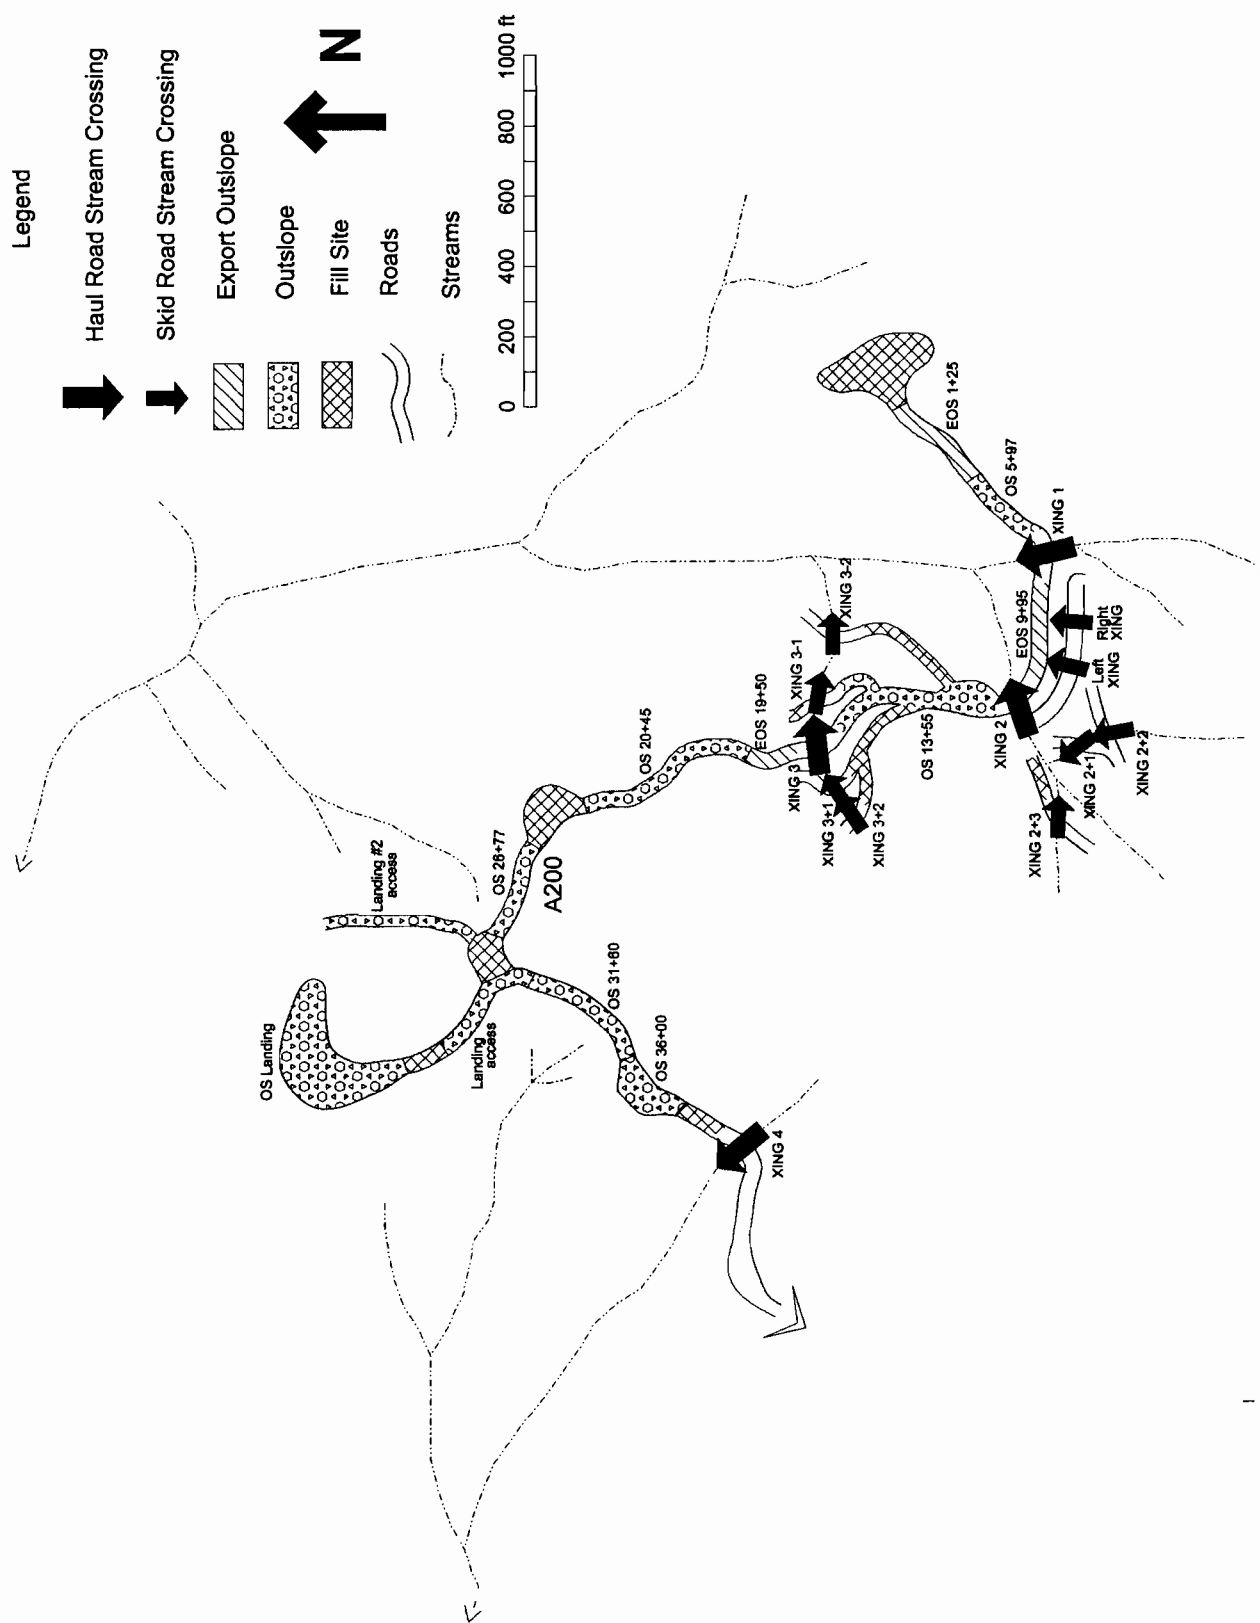
Figure 4: Location of Treatment Types on the A200
