Subject: Coho Salmon Habitat Restoration Project, Prairie Creek, Humboldt County,  
California

MORPHODYNAMIC INVESTIGATION OF PRAIRIE CREEK &

DESIGN CRITERIA FOR A PROPOSED

COHO REARING/ OVERFLOW CHANNEL

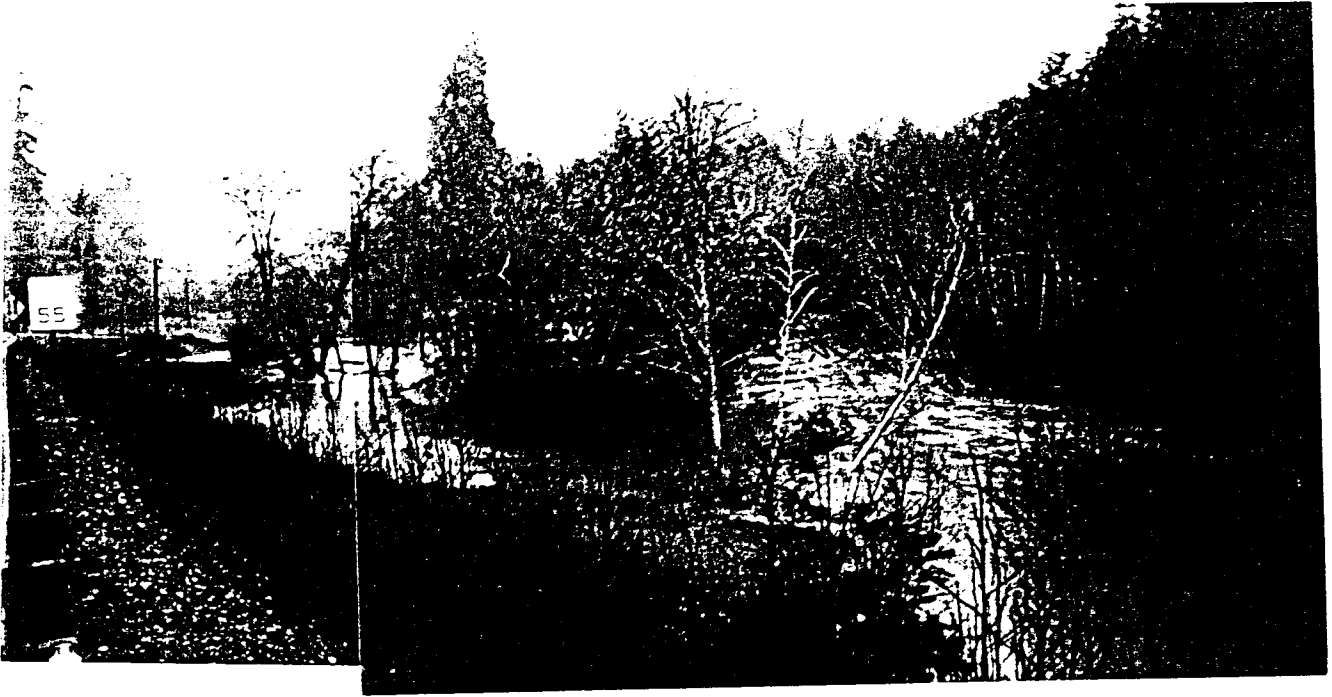
Figure 17:a: Upper part of project site and Prairie Creek looking downstream (southwest) from the edge of Hwy 101. Note the water flowing over the Caltrans-engineered terrace, the debris jam fronting it and the tilted alder in the center foreground.

On December 30, 1995, Prairie Creek witnessed a 12-15 year flood event (Randy Klein, personal communication, 1996) with peak stage at the project site lasting at least 5-6 hours. Mitch Farro took photographs of the project site between 10:00 and 12:00 that day. Robert Capriolo who visited the site around 5 a.m. reported similar stages as those shown in the photographs. The photos allowed us to survey the water surface elevations during this flood event and to recreate the hydrodynamic processes of the flood across the project site (See Figure 17a-f).

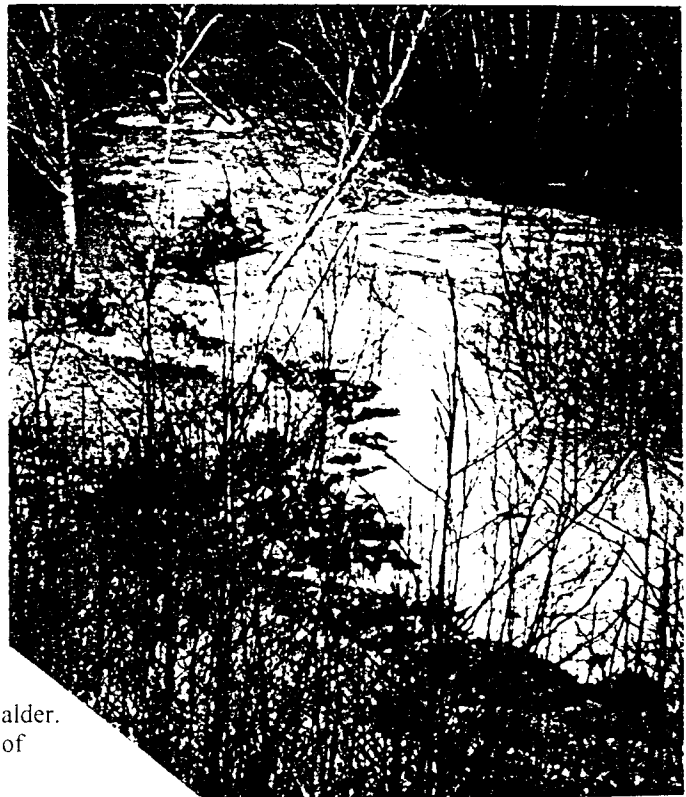
Figure 17b: Close up of the channel. In the center foreground, note the debris jam and tilted alder. In the center background, note the cluster of alders falling into the creek from the west-side terrace.
