National Park Service  
Cultural Landscapes Inventory  
2005

Stanton Park  
National Capital Parks-East - Capitol Hill Parks

## Stanton Park

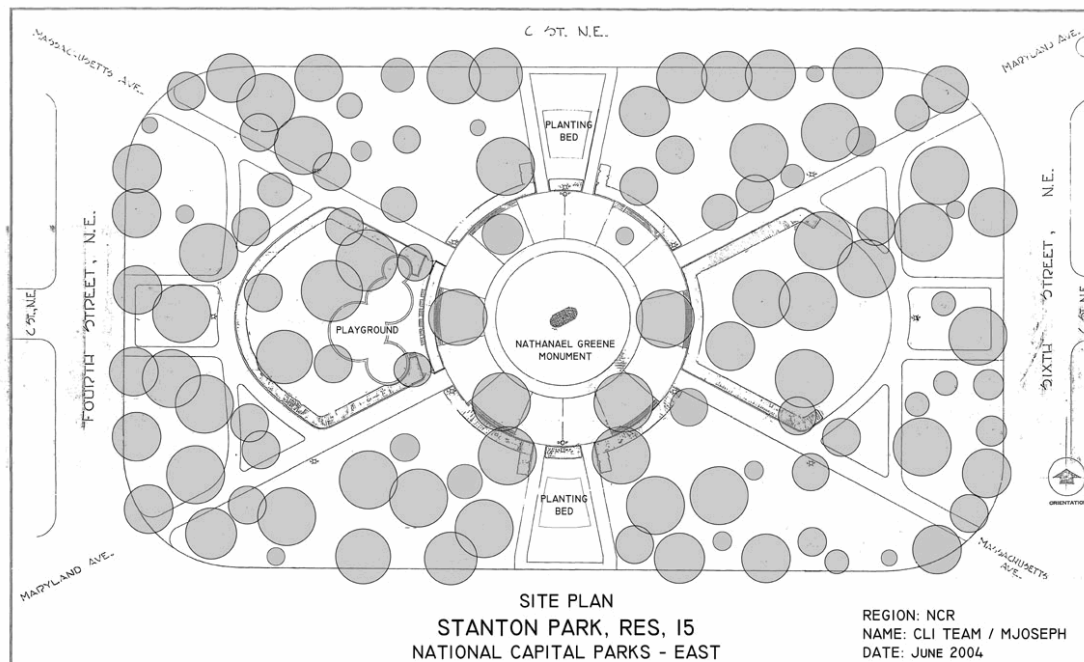
*Updated Site Plan, June 2004 (Corrected and annotated by CLP, June 2004). Based on "Planting Plan, Stanton Park, Res. 15," revised 1987. (NPS-TIC 820/80000 B.)*

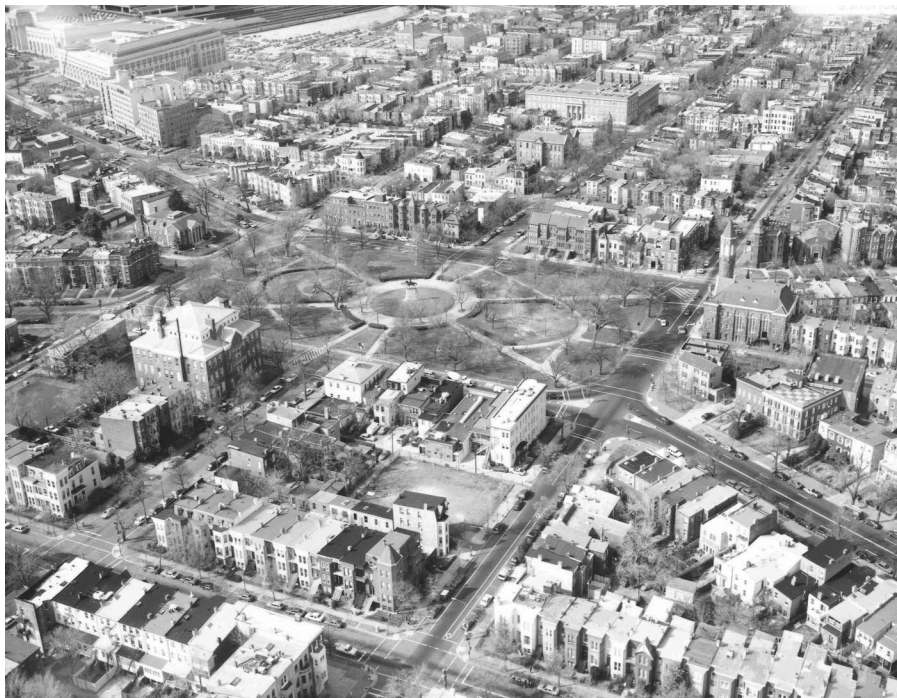
*Aerial view of Stanton Park. National Park Service photograph by Jack E. Boucher, HABS, 1993.*

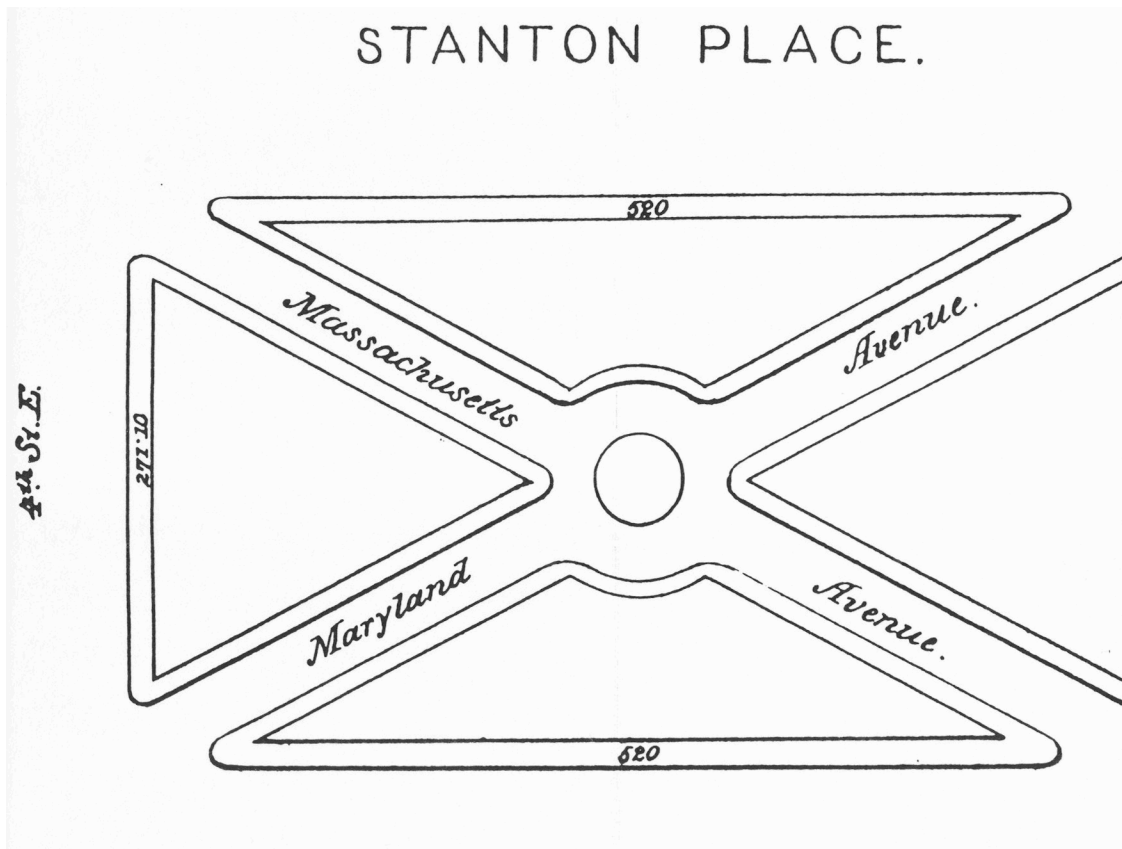
*Earliest known plan of "Stanton Place," 1876. City Lots, Washington, D.C. Real Estate Directory, 1876. National Archives and Records Administration, Record Group 42, Series 230.*

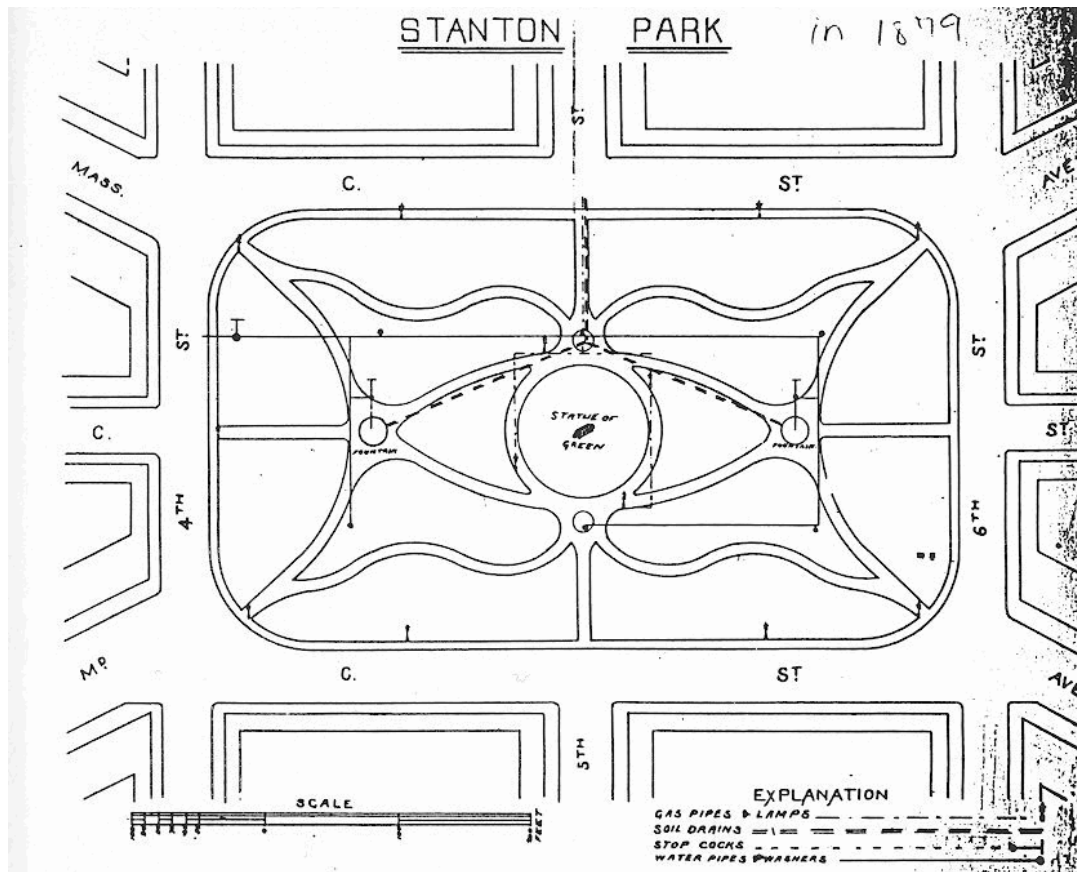
*Appearance of Stanton Park by 1879 with newly designed paths and installation of Greene statue. (Annual Report of the Chief Engineers, 1885)*

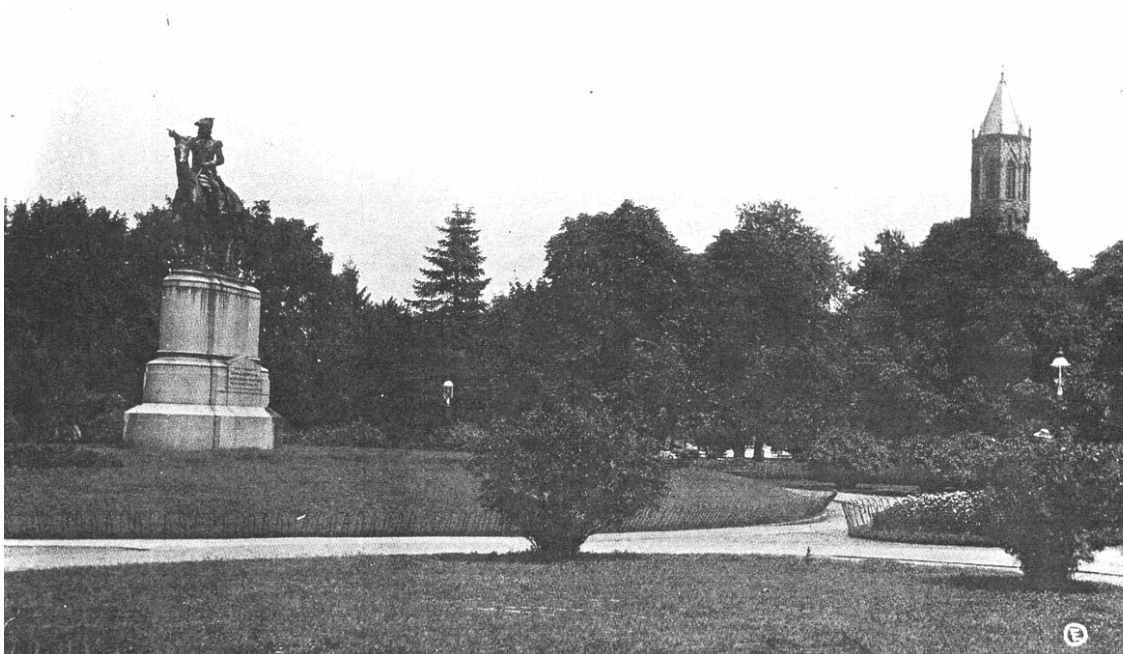
*One of the few photographs showing the 1879 design with the central walkways around the Greene statue, round planting beds and individual specimen shrubs, 1912. (Historical Society of Washington, D.C., Gen. Photo Coll., CHS 2803)*

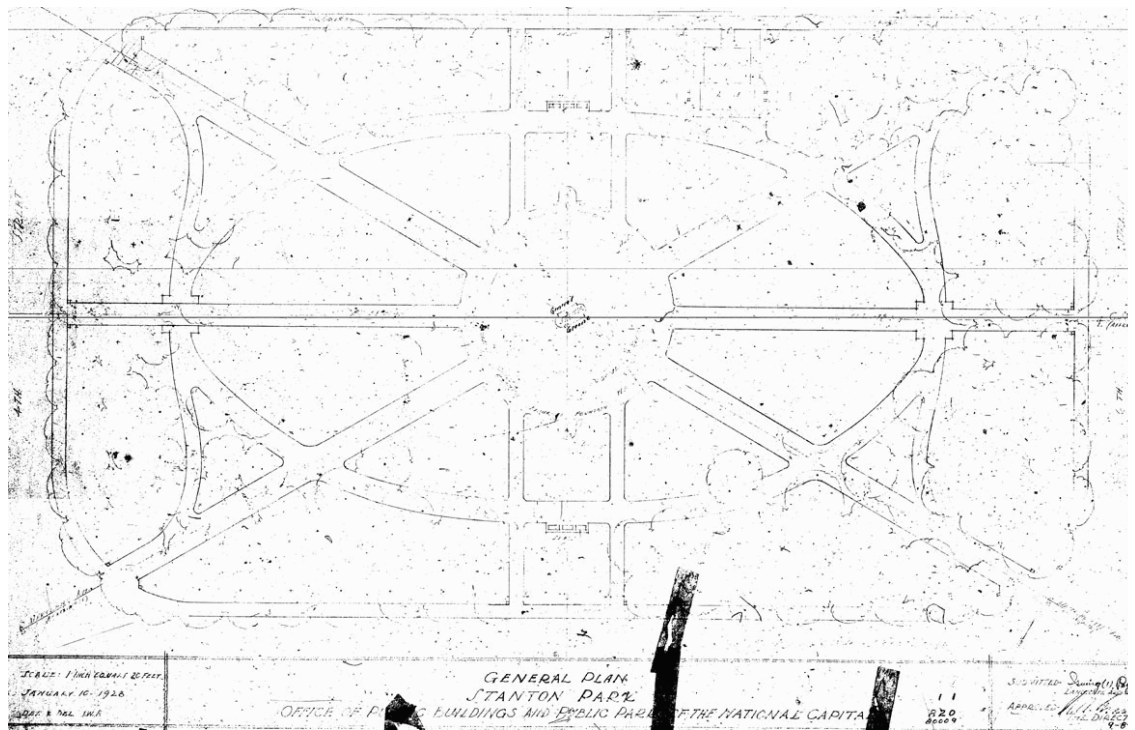
*Irving Payne's proposed redesign for Stanton Park, 1928. Note the C Street east-west walkway through the park. (NPS-TIC 820-80009)*

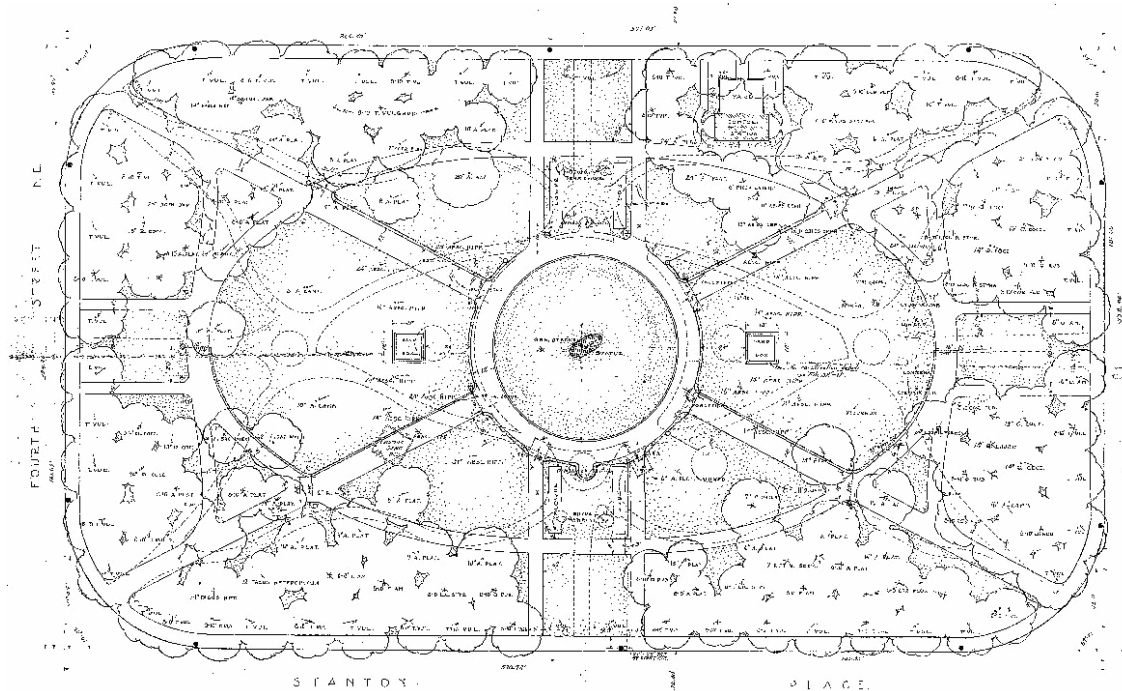
*Final 1930s redesign, based on Payne's 1928 plan, showing realignment of walkways and location of proposed plantings, overlaid on the 1879 design. (NPS-TIC 820-80012.)*

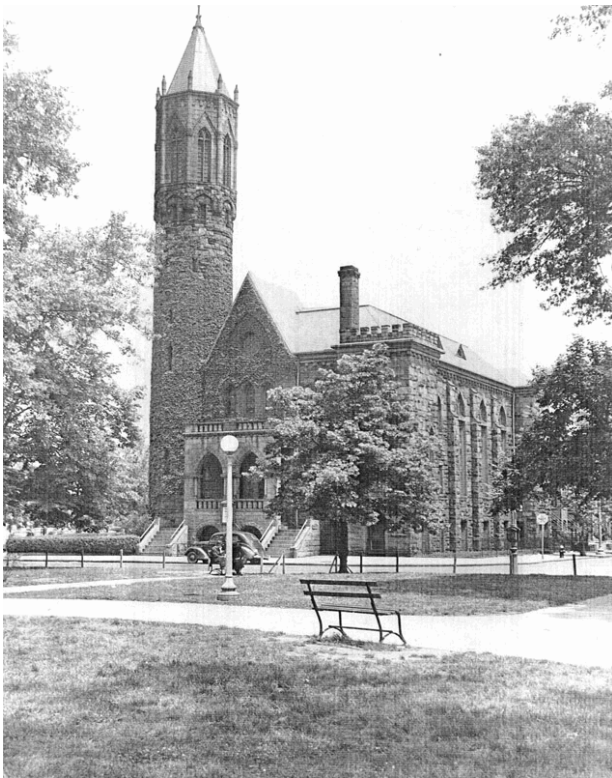
*Eastern Presbyterian Church and east end of Stanton Park with redesigned walkways and new benches and globe lights, May 30, 1942. (MLK, Washingtoniana Division, Washington Historical Image Collection)*

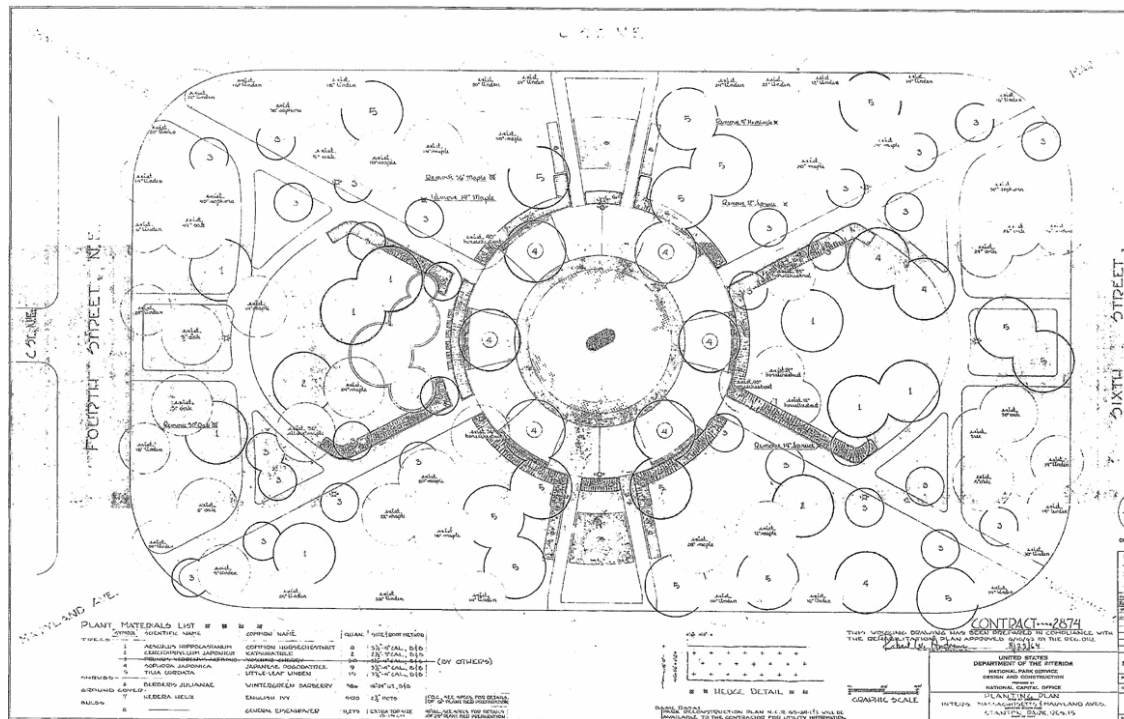
Revised 1964 site plan shows central plaza, realigned north-south walks, placement of playground and modified planting arrangement. (NPS-TIC 820/80000.)

By 1963, the number of trees was less than in 1933. The groupings of trees along the great oval had been replaced by isolated specimen trees. When the NPS implemented an approved rehabilitation plan in 1964, it changed the character of Stanton Park's vegetation in some areas. The approved 1964 plan called for the establishment of Yoshino cherry (*Prunus x yedoensis*) along the two diagonal axes in the park and the planting of six Japanese pagoda trees (*Sophora japonica*) in tree wells within the central plaza. Behind the new continuous wood-and-concrete benches, the NPS installed a barberry hedge (*Berberis julianae*) which followed the outer edge of the central plaza. The hedge continued along the inner diagonal walks and ended at the intersection with the great oval walk. Seasonal flower displays were expanded in a band around the inner edge of the circle and English ivy (*Hedra helix*) covered the once grassy mound up to the Greene statue. The rectangular flower beds introduced in 1933 to the north and south of the central plaza were modified into trapezoid shaped beds. Although the Yoshino cherry trees were recommended on the 1964 plan, they were not planted until 1978. The NPS removed the barberry hedge in 1987 and replaced it with gnome pyracantha (*Pyracantha x 'Gnome'*), expanding the hedge to the west around the play area to enclose the space.

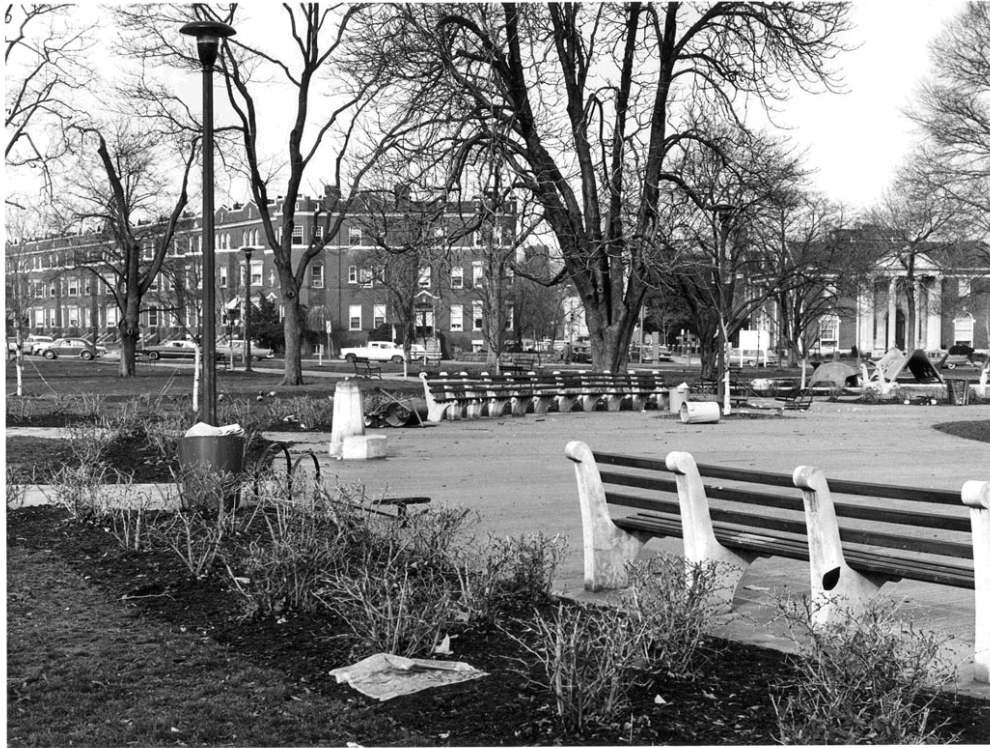
*Newly installed central plaza, continuous concrete and wood benches and mushrooms lights, March 19, 1965. Photo by Abbie Rowe. (MRCE Photographic Collection, Box PH-27 Acc.216)*

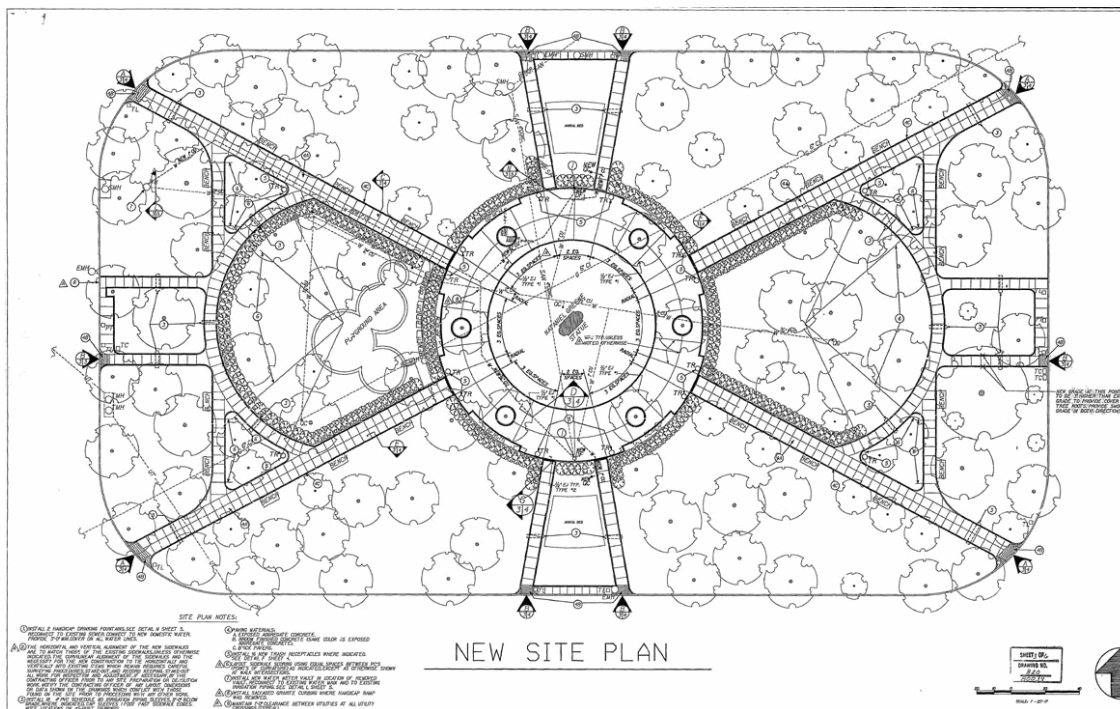
*Rehabilitation Plan for Stanton Park, 1992. (NPS-TIC 820/80039.)*

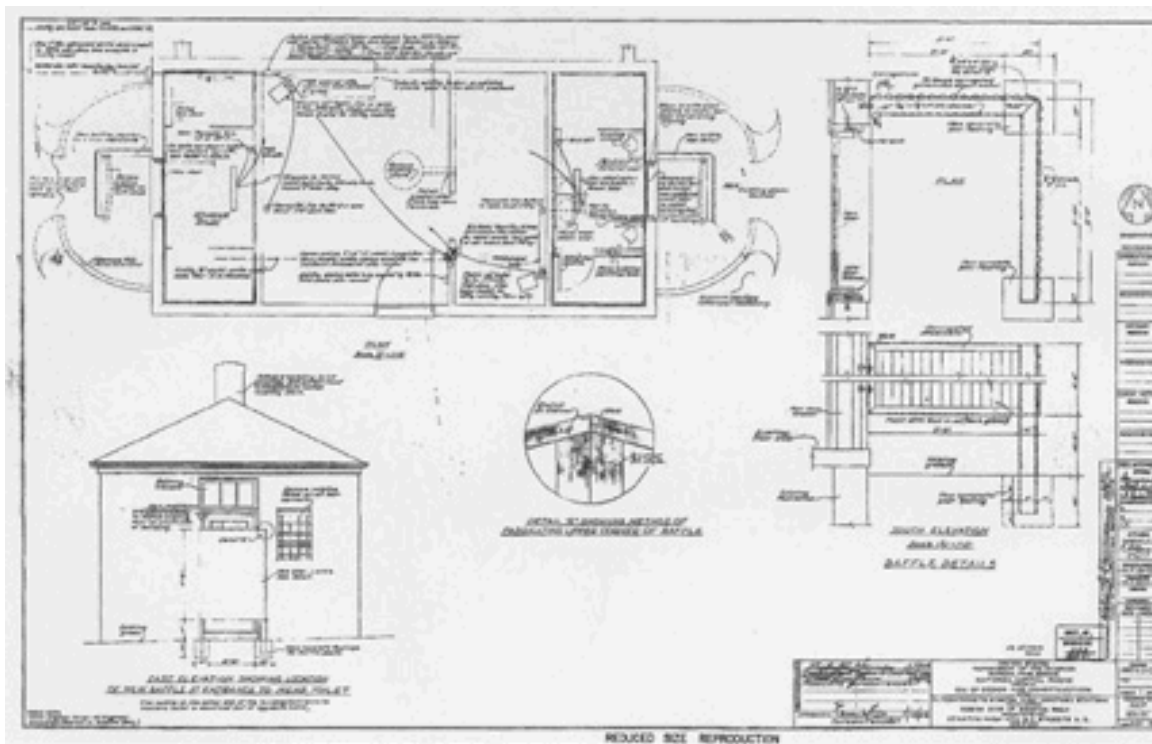
*Stanton Park Lodge, 1957. Rehabilitation construction drawing. (NPS-TIC 820-80021.)*

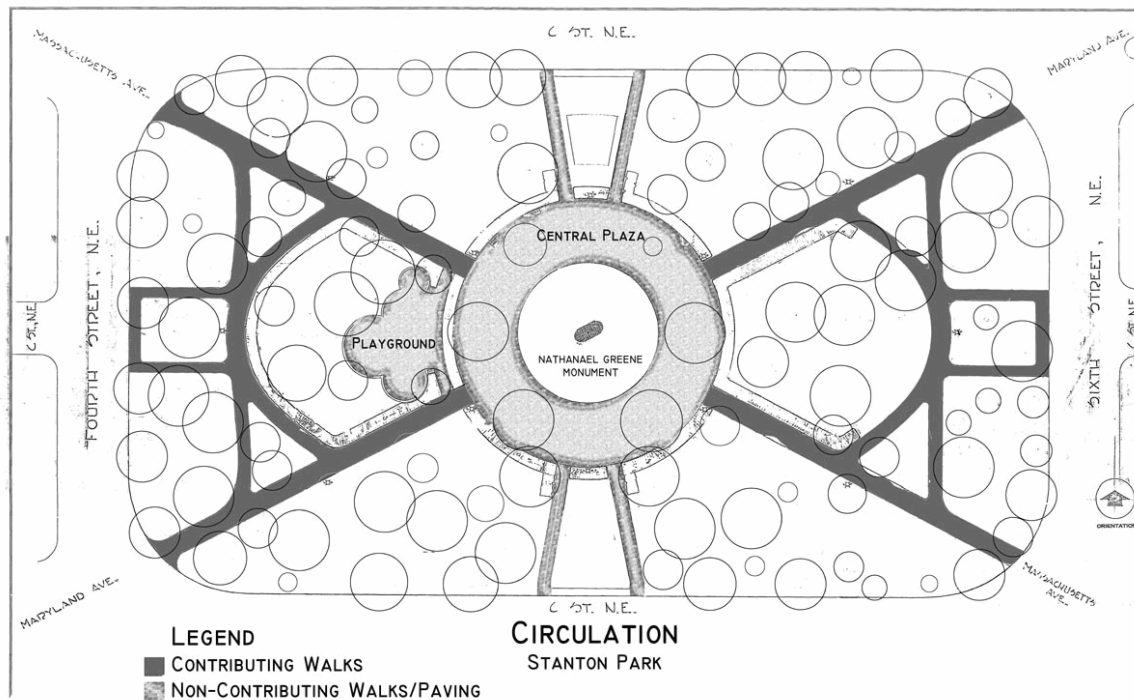
*Depicts current circulation pattern at Stanton Park and the 1964 design modifications that affected the 1930s design. (CLP, 2004.)*

In the 1930s redesign, the winding paths were replaced by straight bituminous asphalt walkways leading in from the four corners and the four sides, converging like the spokes of a wheel at the central circle; these walks were all joined by a "great oval walk" centered on the park. (Irving Payne referred to this walkway as the "great oval walk" on his 1930 plan. NPS-TIC 820/80012) The perimeter brick sidewalk remained.

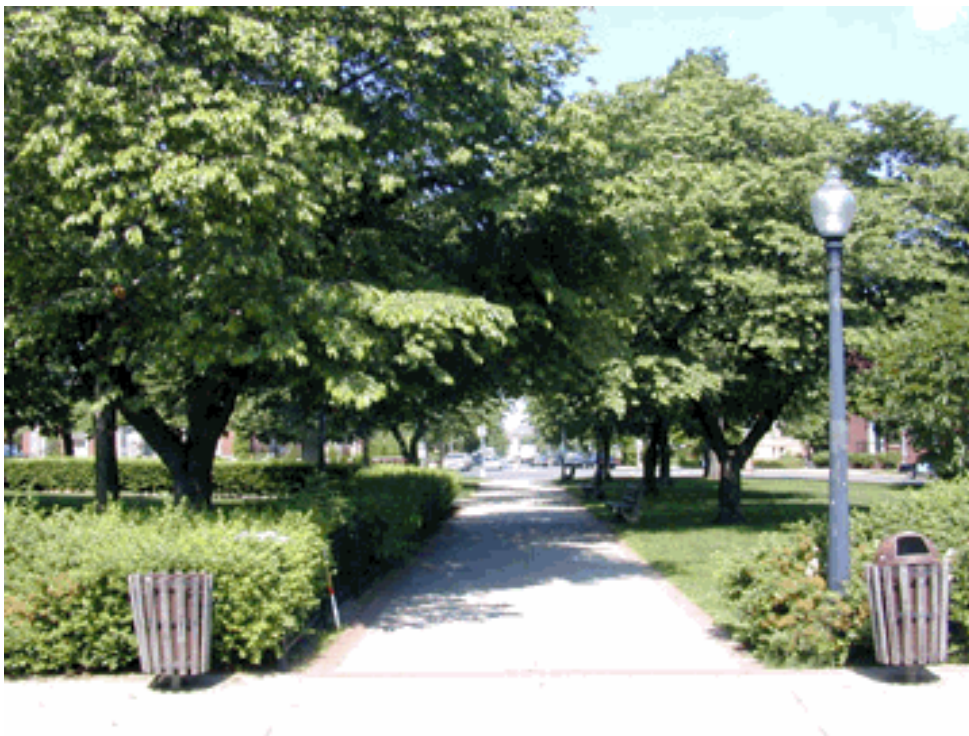
*Yoshino cherries line one of the diagonal paths through the park. View is from Nathanael Greene statue at central plaza to the northwest. (LCS photo, June 2000)*

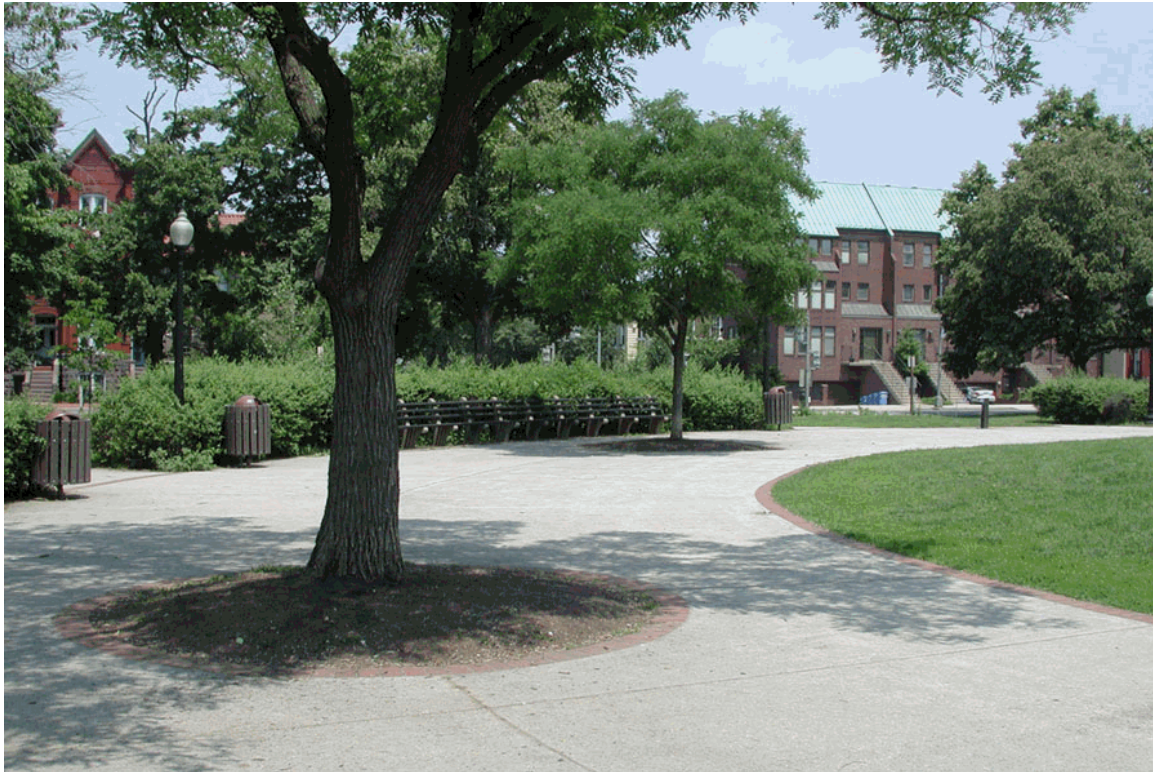
*Wide central plaza around Greene statue installed in the 1960s. (CLP photo, June 2004)*

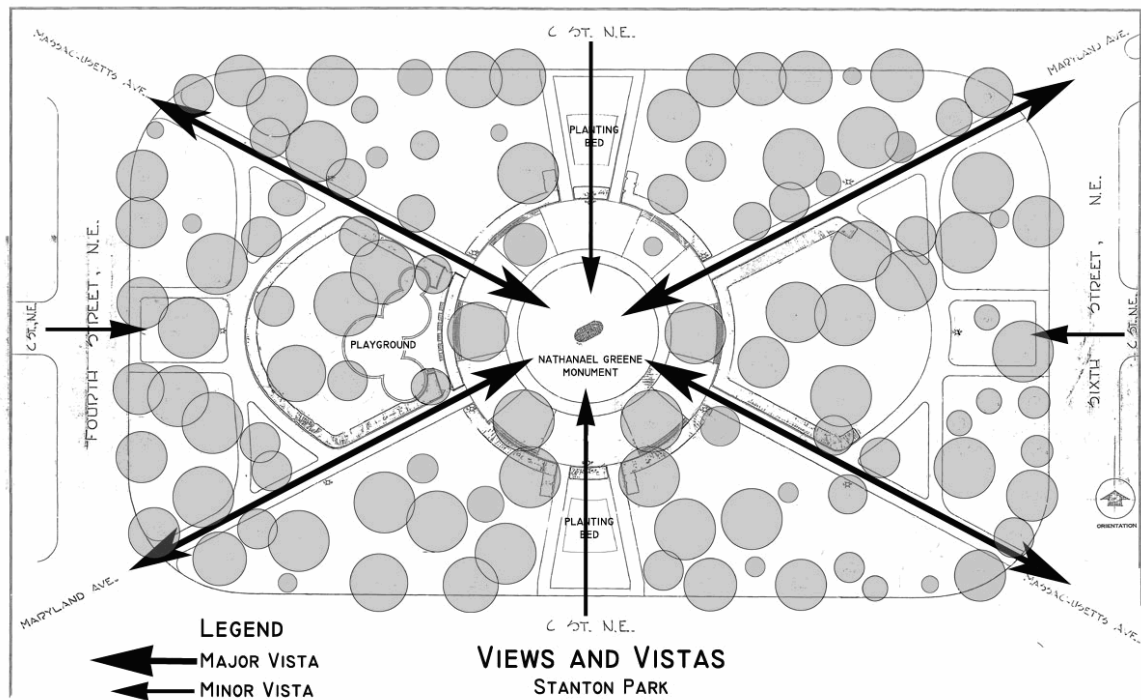
*Designed vistas created by the 1930s redesign of the park are still apparent at the park. (CLP, 2004)*

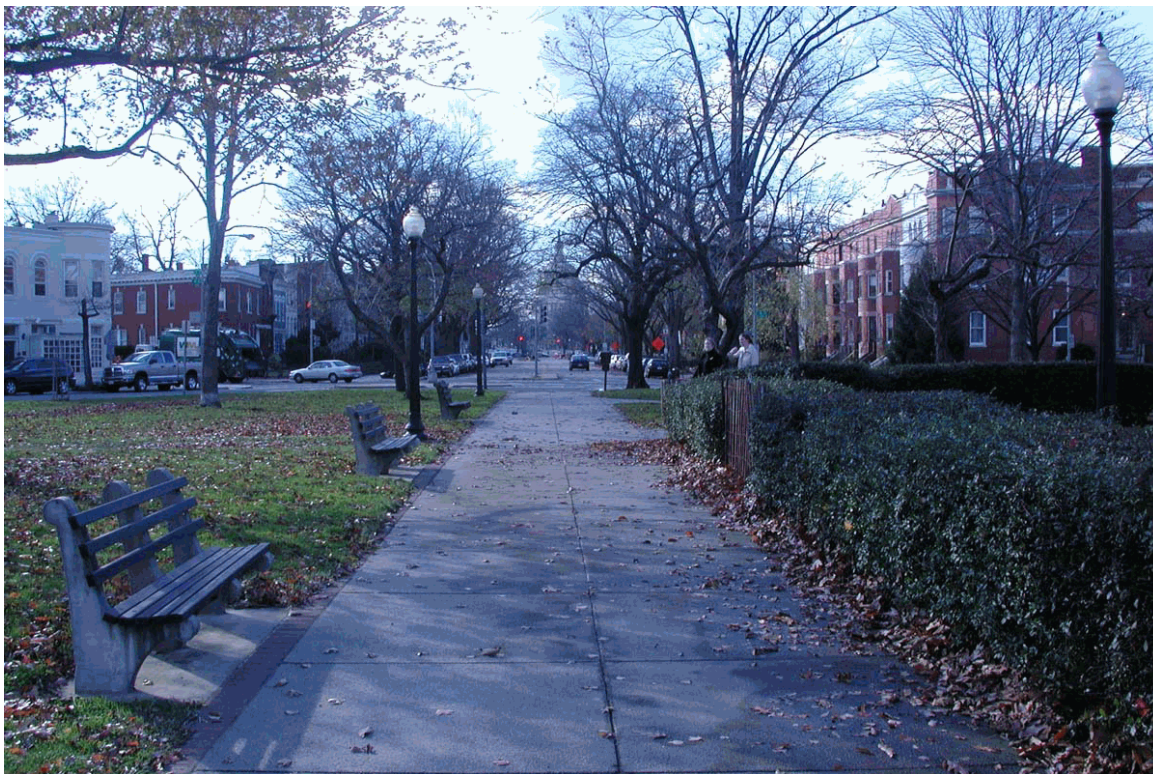
*Axial view to U.S. Capitol accentuated by placement of flowering cherry trees. (CLP photo, Dec. 2004)*

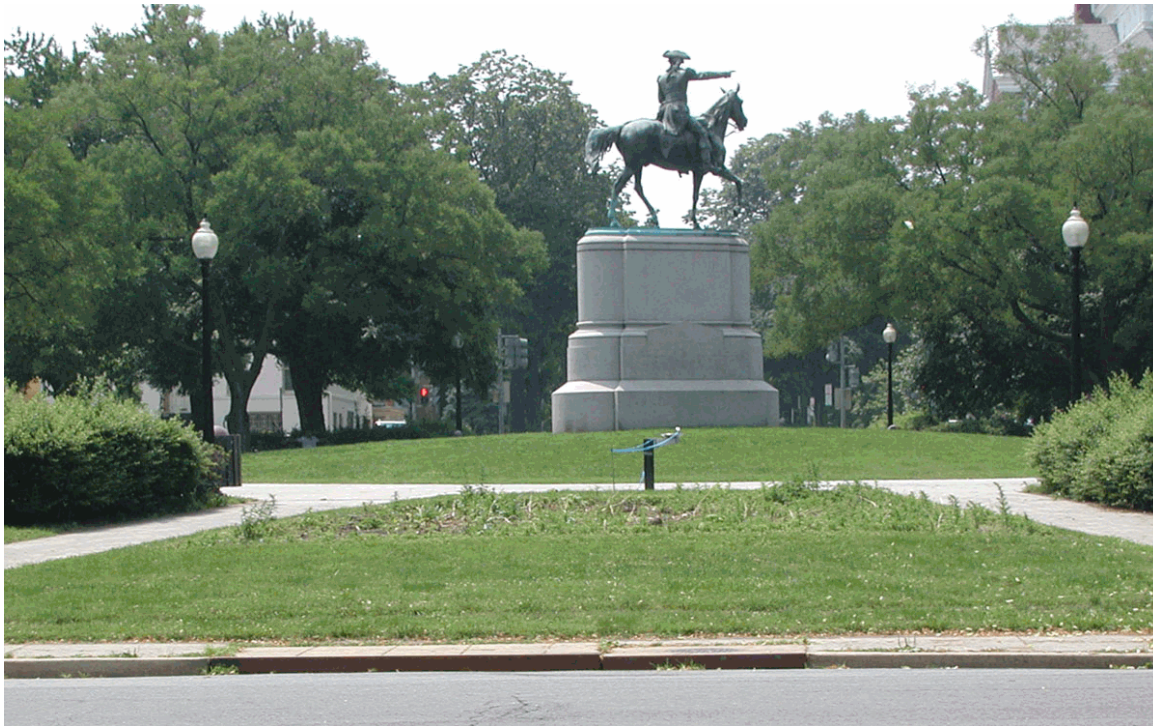
*Prominent vista from the north along the 5th Street axis to the Greene statue. (CLP photo, June 2004)*

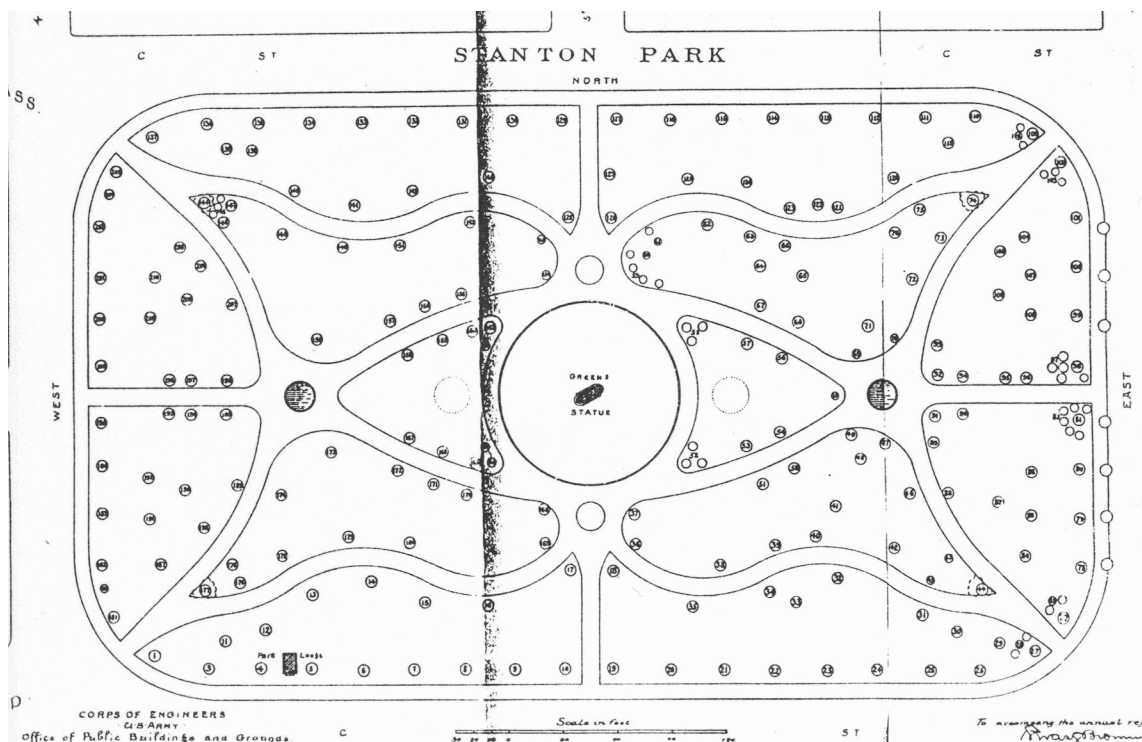
*Tree placement and flower bed locations shown for Stanton Park, 1905. (Annual Report of the Chief of Engineers, 1905)*

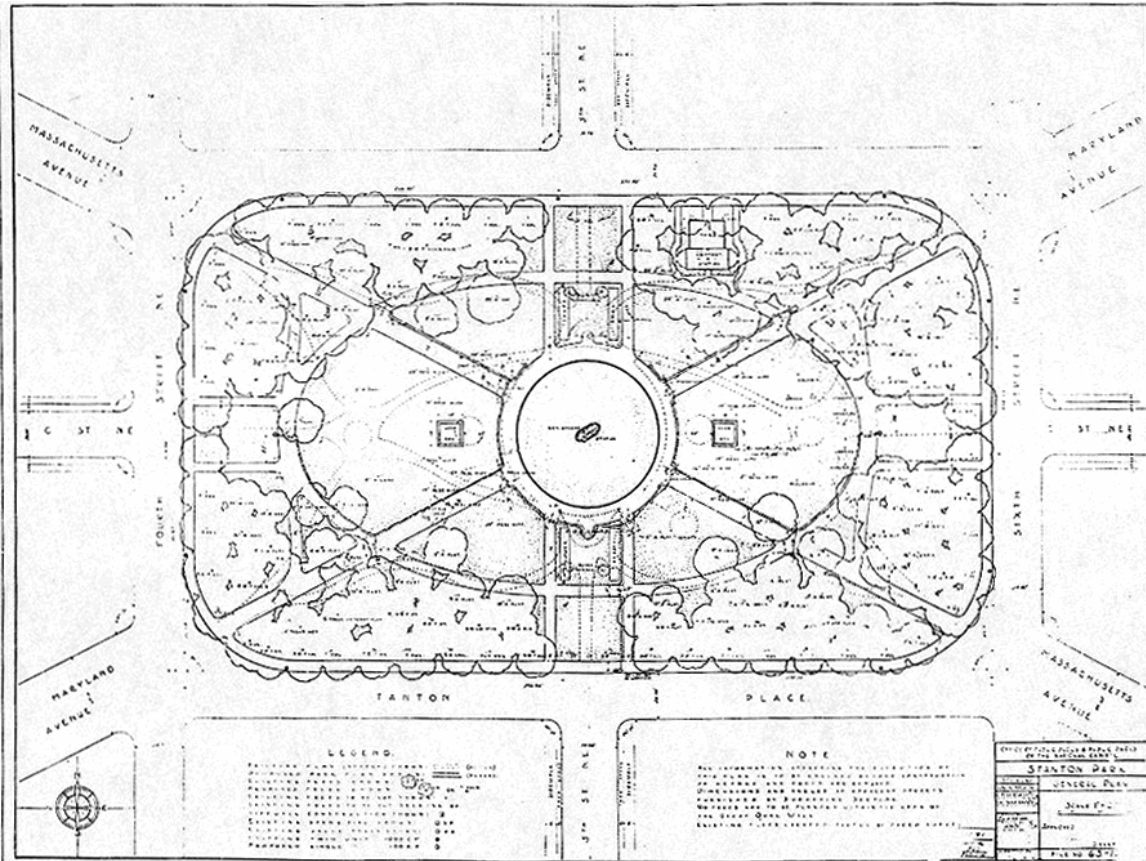
*Office of Public Buildings and Public Parks, "Stanton Park, General Plan, 1930". This shows plantings planned in 1930. (NPS-TIC 820-80012.)*

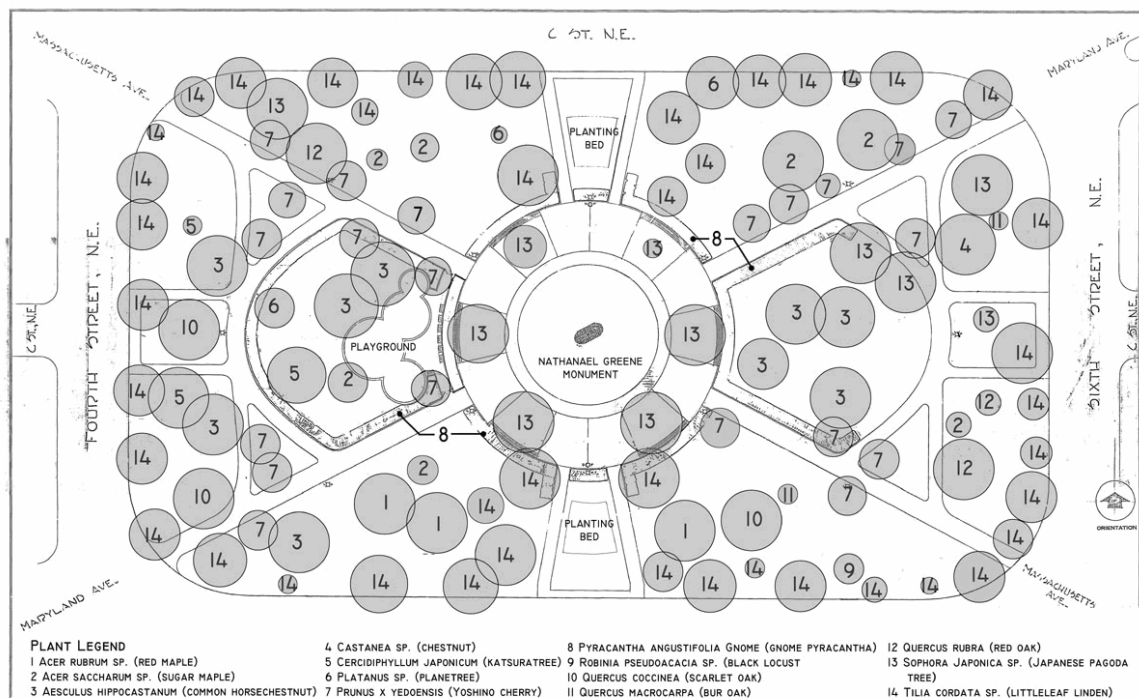
*Existing arrangement of vegetation, 2004. (CLP, 2004.)*

Although the NPS standard operating procedure is to replace mature trees in-kind and in the same location once they die, there are gaps in the line of lindens along the perimeter of the park and other loosely grouped specimens in the interior of the park. Even with the addition of the Yoshino cherry and hedges and Japanese pagoda trees between 1960 and 1978, the historic character of the vegetation has been retained. The perimeter lindens, the interior specimen trees, the presence of annual flower beds north and south of the central plaza, and return of the grassy mound around the base of the statue, represent some of the significant features from the 1930s and earlier designs. The Victorian era arrangement represented by mounds of annual flowers and individual specimen shrubs was abandoned after the 1930s redesign in favor of a simplified layout of canopy trees, turf grass, and two flower beds, which are still evident today.

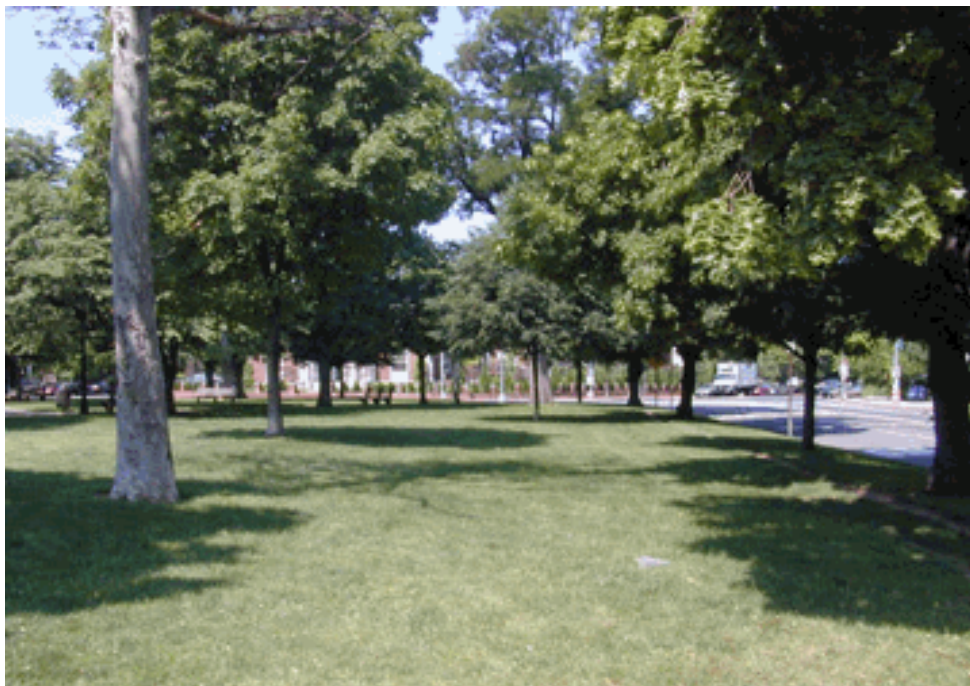
*A single row of lindens border C Steet at the south edge of the park. (LCS photo, June 2000)*

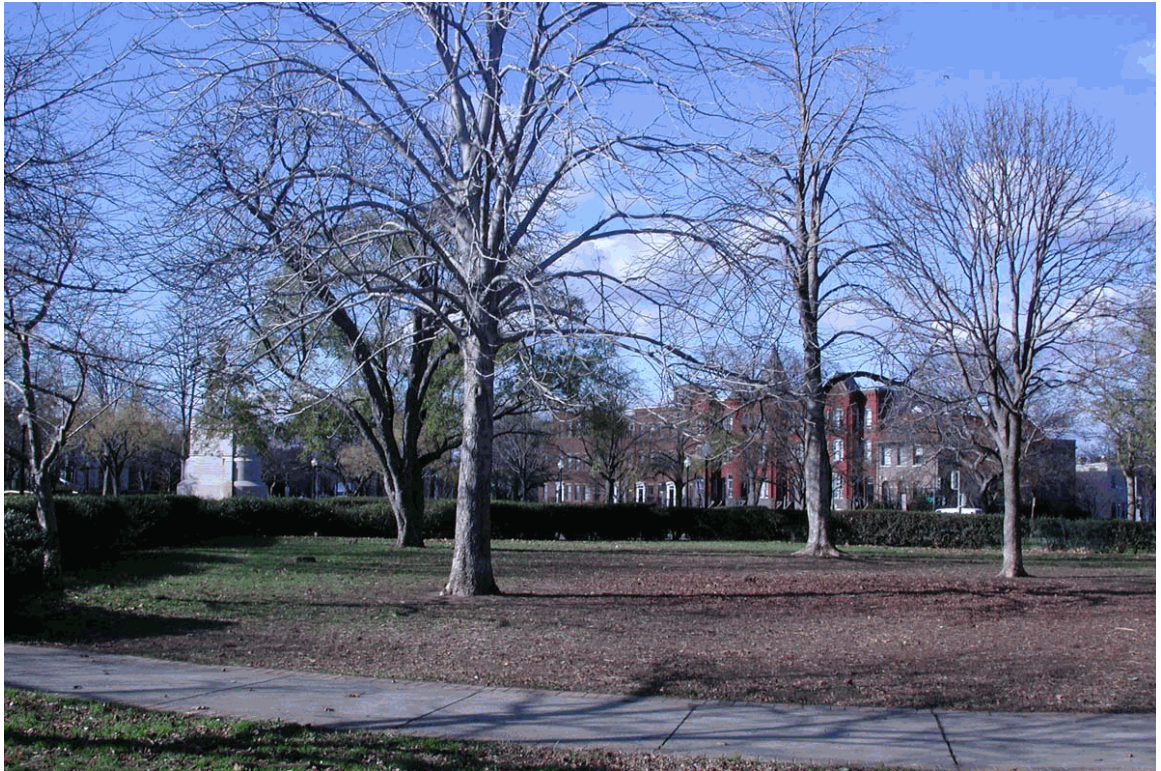
*Stately horse chestnuts trees from the early 1900s shade the eastern portion of the park. (CLP photo, Dec. 2004)*

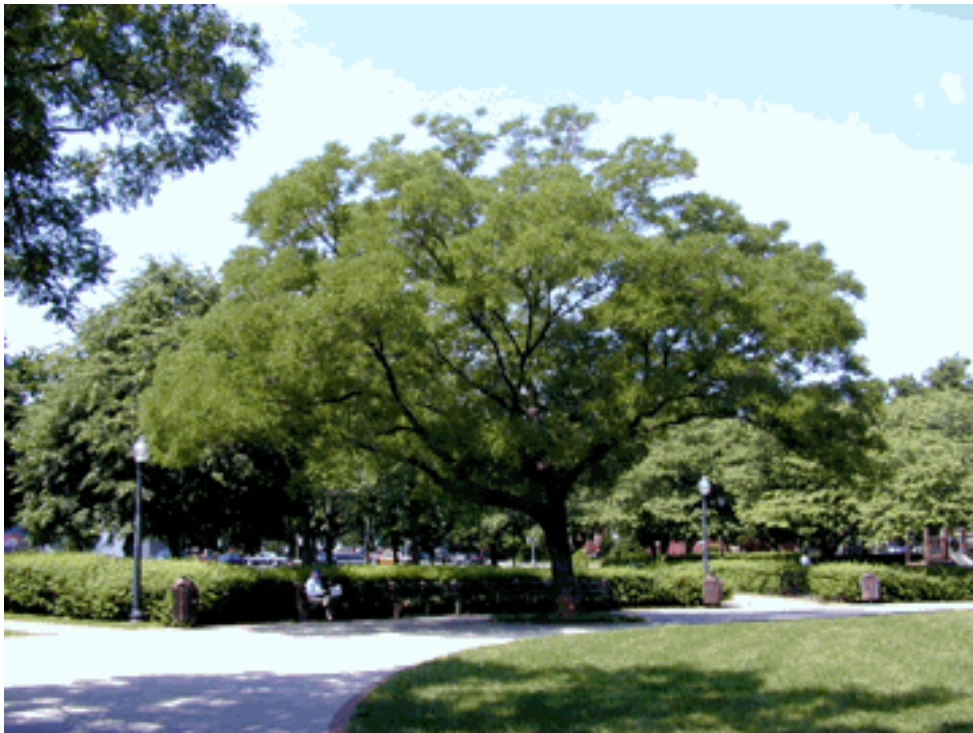
*Japanese pagoda trees and pyracantha hedges ring the central plaza around the Greene statue.  
(LCS photo, June 2000)*

**Impact Description:** To maintain their shape as a hedge, the shrubs are pruned twice a year. Where gaps in the hedge develop due to die back, replacement plants are installed or as an interim measure, snow fencing is positioned in the gaps to prevent cut through traffic.

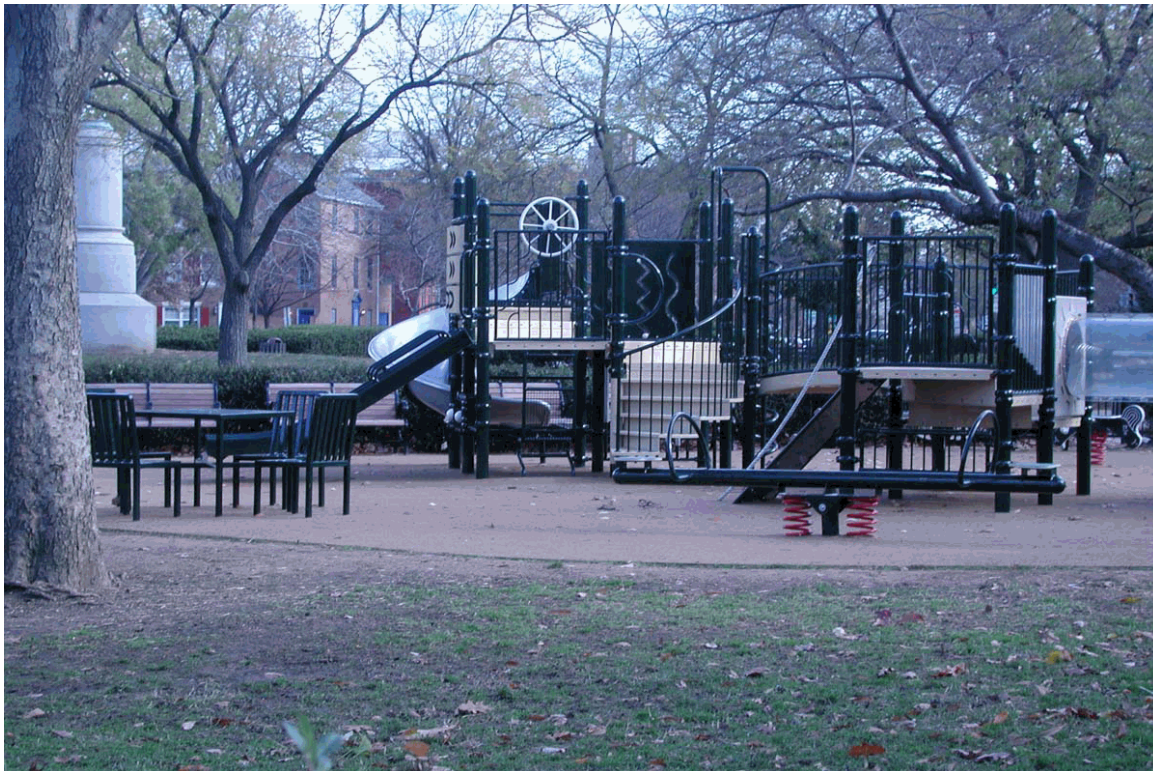
*The new playground structure at Stanton Park. (CLP photo, Dec. 2004)*

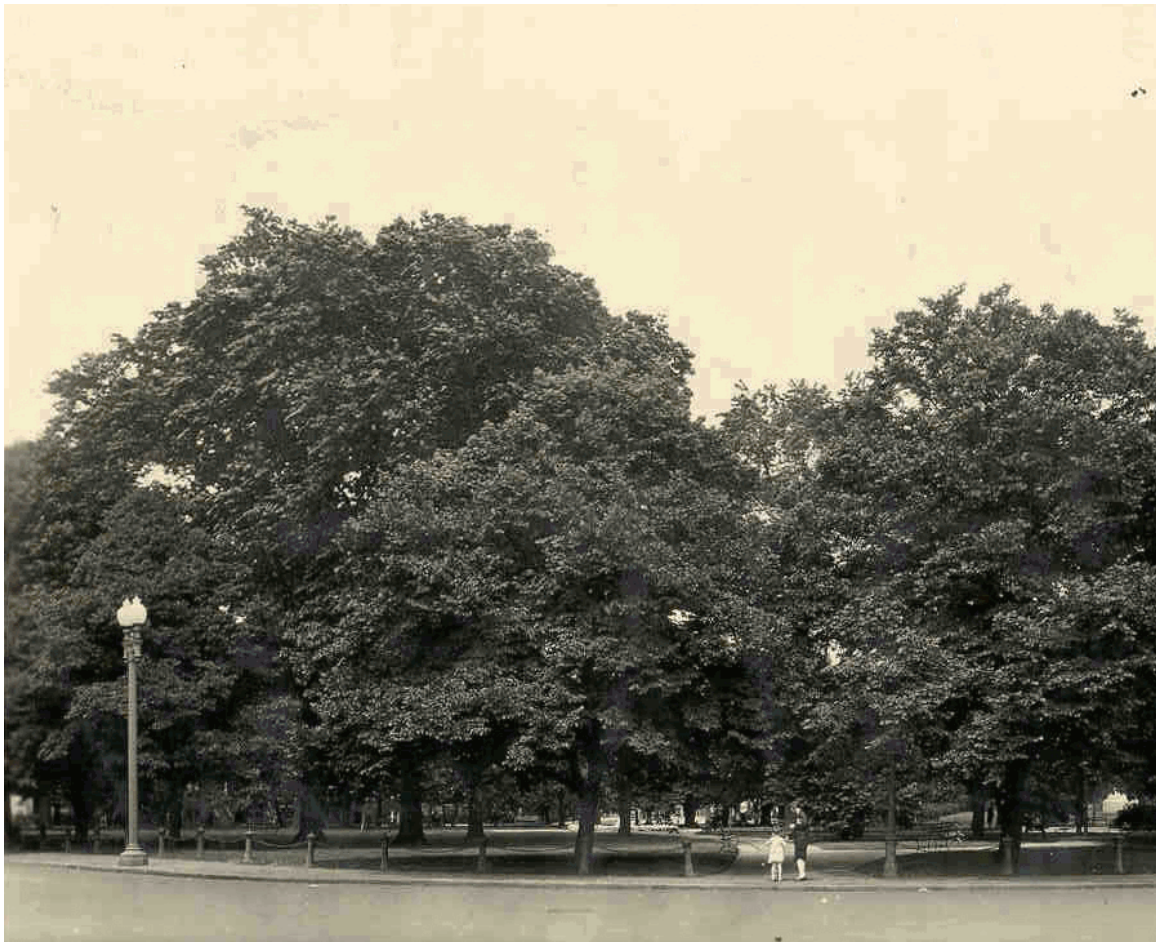
*Perimeter view of Stanton Park. Note twin-twenty Washington Standard lights and standard Office of Public Buildings and Grounds bollards surrounding the park, 1927. (NCR, Division of Lands, Resources and Planning, Reservation File 15.)*
