National Park Service  
Cultural Landscapes Inventory  
2005

Stanton Park  
National Capital Parks-East - Capitol Hill Parks

## Stanton Park

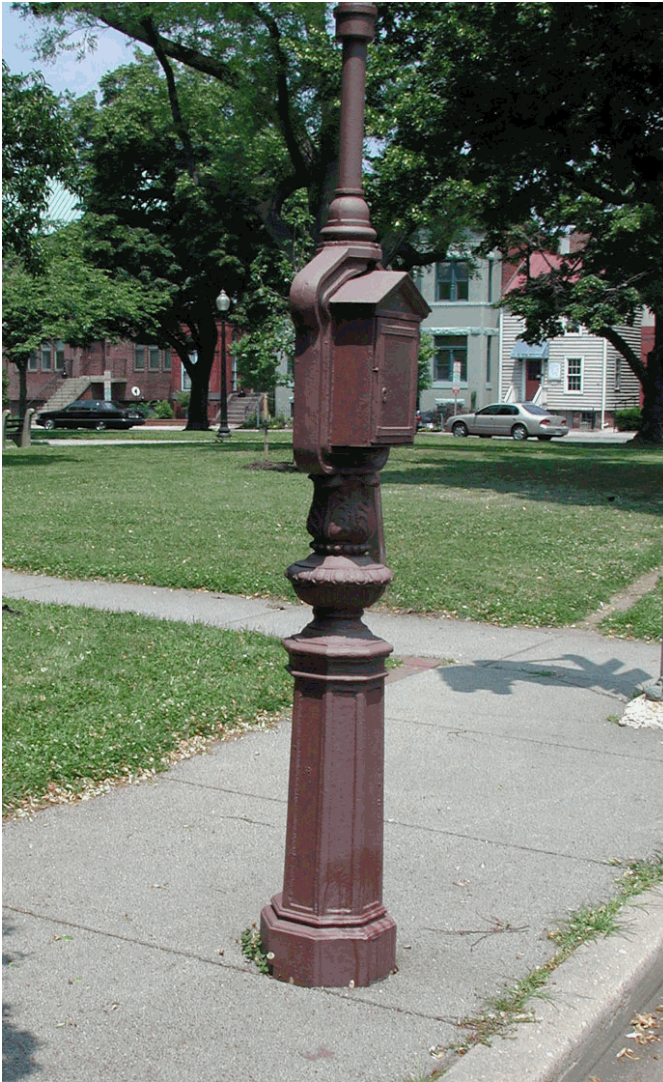
*Original police and fire call box located on the eastern side of the park. (CLP photo, June 2004)*

One unique feature in the park is a fire and police call box, installed by the city around 1933 on the east side of the park along 6th Street N.E. Although this system was abandoned in 1976, the call box remains as a reminder of this earlier era, before residents had their own telephones. The remaining features represent upgrades by the NPS to improve the playground equipment (2004) and replace the aging tulip trash receptacles (2004) and drinking fountains (1992).

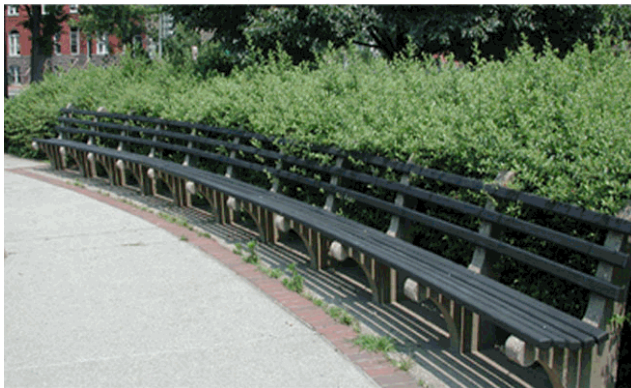
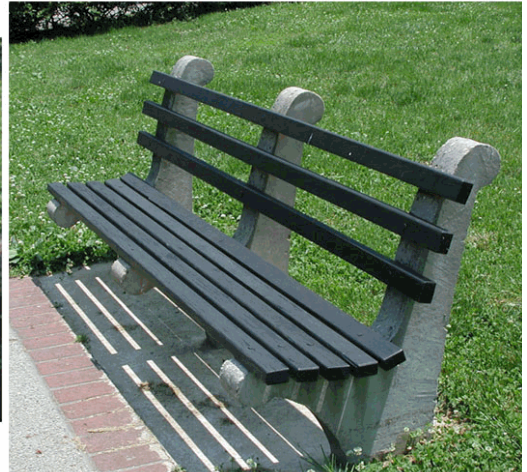
*The 1960s concrete and wood benches. (CLP photo, June 2004)*

**Impact Description:** The wooden benches require frequent maintenance to replace broken or missing wooden slats caused by normal wear, inappropriate use or vandalism. Recent replacement slats used incompatible shape slats for the circular benches causing the

1. Prune dead wood and replace trees and shrubs in-kind in the same location.
2. Reseed the turf once or twice a year to maintain a healthy ground cover.
3. Repair damaged wooden slats on the benches.

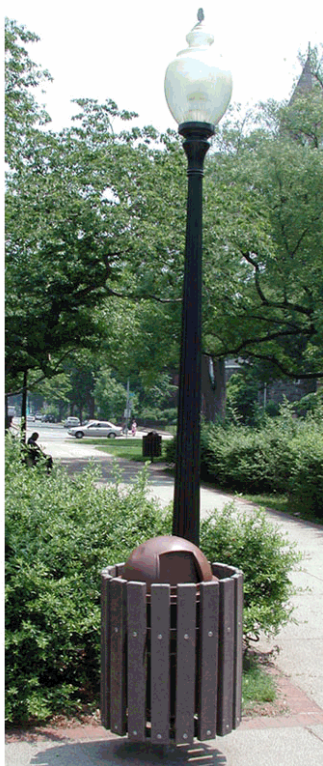
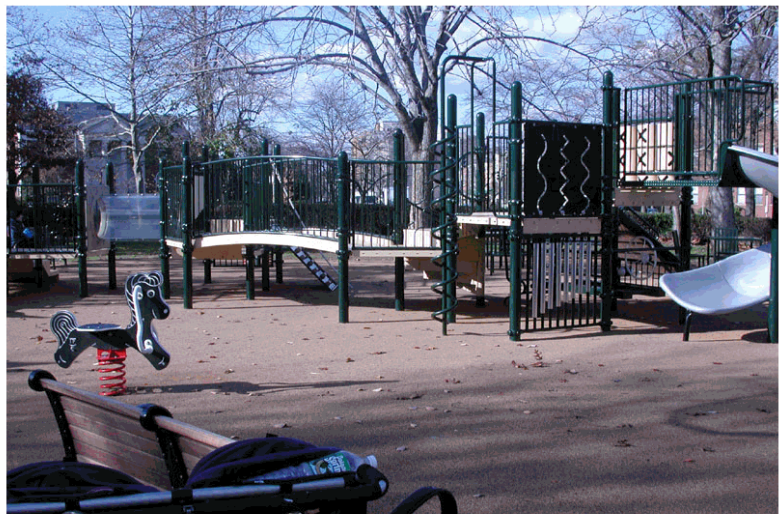
*Replica Washington Standard lights, trash receptacle and new playground (CLP photo, June and Dec. 2004)*
