National Park Service  
Cultural Landscapes Inventory  
2005

Folger Park  
National Capital Parks-East - Capitol Hill Parks

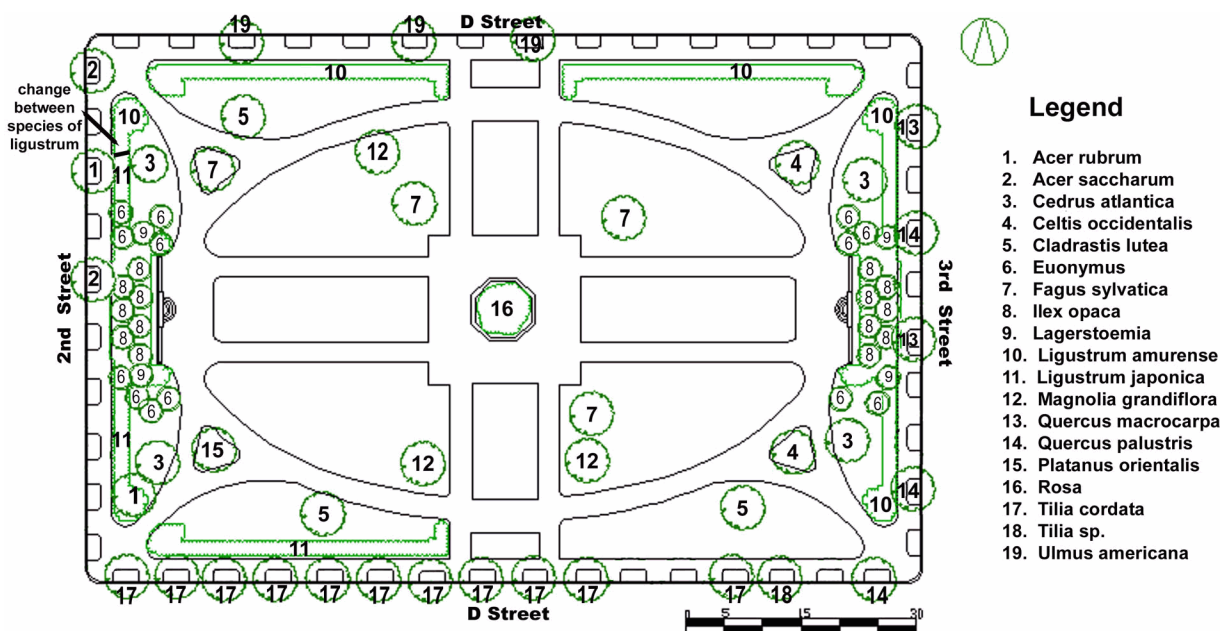
*The site plan of Folger Park reveals the loss of trees around and within the park. (Sept. 2006 Site Plan)*

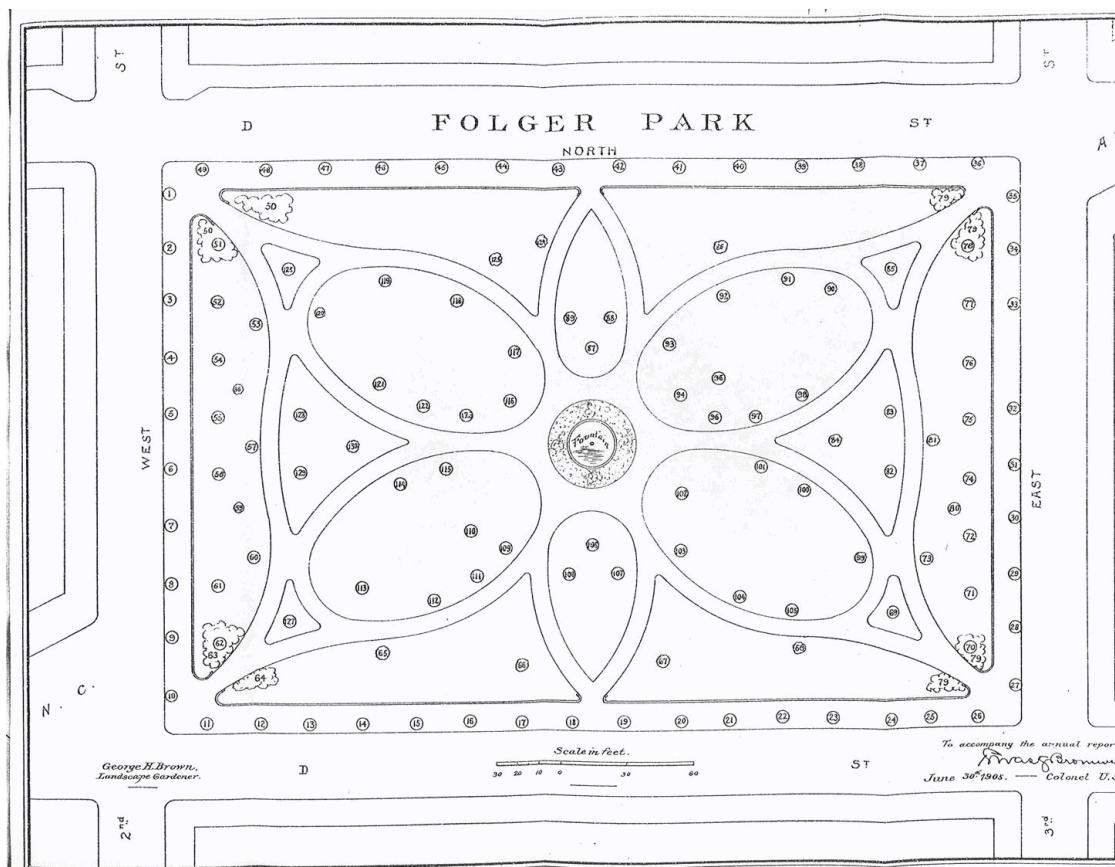
*The intricate path system and dense planting of the first Folger Park design is shown in this plan from 1905. (CLP digital photo, 1905 Survey copy)*

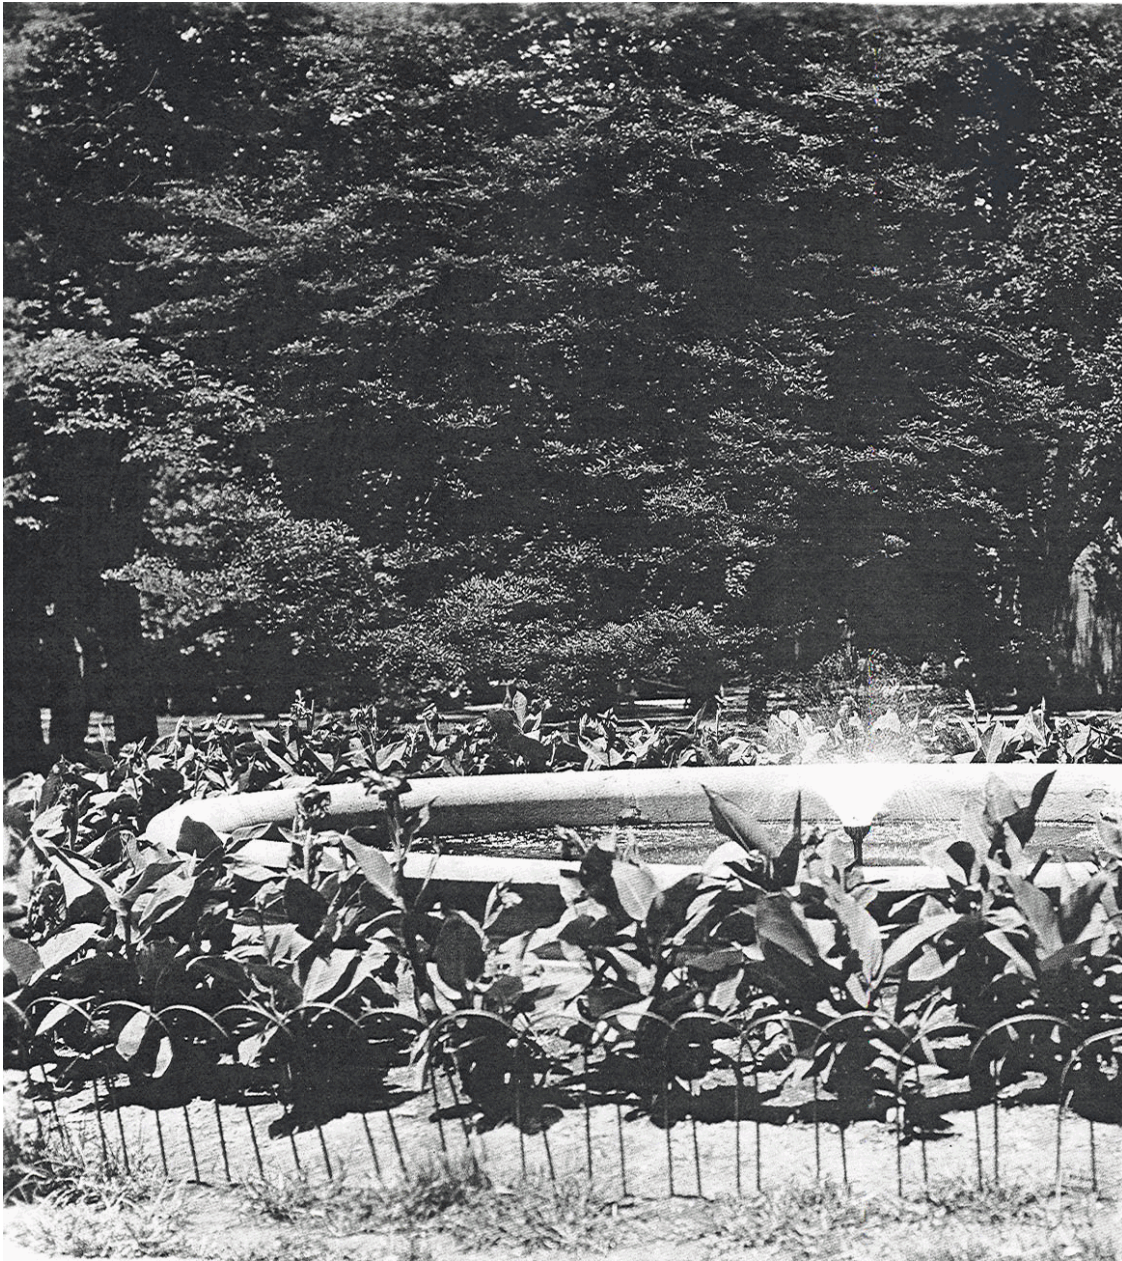
*The Victorian fountain in Folger Park was small, with a granite coping. It resembled the fountain then in Franklin Park. (Washingtoniana Div., MLK Lib., Folger fountain 1923-27 CHS 2186 cropped)*

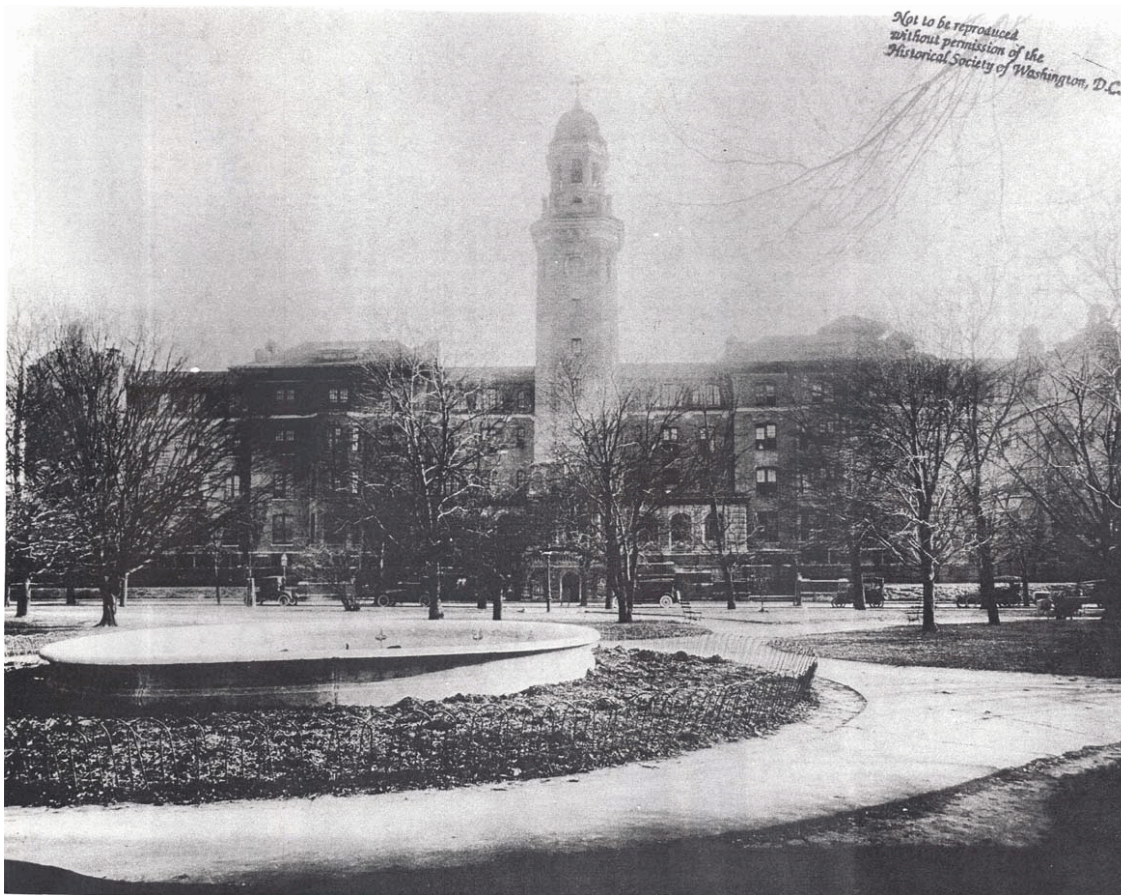
*Looking south past the fountain in Folger Park to Providence Hospital, sometime in the 1920s. (Historical Society of Washington, CHS 2186; CLP digital photo, View of Providence Hosp from Folger Park 1920-1929 200)*

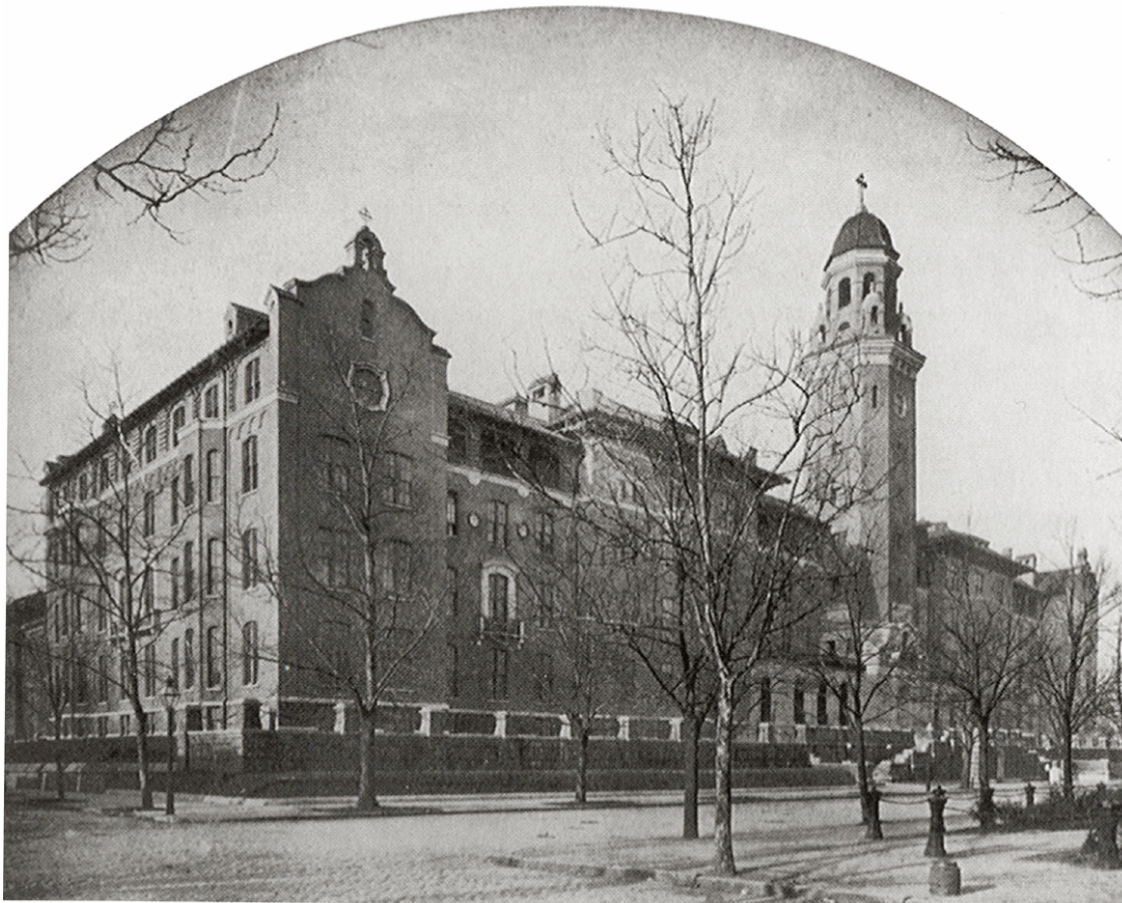
*View of Providence Hospital from northeast, showing corner of Folger Park with iron post-and-chain fencing; c. 1904. (From Goode, *Capitol Losses*, p. 433; CLP digital photo, *Folger and Prov Hosp 1904 posts Goode 200 2*)*

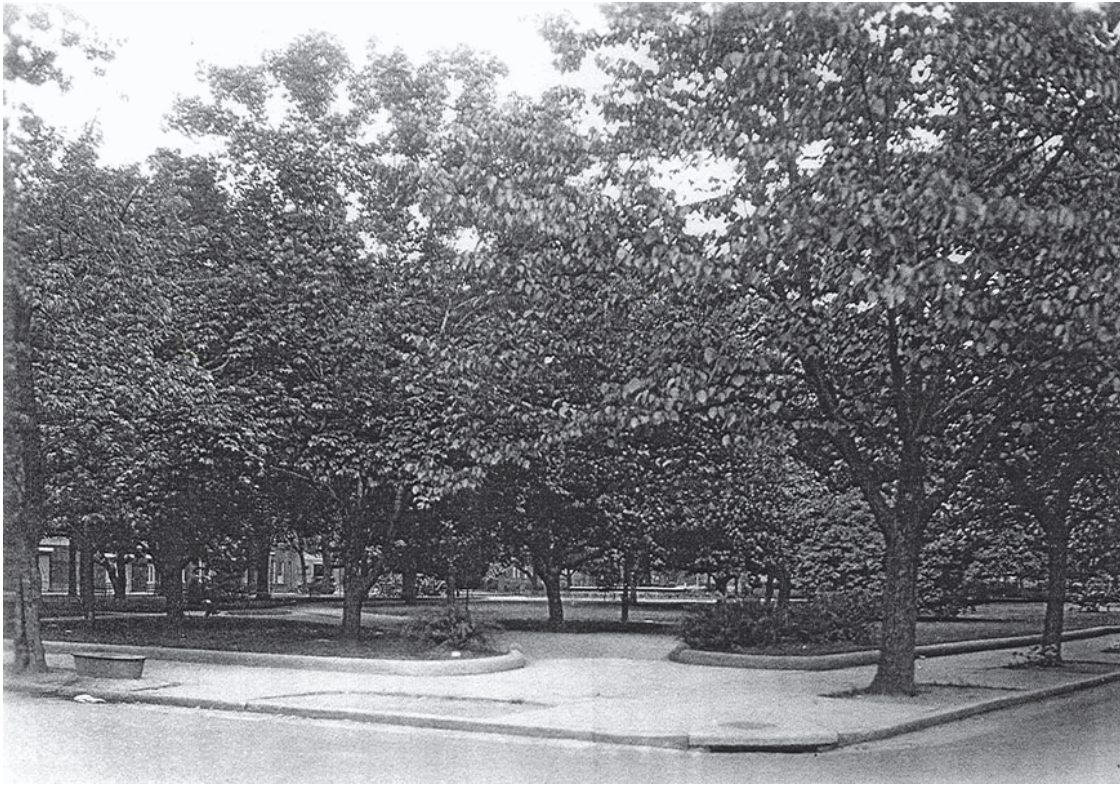
*Forty years after the park was planted, dense trees created deep shade. View from April 1927. Note trough at left. (Source probably Annual Report 1927; CLP digital photo, Folger 1927 view cropped 150)*

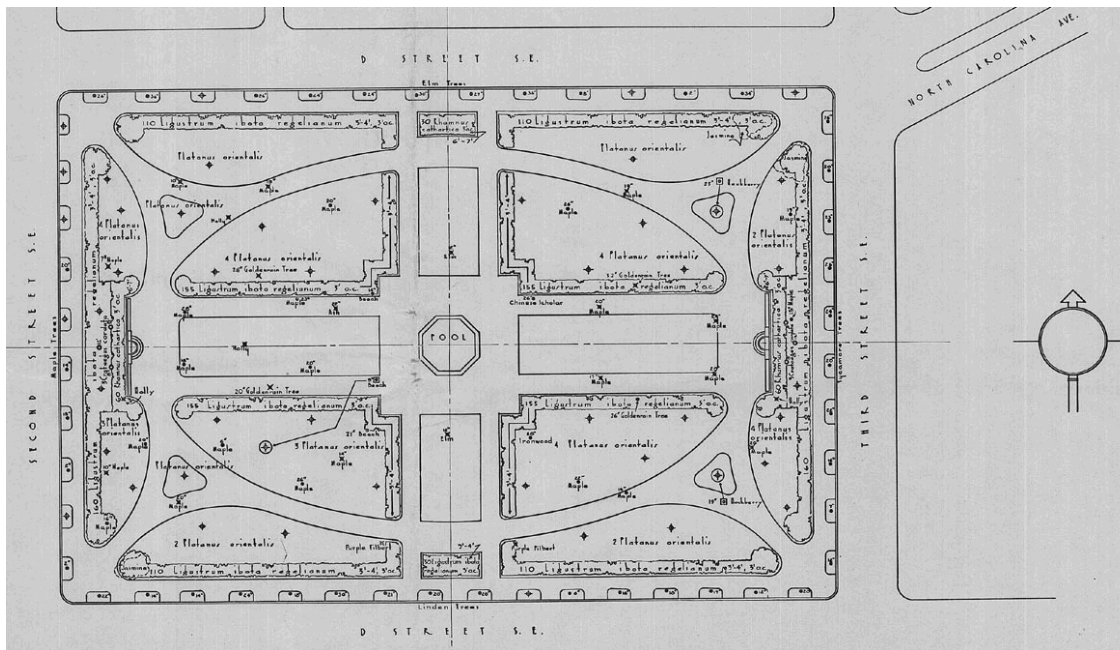
*The new circulation and planting plan for Folger Park replaced the winding paths with a strong geometry. (TIC 822\_80006)*

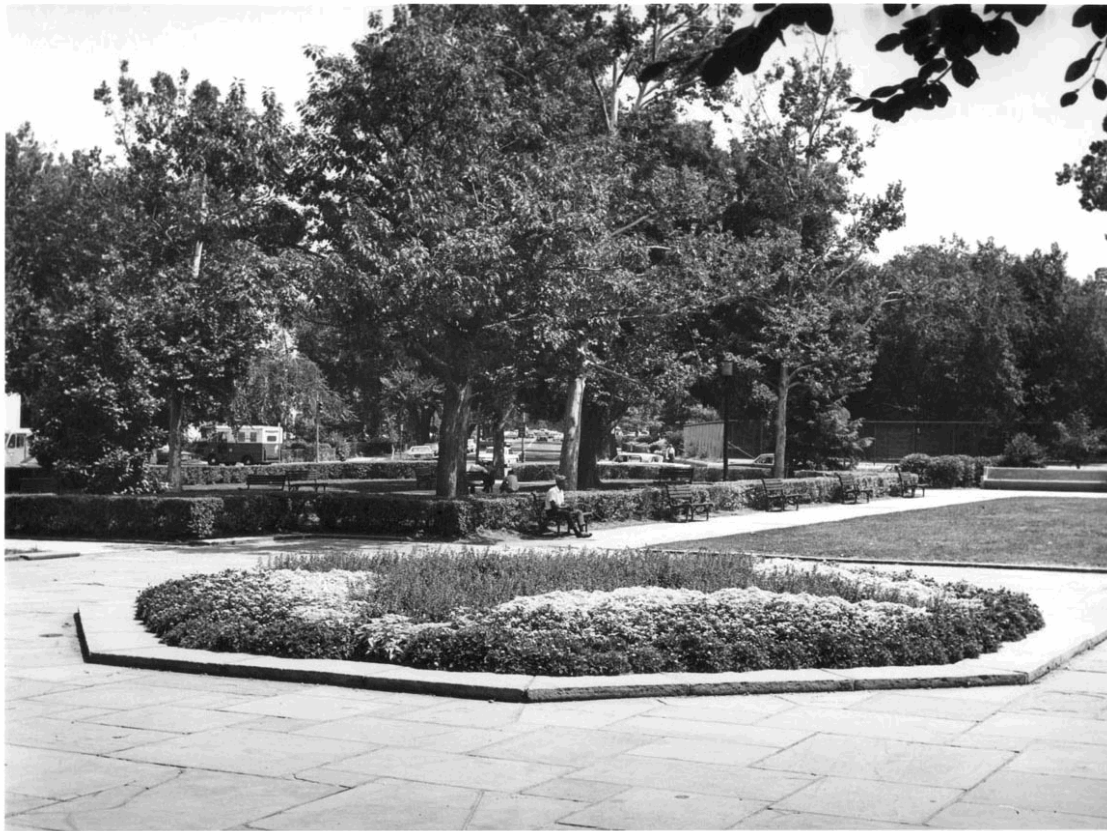
*The central plaza and planter (the former wading pool) in Folger Park in 1964. The view is probably to the southwest, and shows some remnants of the 1936 planting. (CLP digital photo; MRCE Folger 8771-E 1964 j)*

An octagonal "wading" pool replaced the earlier fountain in 1936. It occupies the center of the flagstone plaza. The concrete structure is thirty feet in diameter, including its low, two-foot wide flagstone coping. By 1964, the pool had been filled in and converted into a planter.

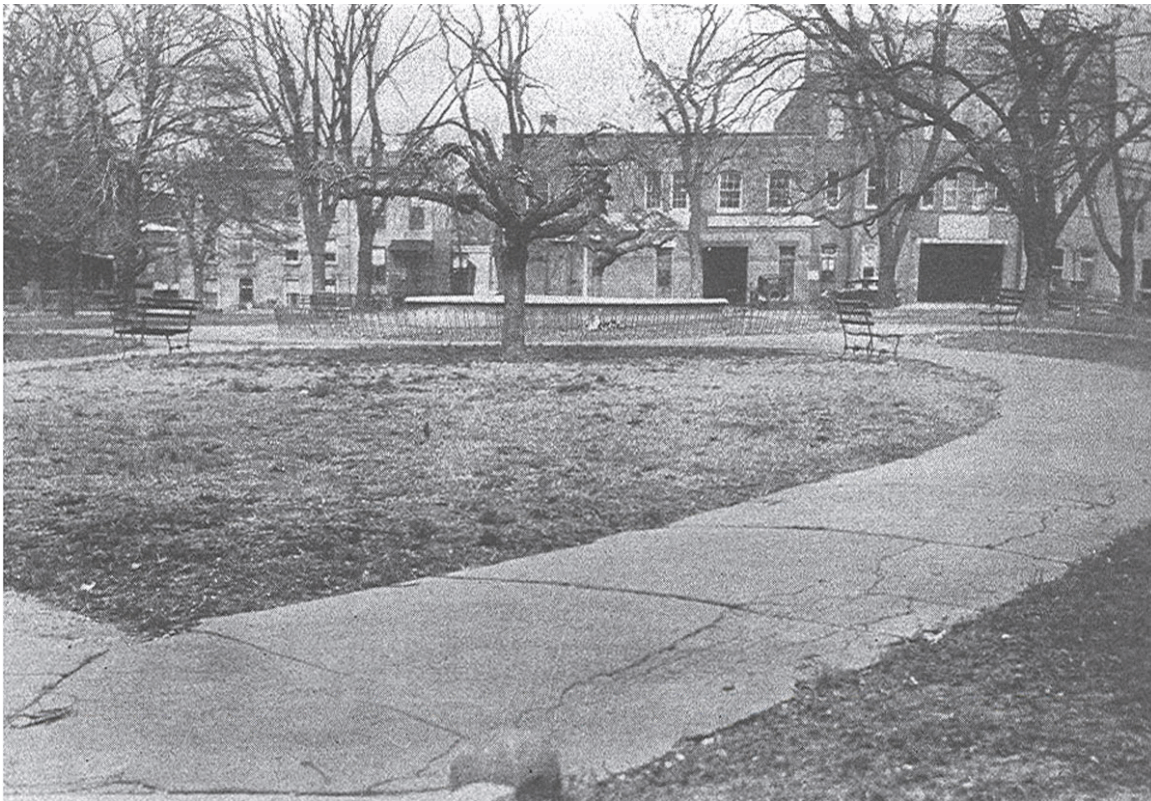
*Folger Park walks, before the 1936 redesign. The view may be to the north. Note the corner post of the curbing, bottom center, and the light benches. (From Rejuvenating Washington's Older Parks, 'in Parks & Recreation,'1938)*

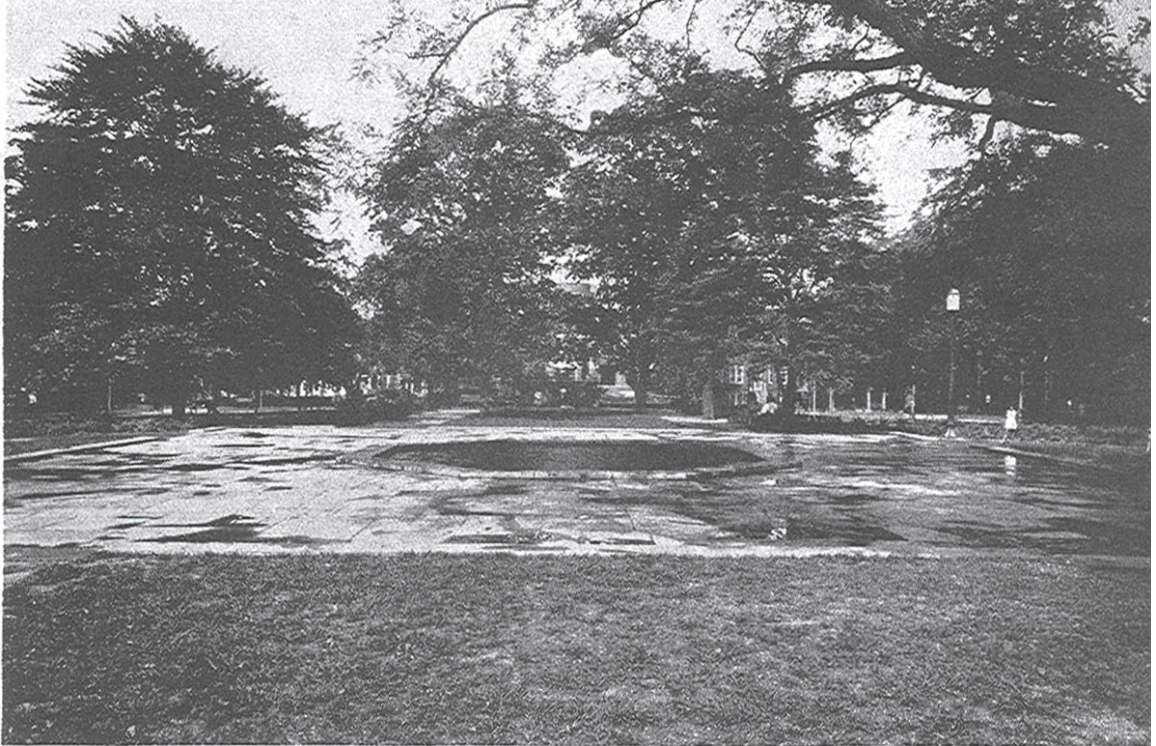
CENTRAL PLAZA IN FOLGER PARK, BEFORE AND AFTER REJUVENATION

*The new flagstone plaza after the 1936 work was done - after rejuvenation, 'as the original caption says. The light post, visible to the right, is a Saratoga. (Rejuvenating Washington's Older Parks, 'in Parks & Recreation,'1938)*

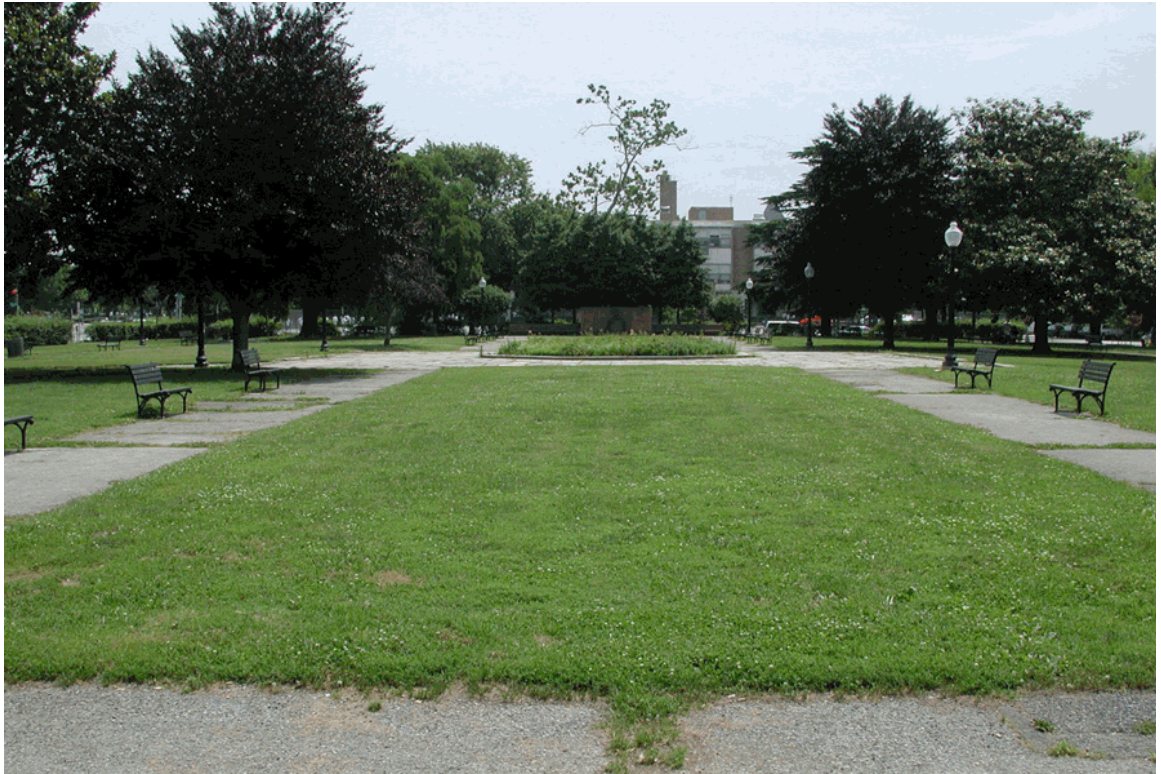
*The walks defining the east-west axis, looking east. June 2004. (CLP digital photo, view parallel walks 3 CLR 150)*

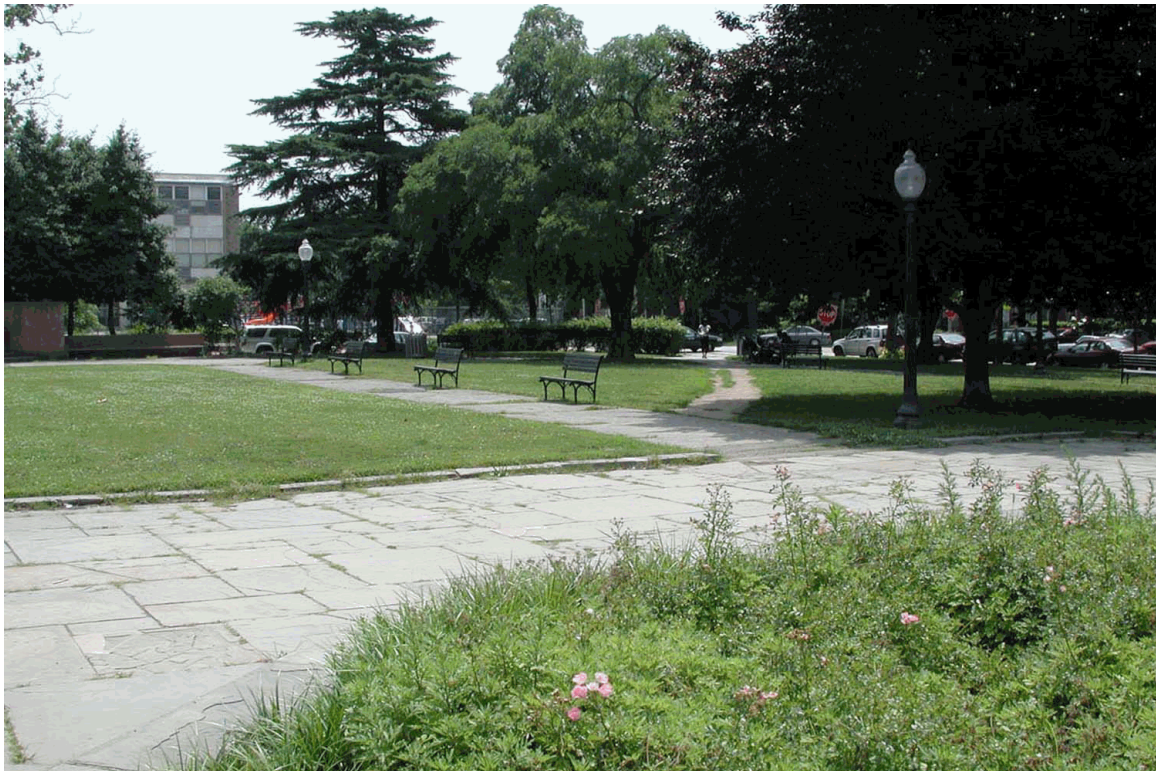
*A social trail cuts across the southeast grass panel. June 2004. (CLP digital photo, looking out from plaza CLR 250)*

Social trails run across the lawns from the northwest to the southeast. The formerly brick sidewalks surrounding Folger Park incorporated evenly spaced openings for shade trees. The sidewalks now are concrete, old and cracked, except for some brick portions on the east side. They vary in width from one street to another. Most of the rectangular tree openings remain, though some have been paved over. Brick street gutters are used on all four sides.

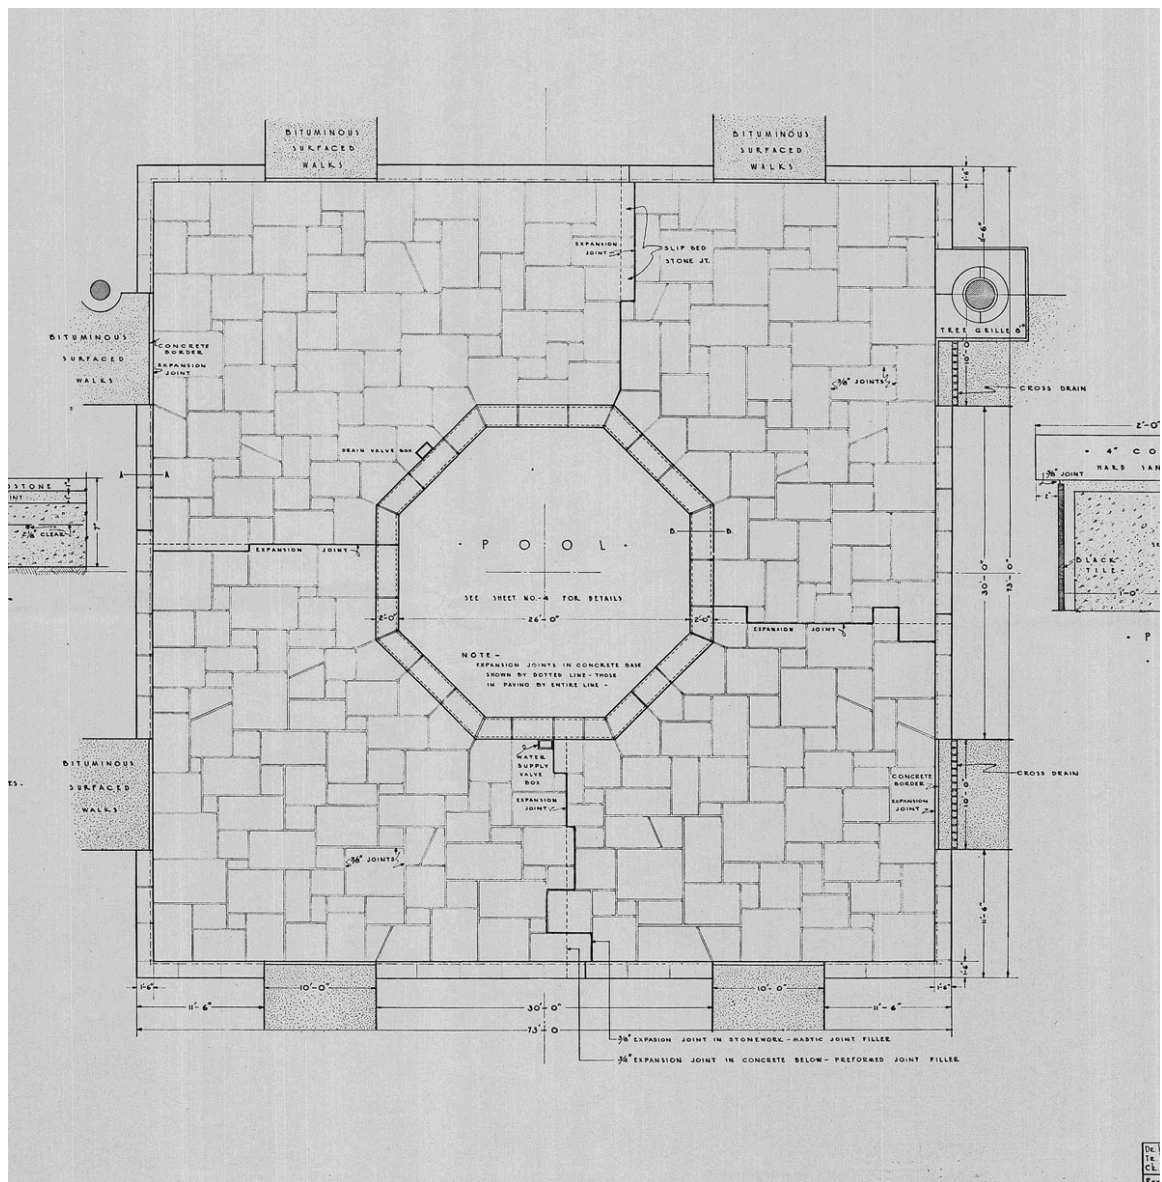
*The new flagstone paving of 1936 for the enlarged central area in the park was set in an elaborate pattern. (CLP digital photo, flagstone paving 822/80008)*

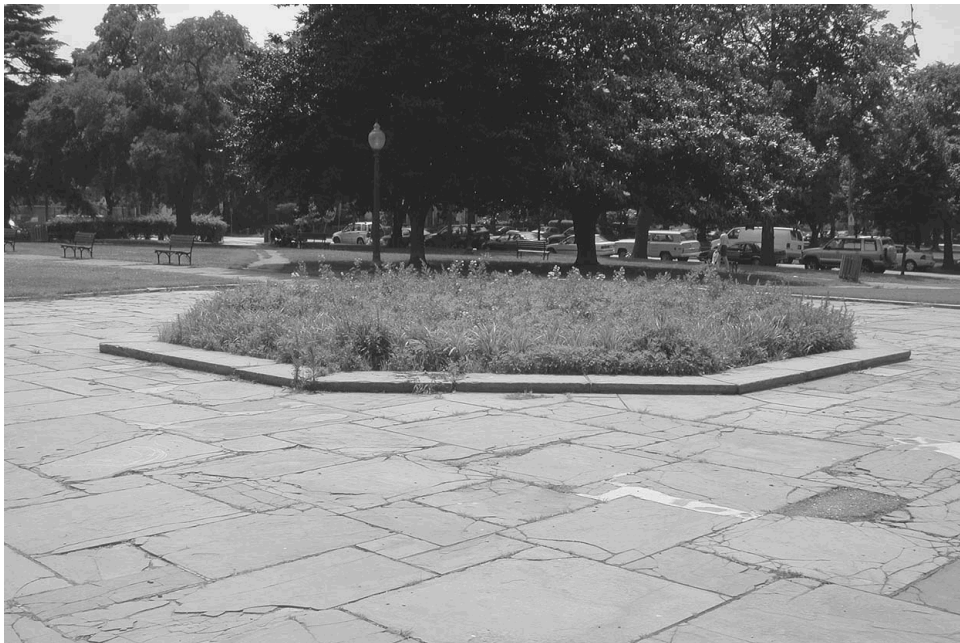
is poor: the walks are cracked, with weeds growing in the cracks. Most of the expansion joints are visible; at least one is missing, leaving just a trough in the walk. The flagstones of the plaza are in very poor condition, extensively cracked, chipped, broken, spalling, and patched with asphalt. The sandstone coping surrounding the plaza – similar to the coping around the central fountain – is eighteen inches wide and two inches high, and is also in poor condition.

*The fine workmanship and current poor condition of the plaza's fieldstone pavers are visible in this photo from June 2004. (CLP digital photo, plaza BW 250)*

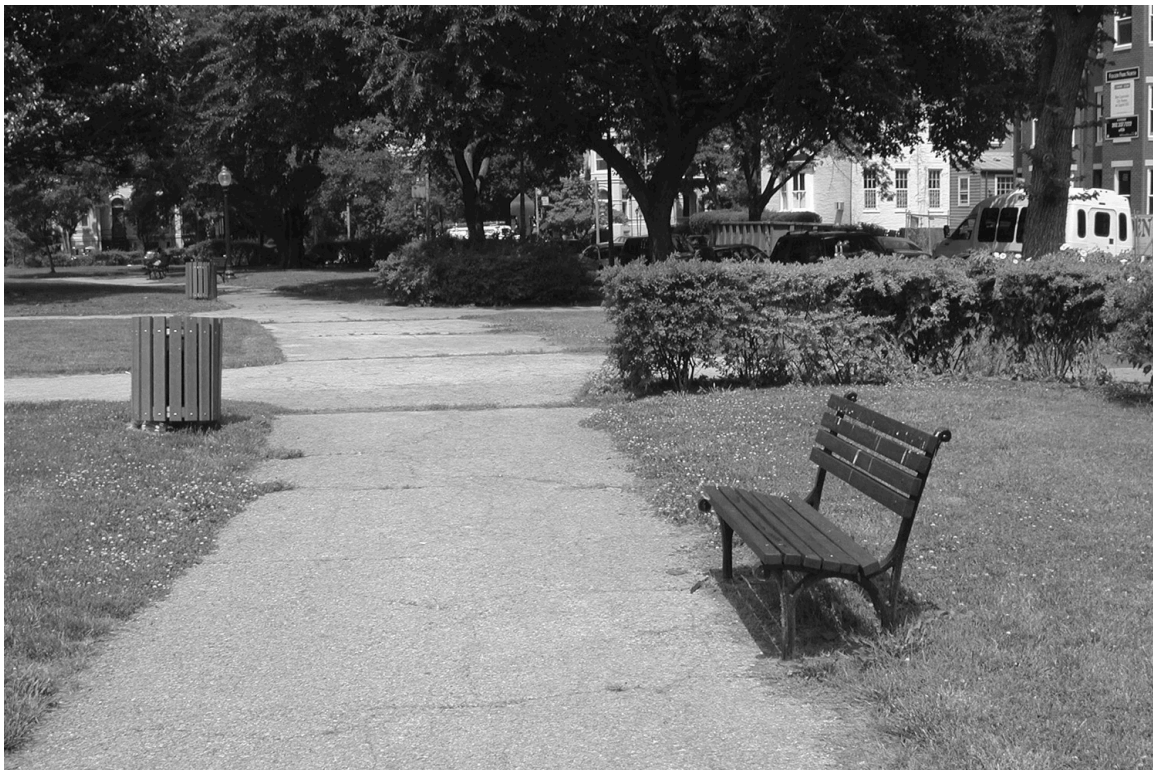
*The 1936 bituminous concrete paving, chosen for its resiliency and dark, non-glare surface, still exists, though cracked and otherwise deteriorated. June 2004. (CLP digital photo, walk and bench BW 250)*

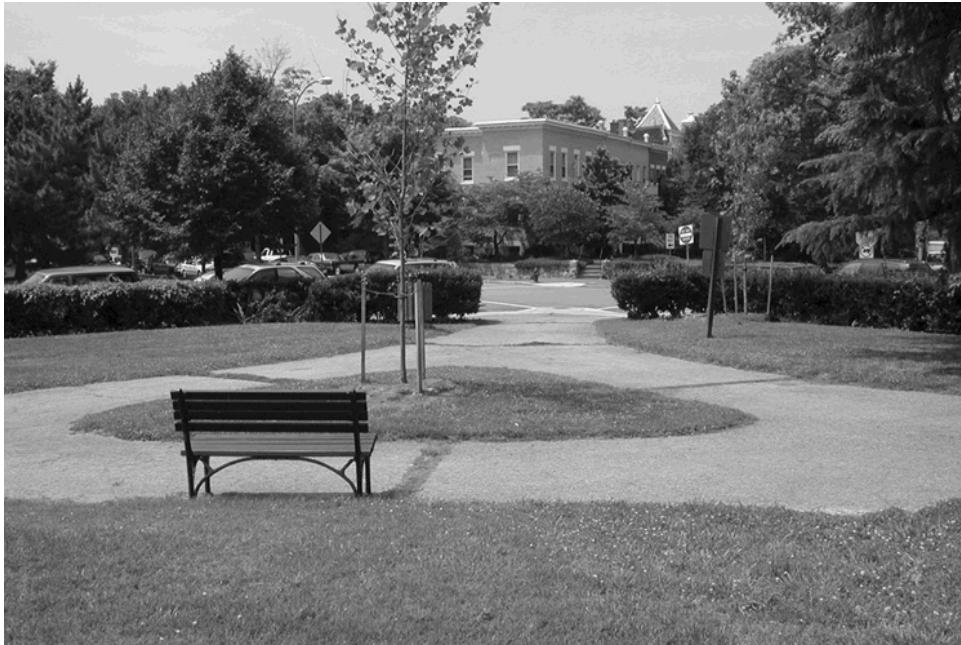
*The southwest corner entrance to Folger Park. The young tree in the triangular panel is the park's sole oriental plane tree. June 2004. (CLP digital photo, triangular panel and corner BW 150 5 inch)*

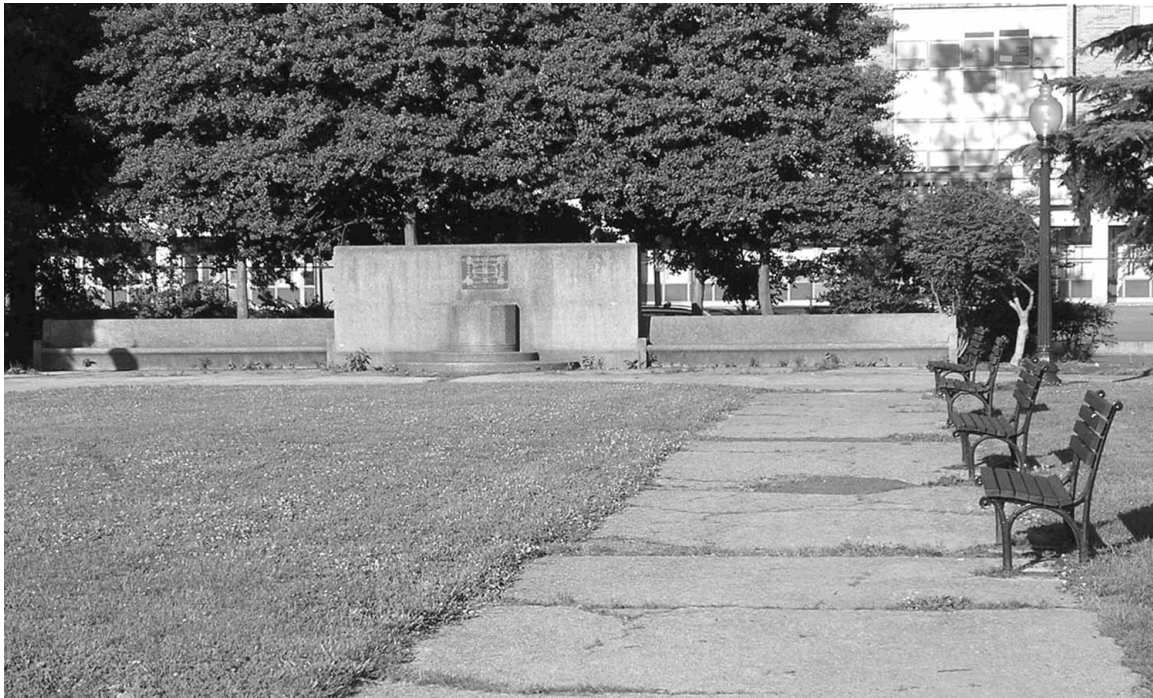
The drinking fountains no longer work, and the brass spigots have been removed. Overall, these structures are in good physical condition. Some edges are chipped, the concrete plaques are worn, and debris and trash litter the seats; there is some graffiti.

*The fountain benches, extending the width of the central grass panel and parallel walks, provide strong terminations to the east-west axis. June 2004. (CLP digital photo, fountain and bench BW 250)*

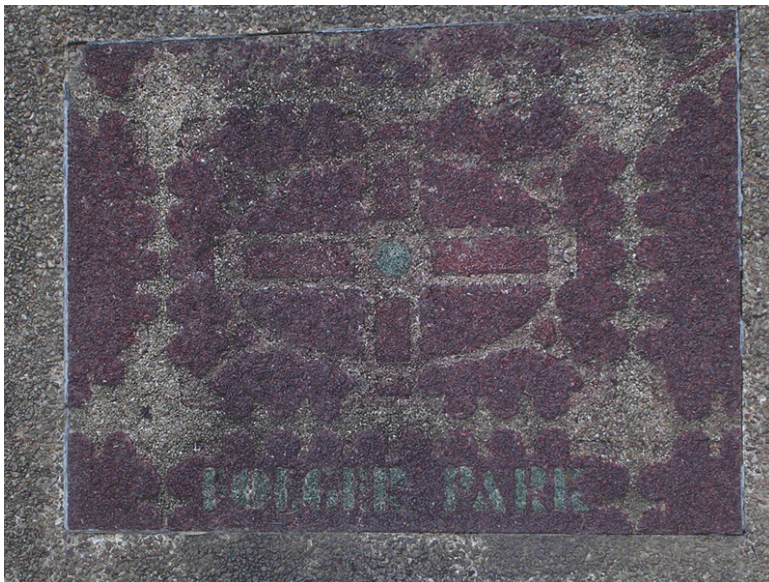
*Though worn, the two plaques above the drinking fountains record the main features of the 1936 plan. (plaque CLR 250 4 inch)*

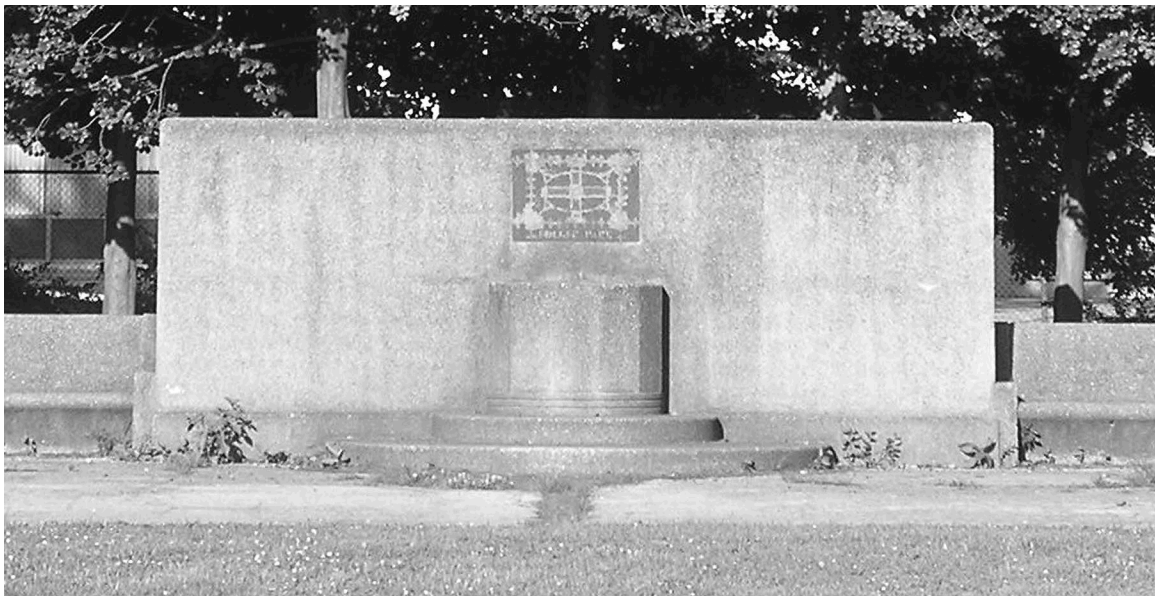
*The central feature of the fountain benches comprises a wall, steps, a drinking fountain in the form of a half-column, and a plaque showing the 1936 plan. (CLP digital photo, Folger drinking fountain June 2004 vertical BW crop)*

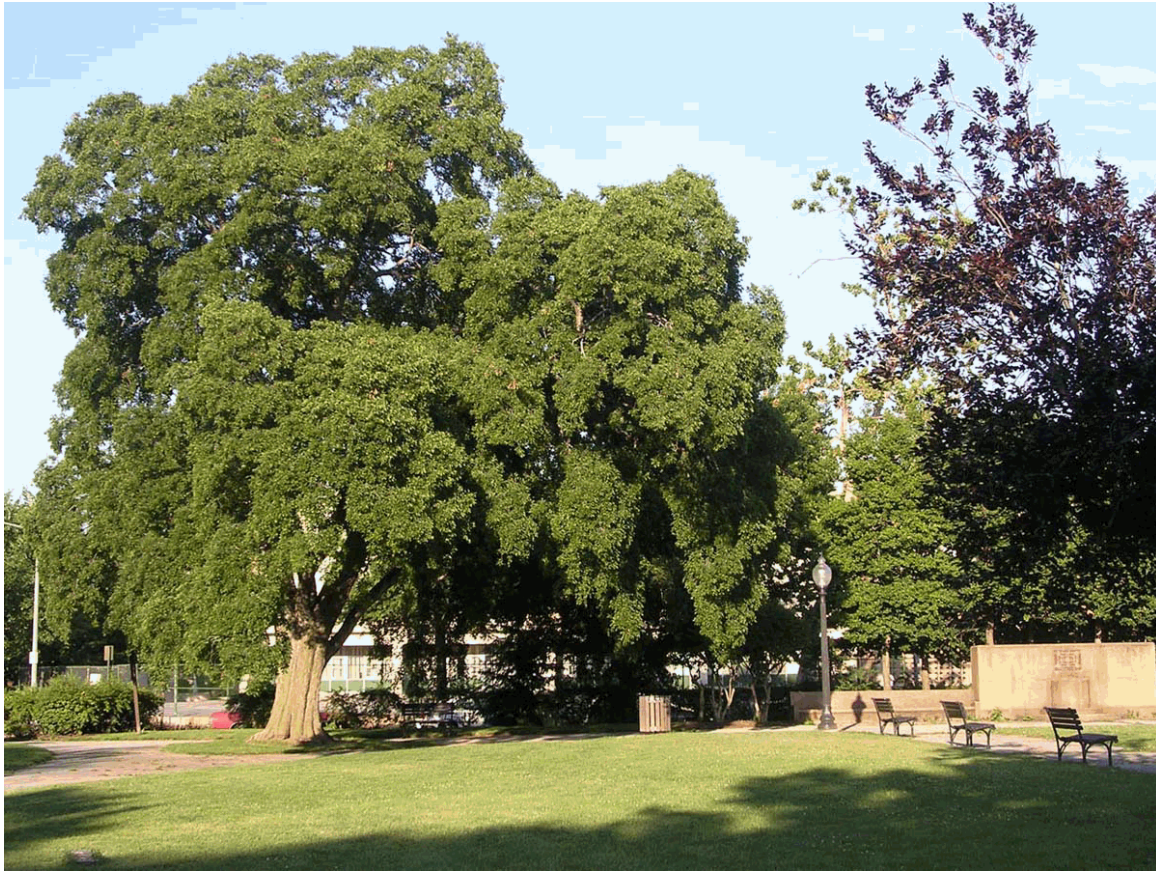
*This large hackberry grows in the small triangular panel in the park's northeast corner, where it was moved in 1936. June 2004. (CLP digital photo, Hackberry tree June 2004 CLR 200)*

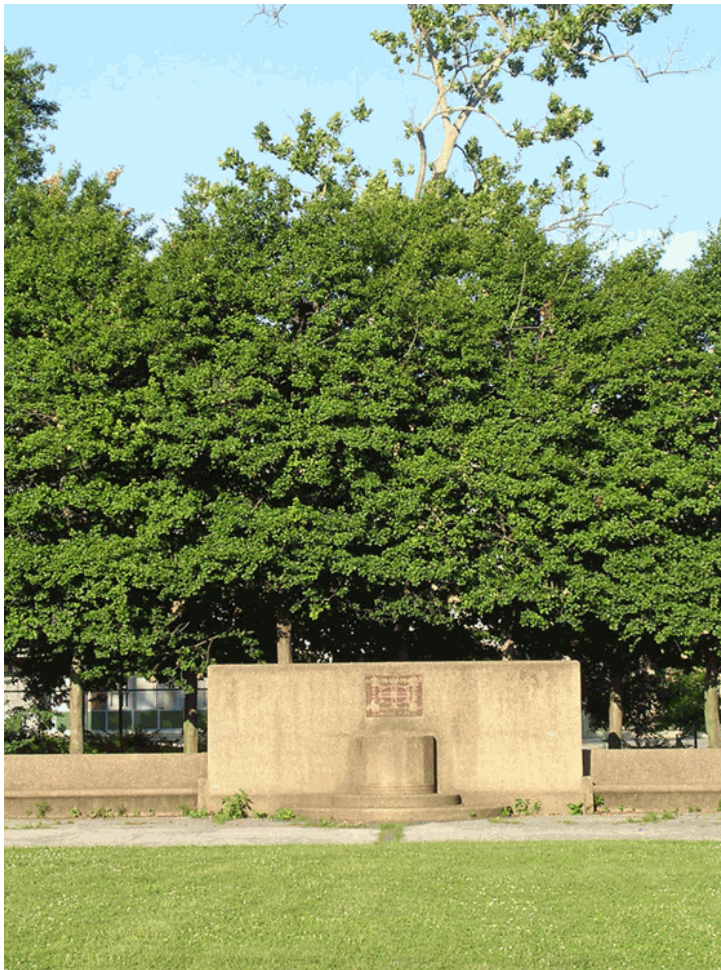
*Hollies were among the plants used to create backdrops for the bench and fountain structures. (CLP digital photo, Folger fountain June 2004 CLR vertical 150)*

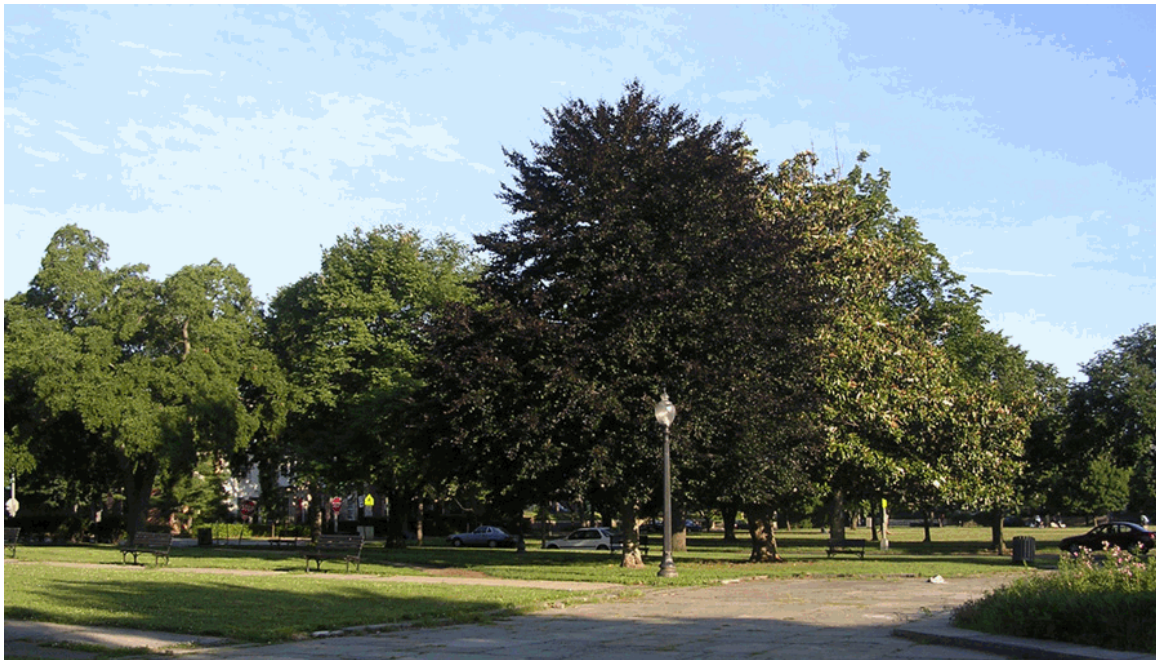
*One of the pairs of Southern magnolias and copper beeches is visible in this view looking southeast from the plaza. June 2004. (CLP digital photo, plaza and copppey beech June 2004 CLR 150)'*

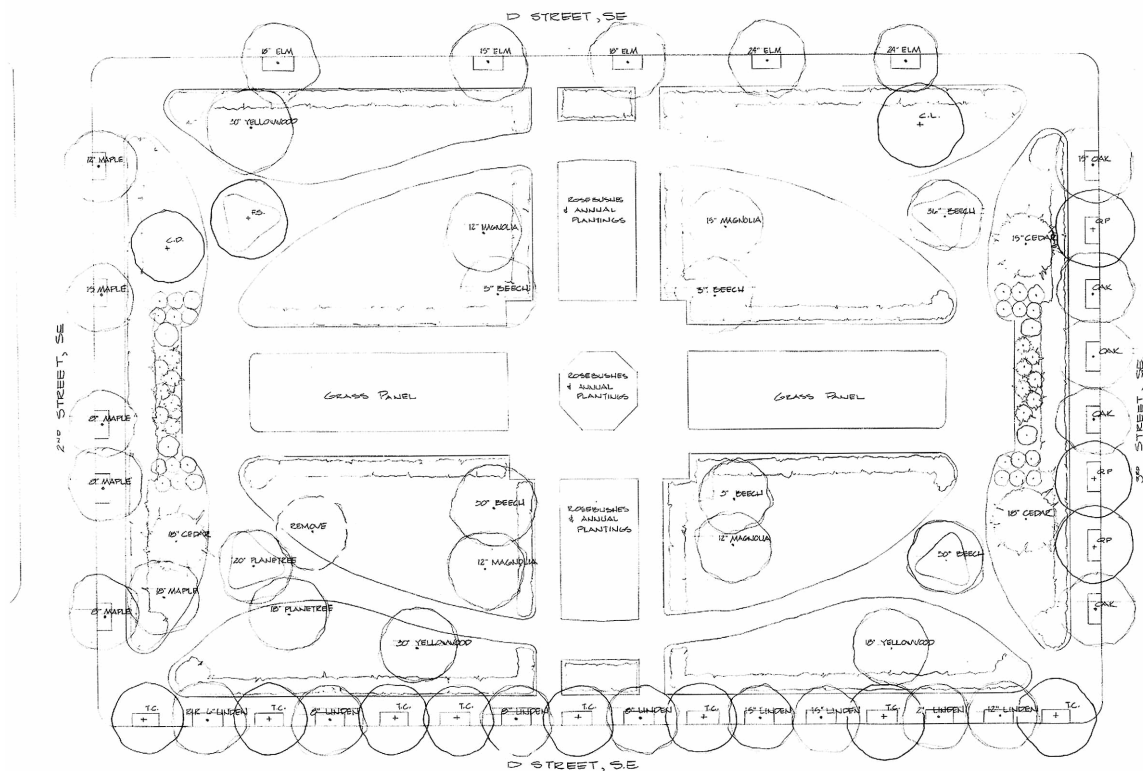
*The 1984 revision to the Folger Park plan added fourteen new trees to create greater symmetry in the planting. (TIC 822/80044; CLP digital photo, 1984 planting design enlarge crop)*

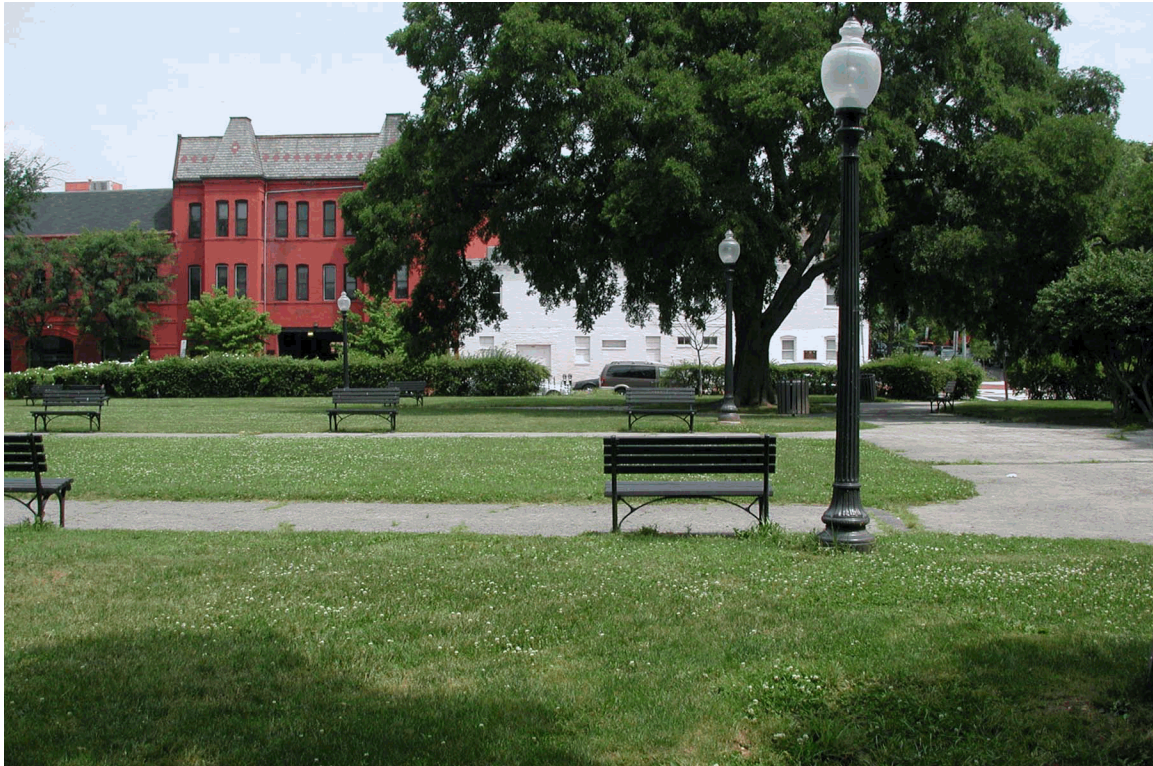
*This view north from the southeast corner of the park shows the current placement of benches and the Washington Standard lights, as well as the hackberry and buildings along D Street. June 2004. (CLP digital photo, Benches lights and rowhouse CLR 300)*
