National Park Service  
Cultural Landscapes Inventory  
2005

Folger Park  
National Capital Parks-East - Capitol Hill Parks

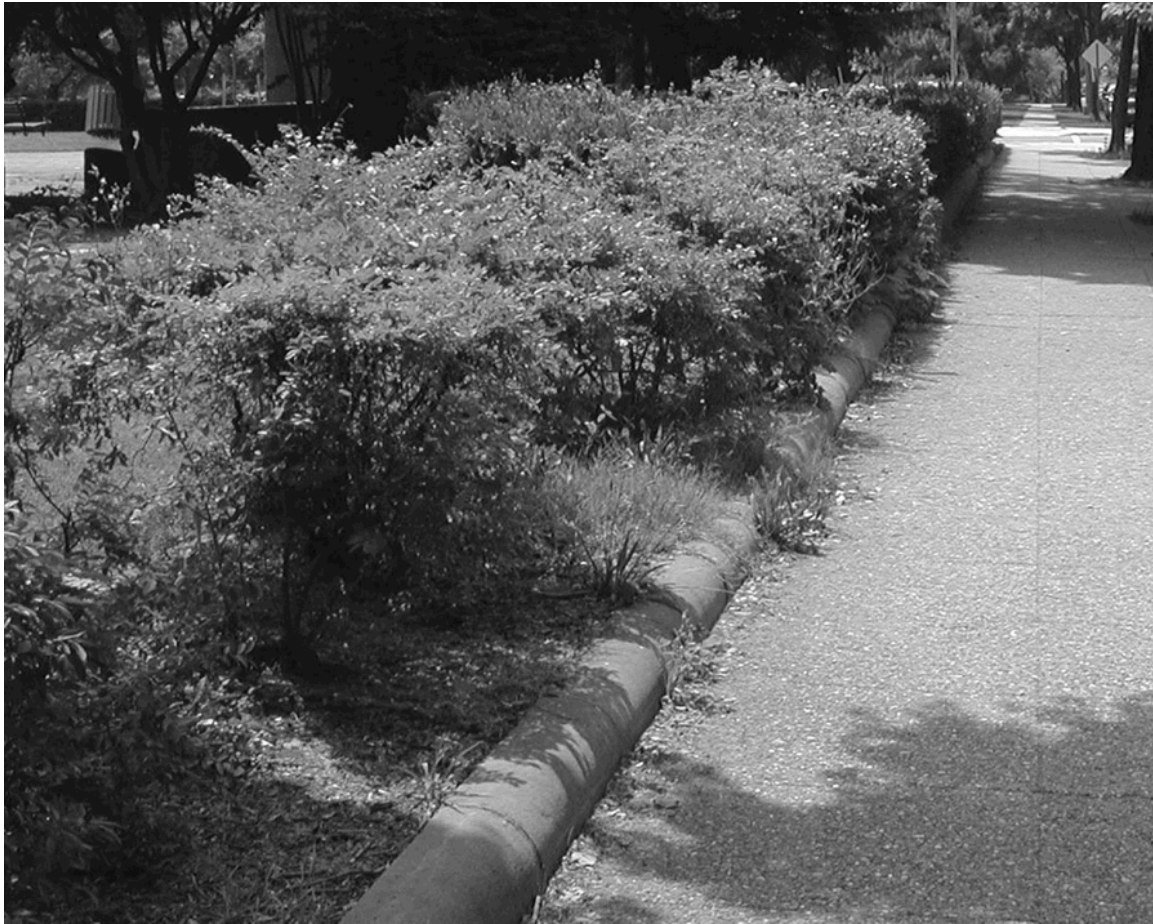
*Curbs along the north perimeter of the park may date from 1905. The privet hedge was probably planted in 1936. June 2004. (CLP digital photo, Sidewalk and curbs crop BW 150)*

In 1902/1903, Congress authorized the elimination of all fences around the city's public parks to make them completely open. An earlier cast-iron post-and-chain fence was removed from Folger Park in 1905, replaced by quarter-round concrete curbing, installed along the outside edges of the grass panels. The extant curbs may be original.

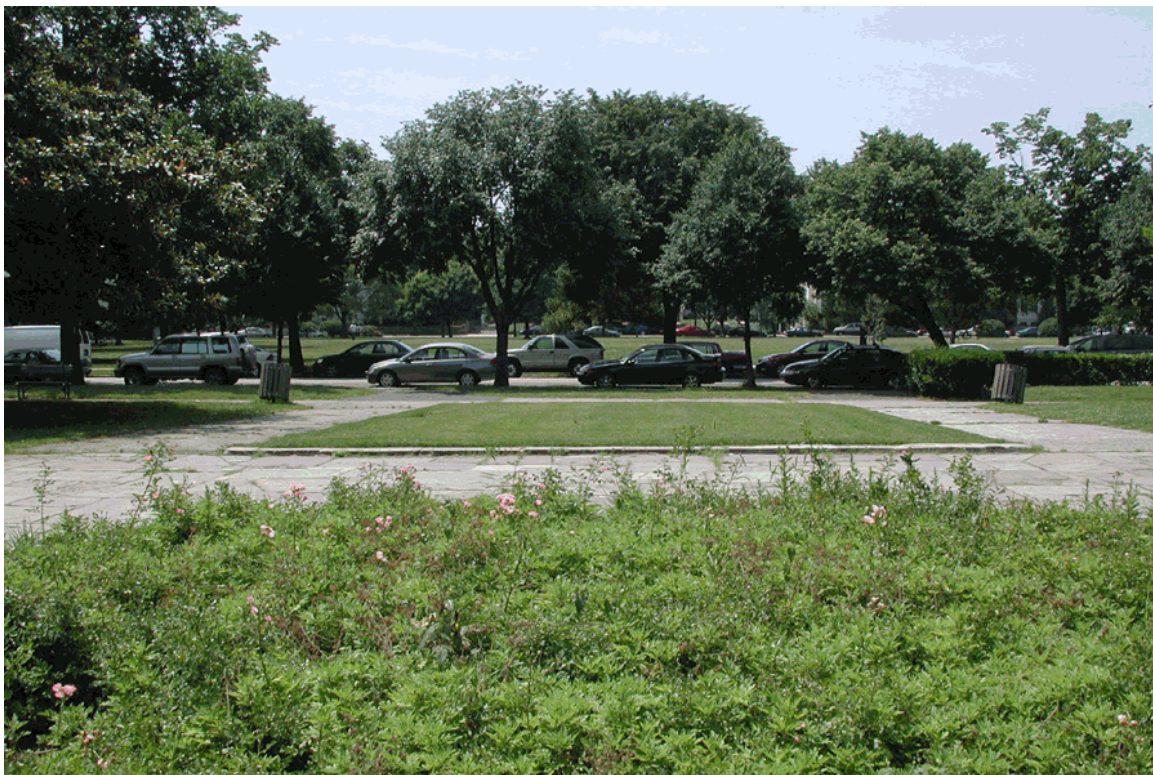
*Looking south from the central rose bed to the Providence Hospital site. (CLP digital photo, view from plaza down central Mall CLR 150')*
