# National Park Service

## Crater Lake

### History of Rim Drive

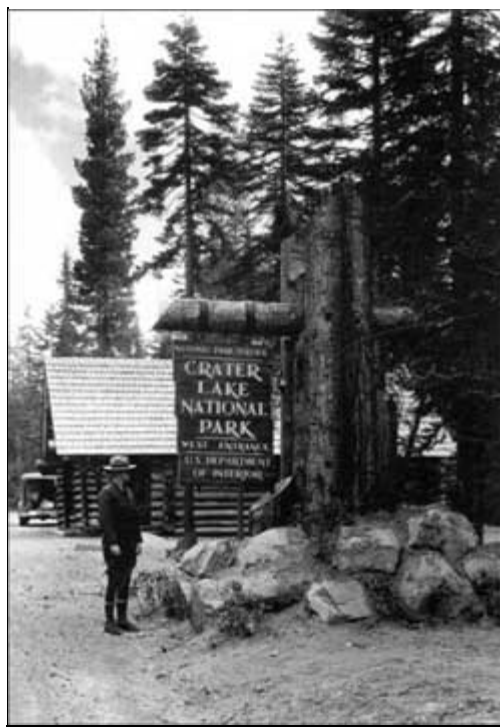
Superintendent Dave Canfield and a new entrance sign, 1936. NPS photo by George Grant.

The West Entrance Road possesses few stopping places or parking areas, even in comparison to other approach routes. With the numerous curves and forested roadside demanding the motorist's attention, some visitors remain unaware they are in the park until reaching the entrance station located next to the road junction at Annie Spring. The Pacific Crest Trail (PCT) nevertheless crosses the roadway within a mile of the junction and a sign points to an adjacent unsurfaced parking area for trail users. Heading west from the PCT crossing, drivers have virtually nowhere to park alongside the roadway for about 5 miles until a paved pullout delineated with bituminous curb called "Elephant's Back" is reached. It permits those who stop on either side of the road to see where the canyons created by Castle Creek and Little Castle Creek meet. A half mile to the west is another paved pullout overlooking Castle Creek Canyon that once served as the park's west entrance before boundary expansion in 1980. The pullout features a vault toilet and information kiosk installed during 2001. Visitors can also stop at the current west entrance a little less than a mile further on, where a sign built in 1998 replicates a rustic log structure erected by the Civilian Conservation Corps in 1935.

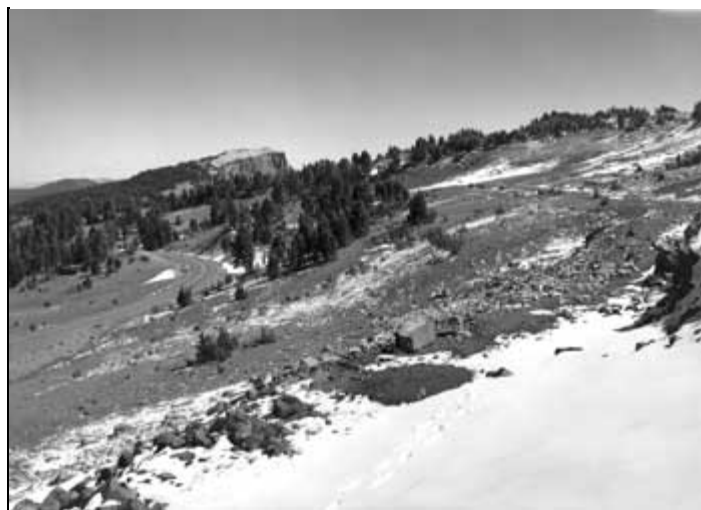
West Rim Drive is shown below (at left); the route of its predecessor, the old Rim Road-- is now part of a hiking trail along the rim.

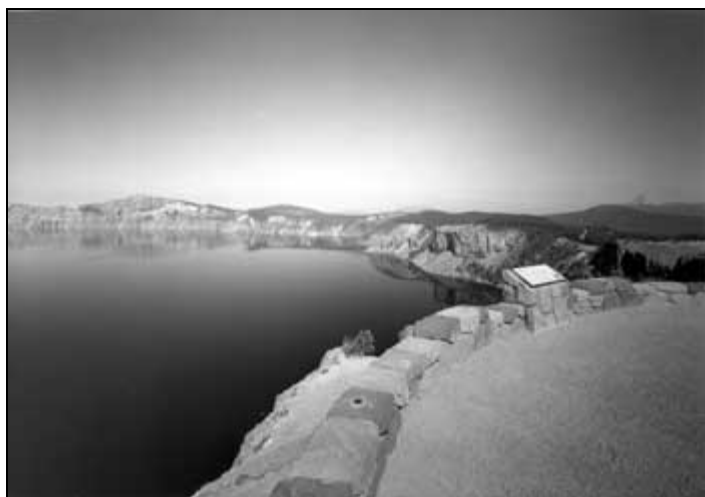
Interpretive marker and parapet wall at Skell Head.

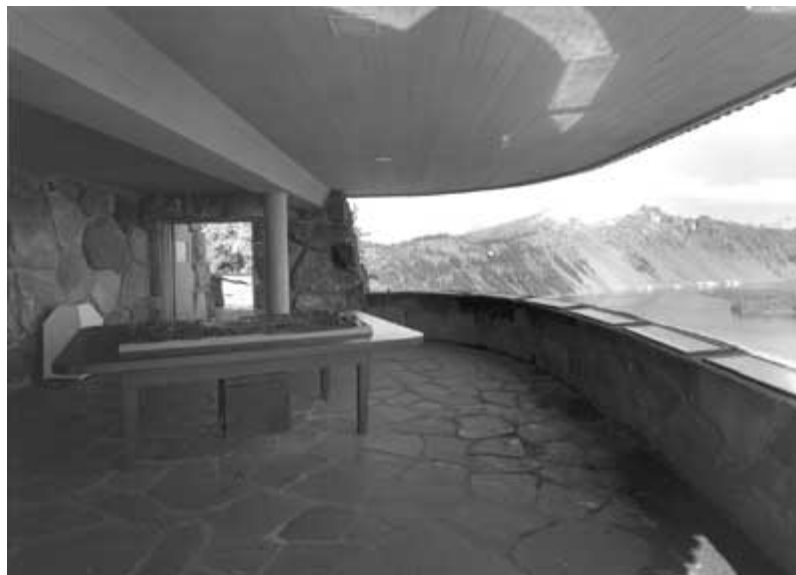
Parapet of the Sinnott Memorial.

Built in 1930, the Sinnott Memorial's design borrowed heavily from the slightly larger Yavapai Station erected on the south rim of the Grand Canyon in 1927. Merriam was the main force behind both buildings and saw to it that each incorporated an open porch or parapet along with an enclosed display room or museum. Sager drew the plans for the Sinnott Memorial, but Merriam expressed the underlying purpose of the building as

"http://www.nps.gov.a window through which it is planned to show the visitor things of major interest at the Lake. The active use of the structure is strictly that of looking out and the museum aspect should be reduced to a minimum, using only such materials as are helpful in development of the window idea."

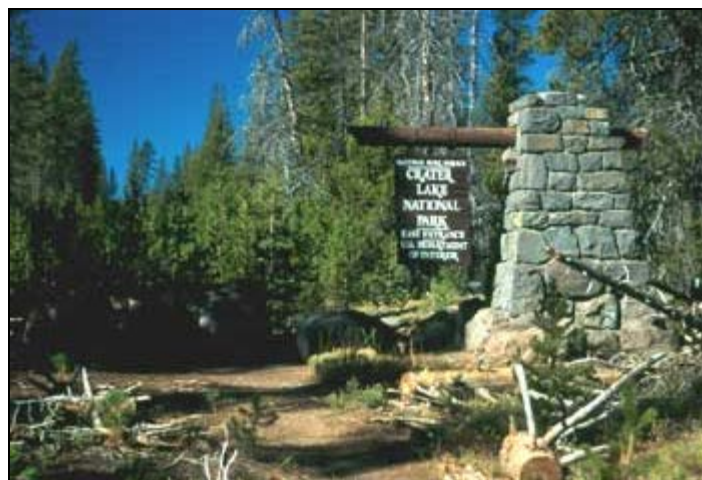
East Entrance motif.

Customized signage for Rim Drive evolved from a CCC project begun in 1936 at Park Headquarters that aimed to replace various types of metal signs posted throughout the park. Enrollees produced hand-carved wood signs of varying sizes with raised letters painted chrome orange (for visibility at night) against a dark brown background, based on Lange's drawings of entrance, directional, and building signs. Their production and placement greatly accelerated over the summer of 1938 after establishing an outdoor workshop at the CCC camp near Annie Spring. Lange reported that 200 signs had been completed by November, including some that identified parking areas and points of interest on Rim Drive. Through photographs in his season-ending report, he attempted to show how this type of sign possessed good visibility, if properly placed, for conveying mileage and direction on Rim Drive. These examples included signs mounted in a triangular configuration at road junctions and others slotted into bollards.

1939 season. They reestablished a workshop at the park that summer for a crew of fifteen men to carve, assemble, and then place eighty signs. Lange provided "field sketch details" as drawings for the crew to follow as he had the previous year, but the signs completed that year varied somewhat more in size and shape because of emphasis on the individualization of signs for points of interest located along Rim Drive. Although he originally expected to complete the project by

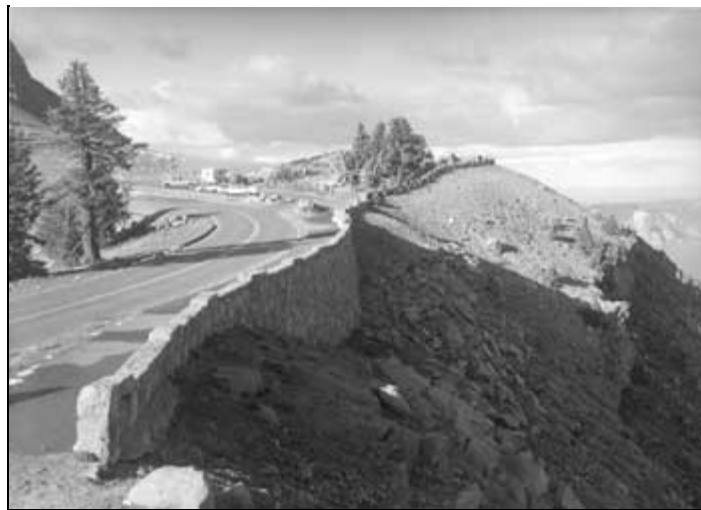
Watchman Overlook.

construction funds in relatively short supply when compared to the Mission 66 program of just a few years earlier, the project at Watchman Overlook remained on hold until the early months of 1971. At that point another site plan suggested dropping the realignment and reworked the design to yield parking for thirty cars that could be oriented diagonally in line with the implementation of a one-way road system. The revised site plan included new features to Rim Drive such as bituminous curb, contrived rock "outcrops," and masonry piers linked by pressure treated wood peeler cores as a safety barrier. Construction at the Watchman Overlook thus began in 1972, though completion of all items in the contract took another two summers. As a cue for visitors to stop, the separated parking and conspicuous design features at the Watchman Overlook quickly made it the most popular stopping place on Rim Drive, even if most park employees expressed little hesitation in referring to the locality by its resulting nickname of the "corrals."
