## *Escherichia coli* monitoring at Little River Canyon National Preserve

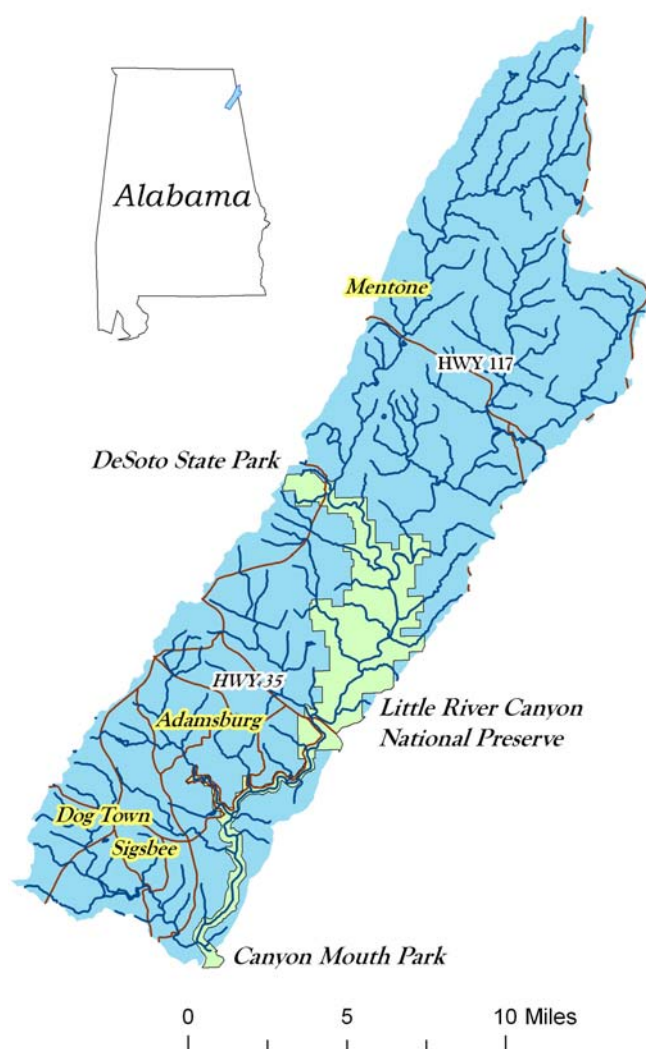
Figure 1. Watershed of Little River Canyon National Preserve.

A watershed is a portion of land that drains to a common point. The watershed of Little River Canyon National Preserve is all land that contributes water to the most downstream point of the preserve, Canyon Mouth. This 127,160 acre watershed contains various land uses that may contribute to the overall bacterial load (Figure 1). These uses include wastewater from a population (US Census 2000) of 7,571 individuals (both rural and small towns alike) and one wastewater treatment facility (Desoto State Park). Non-point contributions include runoff from 21,000 acres of pasture and hay land and its livestock, and the wildlife that are found throughout the watershed, including the 13,798 acres of state and federal park lands. Each may contribute a share to the total bacterial load.

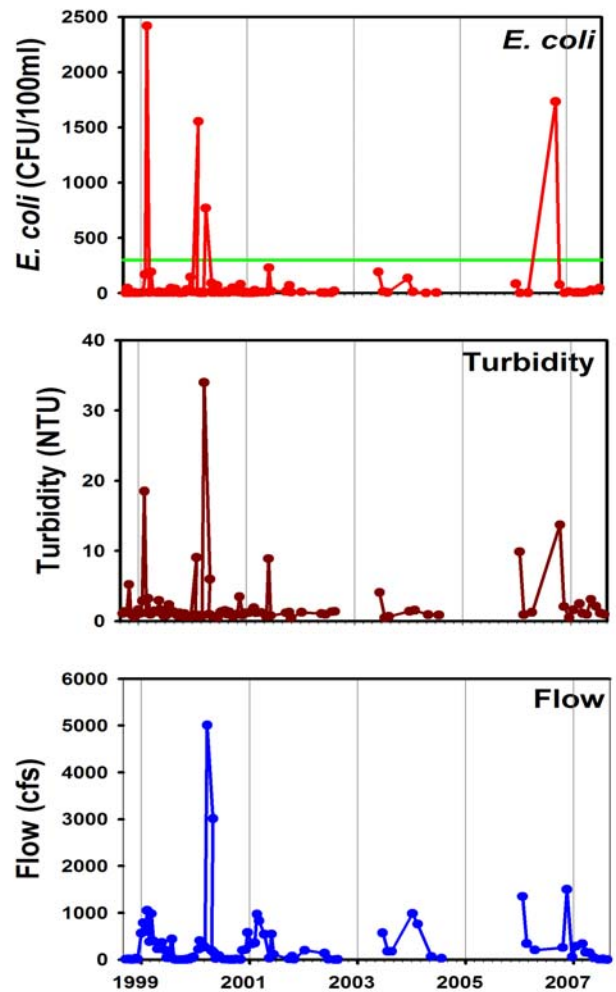
Figure 2. *E. coli*, turbidity, and flow at Canyon Mouth; CFU/100ml = colony forming units per 100 ml of water; NTU = Nephelometric Turbidity Units; cfs = cubic feet per second. The green line represents the USEPA recommended *E. coli* single-sample maximum value for full body contact.

Water quality data are shown in Figure 2. While the park routinely monitors water quality at 11 locations throughout the watershed, for brevity we will examine the results at one station. These data, with gaps between monitoring efforts, were collected over a nine year period at Canyon Mouth. These data display a signature of non-point source delivery of *E. coli* bacteria and turbidity. Turbidity, primarily caused by suspended particles, can be simply described as the clarity of the water; the higher the turbidity, the muddier the water. Increases in flow are met with an increase in *E. coli* and turbidity. This relationship is not apparent in every rainfall event as antecedent condition (for example time since last rainfall), and distribution of the rainfall event (where it rained and how much) produce variance. That is, the less time between run-off producing rainfalls, the less waste is available to wash into the streams.

So, what do these data tell us? We know that *E. coli* and turbidity at Canyon Mouth spike during high flow conditions. These high flow conditions are caused by rainfall events. These rainfall events produce surface run-off. Run-off entrains various contaminants, including *E. coli* and soil particles. The pattern we see is indicative of non-point sources. We also know that as long as there have been animals living within the watershed, there have been *E. coli* in the waters of Little River. What we do not know is the species of animal from which the bacteria originate or natural background concentrations. We also know that at times of high flow the USEPA recommended *E. coli* single-sample maximum value for full body contact was exceeded. It is also unlikely that people were swimming at these times.
