# Interagency Cooperation Produces Sedimentation Study

By Jenness Hall, Brenda Pusso, and Diane Probus

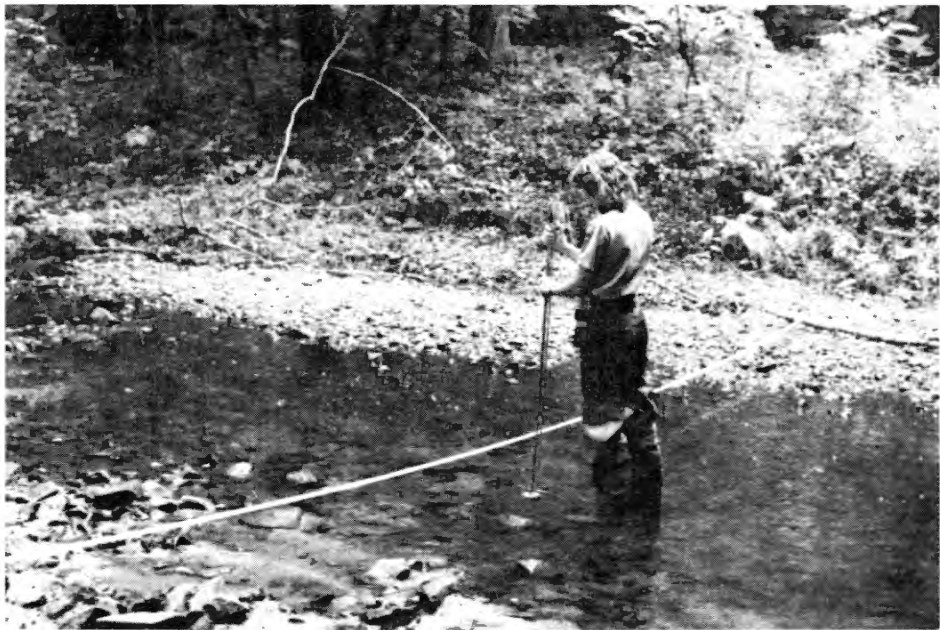
**Park Service Technician** measures velocity and depth across the creek bed to determine the discharge at that one point in the Quantico Creek.

The USGS trained the park's resource management staff to take discharge measurements using a tape measure, calibrated rod, and a velocity meter. Depending on the height and velocity of the water, a pygmy meter or an AA meter attached to the calibrated rod was used. In high flow waters, an AA meter with a 15 or 30 pound weight lowered from a bridge on a handline was necessary. A tape measure was stretched across the creek and the width recorded. The width was then divided into 20 to 25 sampling intervals. At each interval, the distance on the tape measure and depth of water were recorded. Using a stop watch and earphones attached to the meter, the number of revolutions and time in seconds also were recorded.

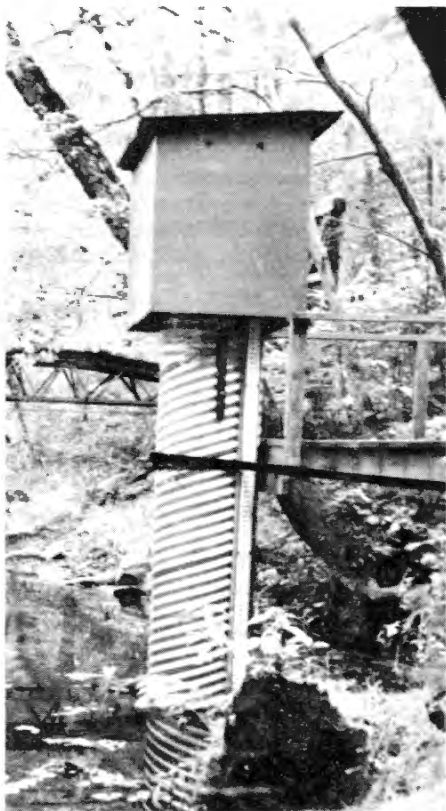
*One of the four gaging stations along the Quantico Creek in Prince William Forrest Park. It houses water level monitoring equipment and an automatic water sampler.*

A USGS gaging station was already in operation on the South Fork of the Quantico Creek at the park's western boundary. As agreed the park maintenance staff constructed the additional three permanent gaging stations, bringing the total to four. For each of the stations, the USGS provided an Automatic Data Recorder, which records the gage height at 15 minute intervals, and a graphic recorder, which produces a continuous hydrograph. The latter was helpful in visualizing storm events and in calculating daily sediment load. The park purchased one Manning S-4050
