# Dissolved Oxygen Levels Restored In the Pools of Carlsbad Caverns

By Cliff Chetwin

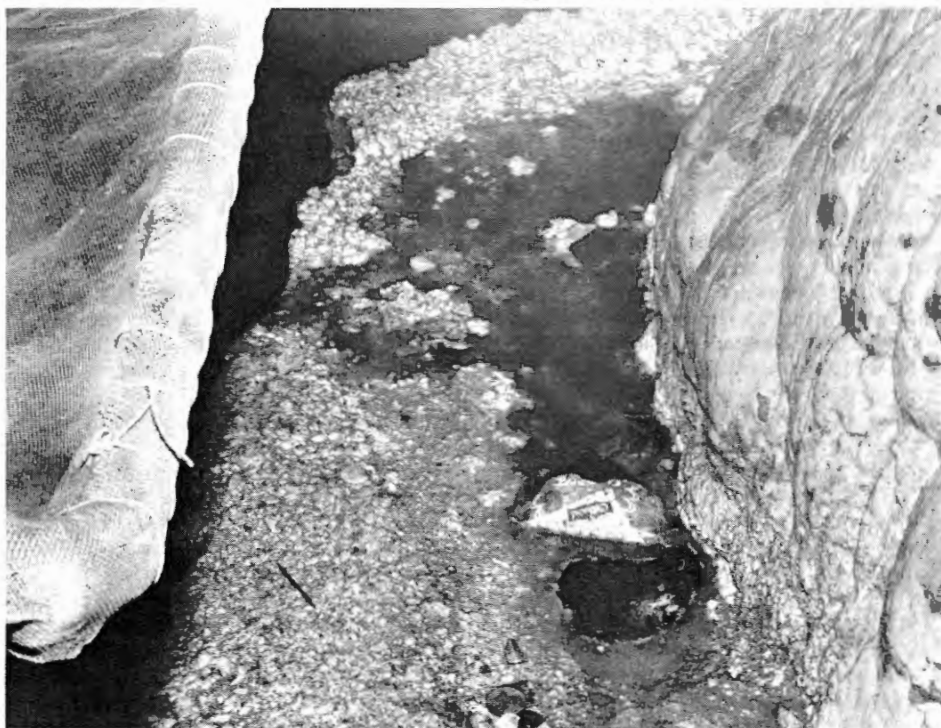
**Park Ranger Donna Giannantonio** uses dipstick to fish coins out of a Carlsbad Cavern pool, prior to mechanical mixing of the water.

**Coins, plastic gunk, bread wrapper**, all contribute to the debris that must be fished out of Carlsbad Cavern pools before they can be restored by mixing procedures. The screen covers, one of which is shown at left, have been tried in pools far off the trail that appear as pits and are targets for thrown items, but eventually they tear and drop their loads into the pools.
