# Environmental Effects and Monitoring of Abandoned Drilling Muds: The Wrangell-St. Elias Approach

By Timothy E. Law

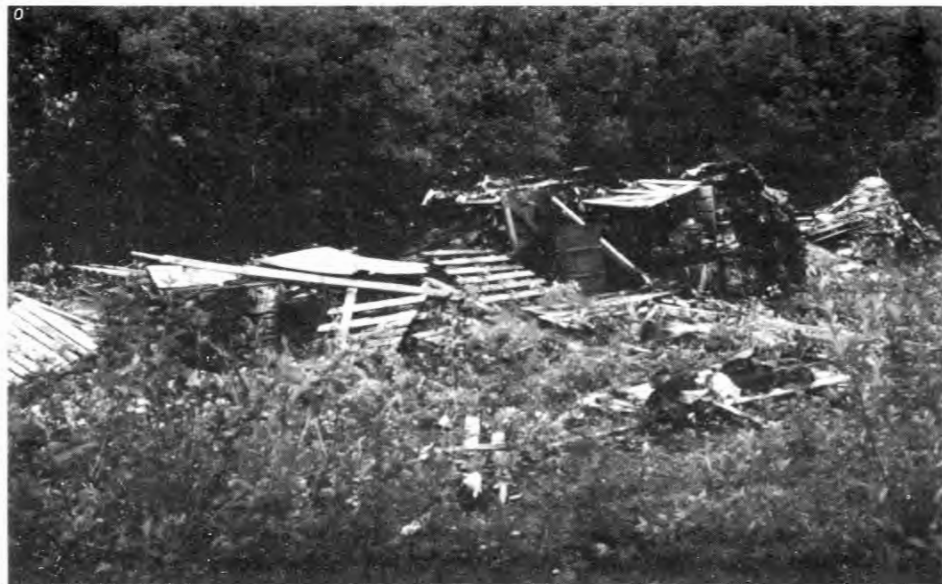
Pile of unused drilling mud in a deteriorated condition, showing scattered debris and remains of the plywood shelter in which it was enclosed. (Photo by Timothy Law)

When the exploration ended, the *unused* muds were abandoned, stacked in their original heavy paper sacks, and housed in a plywood shelter. Over time, the shelter deteriorated and collapsed, exposing the muds to weathering and leaching. In a preliminary site inventory, five mud types were identified: Q-Broxin (16,000 lbs), Maccowate (43,200 lbs), Economy Gel (52,800 lbs), Hydrogel (68,800 lbs) and Arcc (4,500 lbs).

As per EPA recommendations, Wrangell-St. Elias NP&P will continue monitoring and pursue cleanup of the waste site. Additional sampling and analysis will enable us to map more precisely the areas affected and any other sources of contamination (i.e. *used* drilling mud).

Development of a long term groundwater monitoring program, including installation of monitoring wells and collection and analysis of groundwater samples, will be followed by preparation of a feasibility plan for alternative cleanup options. Once a specific option emerges, detailed specs and a site safety plan will be drafted and funding will be sought.
