# Renewable Gravel Sources for Road Maintenance in Denali NP&P

By Kenneth F. Karle

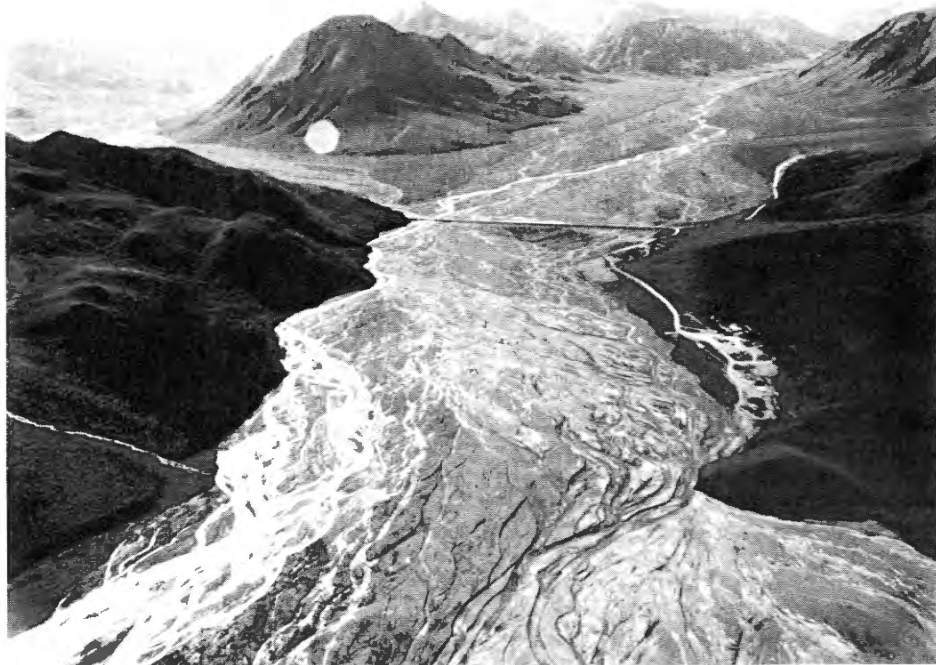
*The Toklat River study site, looking upstream (South).*
