# Stream and Floodplain Restoration On Watersheds Disturbed by Mining

By Kenneth Karle and Roseann Densmore

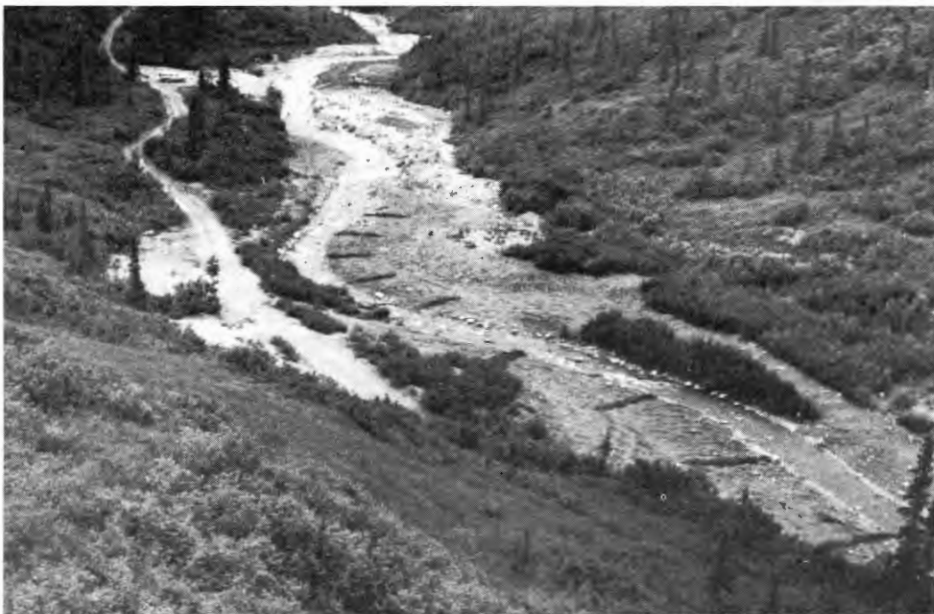
*Brush bars for floodplain stabilization may be seen on either side of the channel in this aerial view of the lower half of the 1991 study reach on Glen Creek in Denali NP.*

Several methods are being tested to temporarily stabilize the new floodplains until natural revegetation becomes adequate, which is predicted to take 5 to 10 years. Methods include well-anchored brush bars 15 to 20 feet long, oriented perpendicular to the channel. Bars are constructed of alder branches tied in bundles, partially buried and spaced at intervals of three channel widths. Streambank plantings of feltleaf willow cuttings and alder seedlings also have been established.

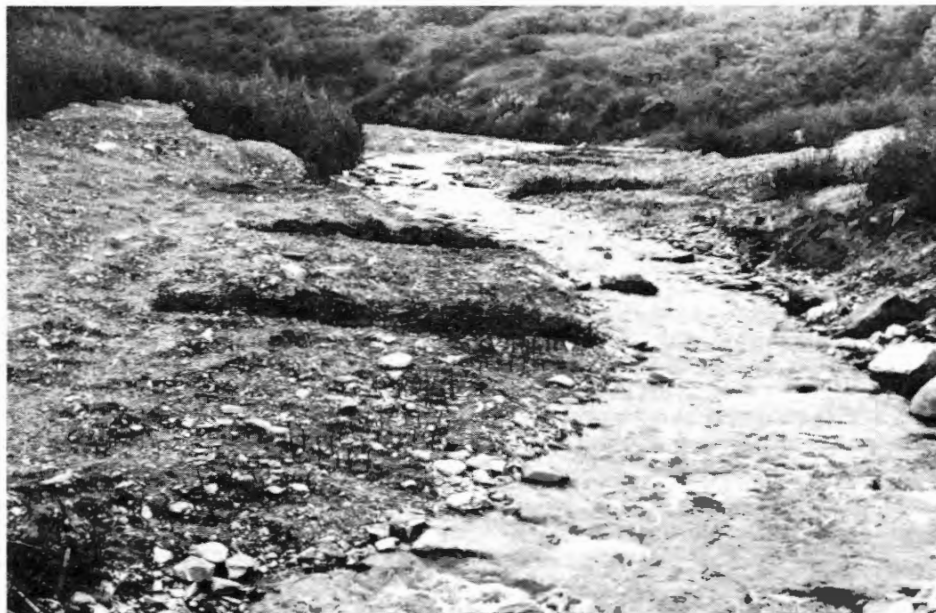
*Feltleaf willow cuttings for revegetation are shown here, along with brush bars for floodplain stabilization on a reclaimed section of Glen Creek.*
