# GIS Analysis Determines Erosion Potential At Buffalo National River Basin

By Tim Stephenson and David Mott

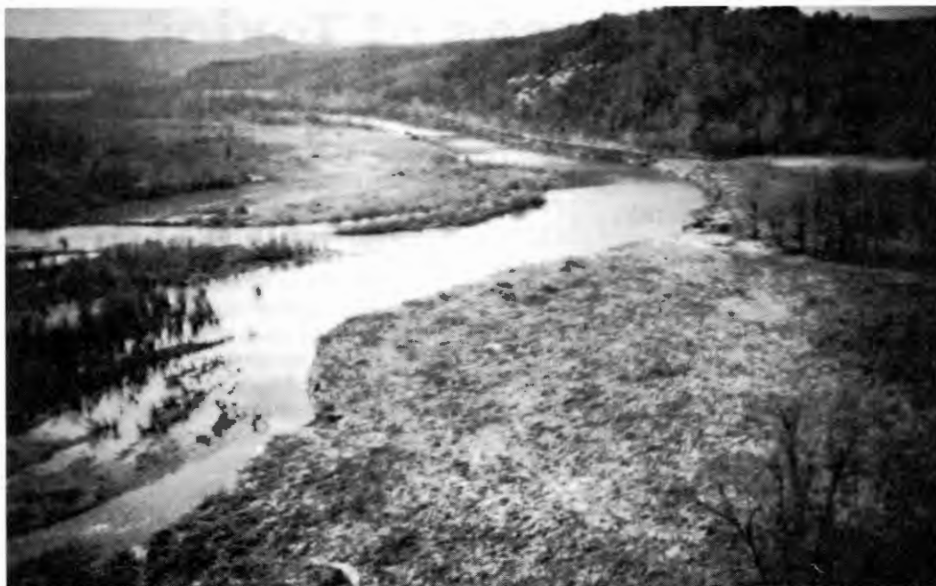
**Gravel aggradation and streambank erosion** in a tributary to the Buffalo National River result from upland clearing and removal of riparian vegetation.

riparian vegetation for agriculture have caused increased channel instability, anastomosing (dividing and reuniting), shallowing and widening (Jacobson and Pugh, 1992). As a result, there is evidence that significant changes are occurring in the physical habitats that influence aquatic ecosystems. This study uses a GIS to define the land use change in relation to slope in a portion of the Buffalo National River Basin and to interpret the potential for upland erosion and gravel transport.

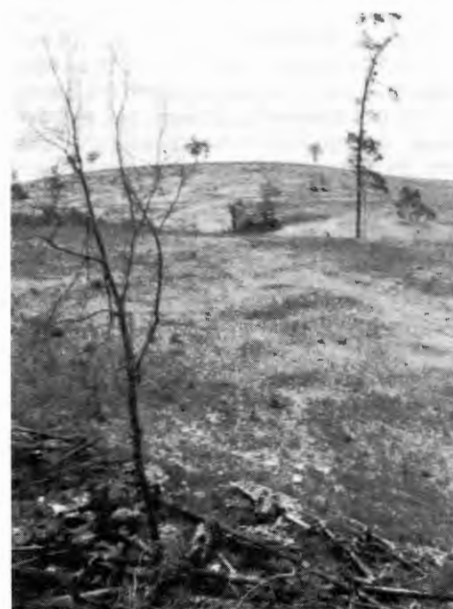
**Poor soils and steep slopes** combine to produce large volumes of gravel, which are transported by heavy rains to the surface hydrologic system at Buffalo River.
