## Stream Channel Characteristics Monitoring in Big Hole National Battlefield

### 2012 Status

### ***Big Hole National Battlefield North Fork Big Hole River - Stream Channel Characteristics Summary 2012***

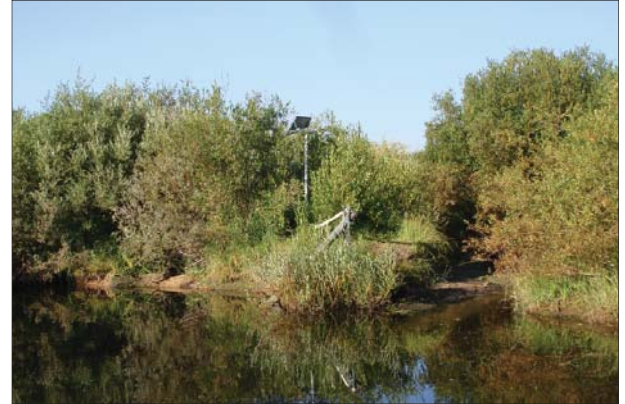
2012 monitoring on North Fork Big Hole River has contributed to the establishment of baseline conditions, which include determining bank stability and reach sinuosity.

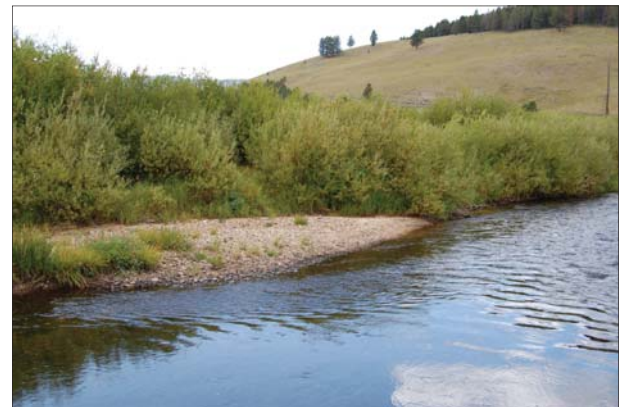
2012 monitoring included the assessment of channel substrate.
