## Stream Channel Characteristics Monitoring in City of Rocks National Reserve

### **2012 Status**

### **Castle Rock State Park and City of Rocks National Reserve - Stream Channel Characteristics Summary 2012**

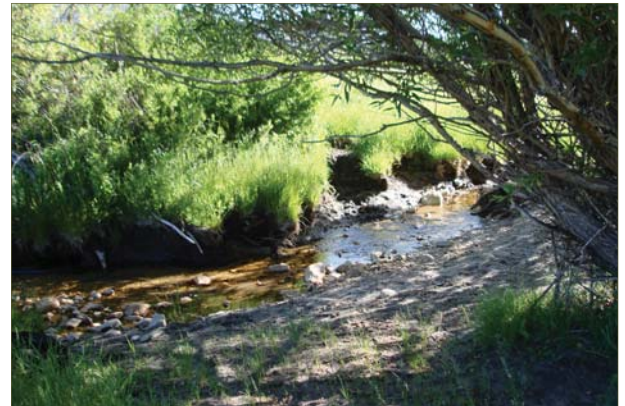
2012 monitoring on Almo Creek (CRSP) included the assessment of channel substrate.

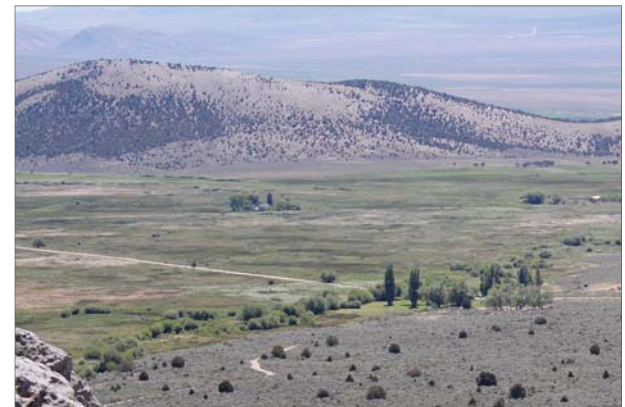
2012 monitoring on both Almo and Circle Creeks has contributed to the establishment of baseline conditions, which include determining bank stability and reach sinuosity.
