# Restoration of the Post Hospital at Fort Davis National Historic Site

## PROJECT SUMMARY

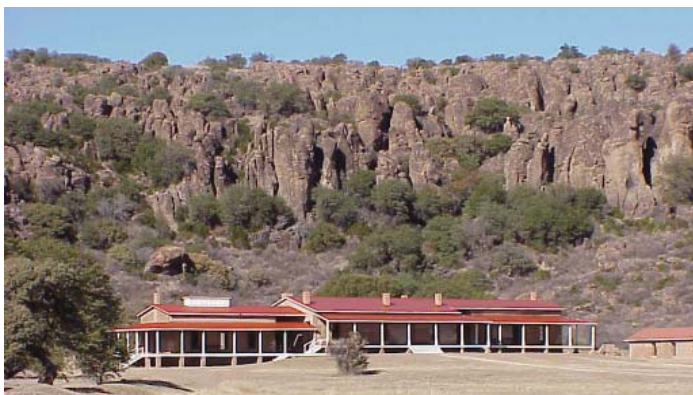
NPS photo

The post hospital at Fort Davis NHS today.

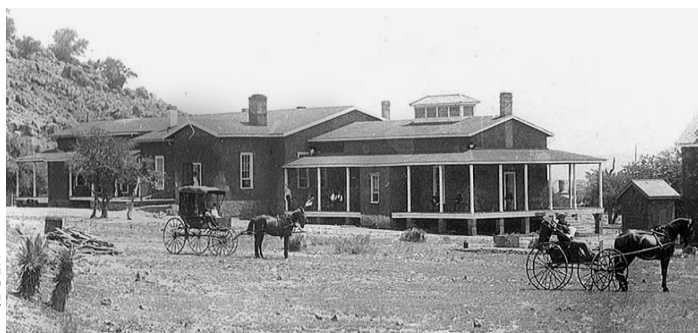
NPS Photo

The post hospital at Fort Davis NHS in the late 1880s.

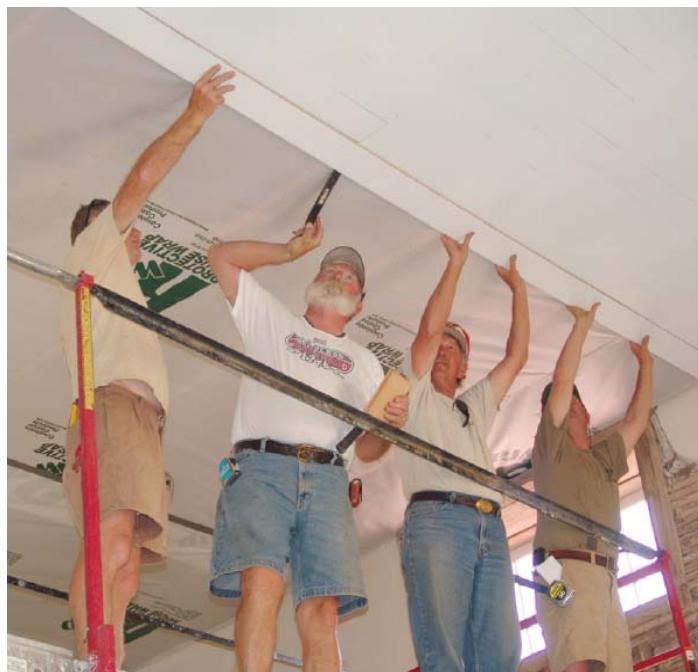
Installing the new ceiling in the north ward (2009).

areas where no plaster remained. Repairing mortar and replacing adobes were necessary to help conserve the exterior of the structure. In the installation of floors, sub-floors and ceilings, great care was taken to retain and preserve existing materials.

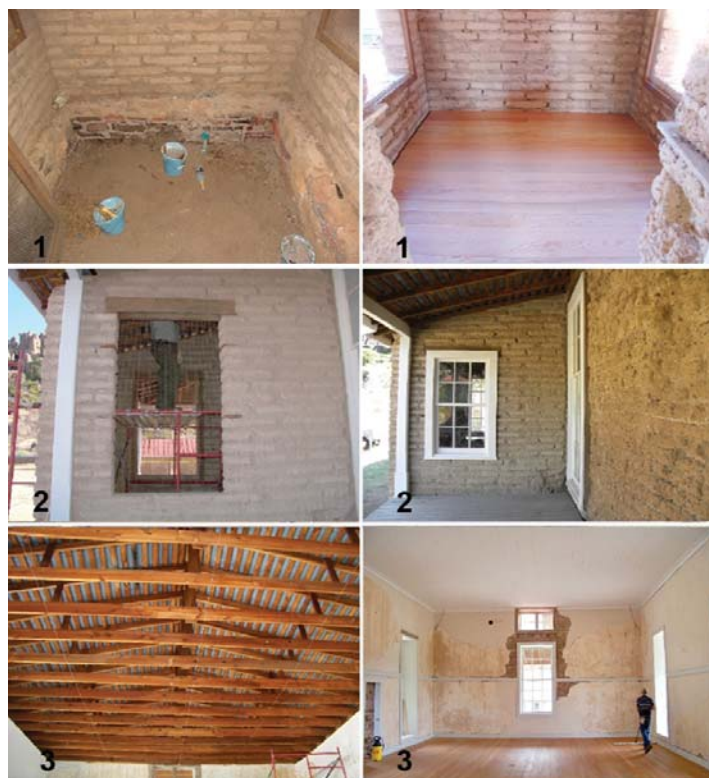
Before and after views of the north ward (1) addition of flooring in wash room (2) wash room window installation, and (3) new ceiling in the ward (2009).

The work, according to the original scope, was completed in 2009 with the exception of new doors and windows in the south ward of the post hospital. The south ward of the building will not undergo interior restoration, but doors and windows may be added at a later time. In total, four historic period doors and door casements were installed, one in the north ward and three in the administrative section. Twenty historic era windows were placed in the north and administrative areas, eleven of which included the window casements. Adobes were stabilized in places where the roof attaches to the walls and around all windows and doors. Historic lime plasters were stabilized and re-attached. In addition to stabilizing historic floors in the dispensary, floors and sub-floors were installed in the north ward, the north ward wash room, the post surgeon's office, the hospital steward's office, the hallway in the administrative section, and in the hallway closet between the post surgeon's office and the hospital steward's office. Tongue and groove ceilings and baseboards were constructed in the north ward, the north ward wash room, the post surgeon's office and the hospital steward's office. The new ceilings, as well as the doors and windows, were primed and painted. Although not part of the
