# Santa Cruz River at Cortaro Road

### Volunteer Restoration Project

Carianne Campbell and Marilyn Hanson, Tucson Chapter  
P.O. Box 41206 Tucson, AZ ♦ [www.aznps.org](http://www.aznps.org)

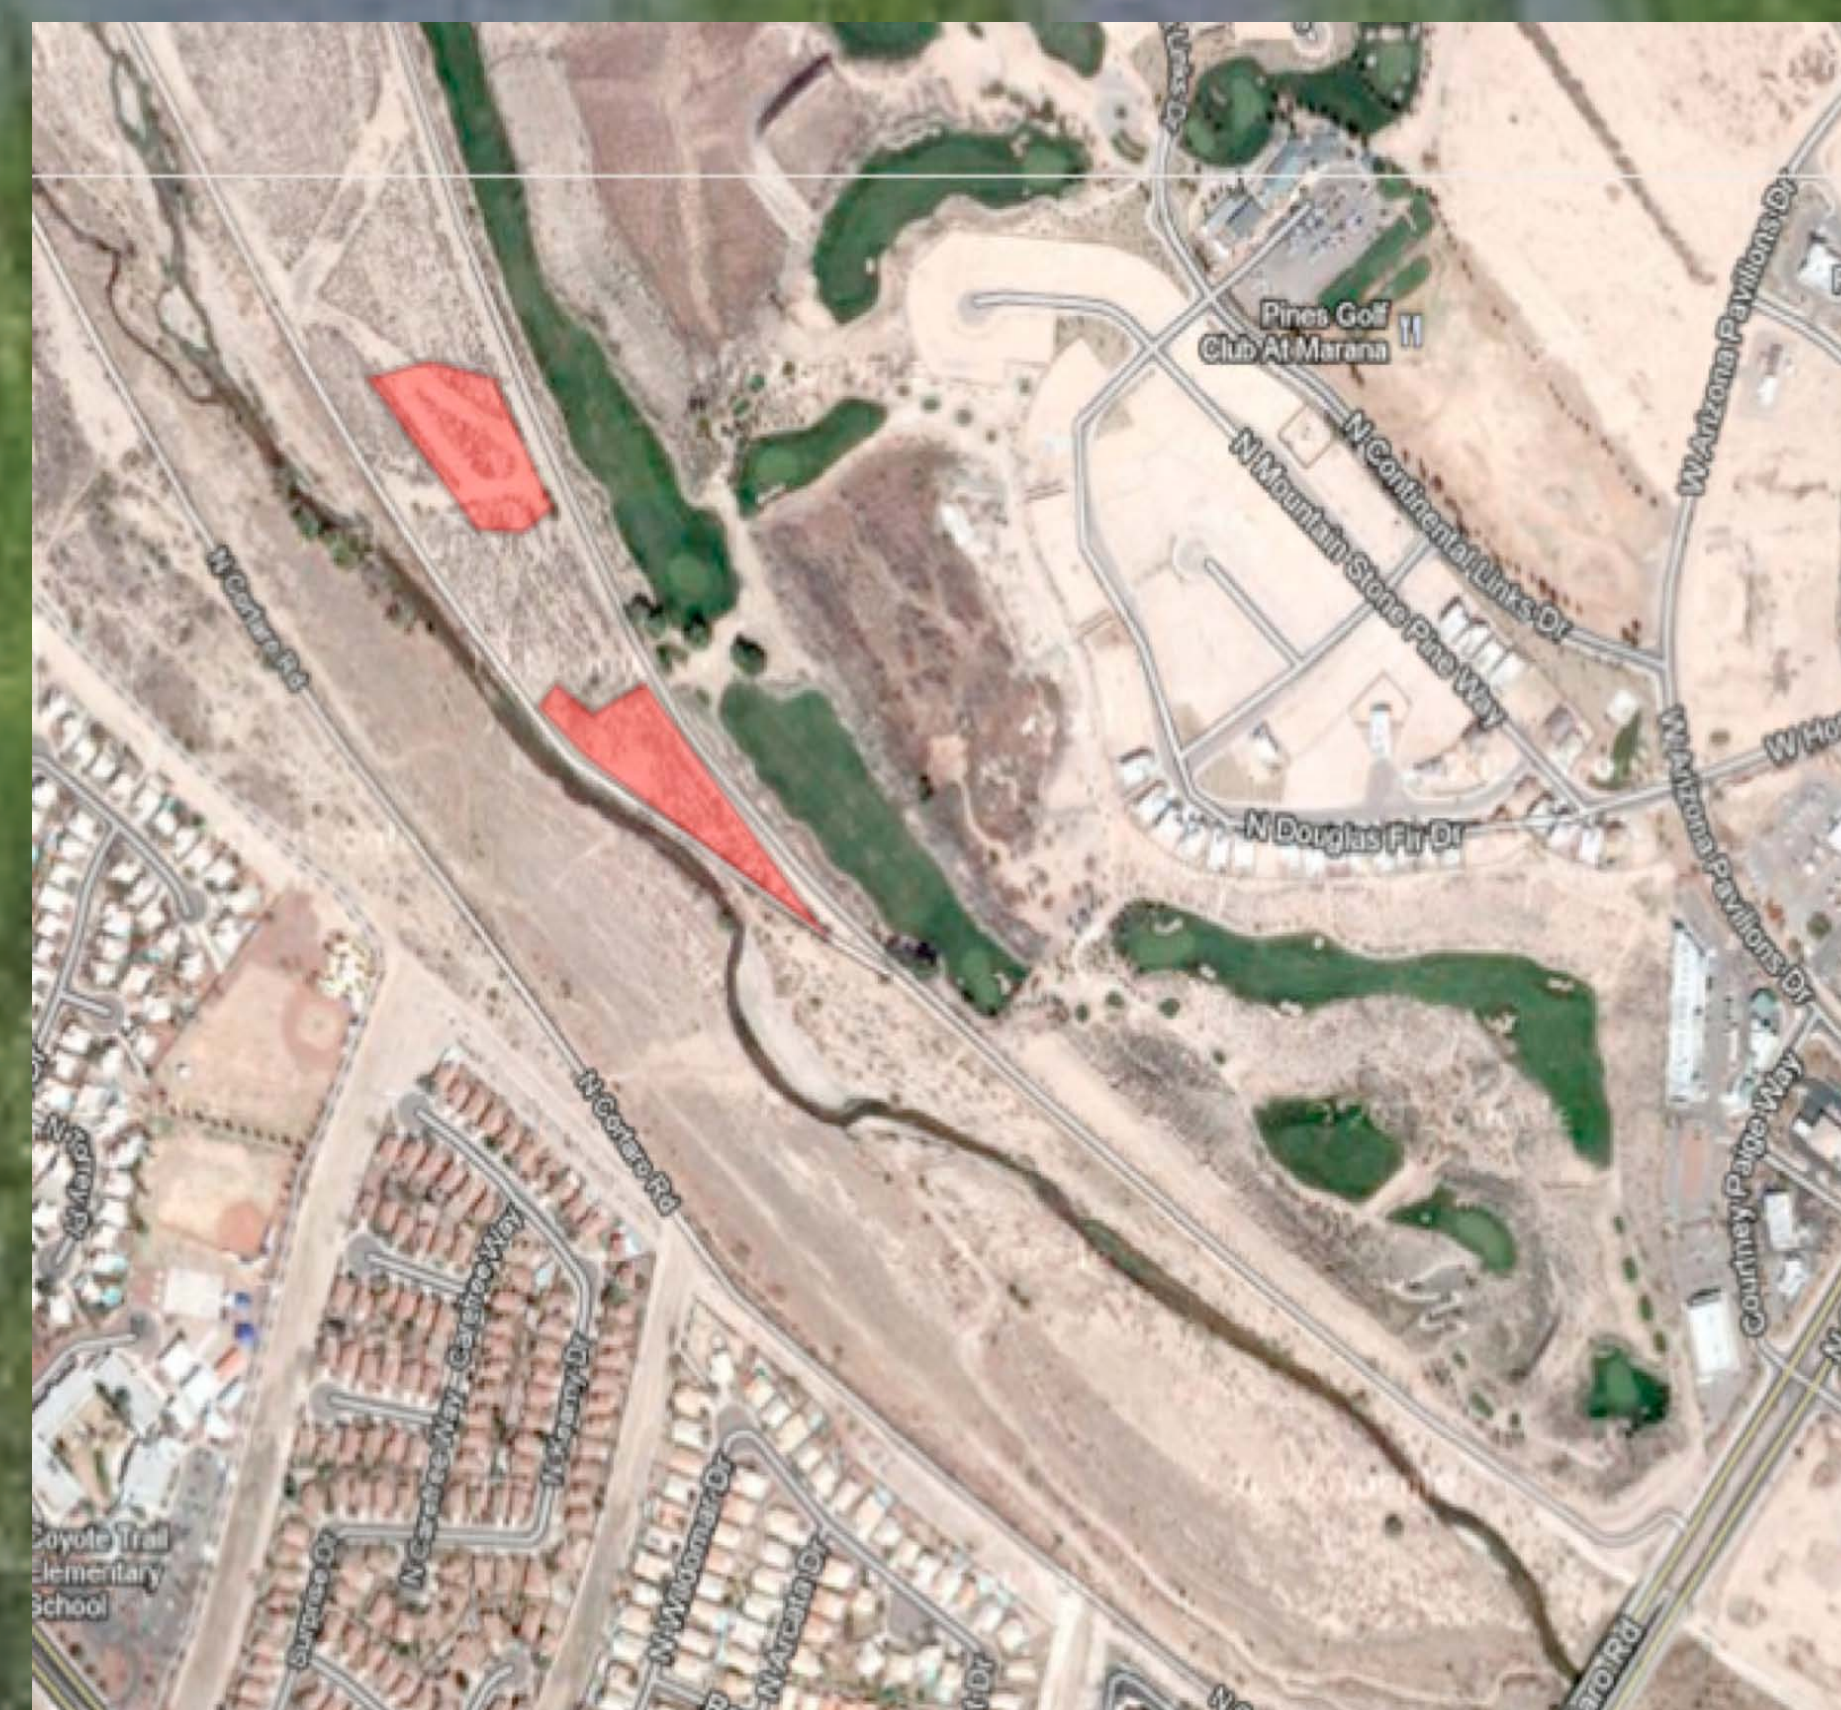
**Figure 1. Proposed project location.** Approximately 3 acres on the east bank of the Santa Cruz River, north of Cortaro Road. The disturbed area is adjacent to the Santa Cruz River Park and the Quarry Pines Golf Course.

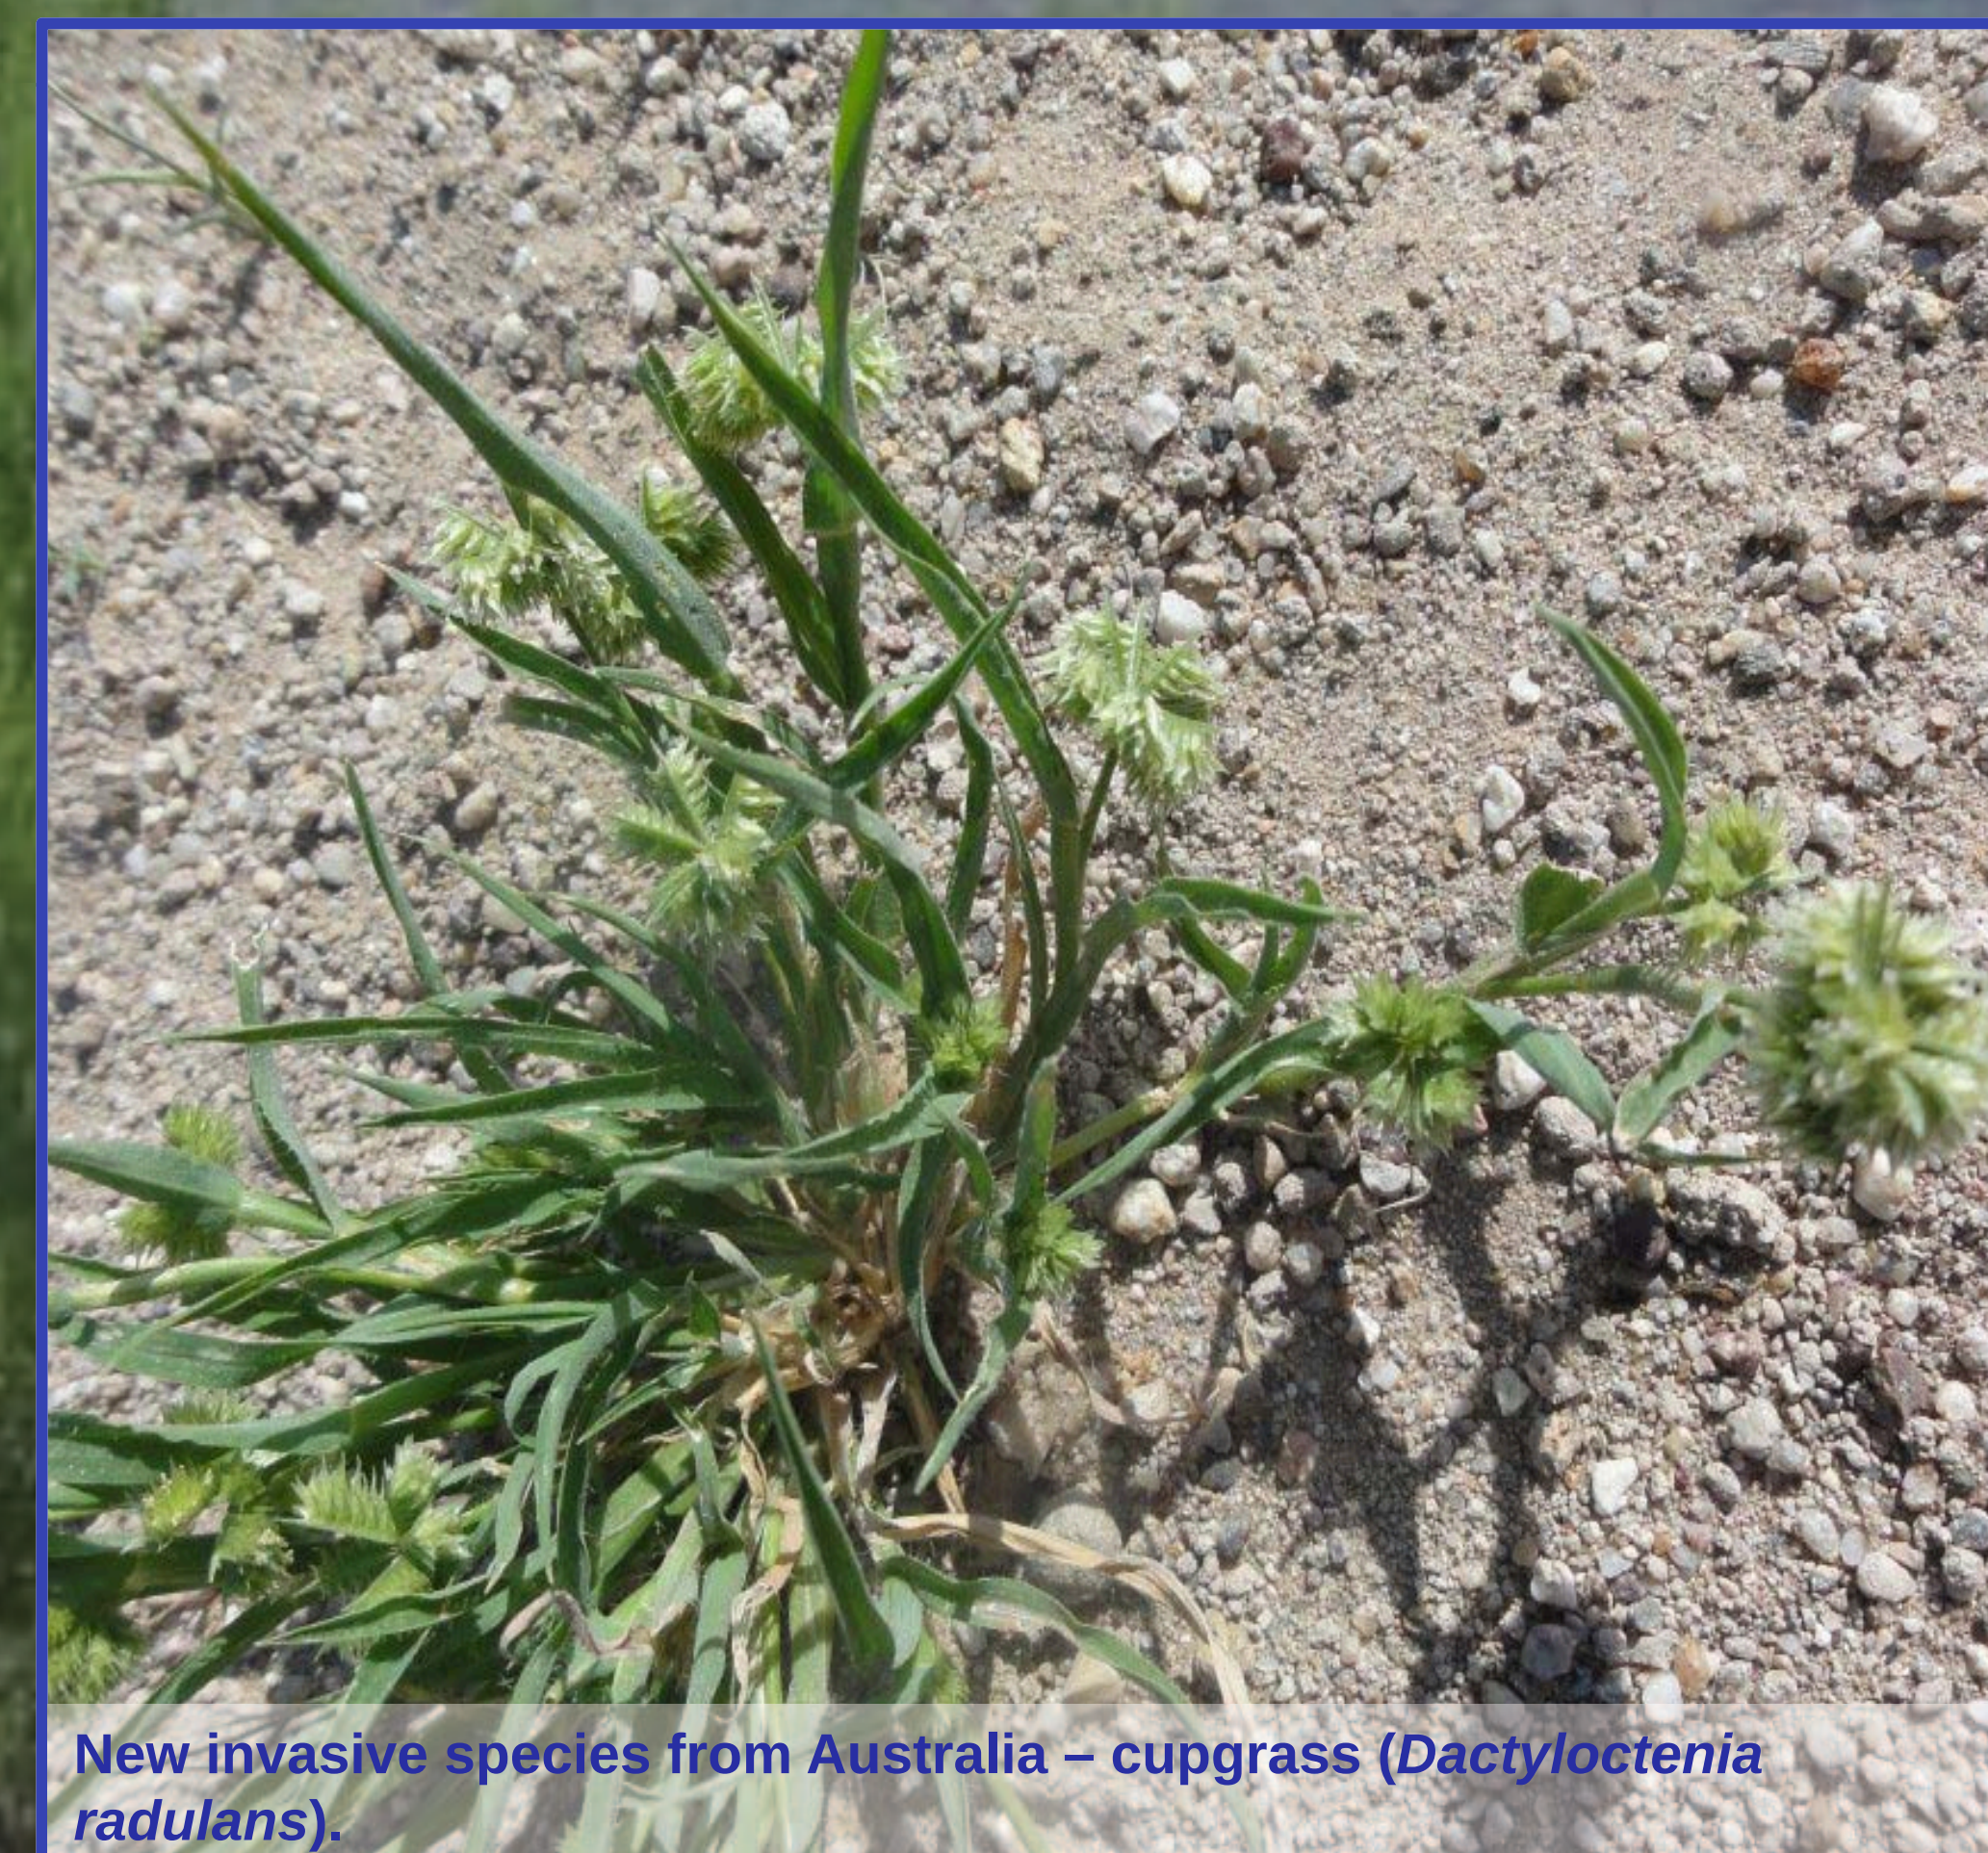
New invasive species from Australia – cupgrass (*Dactyloctenia radulans*).

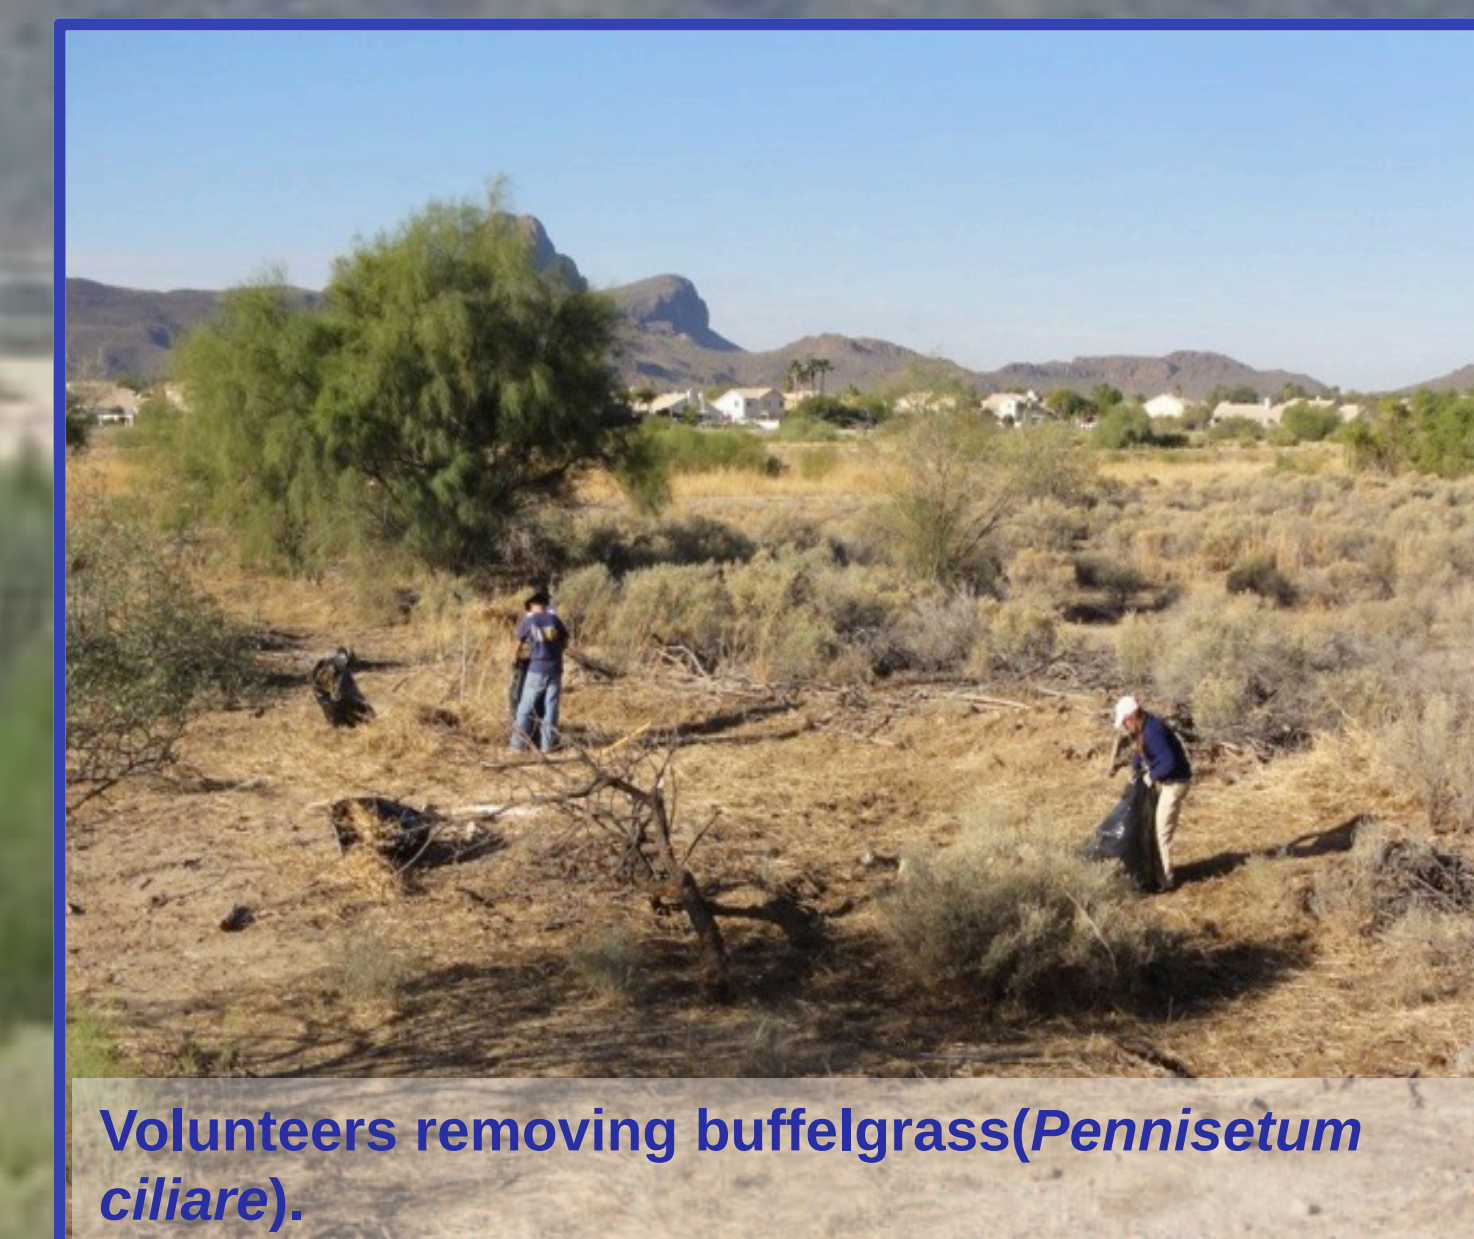
Volunteers removing buffelgrass(*Pennisetum ciliare*).

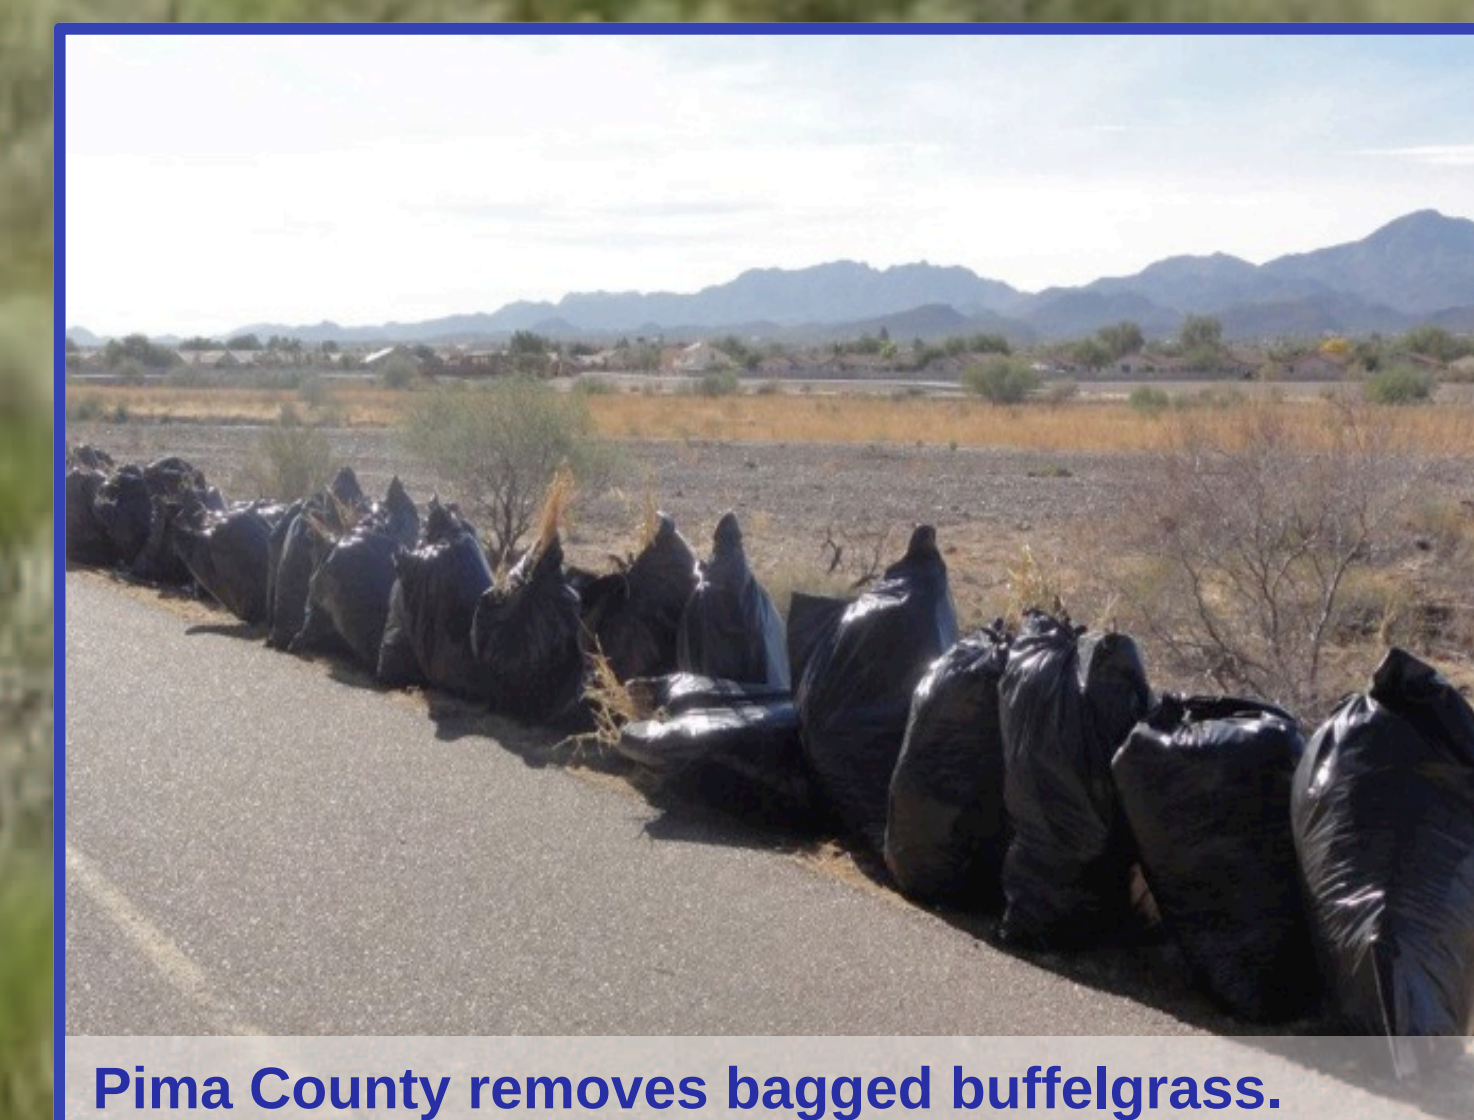
Pima County removes bagged buffelgrass.

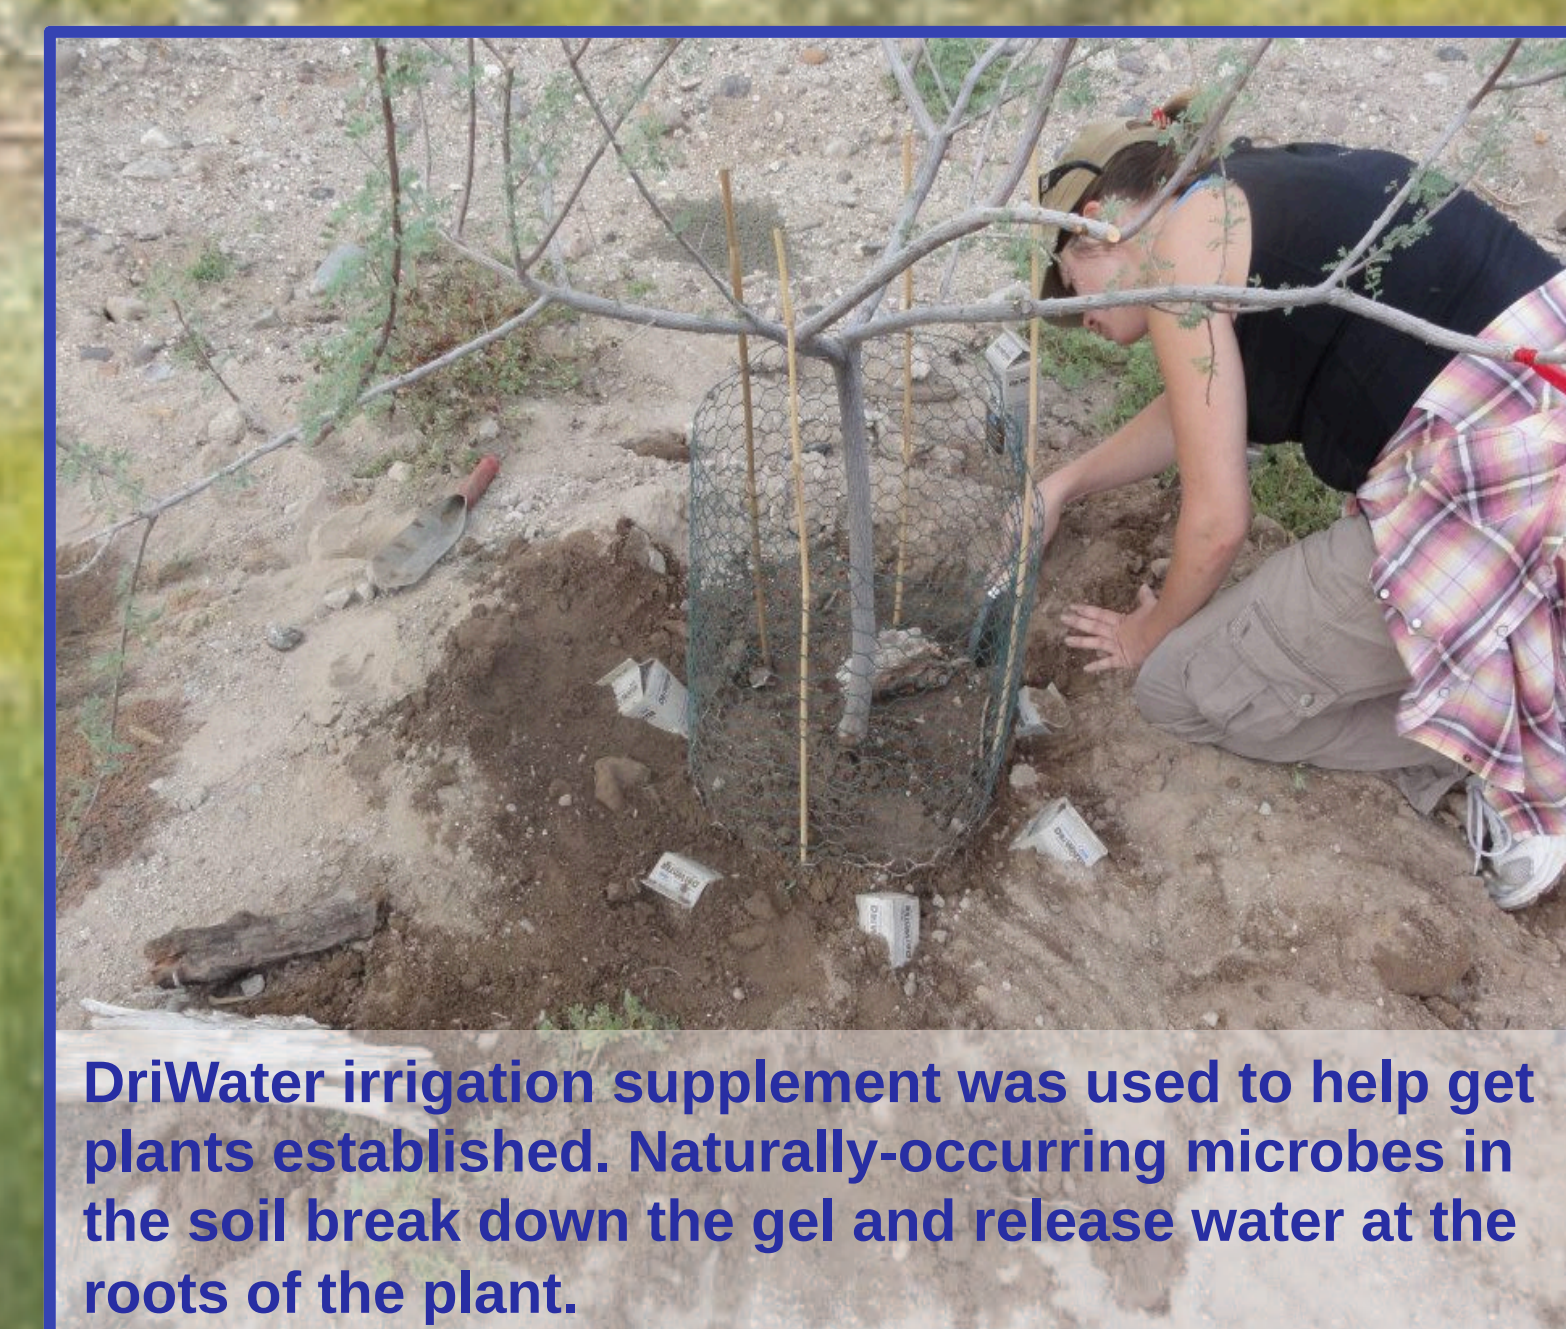
DriWater irrigation supplement was used to help get plants established. Naturally-occurring microbes in the soil break down the gel and release water at the roots of the plant.

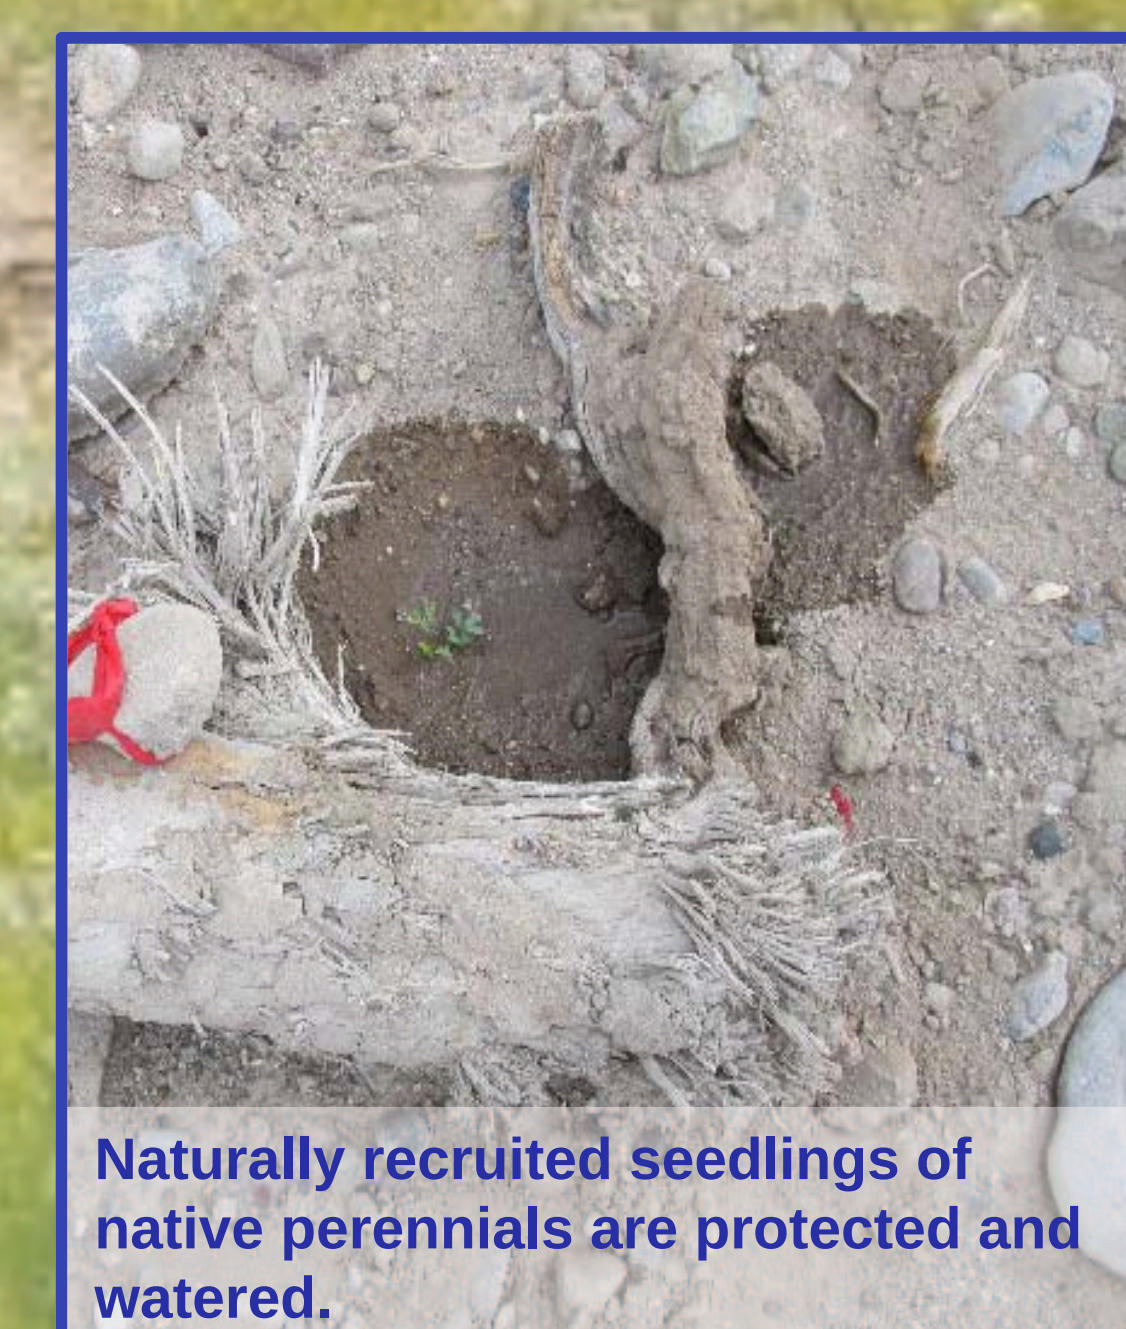
Naturally recruited seedlings of native perennials are protected and watered.

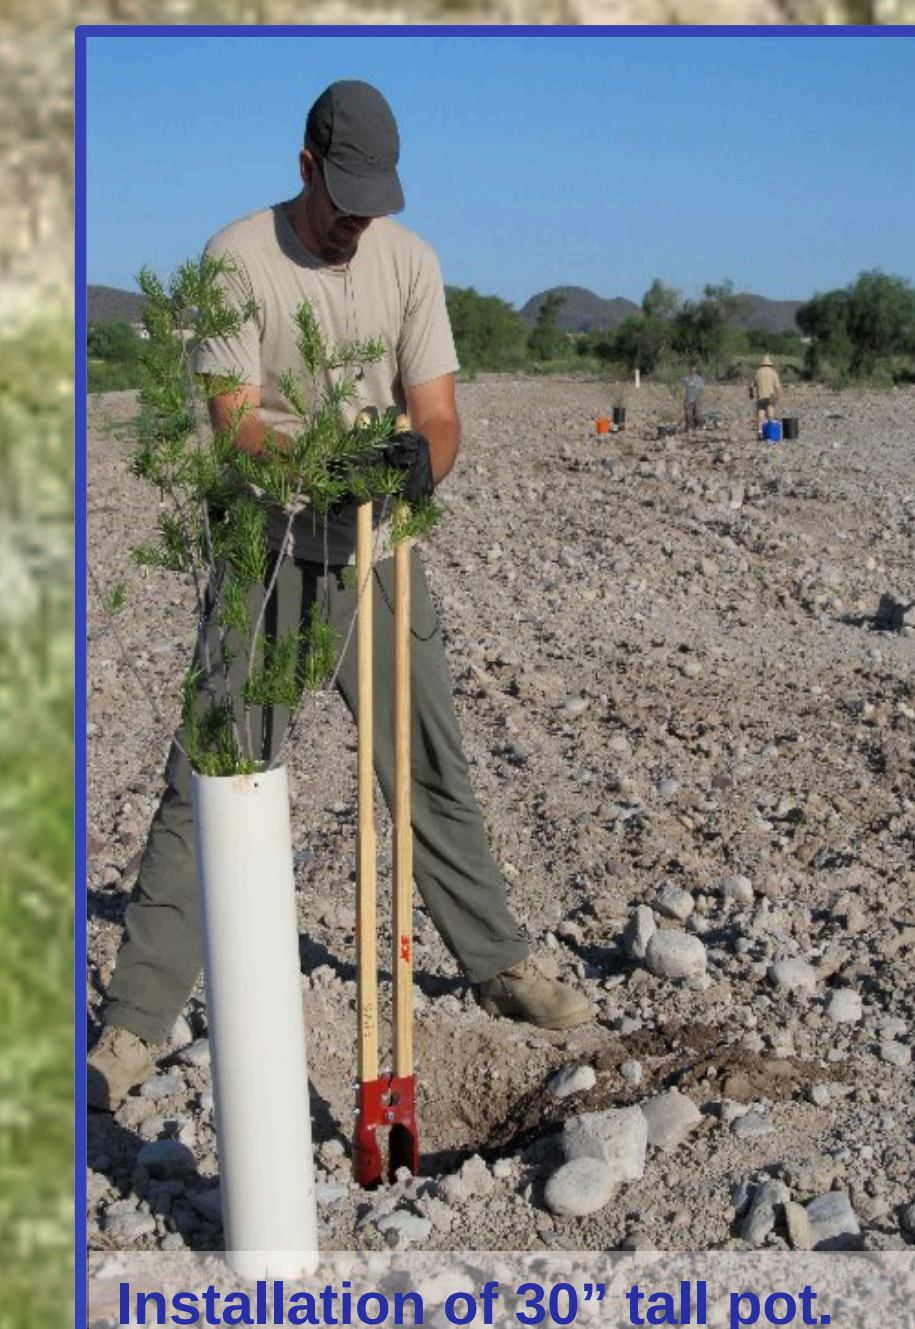
Installation of 30" tall pot.

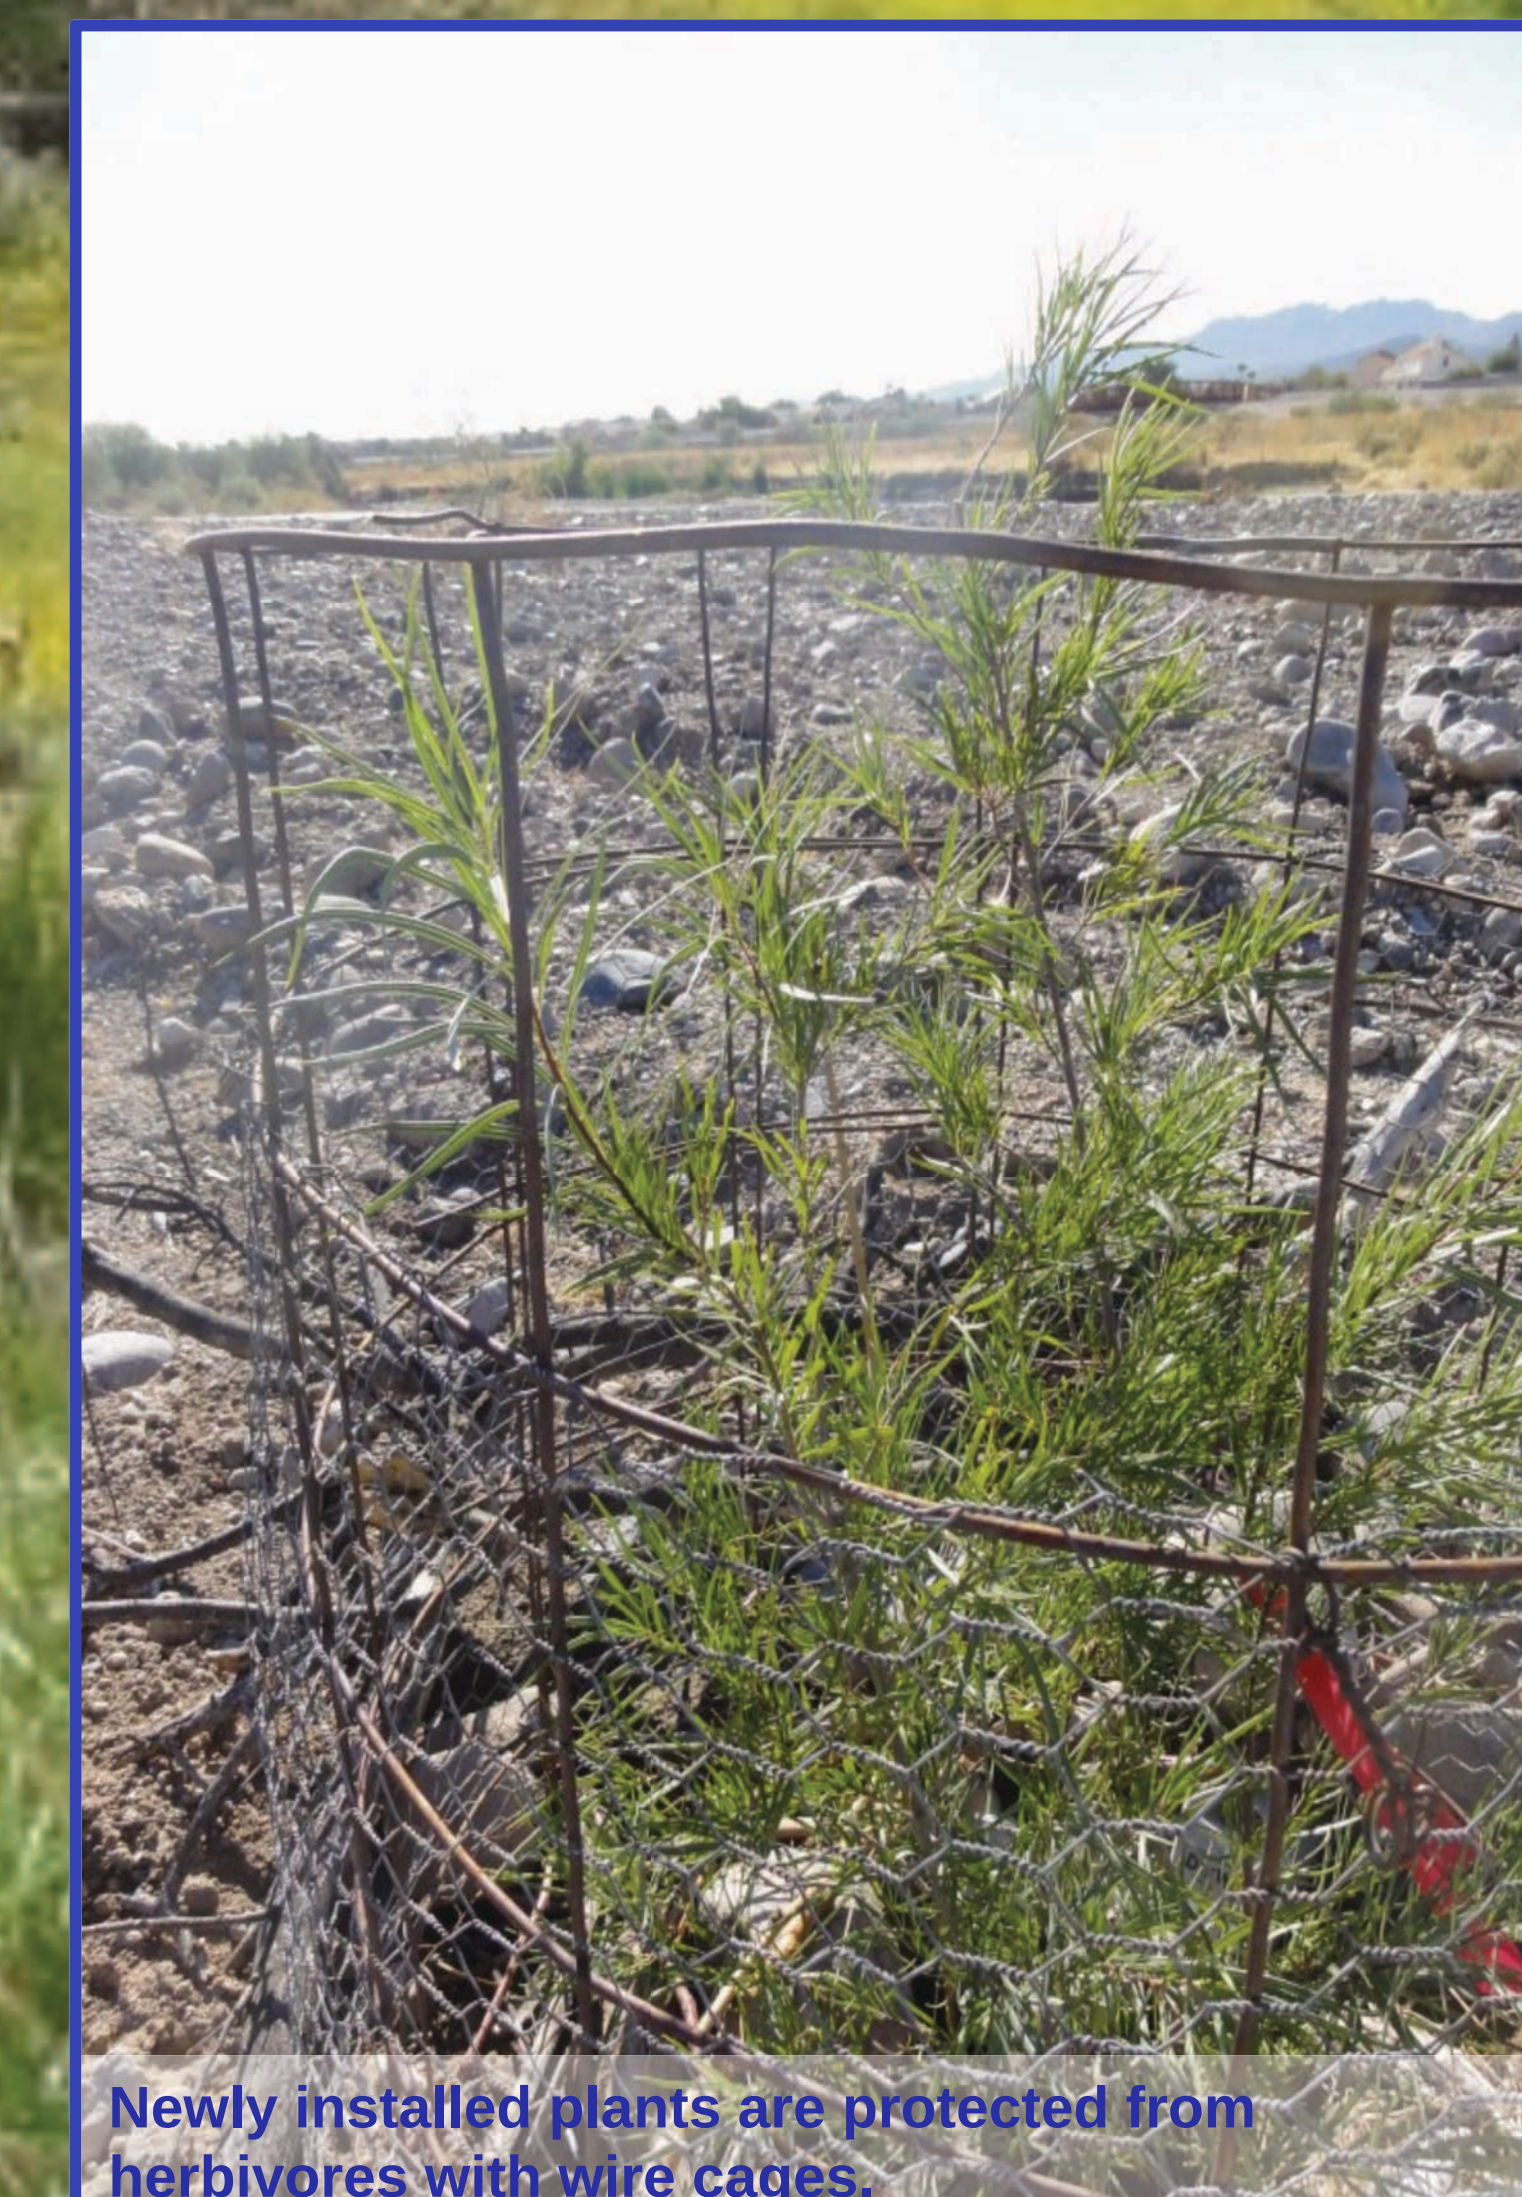
Newly installed plants are protected from herbivores with wire cages.
