## Streams Monitoring at Pecos National Historical Park

2014

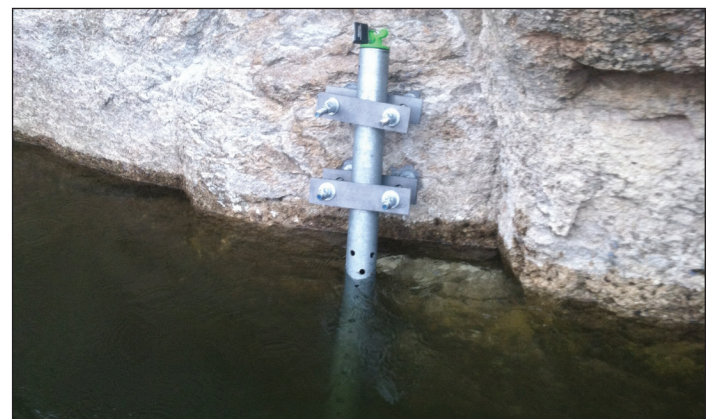
Permanent mount for multiparameter logging probe. For two-week periods, the probe is deployed inside the mount, where it is protected from high-flow events and other potential disturbances.

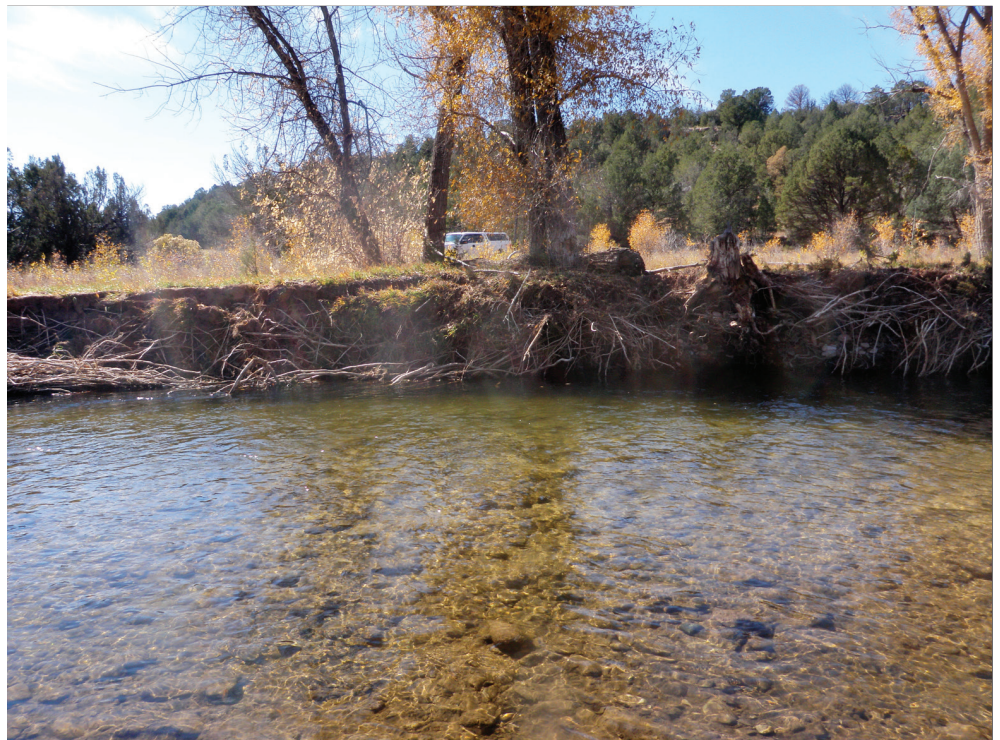
Post-fire bank erosion, Pecos River.

Reduced vegetation cover and soil damage from upstream fires have resulted in sediment-heavy flows. Following monsoon rain events, sediment built up along banks, islands, and in the channel substrate. On September 13, 2013, a flood event occurred with a peak discharge of 2,210 cfs (cubic feet per second). While this flow was largely driven by an intense, regionwide storm, fire effects likely contributed to the high flows. Following this flow event, general observations included bank erosion in isolated locations, widening of the channel in some areas, and a reduction in the depth of pools due to sedimentation.
