# Water Quality Monitoring for El Rito de los Frijoles and Capulin Creek in Bandelier National Monument

## *2012–2013 Summary Report*

Natural Resource Data Series NPS/SCPN/NRDS—2016/1218

May 2016

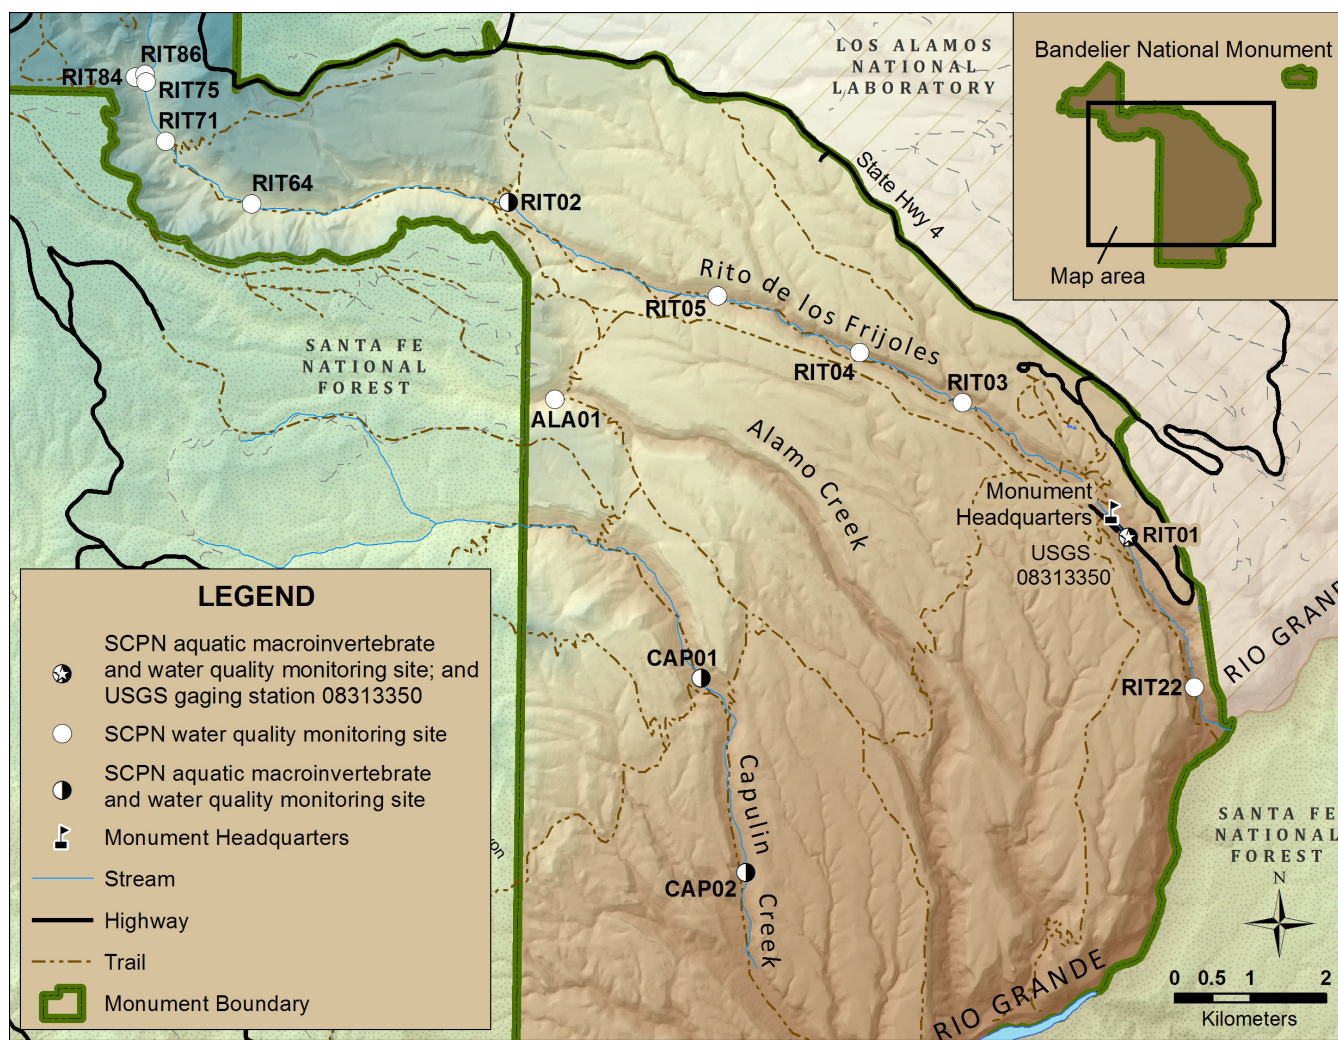
Figure 1. Map of water quality sampling sites on the Rito de los Frijoles, Capulin Creek, and Alamo Creek in Bandelier NM.

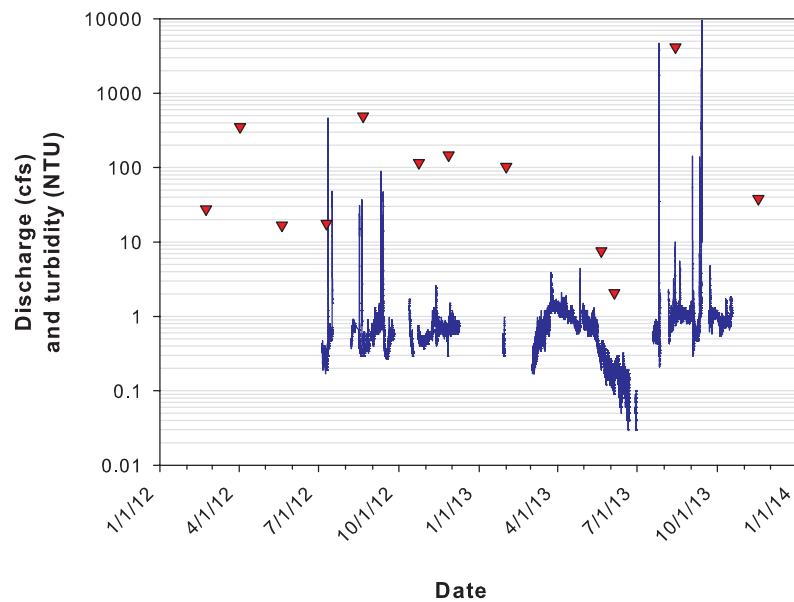
Figure 2. Streamflow for USGS gaging station 08313350 near RIT01 on the Rito de los Frijoles near the visitor center, Bandelier NM, 2012–2013 (USGS 2016). Turbidity is shown in red.

Turbidity varied greatly for the three sites throughout 2012–2013, depending on when the last precipitation event occurred. Generally turbidity readings tended towards pre-fire conditions in the late spring, but were higher during other times of the year. Median turbidity was lowest at RIT02; in 2012 and 2013 it was 7.9 and 3.4 NTU. At RIT01, median turbidity was 116 and 38 NTU, and at RIT03 it was 98 and 45 NTU. Prior to the fire, turbidity samples were usually below 4 NTU, with the exception of samples collected during periods of high streamflow. Turbidity was extremely high in August 2013 due to a large flood which had occurred three weeks earlier.

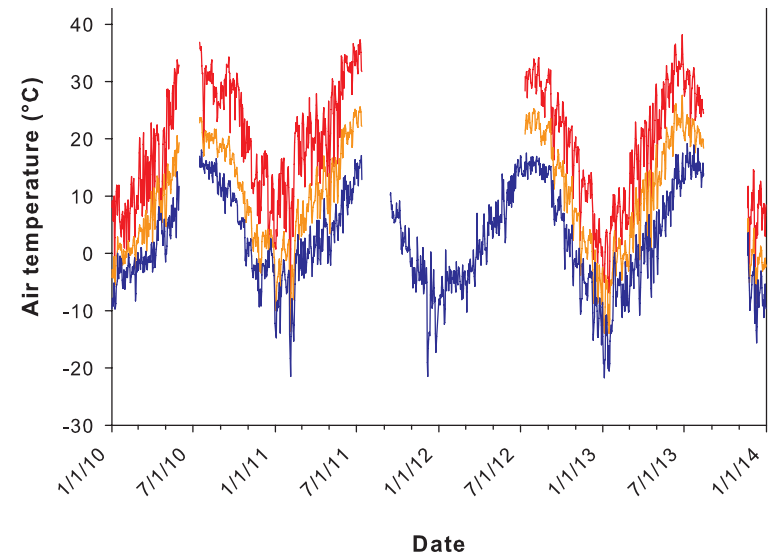
Figure 3. Stream temperature and air temperature data for RIT01 on the Rito de los Frijoles near the visitor center, Bandelier NM, 2009–2013. Water and air temperatures were recorded at 15-minute intervals by either a HOBO Tidbit or HOBO Pendant (Onset Computer Corporation). Data are missing in sections because data loggers were lost due to fire or floods.

Water temperatures at RIT01 in 2012–2013 continued to exceed the water temperature criteria, which is a maximum of 23°C, not to be exceeded at any time, as well as the 4T3 criterion of 20°C, not to be exceeded for four or more consecutive hours on more than three consecutive days (NMED 2013). Only limited water temperature data are available for 2012. The 23°C criterion was exceeded on 5 days, though data are missing between 7/11/12 and 10/24/12. The maximum recorded temperature in 2012 was 24.6°C. In 2013, the 4T3 criterion was exceeded from 6/12–6/15 and 6/18–7/6/12. In 2013, water temperatures were recorded for the entire year. The 23°C criterion was exceeded on 74 days between early June and early September. The maximum recorded temperature that year was 26.3°C. In 2013, the 4T3 criterion was exceeded from 6/9–7/1, 7/3–7/14, 7/16–8/13, and 8/15–9/9—a total of 90 days.

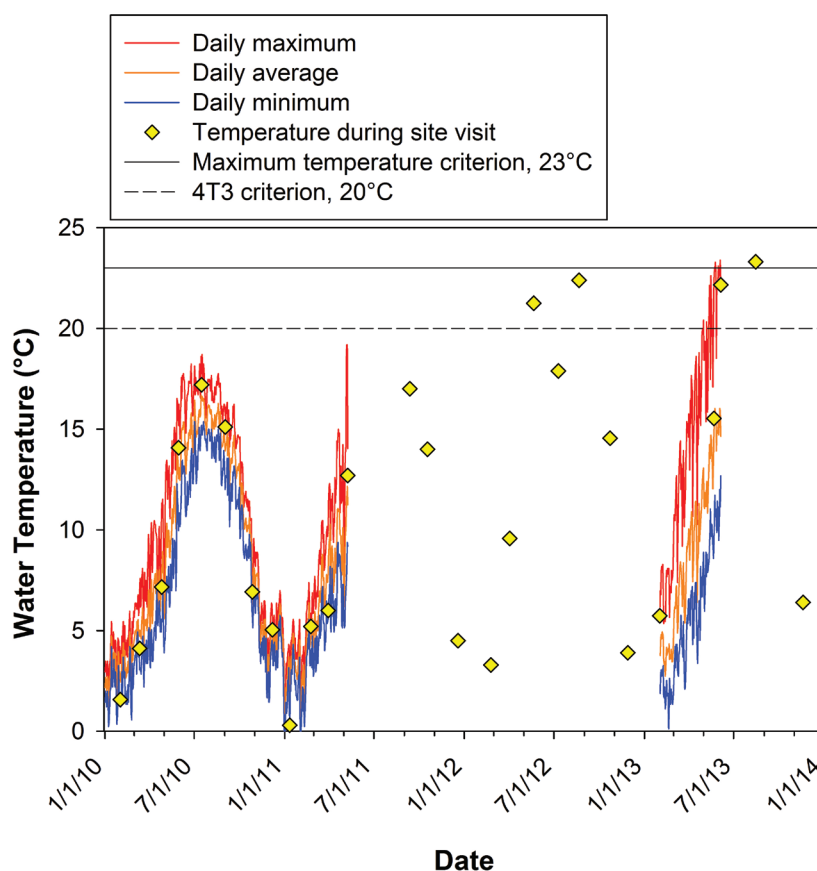
Figure 4. Daily maximum, average, and minimum temperatures for RIT02 on the Rito de los Frijoles, Bandelier NM, 2010–2013. Water temperatures were recorded at 15-minute intervals by a HOBO Pendant (Onset Computer Corporation). Water temperatures recorded by SCPN during site visits are included. Data are missing because data loggers were lost in floods.

recorded at RIT02 from 2010–2013 are displayed in Figure 4, along with temperature criteria for high-quality coldwater streams and measurements collected by SCPN during site visits. Data for this site are very limited due to multiple losses of the loggers caused by the fire and several floods. For this reason, the only 15-minute logger data are from 2/1–6/5/13 and prior to 5/9/11. There are no logger data for 2012; the only post-fire temperature measurements were obtained during site visits. Although the 2013 data stops on June 5, the 23°C maximum was exceeded on four days, and one more exceedance was recorded at a site visit on 8/15 at 11:10. The 4T3 criterion was exceeded from 5/22–5/26 and from 5/30–6/4. Even with this limited data, stream temperatures recorded after the 2011 fire were higher than those recorded prior to the fire.

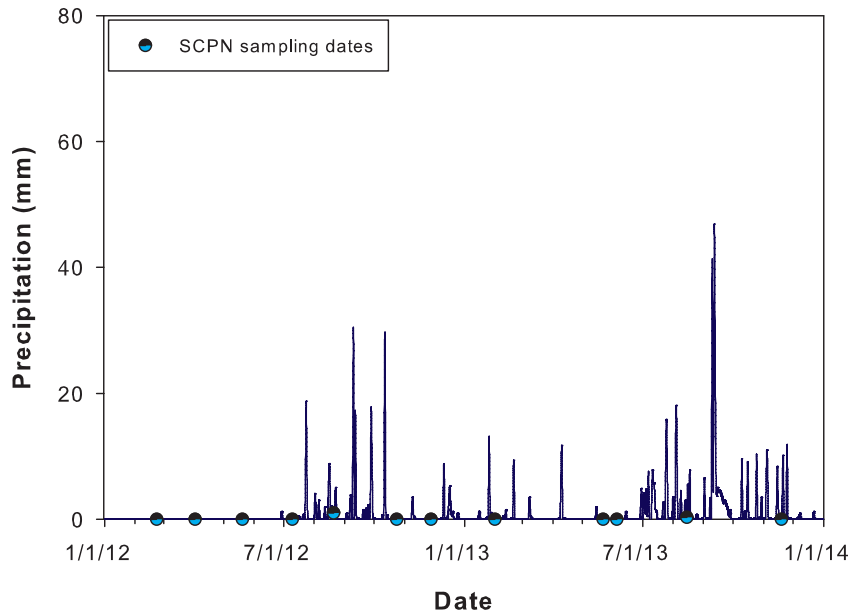
Figure 5. Daily precipitation from the rain gage (#31057) at Ponderosa C.G. in Bandelier NM, 2012–2013.

Data from the early warning system weather stations Ponderosa C.G. (#31507) and Dome Road (#31508) (OneRain 2015) are shown in Figures 5 and 6. The Ponderosa C.G. rain gage, located 2 km north from RIT02, started collecting data on June 29, 2012, and continued through 2013. Significant precipitation did not occur until July 23, 2012, when the gage recorded wet periods several days in length, followed by dry periods several days in length. This pattern continued through September. About 151 mm of rainfall fell during the monsoon months of July, August, and September, but over half of this (86 mm) fell in September. The total precipitation recorded from June–December 2012 was 210 cm.

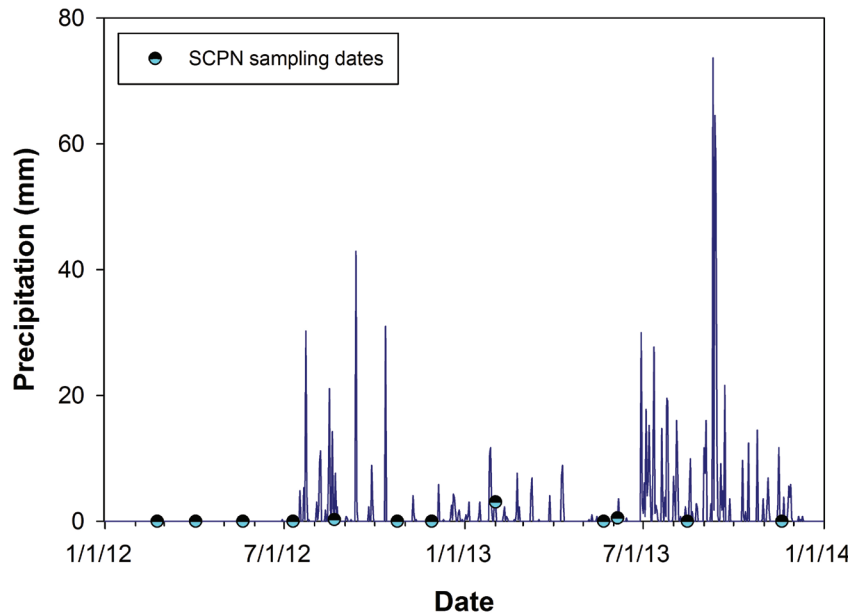
Figure 6. Daily precipitation from the Dome Road rain gage (#31058) in Bandelier NM, 2012–2013.

In 2013, a total of 456 mm of precipitation was recorded at the rain gage. The first six months of the year were fairly dry without any large storms. Two-thirds of the total precipitation for 2013 occurred during the months of July, August, and September, though September was a particularly wet month with 171 mm of rain.

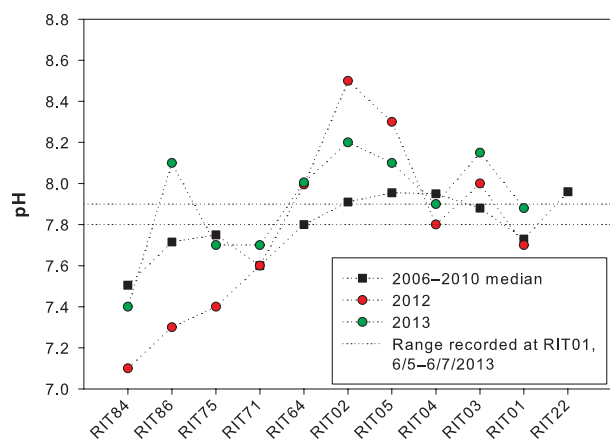
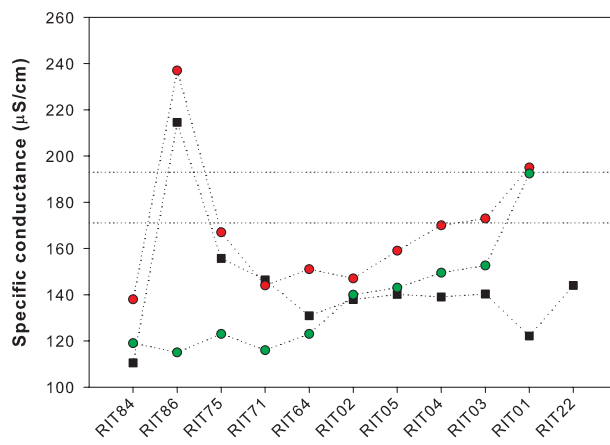
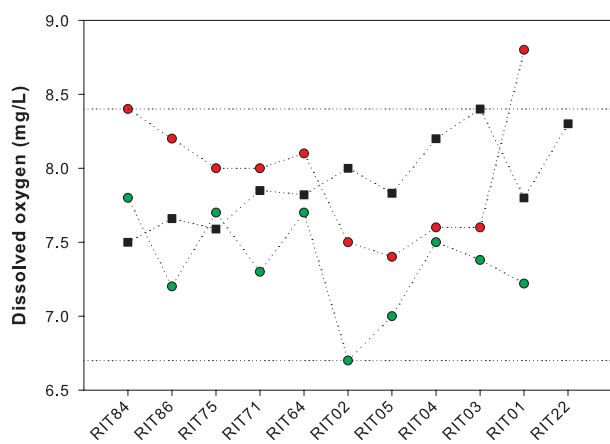
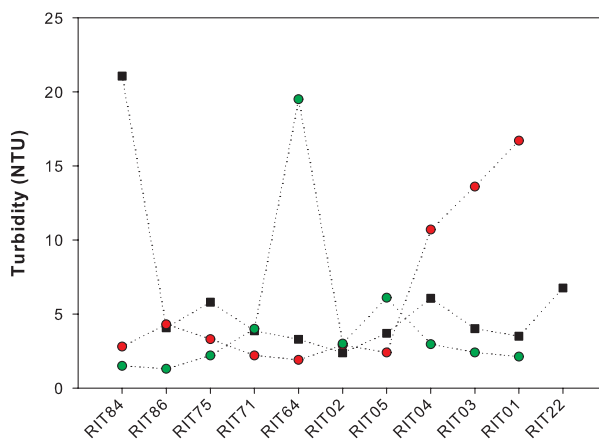
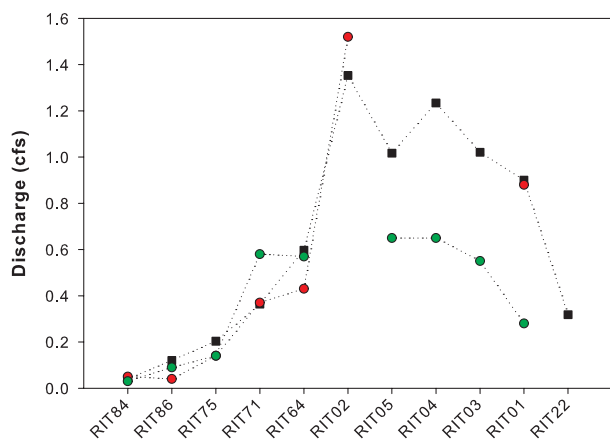
Figure 7. Spatial variability along the Rito de los Frijoles in Bandelier NM, 2012–2013. Values for core parameters measured during base flow conditions: (a) pH, (b) specific conductance, (c) dissolved oxygen, (d) turbidity, and (e) discharge. Median values measured from 2006–2010 are included for comparison.

near the Rio Grande, to assess the spatial variability of these parameters along the length of the stream. Values for all parameters measured during May 21–22, 2012 and June 5–6, 2013 are presented in Figure 7, along with median values for measurements taken from 2006–2010, which were taken during base flow conditions prior to the Las Conchas fire. In 2013, a multiparameter sonde recorded temperature, pH, specific conductance, and dissolved oxygen data at RIT01 from June 5–7. The ranges of these values are plotted in Figure 7 so that the upstream sites can be compared to RIT01. Sites are listed in order from upstream to downstream, except for RIT84 and RIT86 which represent two forks of El Rito de los Frijoles shortly before they converge just upstream of RIT75. The data used in Figure 7 are in Appendix G.

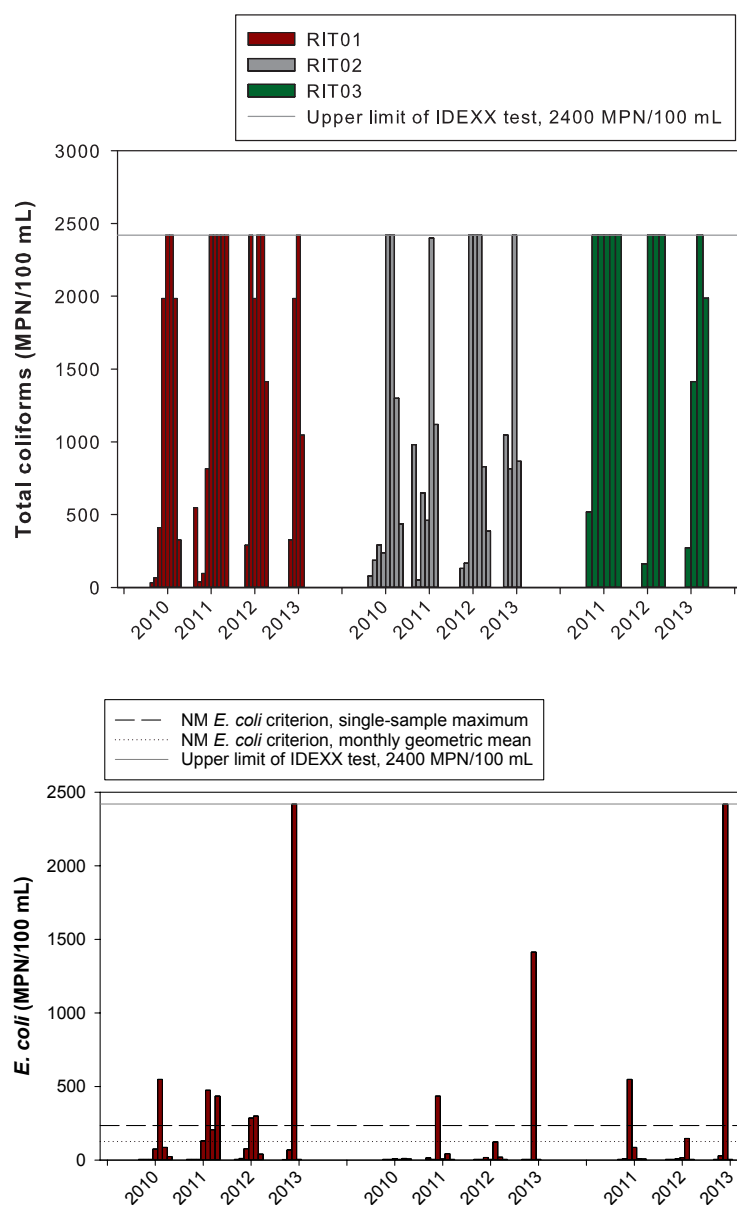
Figure 8. Total coliforms (top) and *E. coli* data (bottom) in samples collected from RIT01, RIT02, and RIT03 on the Rito de los Frijoles in Bandelier NM, 2010–2013.

Bacteria data for samples collected by SCPN at RIT01, RIT02, and RIT03 in 2012–2013 are plotted in Figure 8; 2010 and 2011 data are included for comparison. Numeric results for 2012–2013 are presented in Appendices B–D. In 2012, seven bacteria samples were collected each from RIT01 and RIT02, and four were collected from RIT03. Four samples were collected at each of the sites in 2013. SCPN's data are expressed as a most probable number (MPN), a statistical estimate of the number of bacteria per 100 mL of stream water. Water quality criteria are expressed as colony forming units (cfu) per 100 mL and do not assume an estimation, but the two units are comparable. The *E. coli* criteria applicable at Bandelier are a monthly geometric mean of 126 cfu/100 mL or a single-sample maximum of 235 cfu/100 mL. We analyze our samples for total coliforms because theoretically they are indicators of the presence of all coliform groups of bacteria, both vegetative and fecal in origin. For drinking water, total coliforms are still the standard test because their presence indicates contamination of a water supply by an outside source. There are no water quality criteria for total coliforms.

Median total coliform levels at RIT01, RIT02, and RIT03 were 2000, 940, and 2200 MPN/100 mL, respectively. The two downstream sites, RIT01 and RIT03, were higher than RIT02, which is located 9.5 km upstream from RIT01.

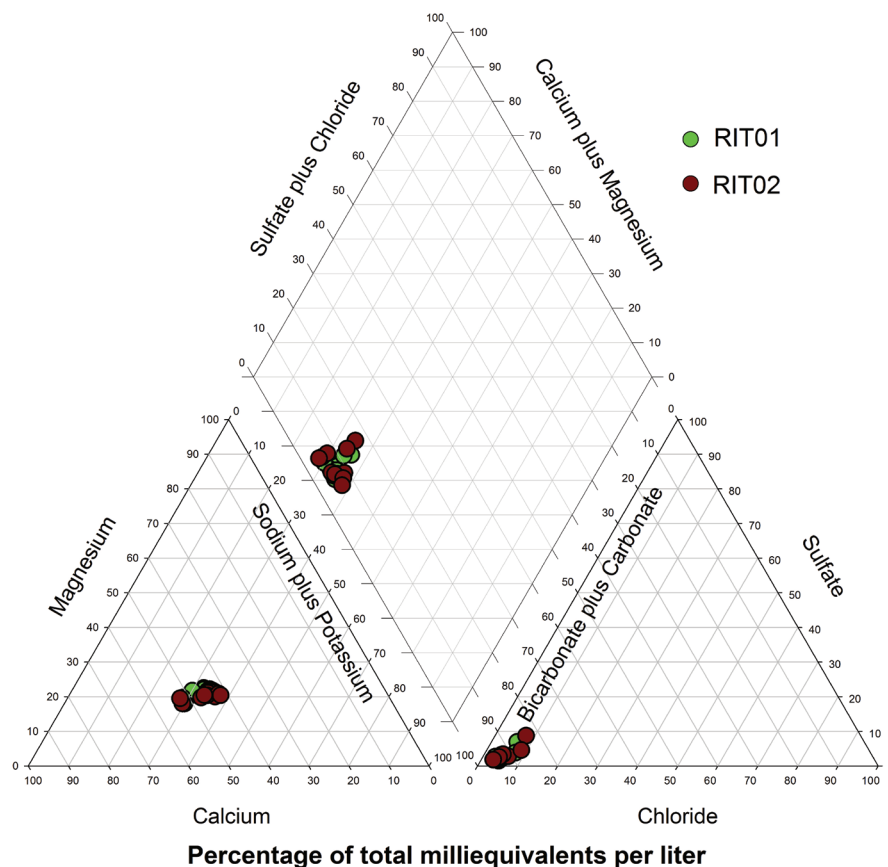
Figure 9. Major ion composition from samples collected at RIT01 and RIT02 on the Rito de los Frijoles in Bandelier NM, 2012–2013.

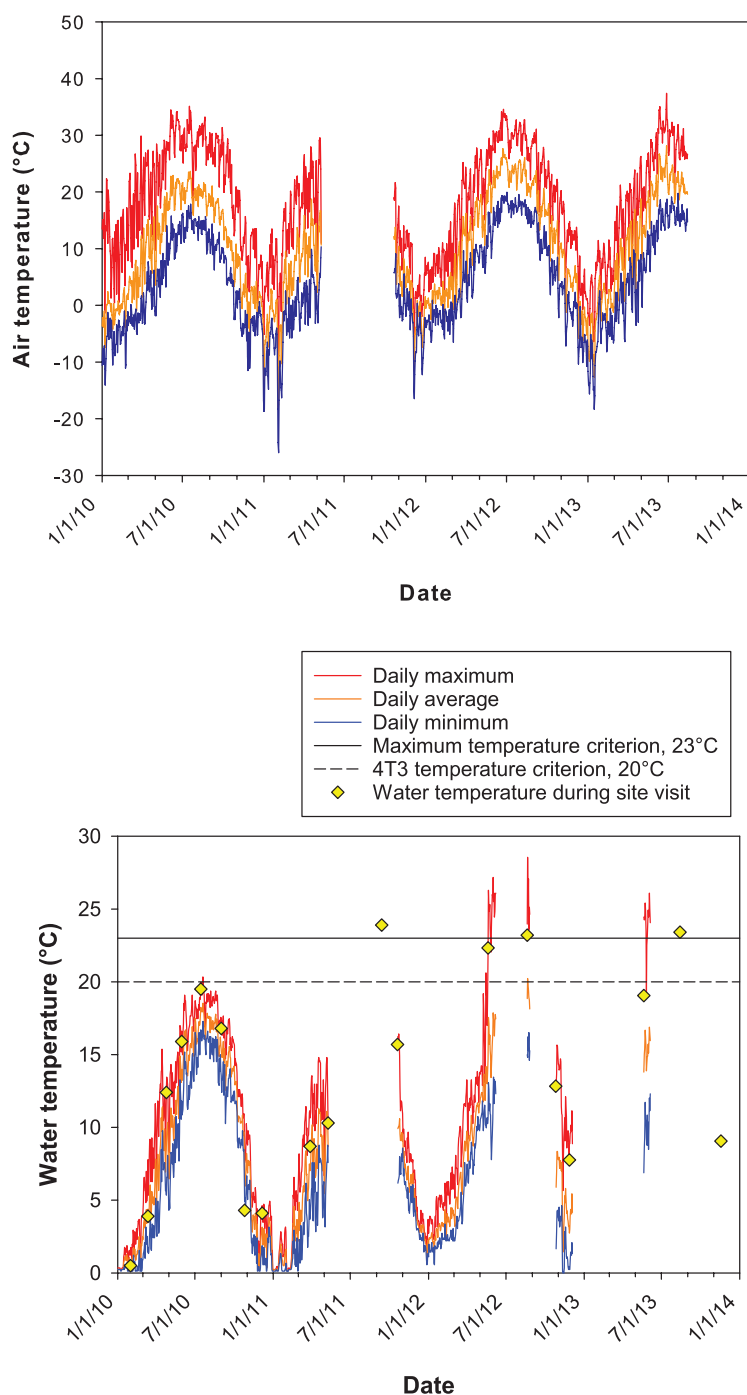
Figure 10. Daily maximum, average, and minimum air temperatures (top) and water temperatures (bottom) recorded at 15-minute intervals by HOBO Pendants (Onset Computer Corporation) at CAP01 on Capulin Creek in Bandelier NM, 2010–2013. Water temperatures recorded during SCPN site visits are also shown. There are several periods of missing data due to flooding.

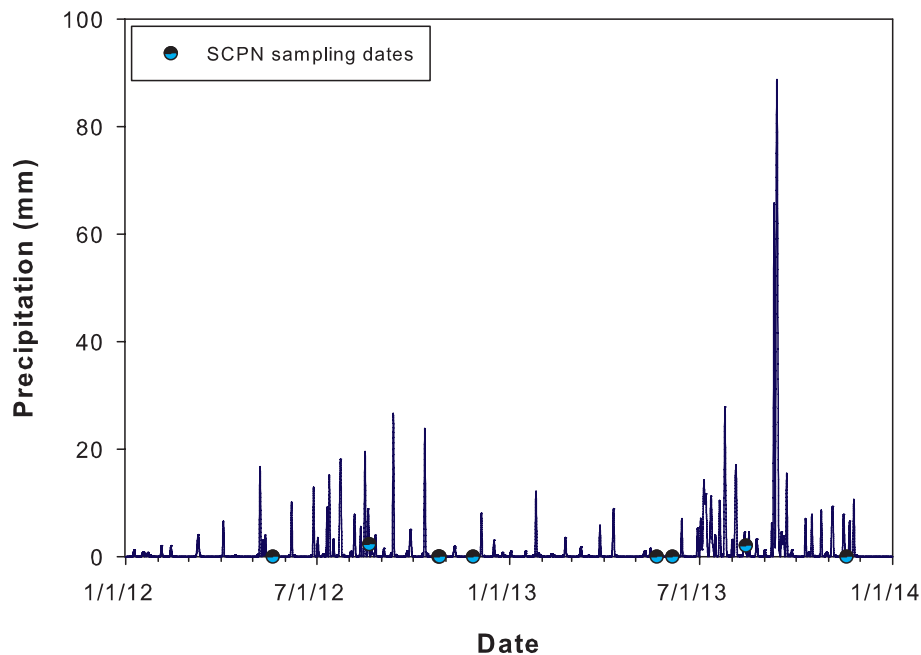
Figure 11. Daily precipitation from the rain gage (#31045) at the headwaters of Cochiti Canyon and Capulin Canyons in Bandelier NM, 2012–2013, with dates of SCPN water quality sampling visits.

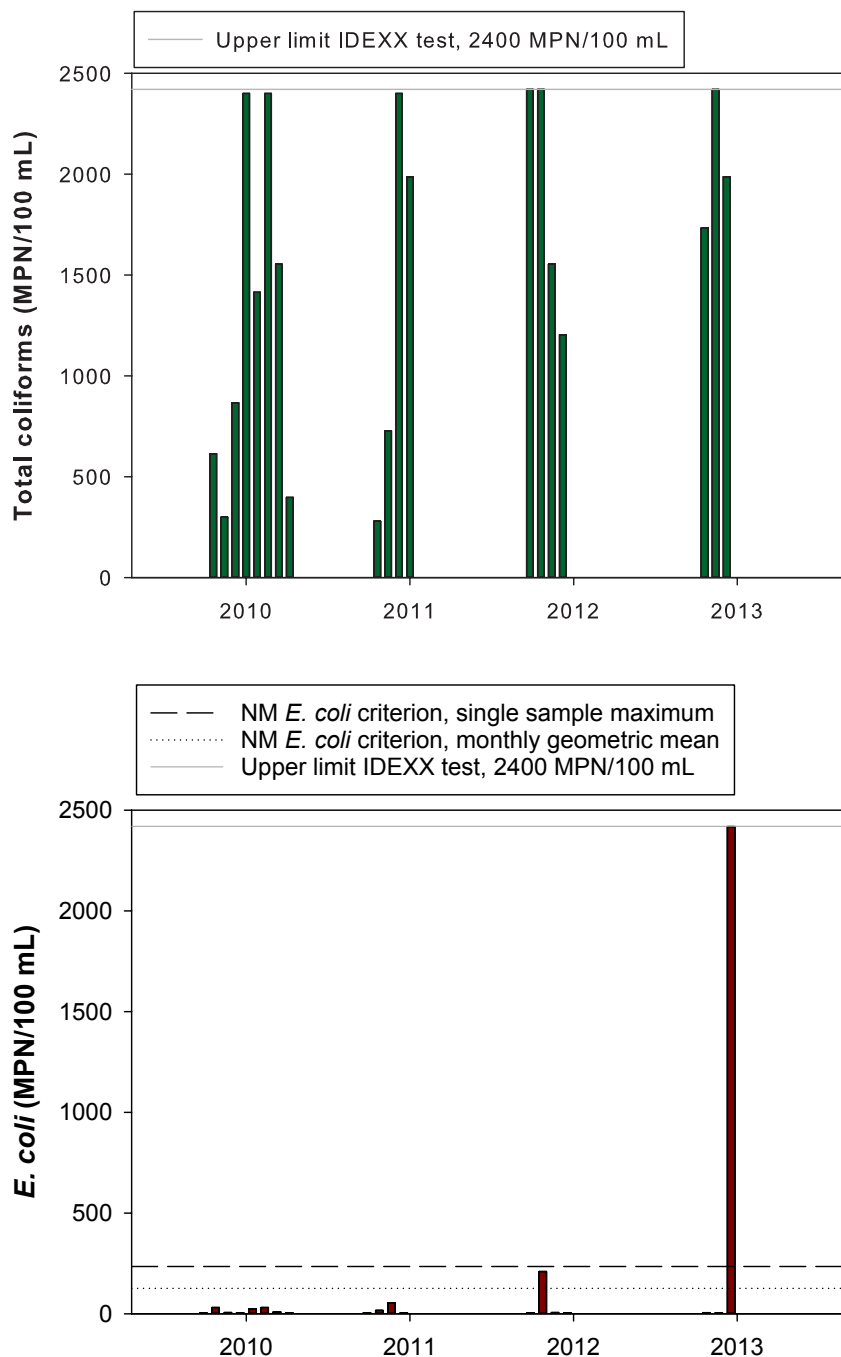
Figure 12. Total coliforms (top) and *E. coli* data (bottom) in samples collected from CAP01 on Capulin Creek in Bandelier NM, 2010–2013.

Total coliforms and *E. coli* results from CAP01 are displayed in Figure 12, with 2010–2011 results for comparison. Total coliforms in the 2012–2013 samples ranged from 1600 to >2400 MPN/100 mL, with a median of 2000 MPN/100 mL. *E. coli* ranged from <1 to 2400 MPN/100 mL, with a median of 5 MPN/100 mL. One sample collected on 8/14/13 was 2400 MPN/100 mL, which exceeded the single sample maximum criterion of 235 cfu/100 mL. The stream was very turbid that day due to recent high flows from monsoon thunderstorms. Another sample from 8/20/12 was 210 MPN/100 mL, which is above the chronic criterion of 126 cfu/100 mL; however, more samples would be needed to

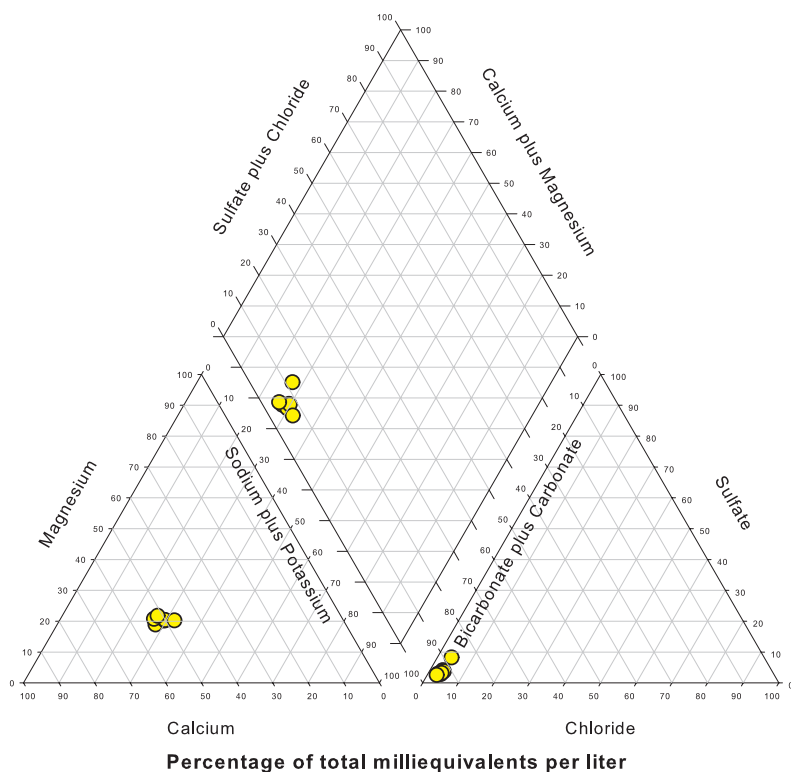
Figure 13. Major ion composition from samples collected at CAP01 on Capulin Creek in Bandelier NM, 2012–2013.
