# City of Newton Historic Preservation

## DESIGN GUIDELINES INTRODUCTION

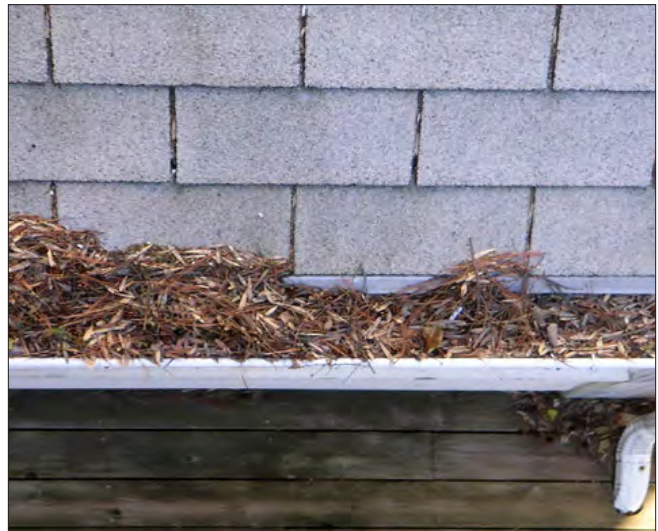
*The regular cleaning of gutters and downspouts is one of the most effective preventive maintenance tasks. Clean gutters and downspouts provide a means for moisture that accumulates on the roof to be directed away from the building without causing damage. This gutter is filled with leaves, twigs and debris preventing clear drainage and allowing water to overflow the gutter and damage exterior wall surfaces. Gutters and downspouts should be cleaned at least twice each year to minimize potential problems.*

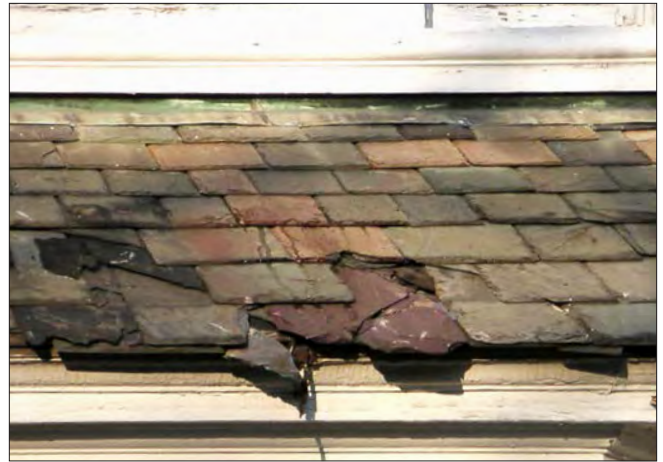
*Slates are cracked, dislodged and missing. Some of the surfaces are delaminating. Approximately 25 to 30 percent of the slates on this roof are either missing or damaged. Given the pervasiveness of the problems, considering roof replacement would be appropriate.*

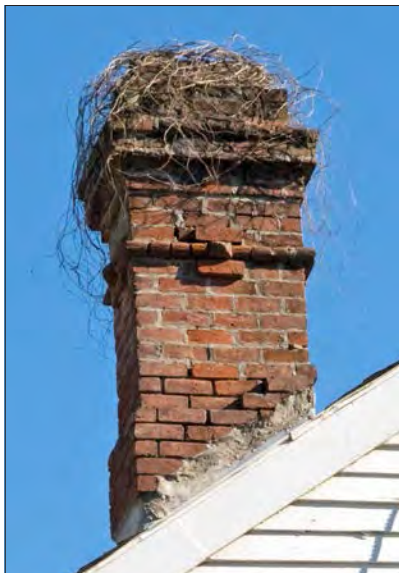
*This chimney is leaning and has several visible open joints. Rebuilding to match existing detailing is recommended.*

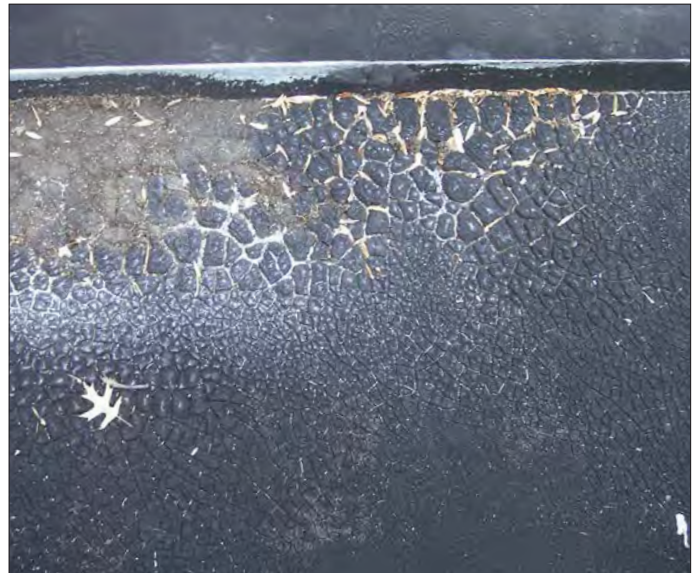
*The alligatored roof surface indicates deterioration and possible need for replacement.*

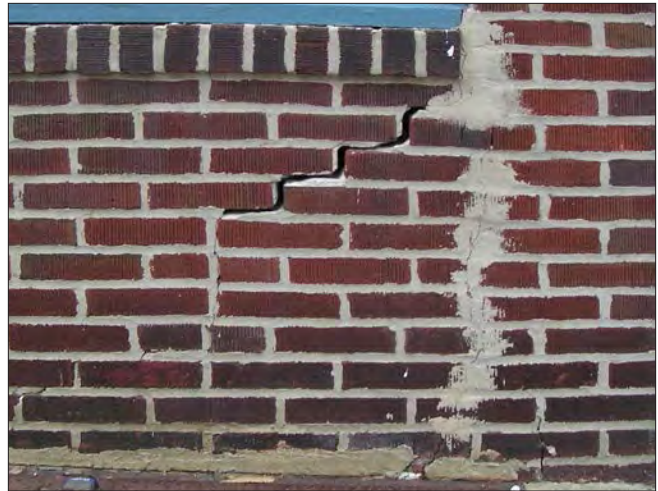
*A previous vertical crack has been improperly repaired with hard grout smeared onto the wall surface. The second diagonal crack suggests a settlement or movement problem, that warrants consultation with an architect or engineer.*

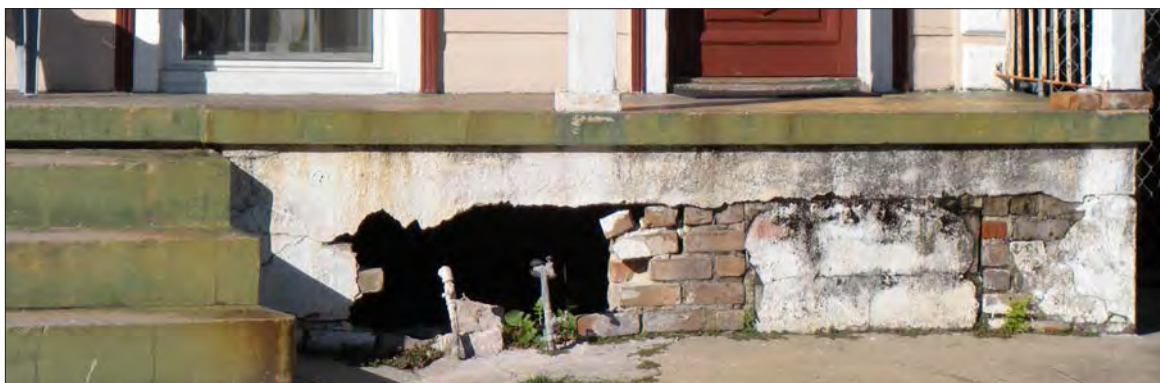
*The stucco has not been maintained and the bricks under the porch post are falling out of position. The dislodged bricks can lead to structural problems in the porch if not repaired.*

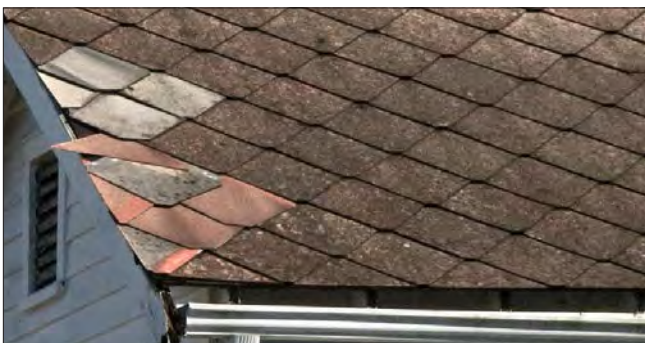
Asbestos roofing shingles came in various shapes, with diamond-shaped being the most common. This asbestos roof has some non-asbestos replacement shingles of similar size and shape as the existing roofing.

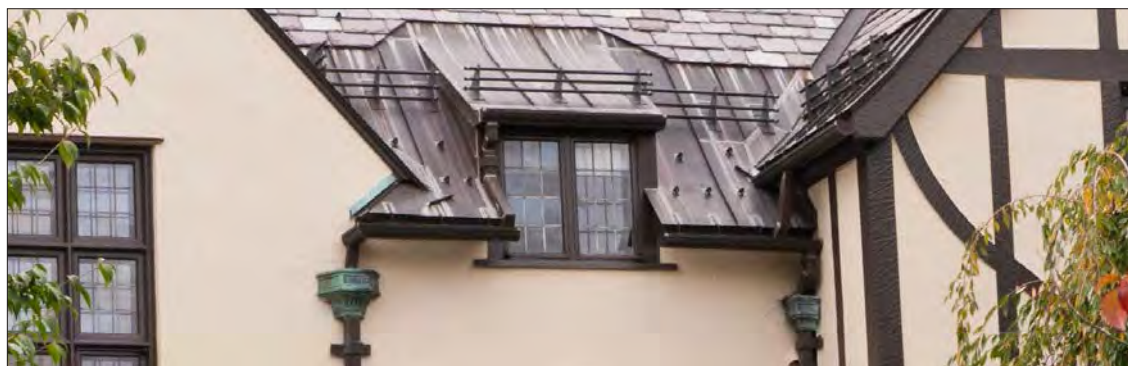
*Snow guards come in a variety of types and styles, as seen on this roof. Also note the standing-seam metal roof with copper gutters, downspouts and decorative copper scuppers.*

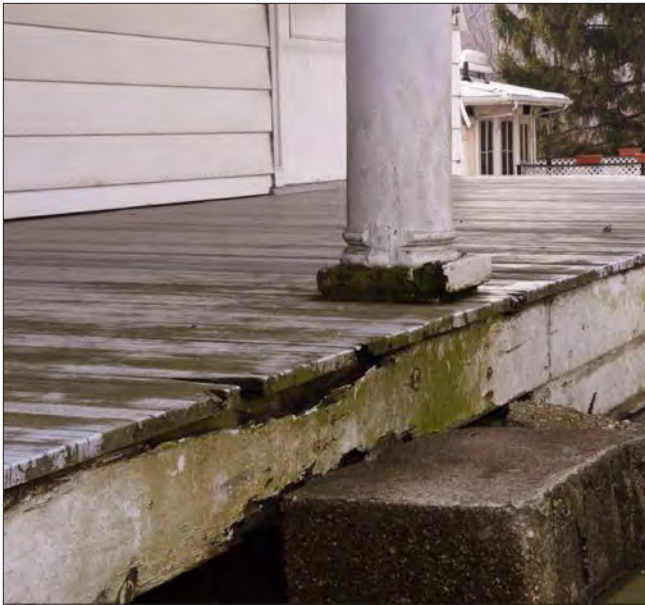
*Porches, steps and other areas where the woodwork is laid horizontally or located close to the ground are often first to deteriorate. Ongoing exposure to moisture can lead to rot of the column bases, porch deck and apron.*

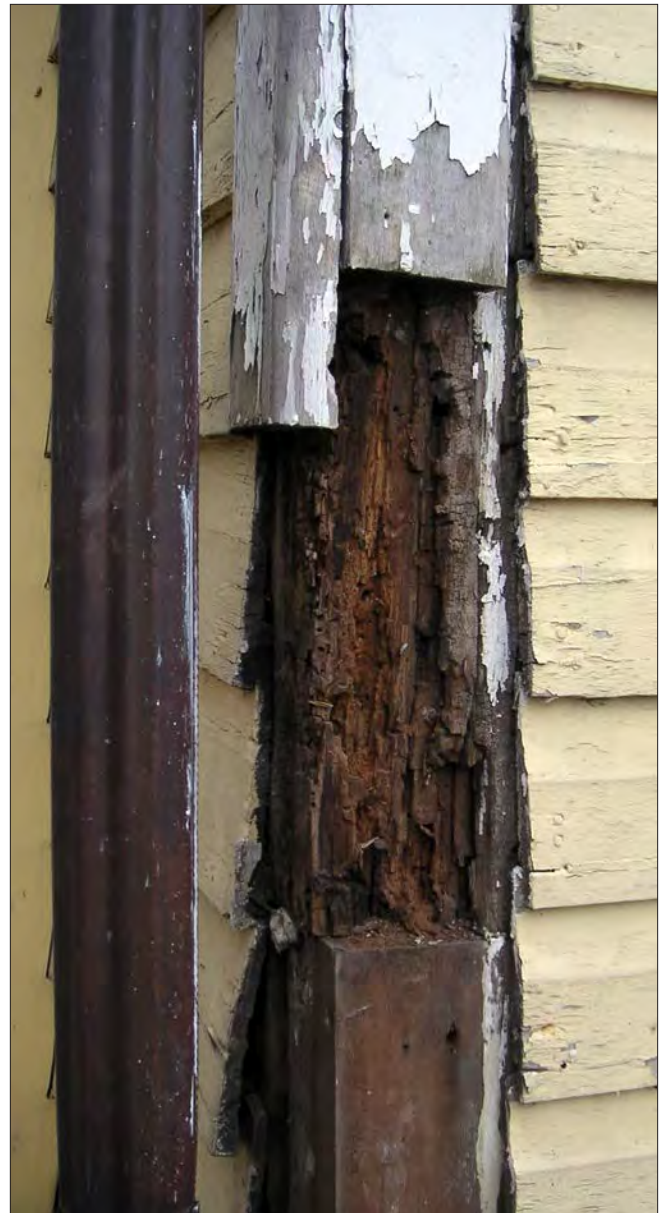
The vertical wood corner boards were removed adjacent to the downspout exposing the structural wood post. Additional exploration revealed that there was significant rot of the post that extended deep into the thickness of the wood, compromising the structural capacity. It is likely that a persistent leak at the juncture of the roof gutter and downspout made the situation much worse.

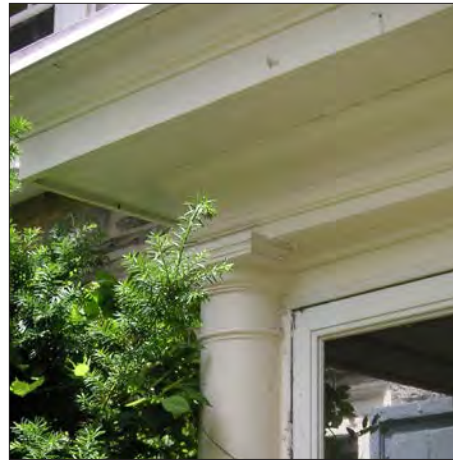
*Porch enclosures that are attached to existing decorative porch elements such as this column can cause damage that is both difficult and costly to repair.*

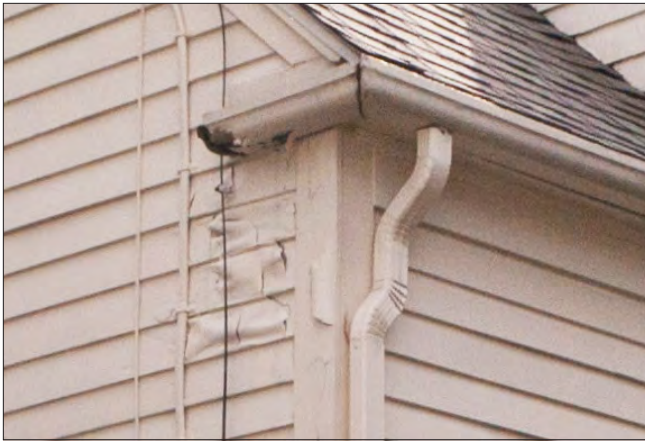
*Paint problems at exterior woodwork are sometimes the first indication of an underlying moisture problem. The paint below the end of the gutter is peeling off the siding. Repairing the gutter and verifying that storm water is draining through the downspout is recommended prior to repainting.*

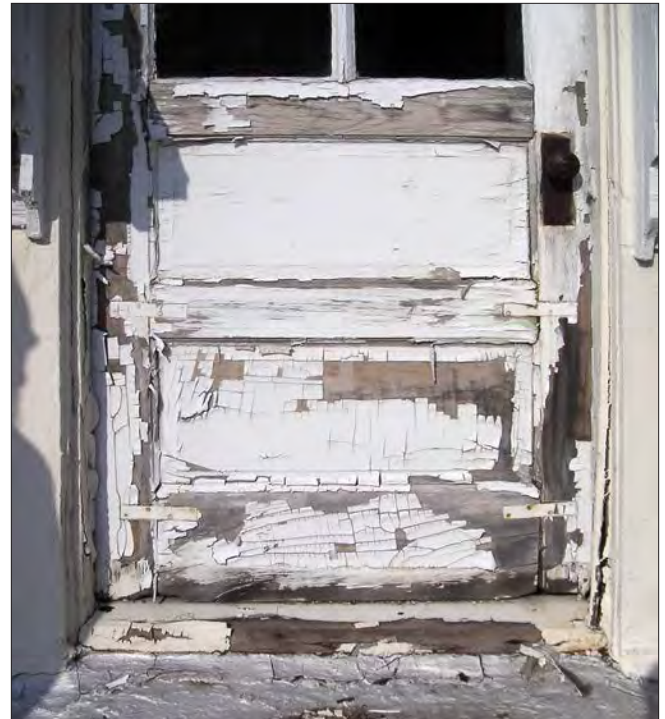
*The paint on this door has alligatored, and severe cracking is visible. Removal of paint down to bare wood and proper door repair are recommended prior to repainting.*

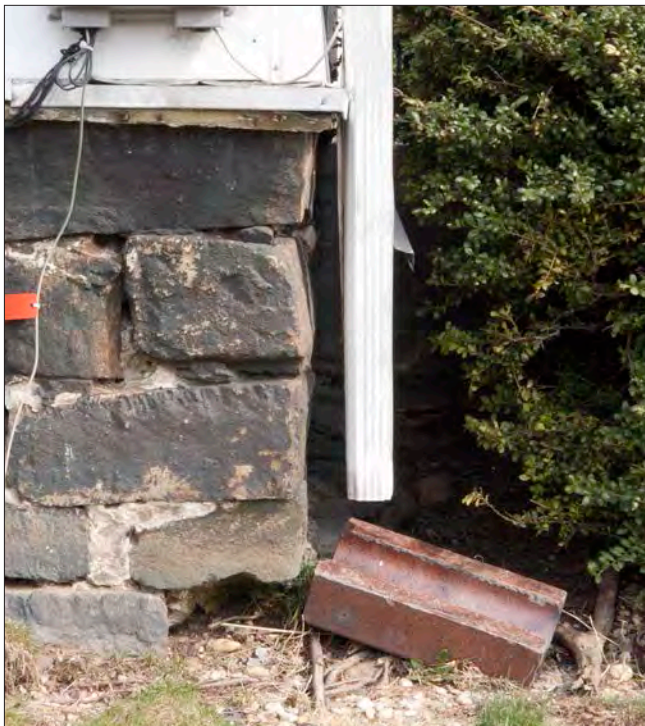
*The storm water from the downspout has deteriorated the foundation's mortar and the bottom stone has been dislodged. It is recommended that water from the downspout be directed at least 3 feet away from the foundation and that the shrubs be trimmed or relocated away from the building.*

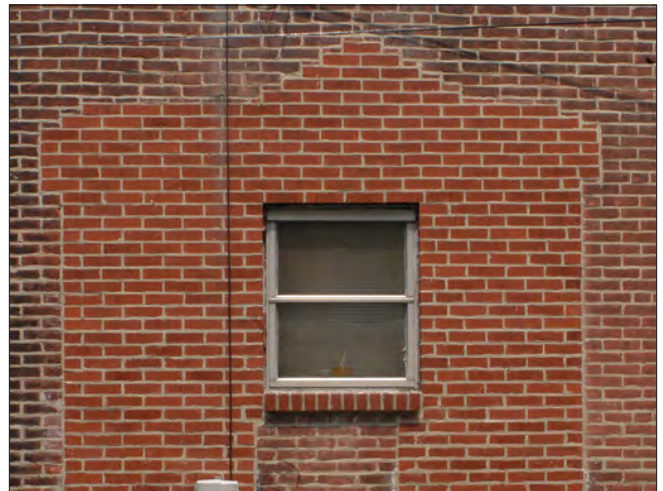
*The brick infill area is clearly visible. The infill area uses bricks of a different size and color than the historic bricks and is outlined by a thicker mortar joint rather than being "keyed" into the adjacent brickwork. The bricks and mortar used in the infill areas should be the same size, color, texture, appearance, profile and hardness as the adjacent historic bricks. The repair should also be "toothed" into the adjacent brick to appear continuous with the wall surface.*

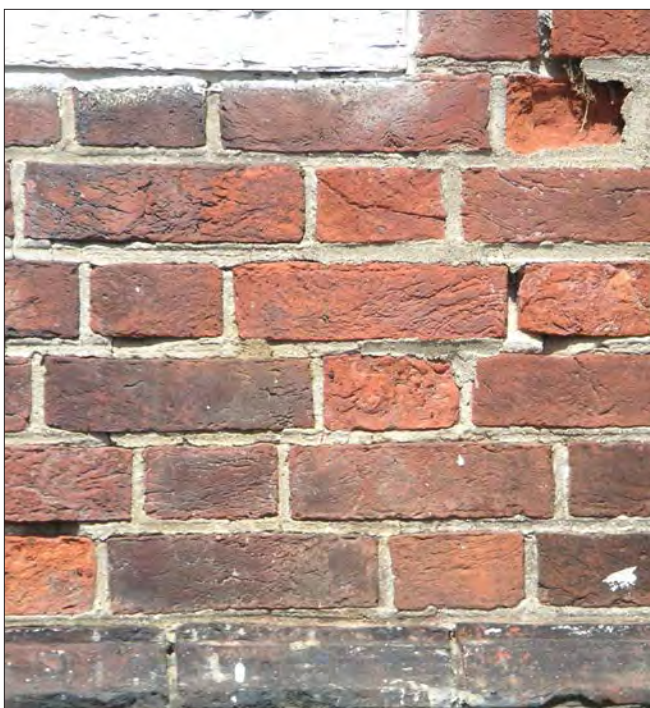
*The repointing mortar in this wall is likely harder than the bricks, containing too much Portland cement. The surface of the upper brick has spalled, exposing the softer interior of the core. The mortar is also beginning to crack and pop out of the lower joints.*

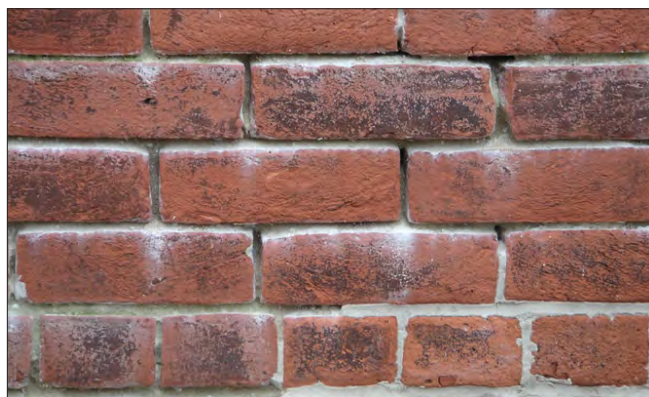
*The mortar joints between the bricks has deteriorated, particularly at the vertical joints, increasing the potential for moisture infiltration. The area at the lower right corner of the photograph has been recently repointed and mortar has been smeared over the surface of the brick rather than tooled. To maintain the historic appearance, it is recommended that the replacement mortar match the historic in appearance, color, texture, hardness and joint profile.*

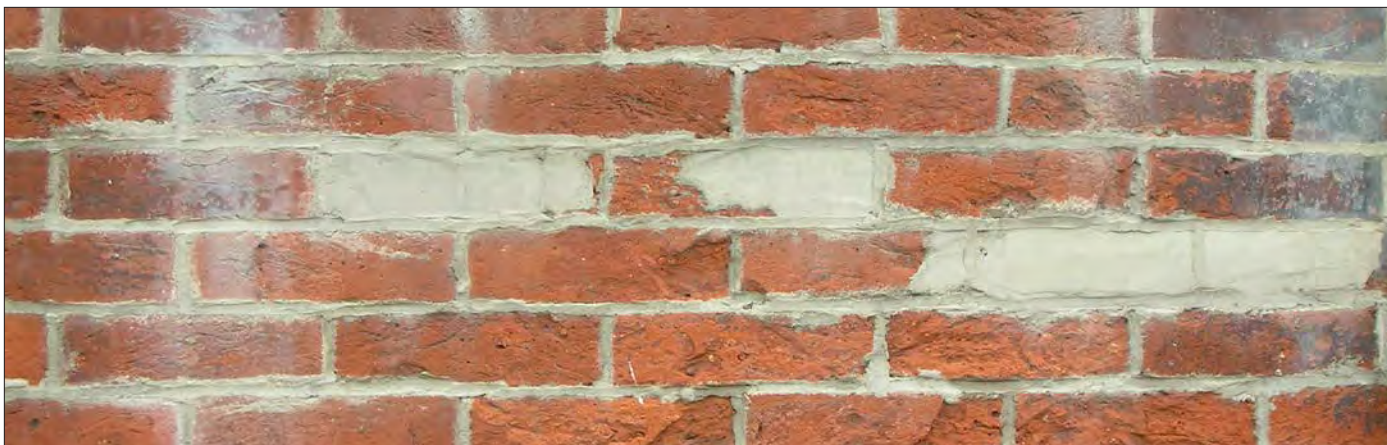
*The rough texture and uneven surface suggest that an overly aggressive cleaning method was used. Stucco patches replace bricks and efflorescence, a powdery white substance, can be seen on the surface.*

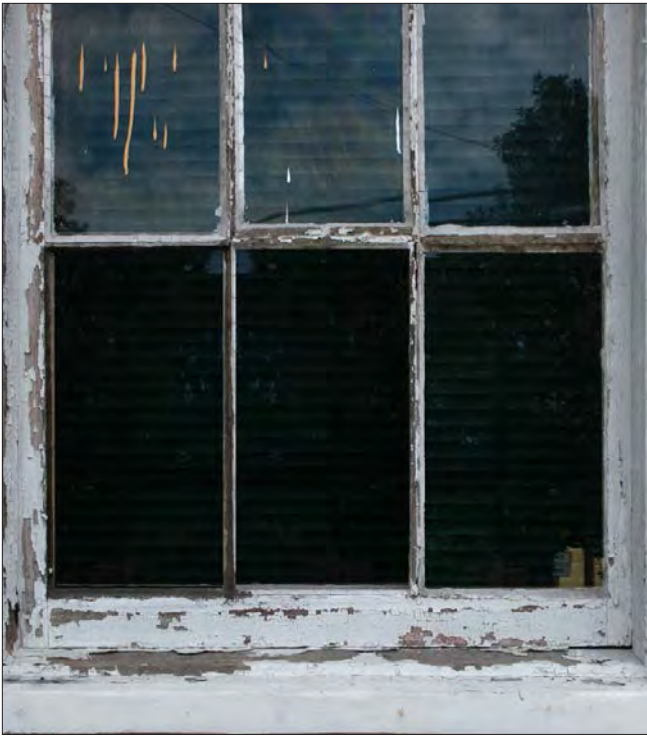
*Typically, the deterioration of wood windows first occurs at the sill. Peeling paint can allow moisture to enter wood and cause rot. Regular repainting is recommended to provide a protective layer against moisture.*

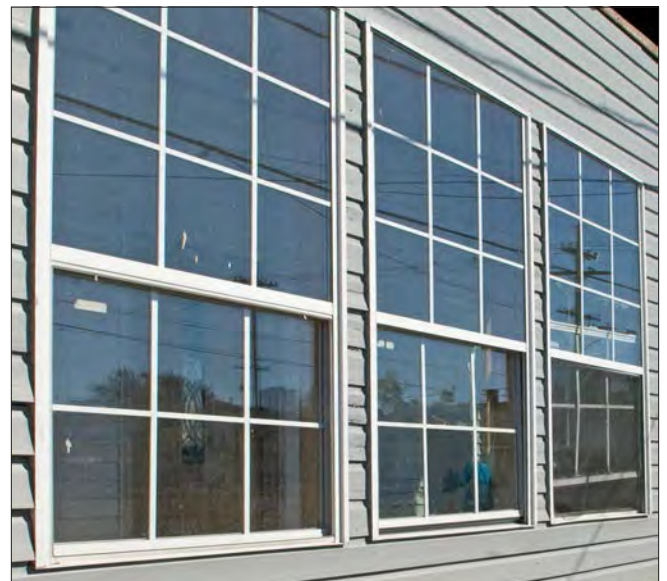
*The 9-over-6 vinyl replacement windows have applied muntins, are mounted flush against the outside wall and lack the depth of traditional windows. They do not have trim or casings. They are not appropriate for historic buildings.*
