HISTORIC STRUCTURES REPORT

DUCK POND - PART I

ADAMS NATIONAL HISTORIC SITE

Superintendent Wilhelmina S. Harris  
Architect George L. Wrenn  
May 1964

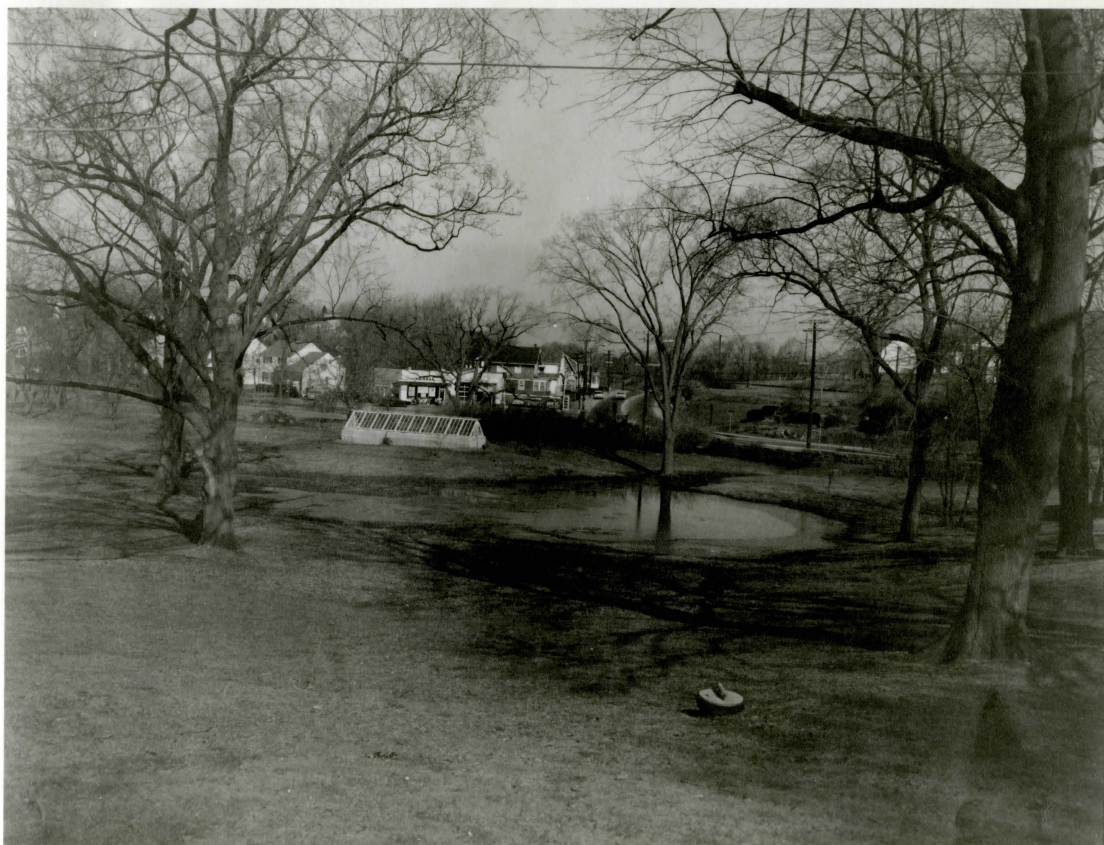
Illustration No. 1

View of Duck Pond from south.

In order to restore the Pond to and keep it at its level during the historic period it is proposed to let the Pond dry out (The Pond has almost completely dried out as of June 2, 1964), clean it out, restore the historic contours banking it slightly where necessary, install an underground water supply pipe to feed it, and an underground drain to maintain the water at the correct level.
