# Geologic Resources Inventory Scoping Summary

## Fire Island National Seashore

Prepared by Trista L. Thornberry-Ehrlich  
October 19, 2011

Geologic Resources Division  
National Park Service  
US Department of the Interior

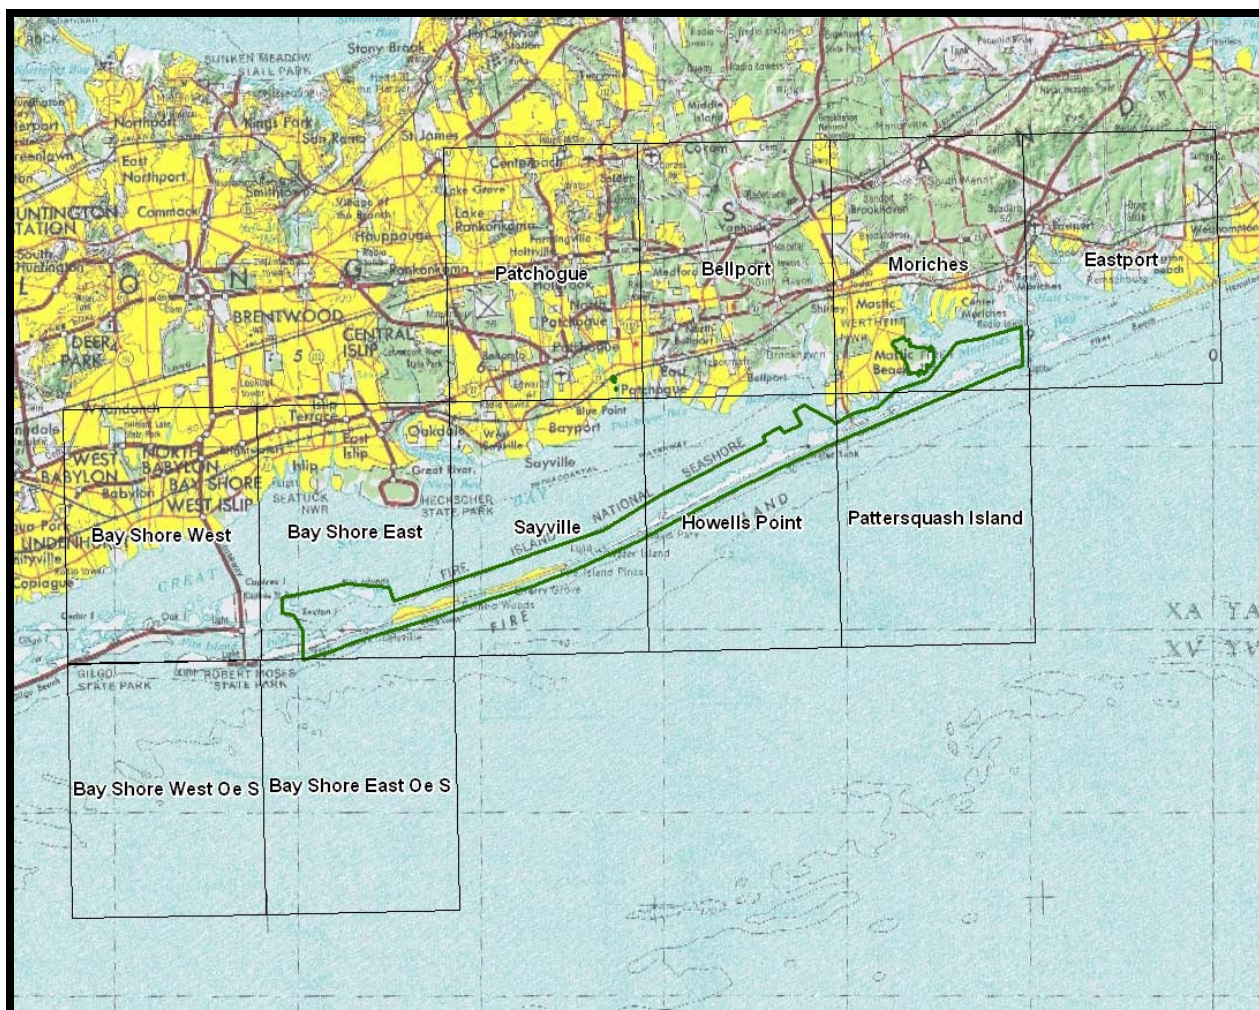
Figure 1. Area of interest for Fire Island National Seashore, New York. The 7.5-minute quadrangles are labeled in black. Green outlines indicate national seashore boundaries.

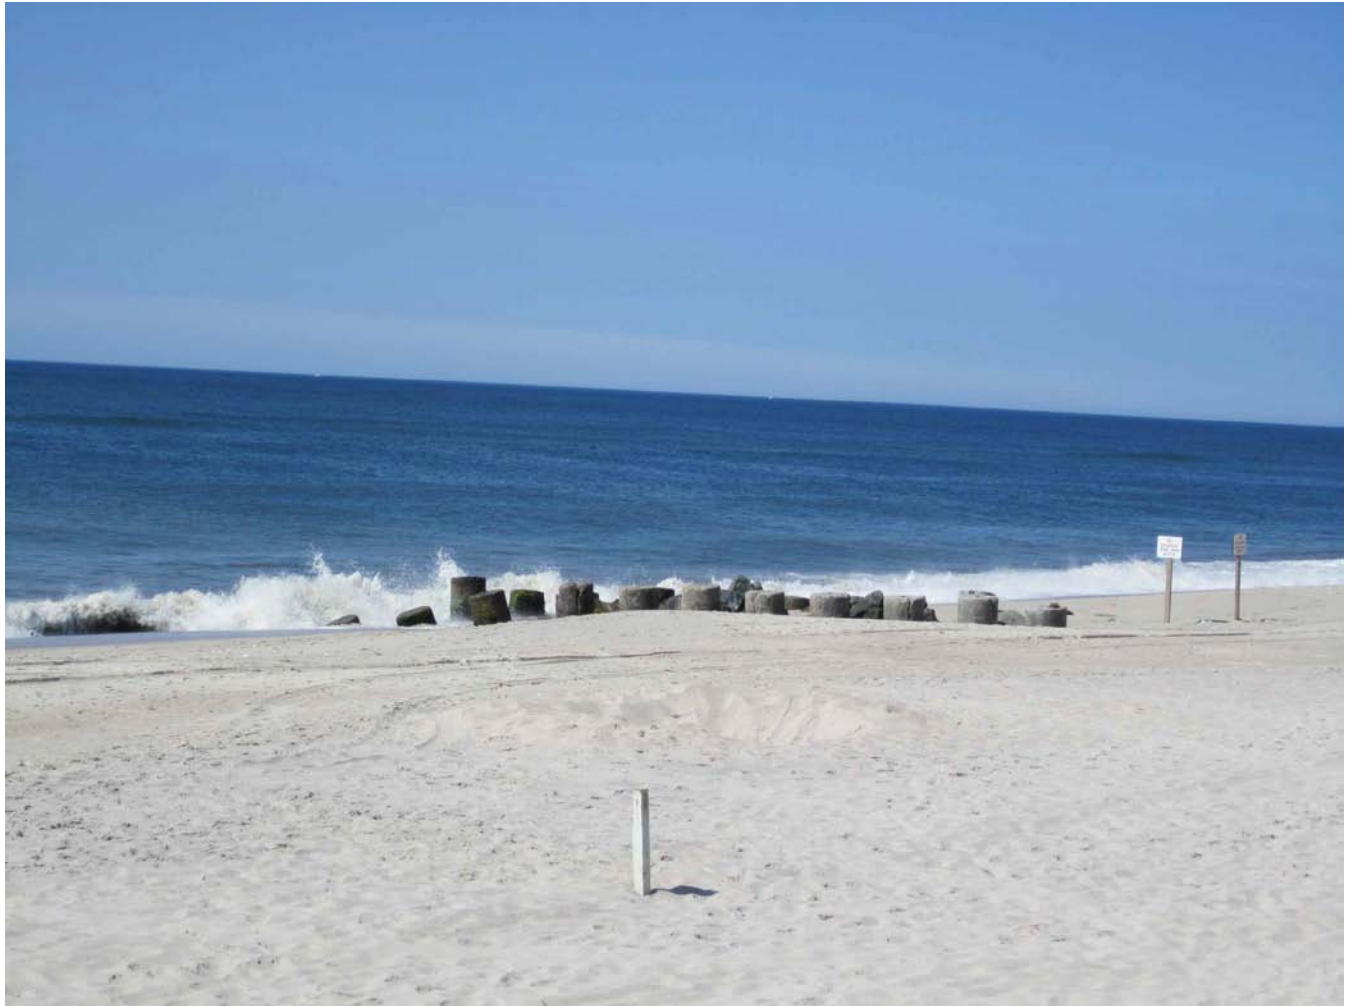
Figure 2. Groins at Ocean Beach. These tetrapods were originally put in place to protect a water tower from inundation and/or coastal erosion. The tower has since been moved inland. View is to the west. Photograph is by Trista L. Thornberry-Ehrlich (Colorado State University).

*Stop 5: Groins at Ocean Beach.* These groins were in place by 1969. Older groins are buried in the beach. They are bags of concrete. The present groins are individual tetrapods with some other rock boulders inland. Much of the beach and dune is a product of accumulation related to the groins on the updrift side and erosion on the downdrift side. The groins were placed to protect the old water tower, which is now moved further inland. There are deep wells here as well. This is the only community on the island to have a sewer system.

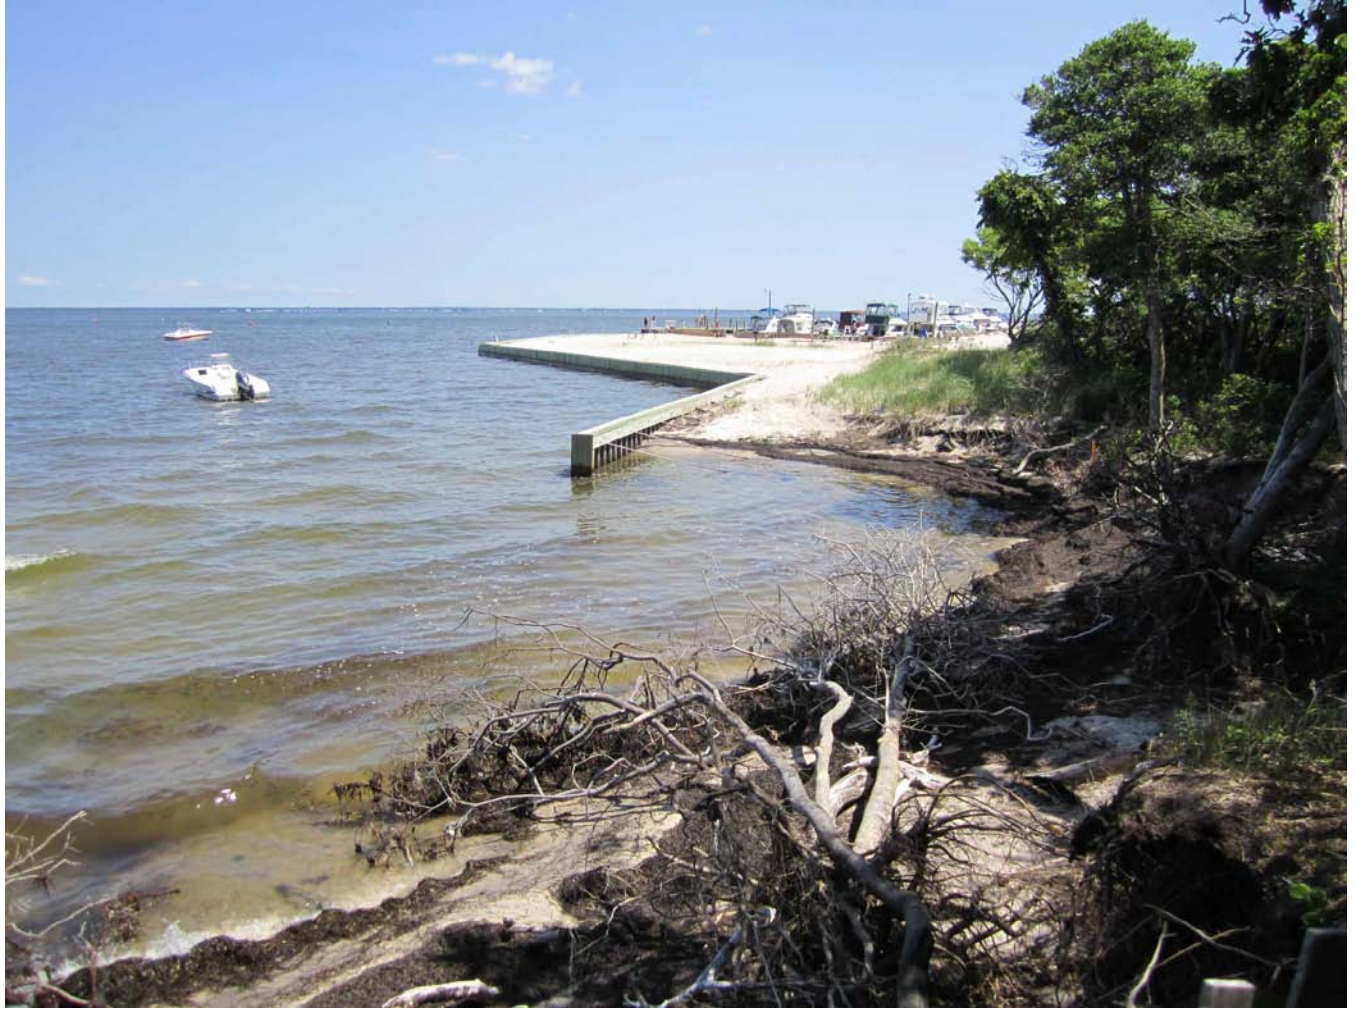
Figure 3. Erosion on the bay side near the Sunken Forest at a NPS bulkhead protecting a small marina. View is to the northeast. Photograph is by Trista L. Thornberry-Ehrlich (Colorado State University).

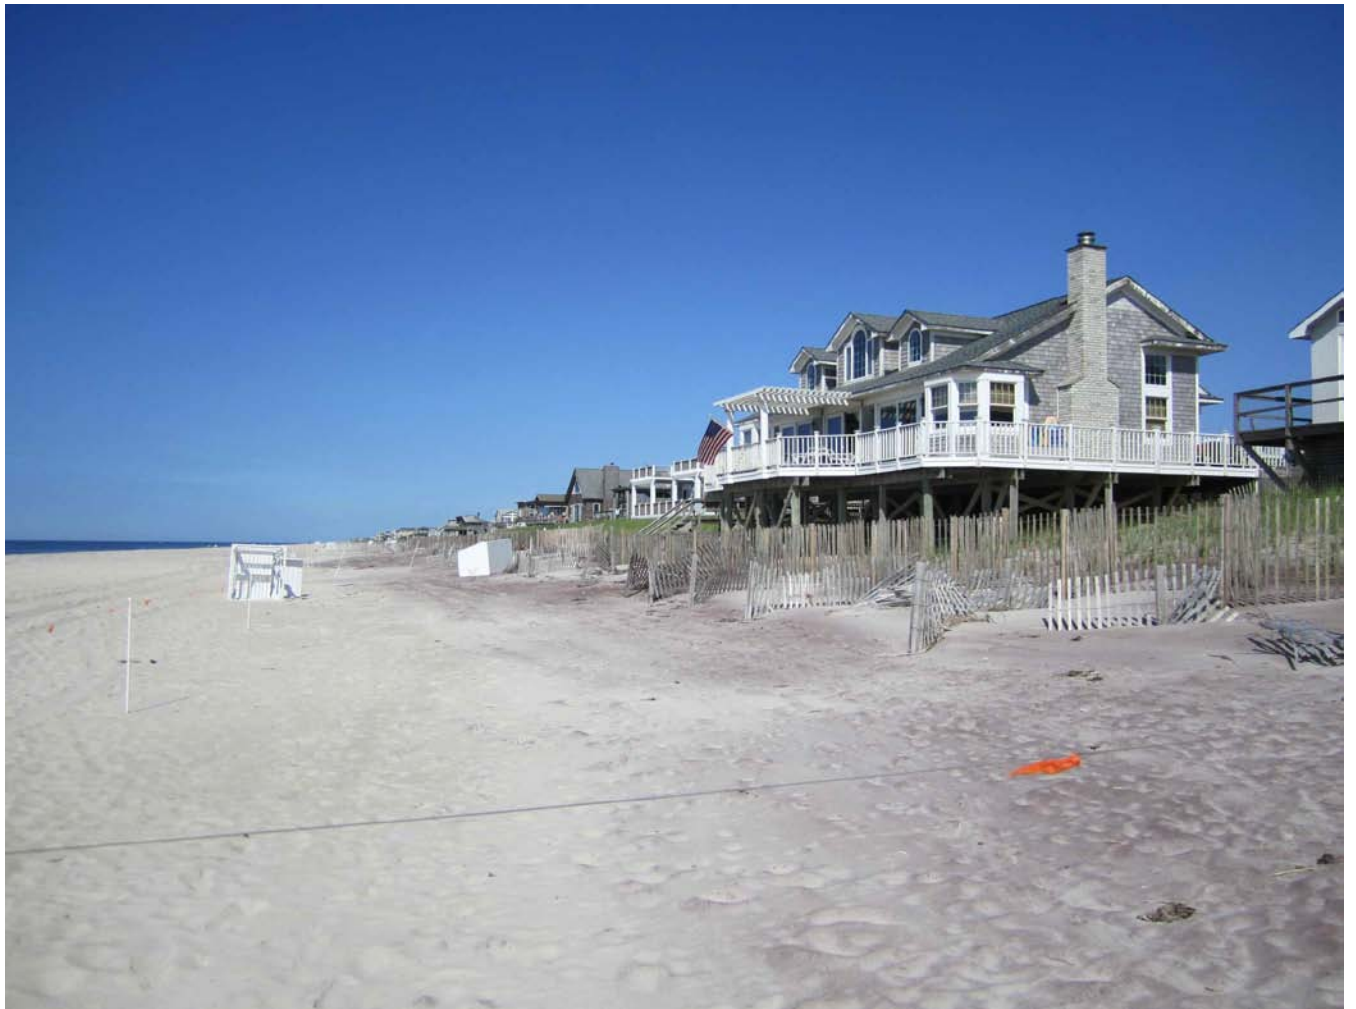
Figure 4. A newly constructed house (2005) located on the seaward side of the natural foredune at Fire Island. Note sand fences in place to trap windblown sand. Purplish sand in the foreground is enriched in dense garnet/magnetite grains. View is to the west. Photograph is by Trista L. Thornberry-Ehrlich (Colorado State University).

*Stop 4: Dunewood.* There is a newer house extending well onto the beach. It was rebuilt seaward in 2005 after a 1992 storm washed away the former structure. Since Norb Psuty’s original work here, over 100 houses have been lost to coastal processes at Fire Island National Seashore. The dune crest line is behind the houses. This line is created by connecting the dots between natural dunes and small remnants of the dune between structures. The dune is augmented for septic reasons, but no building should have been constructed here. From the defined dune line, there are regulations not to add sand to the dune south of that line, extending to the base of the dune itself. There is no “moving” crestline. Houses started being built here in the early 1900s and development is still continuing sporadically.

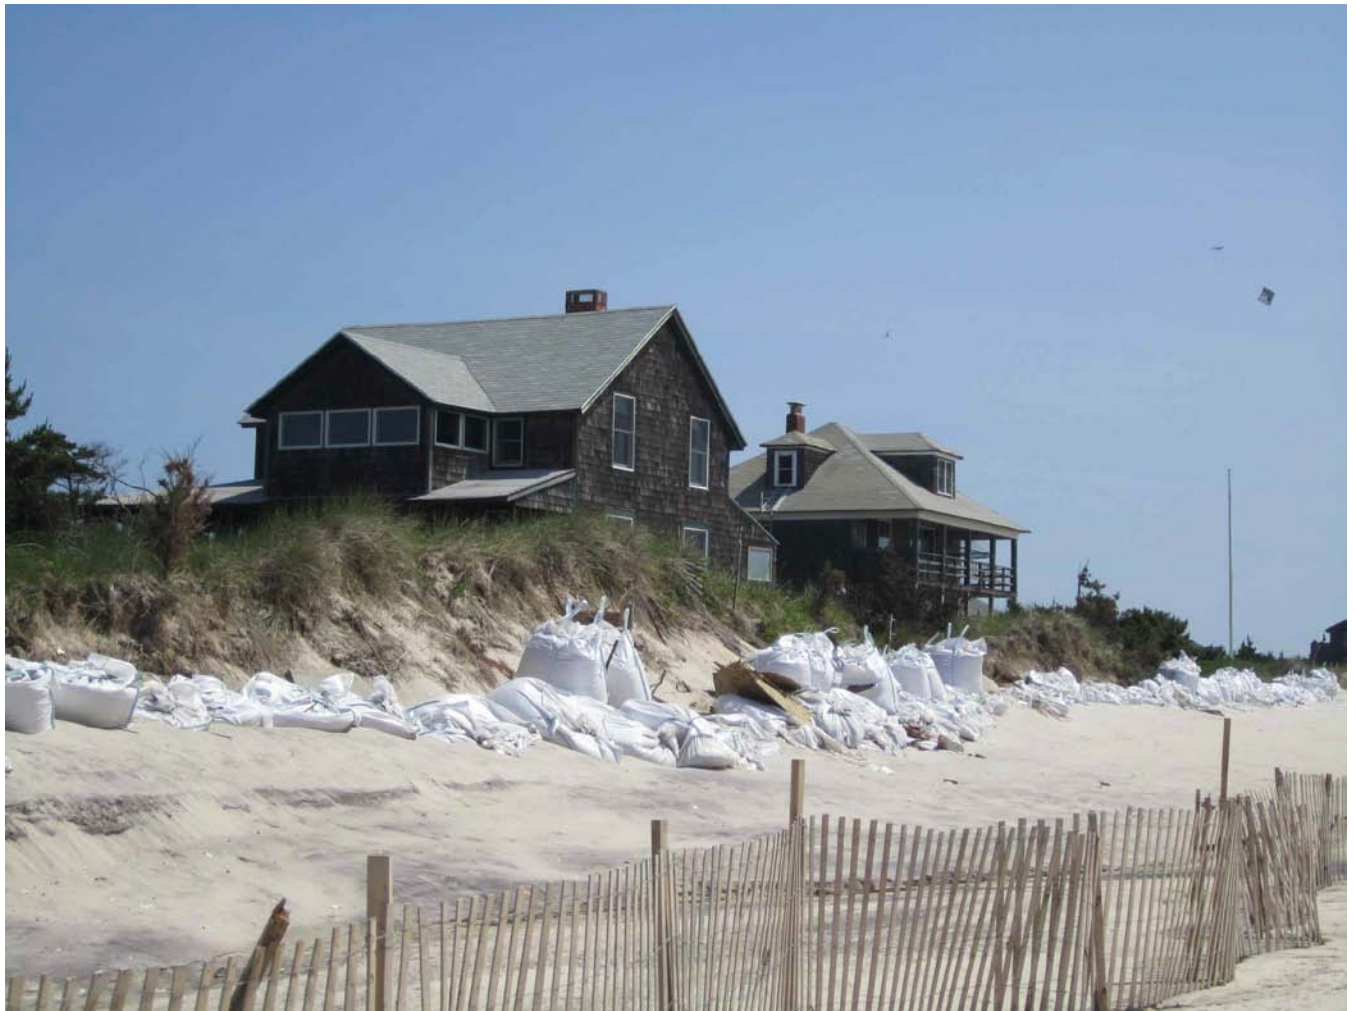
Figure 5. Houses at Point O'Woods with sandbags on the beach in an attempt to harden the seaward face of the foredune and reduce further erosion. Impact is associated with the March 2010 storm. View is to the northeast. Photograph is by Trista L. Thornberry-Ehrlich (Colorado State University).

*Stop 6: Point O'Woods.* This community has its own light-gauge railroad. The beach here was severely eroded during and after the 2010 March storm when water was lapping against the dunes. They are defending the base of the foredune with white bags of sand. The beach is naturally re-accreting. There are scarps in the upper beach and dunes showing heavy mineral sands and garnet layers. Two dune crests merge near here, with Sunken Forest inland of the dune crests.

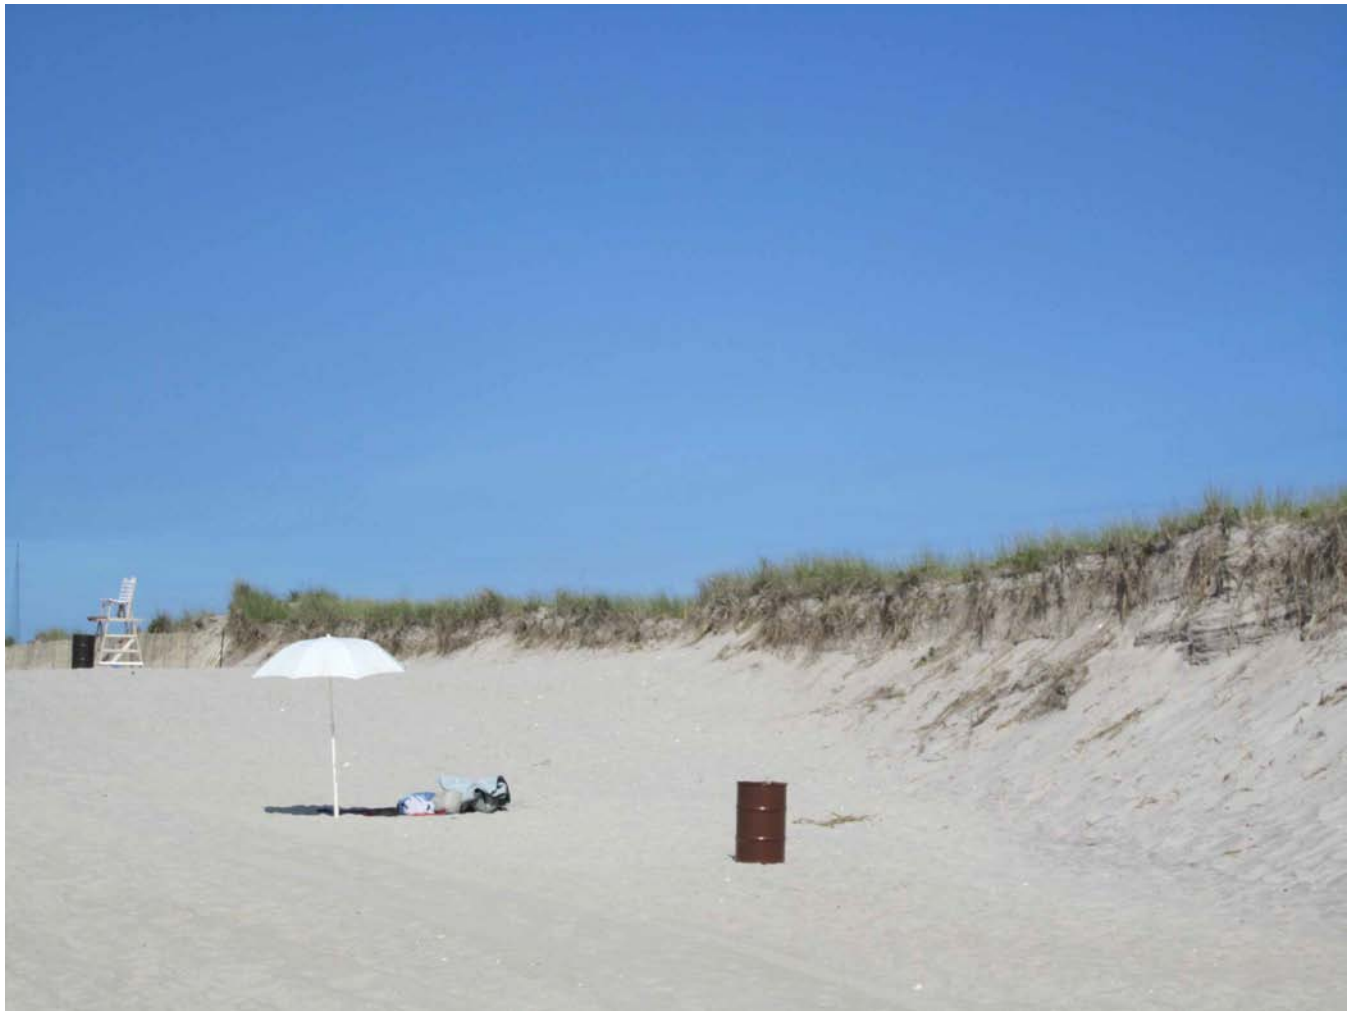
Figure 6. Erosional scarp from the March 2010 storm at Robert Moses State Park. Note the high beach surface (beach nourishment area) just beyond the umbrella. View is to the northwest. Photograph is by Trista L. Thornberry-Ehrlich (Colorado State University).

*Stop 2: Beach near Robert Moses State Park.* The well-developed foredune is characteristic of Fire Island National Seashore. There is a local scarp along the foredune from the March 2010 storm. Beach fill and nourishment efforts after the storm are obvious on the neighboring beach. Sand stockpiles exist on Democrat Point, which are used to fill breaches if they do not appear to be filling naturally. Nourishment material was taken from the ACOE inlet stockpile and brought in by dump trucks. It has raised the beach some 2-3 m (7-10 ft) above the storm flat. There is a sand dike here that is protection for the road and a parabolic dune some 5-6 m (16-20 ft) above the beach.

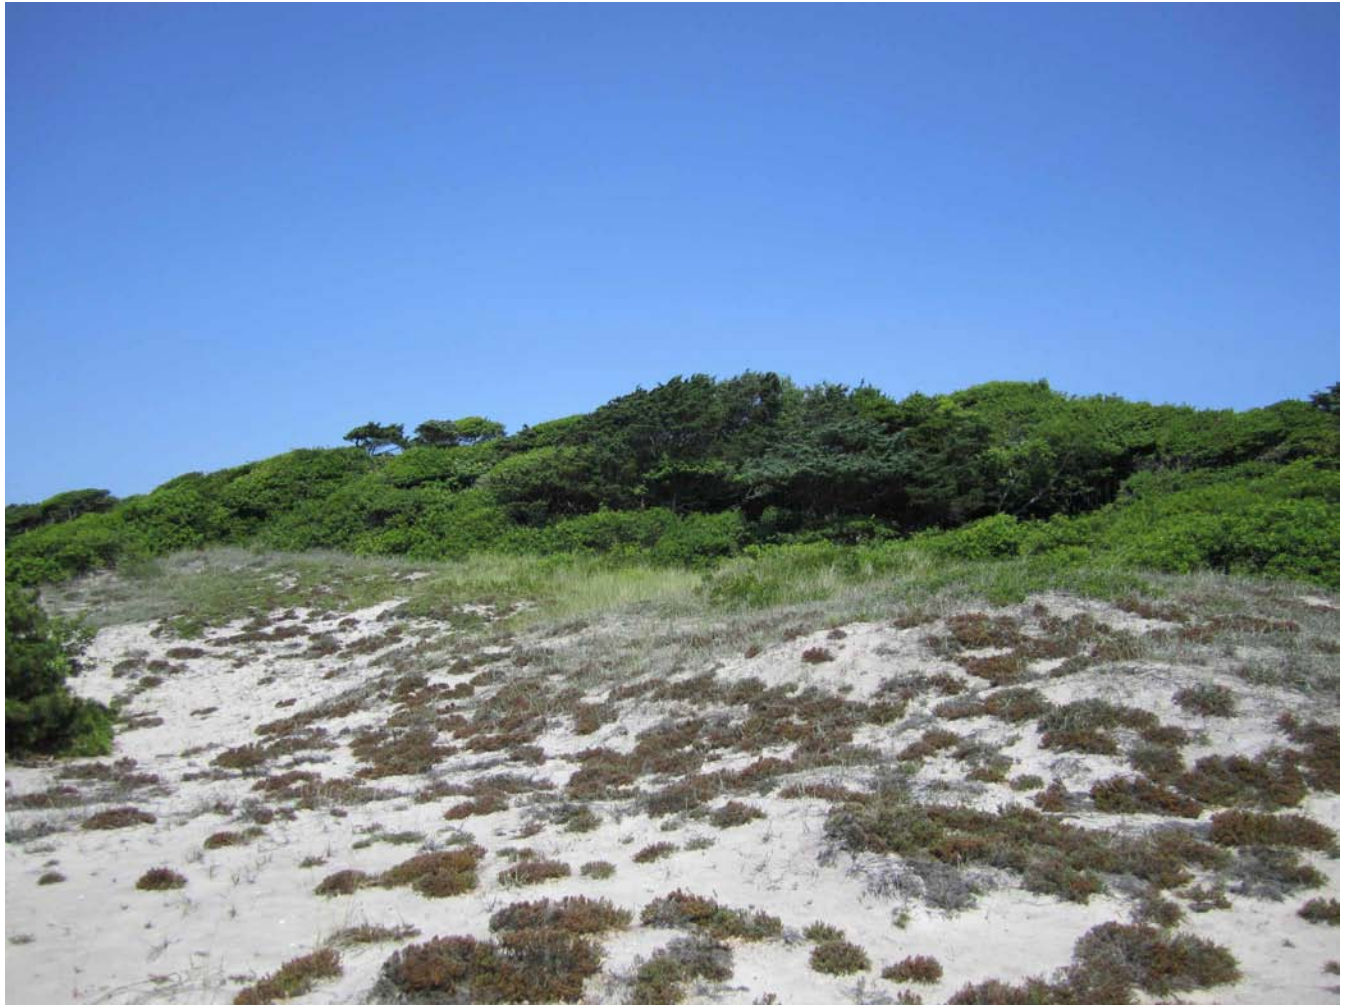
Figure 8. A high forested dune near the Sunken Forest. View is to the north. Photograph is by Trista L. Thornberry-Ehrlich (Colorado State University).

There are several areas of active dune formation and migration on Fire Island. The primary dunes east of Watch Hill are as high as 12 m (40 ft) (fig. 8). Secondary dunes, behind many primary dunes are crescent shaped with low interdunal swales in between. There are dune blowout features on Fire Island. Aeolian processes tend to transport the finer, lighter grains of sand from the beach into the dune zone. Suites of heavy minerals have been brought to the area by glacial processes to be re-worked in the beaches and dunes. Magnetite/garnet sand layers often remain on the upper beach surface after the winter season and are an important component of the beach sand profile. Most of the major categories of dunes are represented here and mappable. These include foredunes, blowouts, dissected dunes, parabolic dunes, and artificial dunes/dikes (“artificial sand feature”). Some human-induced dunal sand ridges form as blowing wind and saltation encounter sand fences. At Davis Park, local residents persist in trying to accumulate sand through the erection of fence lines and by earth-moving equipment. Human activities are creating artificial features that must be reconciled on any geomorphic map. There is no loess on Fire Island, but wind-blown silt deposits are possible at the Floyd Estate.

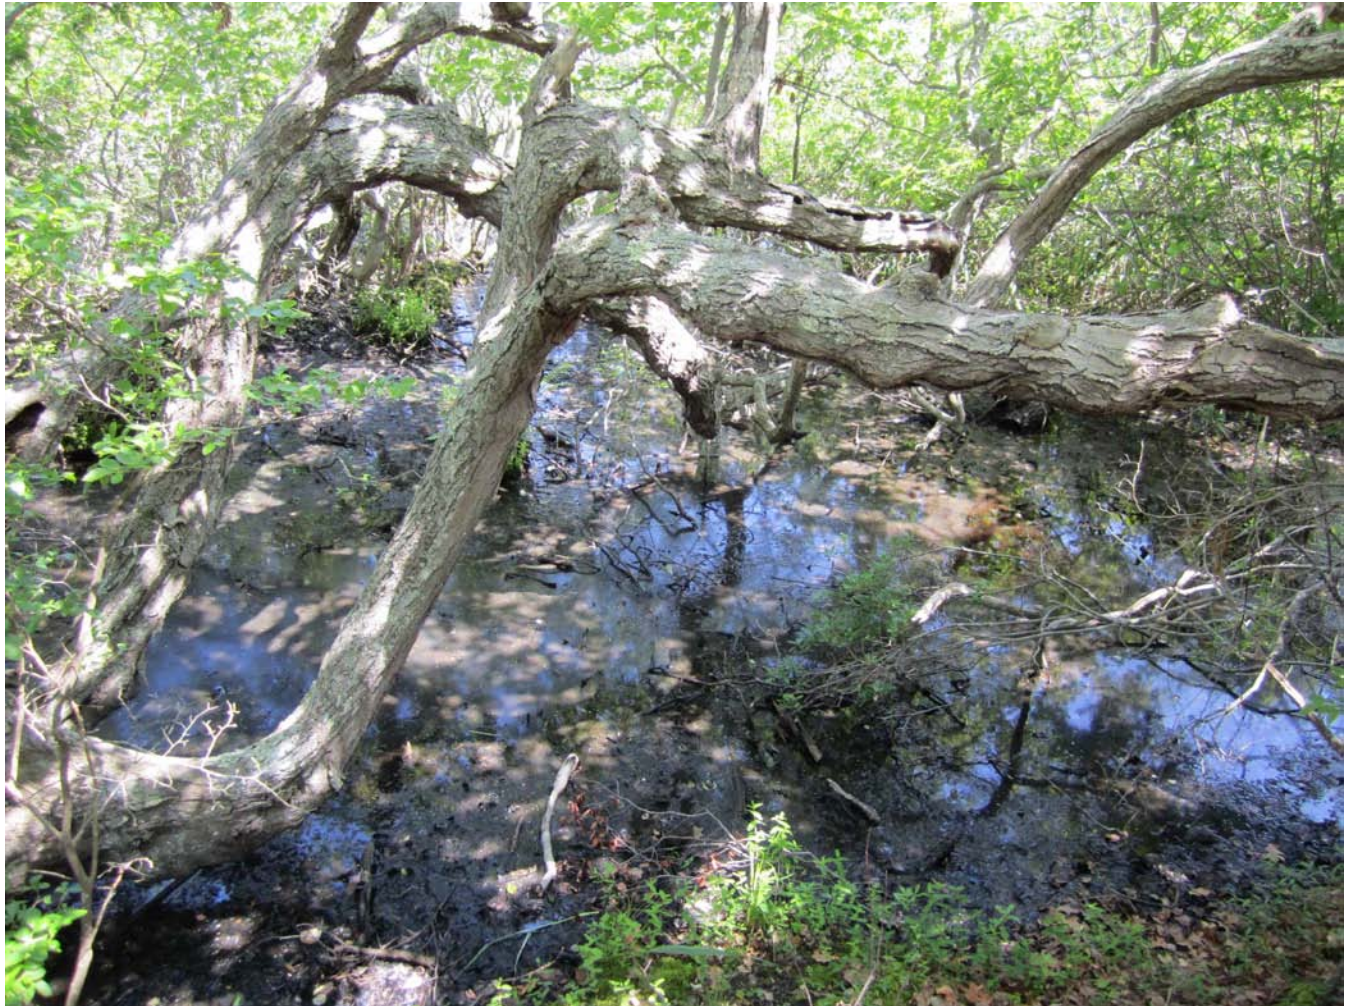
Figure 9. Wetland area within the Sunken Forest. Note the mature trees. Photograph is by Trista L. Thornberry-Ehrlich (Colorado State University).

*Stop 7: Sunken Forest.* This area is a portion of an ancestral barrier core (an older foredune complex) that is now forested. The remnant holly forests here at Fire Island National Seashore are older than those at Sandy Hook in Gateway National Recreation Area. There are wetlands within Sunken Forest. There is bay side erosion at the NPS bulkhead protecting a marina. Local dredging and the structure created localized erosion. Trees are falling into the bay. Channel dredging here may aid shoreline stabilization by supplying the dredged material to positions of erosion, but the New York Department of Environmental Conservation does not allow wetland filling.
