**HAFE PKG. PMIS 110188`  
REPAIR ALLEYS OF HISTORIC BUILDINGS #35&36  
(PRESERVATION OF WINDOWS AND DOORS)**

**HARPERS FERRY NATIONAL HISTORICAL PARK  
FY07**

**HISTORIC STRUCTURES TREATMENT RECORD**

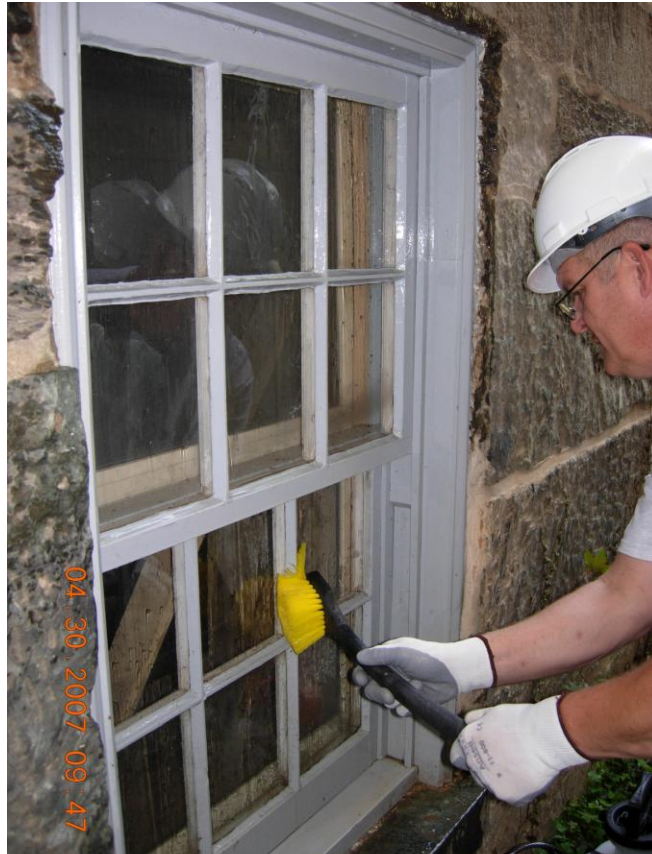
**Photo 1: Cleaning procedures of basement level sash on Building 36**

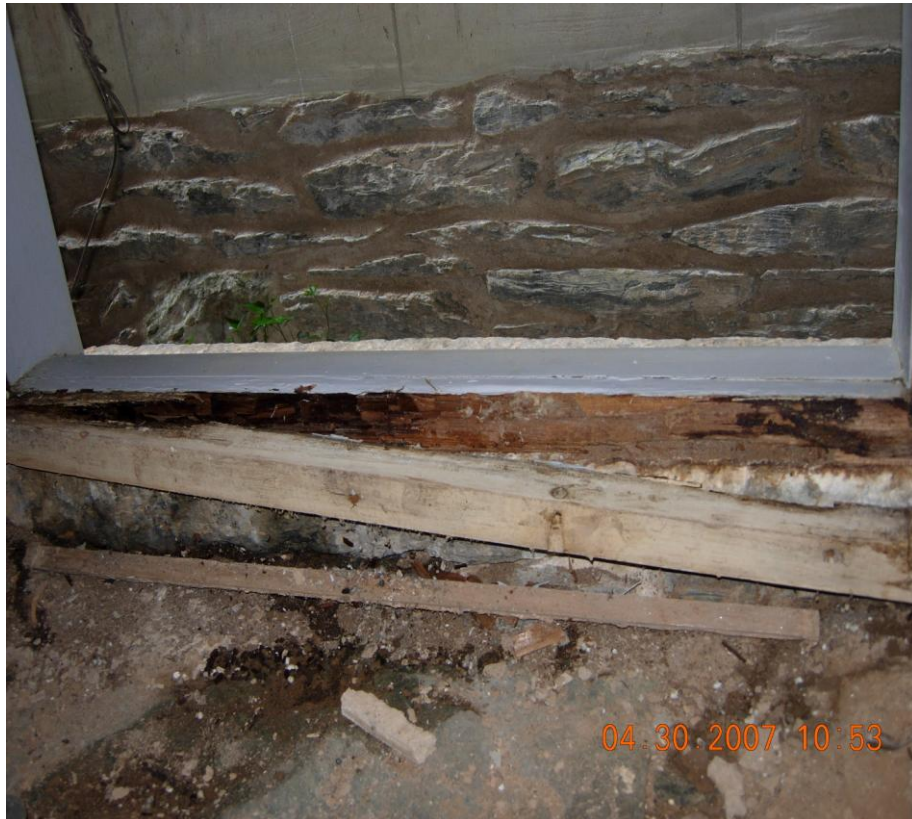
**Photo 2: Deteriorated sill located on the basement level of building 36.**

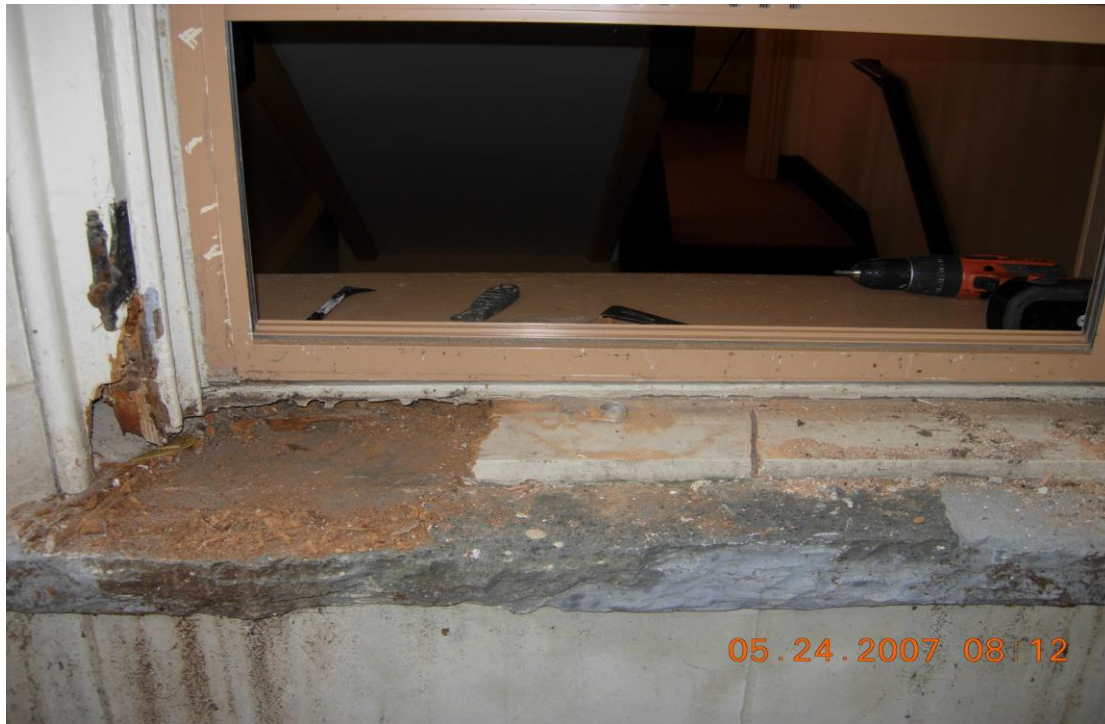
**Photo 3: Sill removed due to deterioration and left jamb rot pocket being removed for consolidation.**

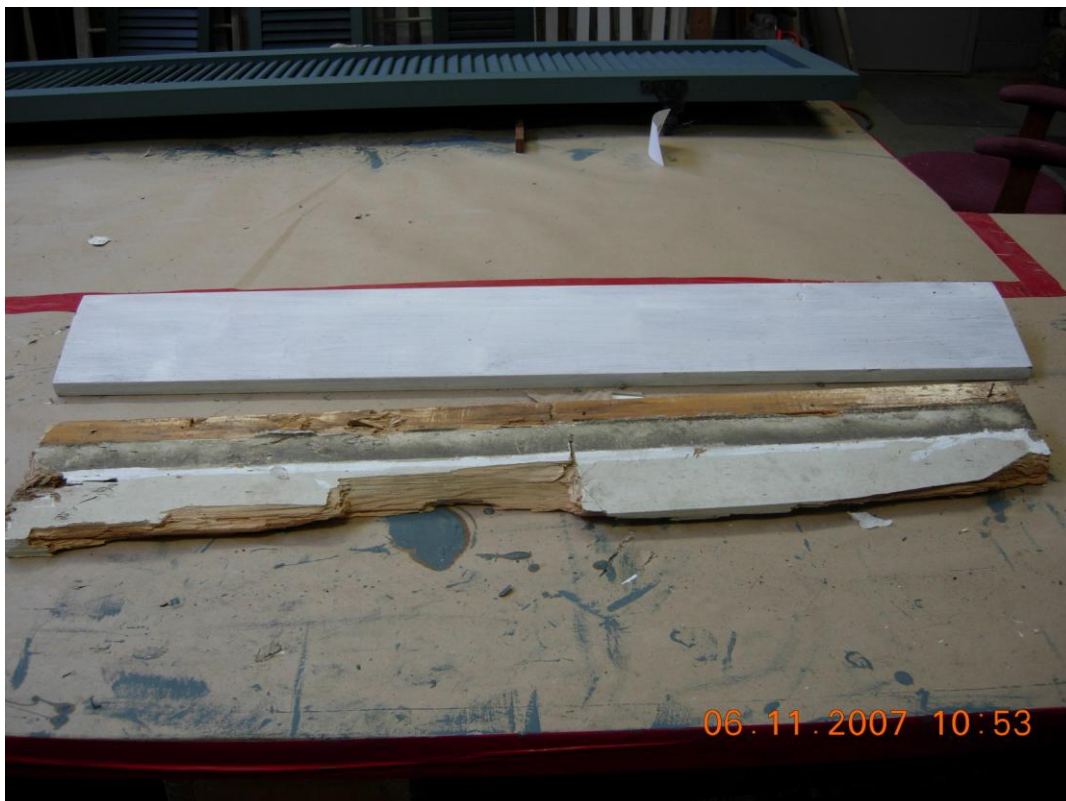
**Photo 4: Deteriorated jamb and freshly primed replacement jamb**

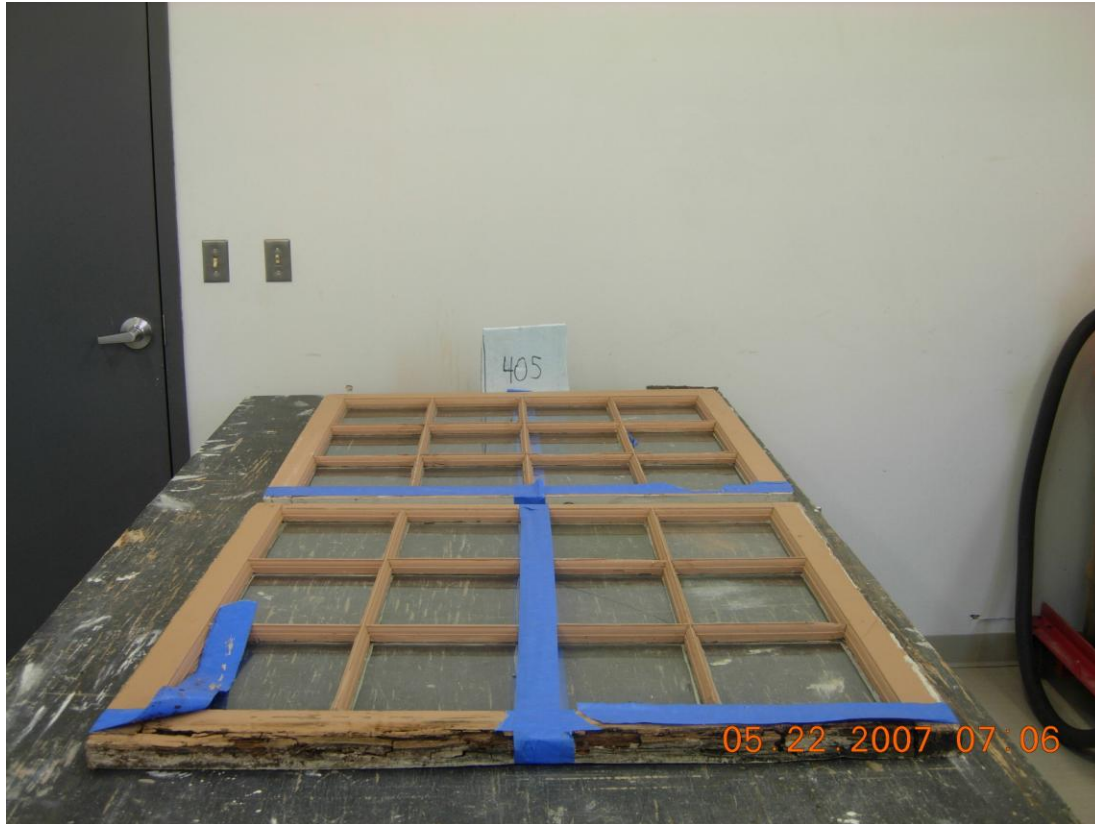
**Photo 5: Deteriorated sash of building 35**

Preservation activities on building#35 focused on the removal of several deteriorated sash located on the 4<sup>th</sup> floor of the building. Three of the four windows units to be addressed on this floor are in a very serious state of disrepair. All four of the sills have been cleared of deteriorated material and have been consolidated and filled with epoxy. The header jamb of window opening #407 displayed serious failures, the crew was able to remove the deteriorated material, consolidate and fill using epoxy filler.

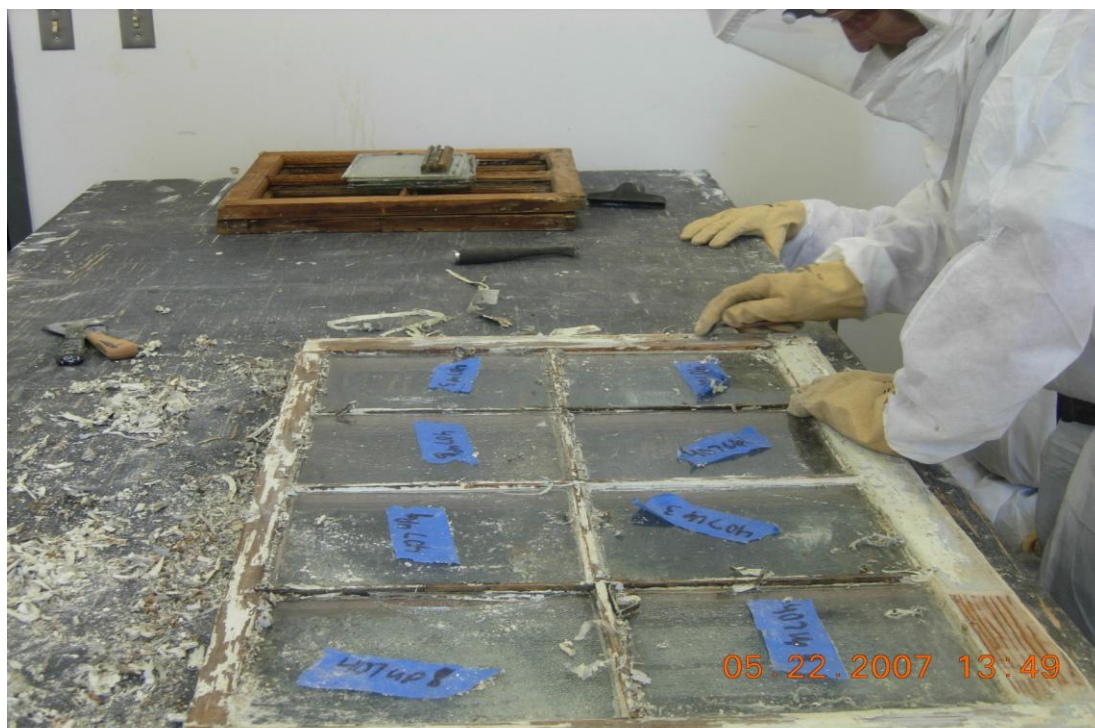
**Photo 6: Lead Abatement in progress (saving the historic sash lites).**

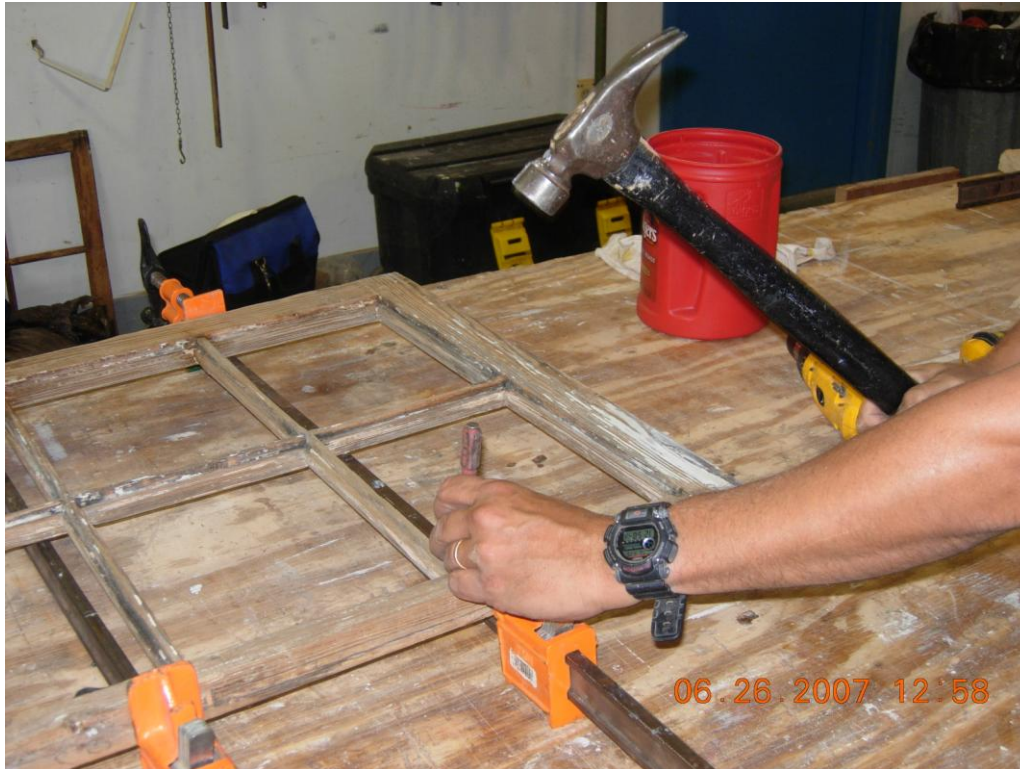
**Photo 7: Sash repair in progress (setting new sash sprigs).**

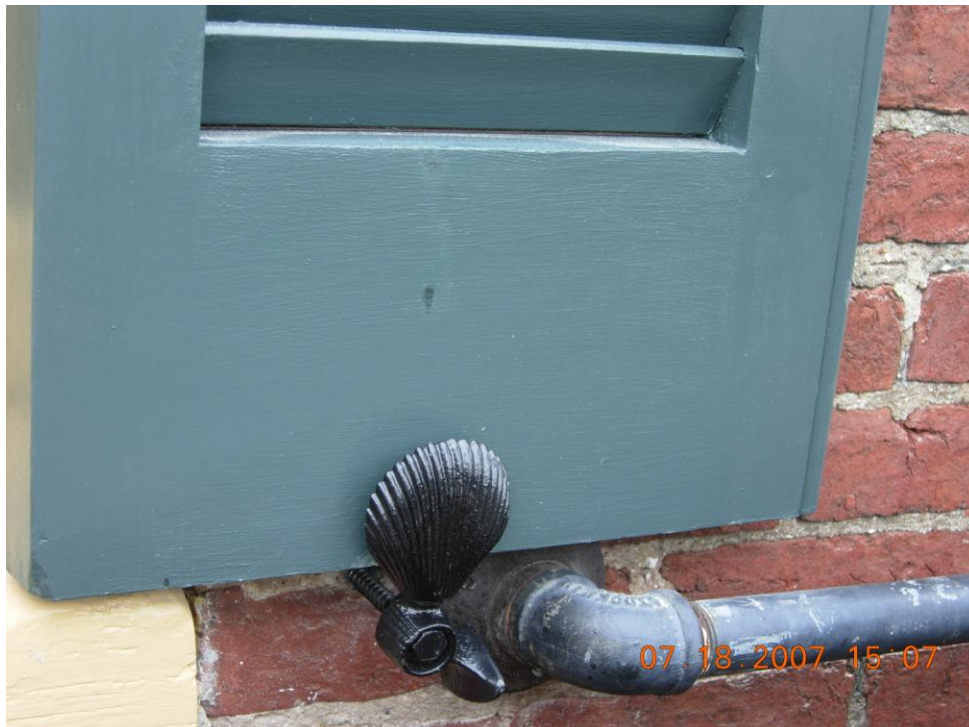
**Photo 8: Preserved shutter hung with new clam shell shutter dog attached**
