**Supplement I to  
Historic Grounds Report, Part I  
on  
State House Yard**

**Prepared by  
Historian Paul G. Sifton**

**Independence National Historical Park**

**January 1965**

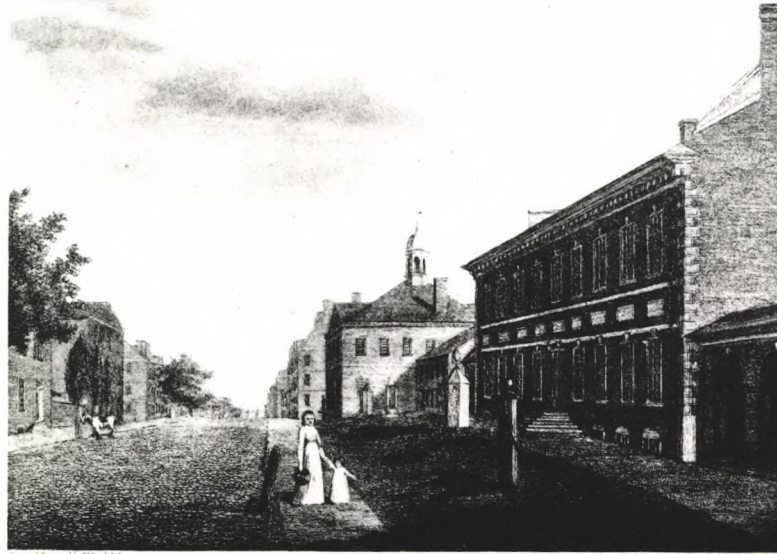
All-inclusive view of ground features before Independence Hall is furnished by this 1798 Birch print. Grass plot is indicated dark, bordered by brick walks. Brick gutter and row of posts are to be seen left of strollers. Pumps are in foreground and at far end of plot. Watchboxes show clearly in grass plot. The near one fails to show in 1804 Birch print.

The Birch prints show a walk along the street half again a man's height in width, (the nine feet specified by the House's report) and one of corresponding width in front of Independence Hall. The two prints are not in complete agreement, but are readily reconcilable. They were drawn in 1798 and 1799, by which time Congress Hall and Old City Hall had been built and the brick pavement extended, as they show, to cover the entire space between these buildings and the curb line. An examination of the Thomas Birch colored engraving "Congress-Hall and New Theatre" at the Philadelphia Free Library shows more clearly than Illustration No. 2 the ending of the plot in front of the West Wing building, with indications that much of its area was in grass though some apparently was bare earth. Both views suggest an extent of ground between the street and Independence Hall narrower than the present. Chestnut Street is scaled in the 1783 ground plan at fifty feet, where for a number of years now it has been forty feet. The 1783 ground plan shows the front of the State House to have been approximately 58 feet from the curb as against 53 feet today. Sometime after 1799 the street was reduced ten feet in width and the curb moved five feet.

In May 1789 carpenter Christian Schaffer made three watchboxes for the Commonwealth of Pennsylvania.<sup>10</sup> State authorities placed one or both of them on the plot in front of Independence Hall, where William Birch shows them in his "State-House with a View of Chesnut Street." (The Pennsylvania financial records show construction of three only, though the 1798 Birch print shows two in front of the building and the 1799 print two in back.) Perhaps during the one year interval between prints, one was moved from the front to the back. The 1804 view of the front shows only one watchbox and thus tends to support this interpretation of the views.

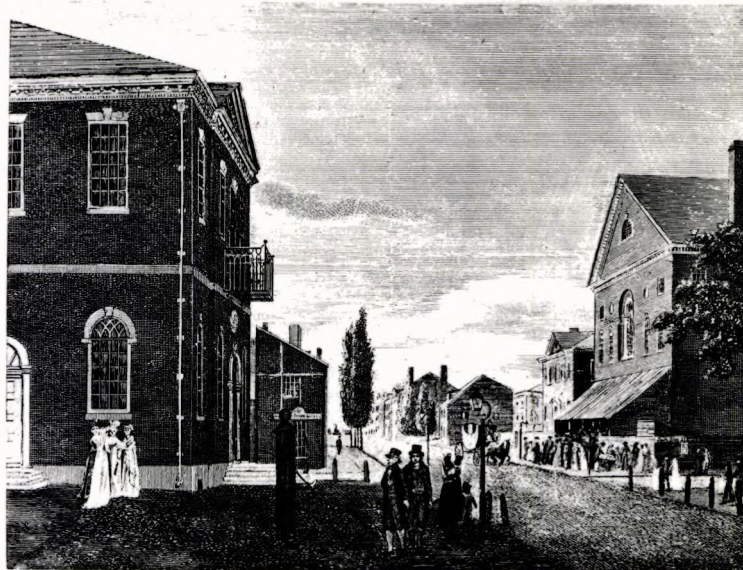
Chapter II  
Illustration No. 2

"Congress Hall and New Theatre, in Chesnut Street Philadelphia." This 1799 Birch print presents the location of two lamps, and one pump near Congress Hall.

The Birch print "Congress Hall and New Theatre" shows two lamps in front of Congress Hall. The Krimmel shows one in front of the West Wing Building (Illustration No. 3). All three are judged to have been on the curb line. Lamps on the Independence Hall facade may have precluded others along Chestnut Street before 1800.

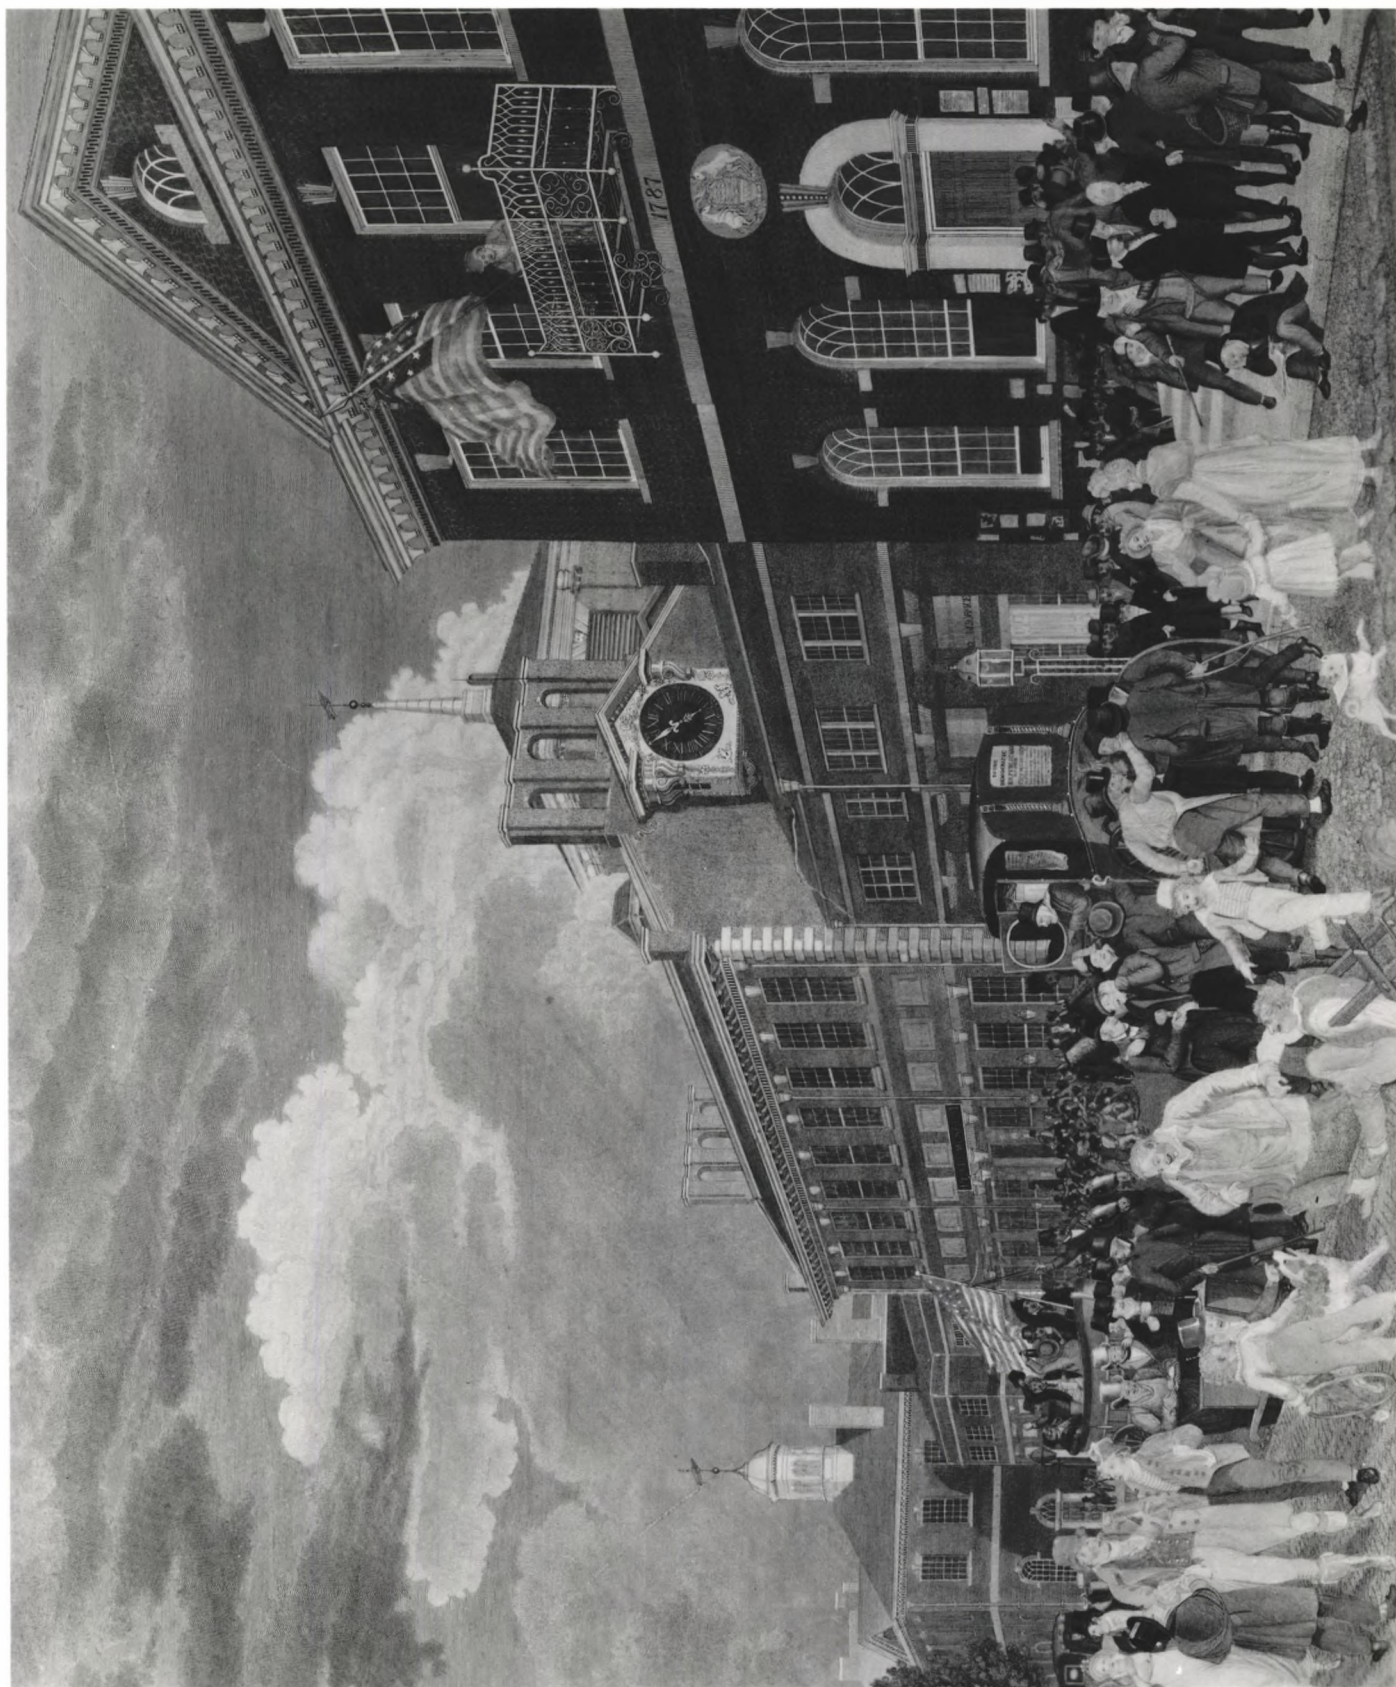
Little of the ground before Independence Hall can be seen through Krimmel's election-day mob in 1815 view. Changes in gutter and adding of curbstone is visible at lower right. Lamp to left of boat-on-wheels is believed to be the same one shown in Illustration No. 2.

In 1763 Philadelphia ordinances required that house owners on streets having paved cartways, provide stone or brick footways and gutters. In conjunction with these features they were to erect a cedar post of six or more inches thickness for every ten or twelve feet of frontage.<sup>9</sup> The gutters were to be 22 inches in width. Gutters and posts answering to these prescriptions are discernible in the 1798 Birch print "State-House With a View of Chesnut Street," although the 1763 ordinance had by then been superseded by one requiring curbstones. This latter method of edging was employed while paving the walks on the other three sides of Independence Square and by the time of the 1815 Krimmel engraving had been used in front of Independence Hall as well (Illustration No. 3).
