# Clay County Historic Preservation Commission Newsletter Spring 2013

## Renovation and Relocation of the Old Log Cabin School House

## Historic “Danish Brick Barn”: Topic for Upcoming Book

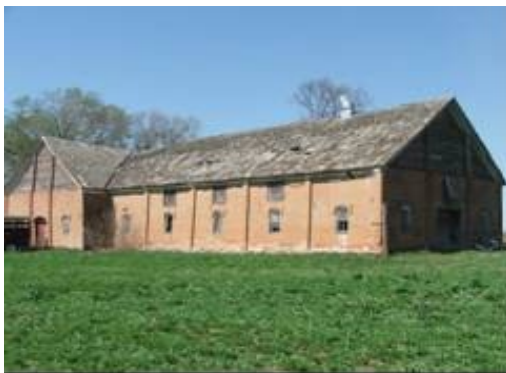
**A NW, SE corner view of the barn.**

The most distinctive feature of this rural historic district is the clay brick barn, thought to be the only remaining brick barn from the 1870's in the area. With unique walls constructed of clay brick manufactured on the property, work commenced in 1870 and was completed in 1878. The T shaped barn 47'long (North to South) and 36' wide (East to West) on the West end and a 36' wide (North to South) by 67' (East to West) on the East side. The foundation is native granite/quartzite stone, which is about 1'-5" above ground level. The brickwork is very ornate with soldier brick arches above all door and window openings, except the seven hayloft doors (three on the North wall, three on the South wall and one on the East wall of the East wing of the barn) as the top of the door is at the top of the 12' wall (see both top and right bottom photographs.) The brick walls have pilasters built into all six corners and four in each of the 67' walls on the East part of the barn. The West side and all of the 36' gable ends each have two pilasters and the corner pilasters (see both top photographs.) The foundation and bricks are mortared with sand and lime, as Portland cement was not available before 1880.

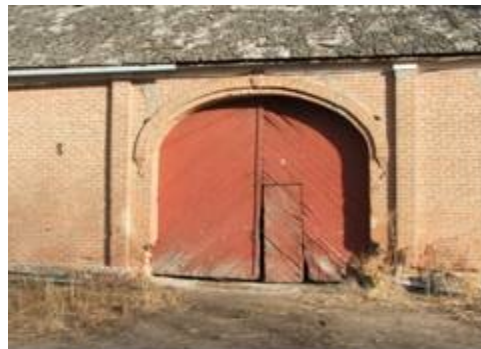
**The west wall of west wing showing the arched doorway .**

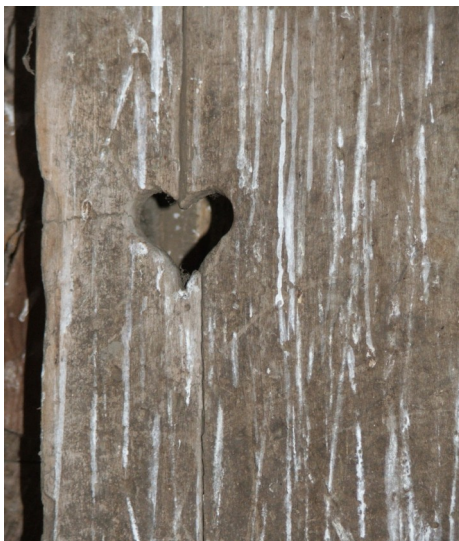
**An example of a heart-shaped figure pull that is characteristic of several doors in this barn.**

The hayloft in the 36'x47' West end has six rows of the massive hand hewn cottonwood 8"x 9" x 36' beams running the 36' width East to West. These beams are 8' O.C. from the South wall and about 5' O.C. from the North wall leaving a 14' alley, which lines up with the alley to the East. Plus another 8"x 9" beam imbedded into the South brick wall. These beams are supported by hand hewn cottonwood posts 8' O.C. on the North side and 4'-6" O. C. for the five single horse stalls and 9' O.C. for the double horse stall on the South side. Each post is mortised and tendon into the bottom of the beams. The wall between the alley and the horse stalls is covered with boards for a solid wall. There are doors with heart shaped finger pulls to open to feed the horses (see left photograph at the bottom of this page).

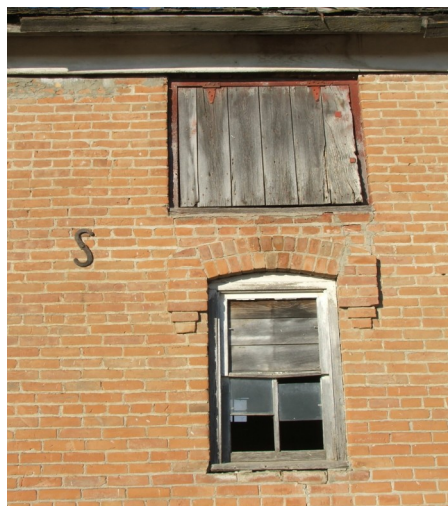
**Above bottom window is a soldier brick arch above . A hayloft door is situated at the top of brick wall .**

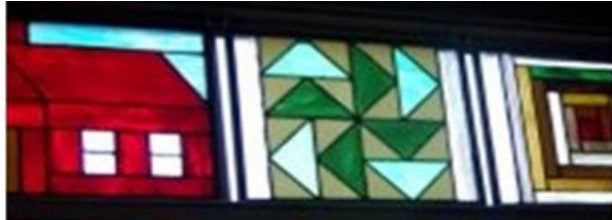
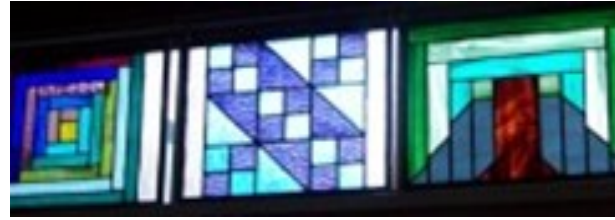
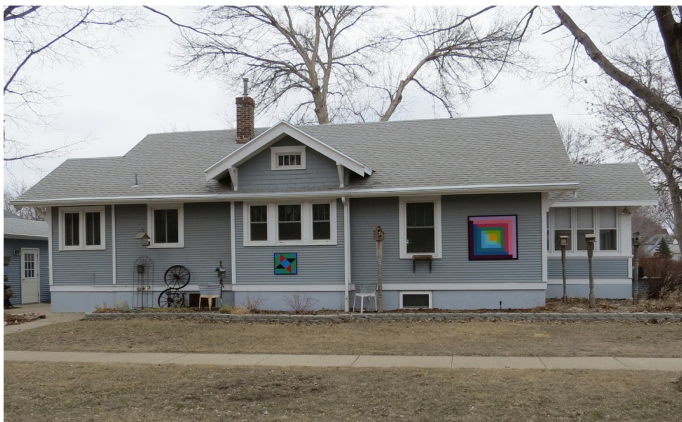
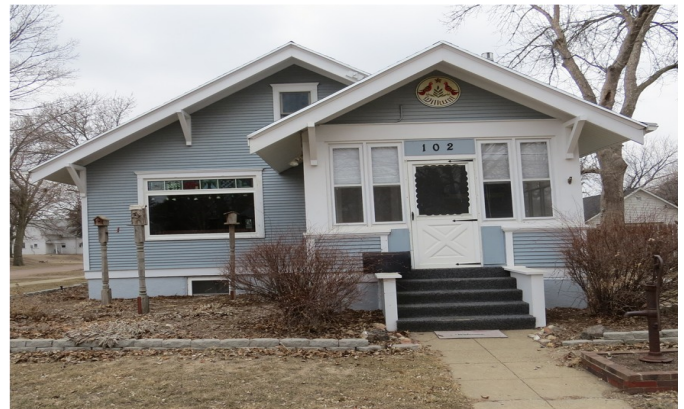
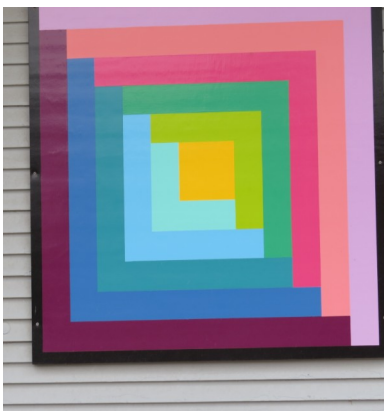
The top left photo depicts the south side of the house with the two barn quilts. These are enlarged in the two photographs.

The large picture window is now the “home “ of 6 small stained glass windows depicting Joyce Zimmer’s favorite quilt patterns.

The Zimmer House built in 1919 and located on the western corner of Harvard and National represents a new form of “Barn Quilting”. Aside from the nor traditional barn quilts on the South side of the House ( larger log cabin motif) and smaller (neighbor motif), the large east facing window is framed on top by a series of 6 stained glass “barn quilts” . The stained glass quilt patterns were selected by Joyce Zimmer and the windows made by the very talented Cal Peterson, of here in Vermillion. Designs included two Log Cabin blocks, a Jacob’s Ladder, the Willow Tree is to honor Joyce’s Dad ( the house they lived in on Willow Street was selected by her father) and the Little Red School House is to honor Joyce’s Mom, who taught school for 42 years. The sixth pattern is a pinwheel motif.
