# Preservation/Restoration of Moton Field

Tuskegee Airmen  
National Historic Site  
Tuskegee, Alabama

*Historic Structure Report*  
Army Supply Building

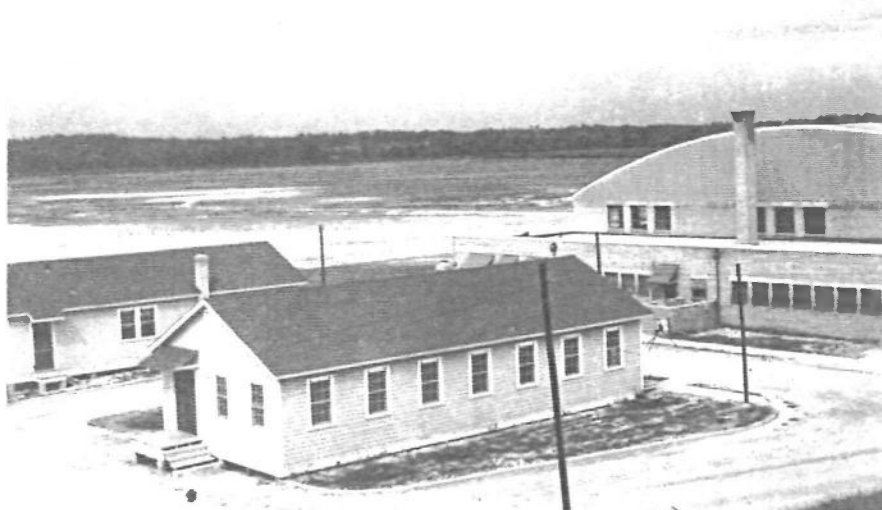
**Figure 2:** Historic photograph of the Army Supply Building (center foreground) behind Hangar Number One. Historic Photograph Collection, Howard University.

Based on historic photographs, the building was a one-story, frame, front-gabled structure set on a pier foundation. (See *Figure 2*.) The building was constructed west of Hangar Number One and adjacent to the similarly designed and constructed Flight Command – Office/Cadet Class and Waiting Room. The Army Supply Building was constructed to provide storage space for military supplies needed for operation of the primary flying school. Historic photographs show that the exterior additions to the building proposed in the May

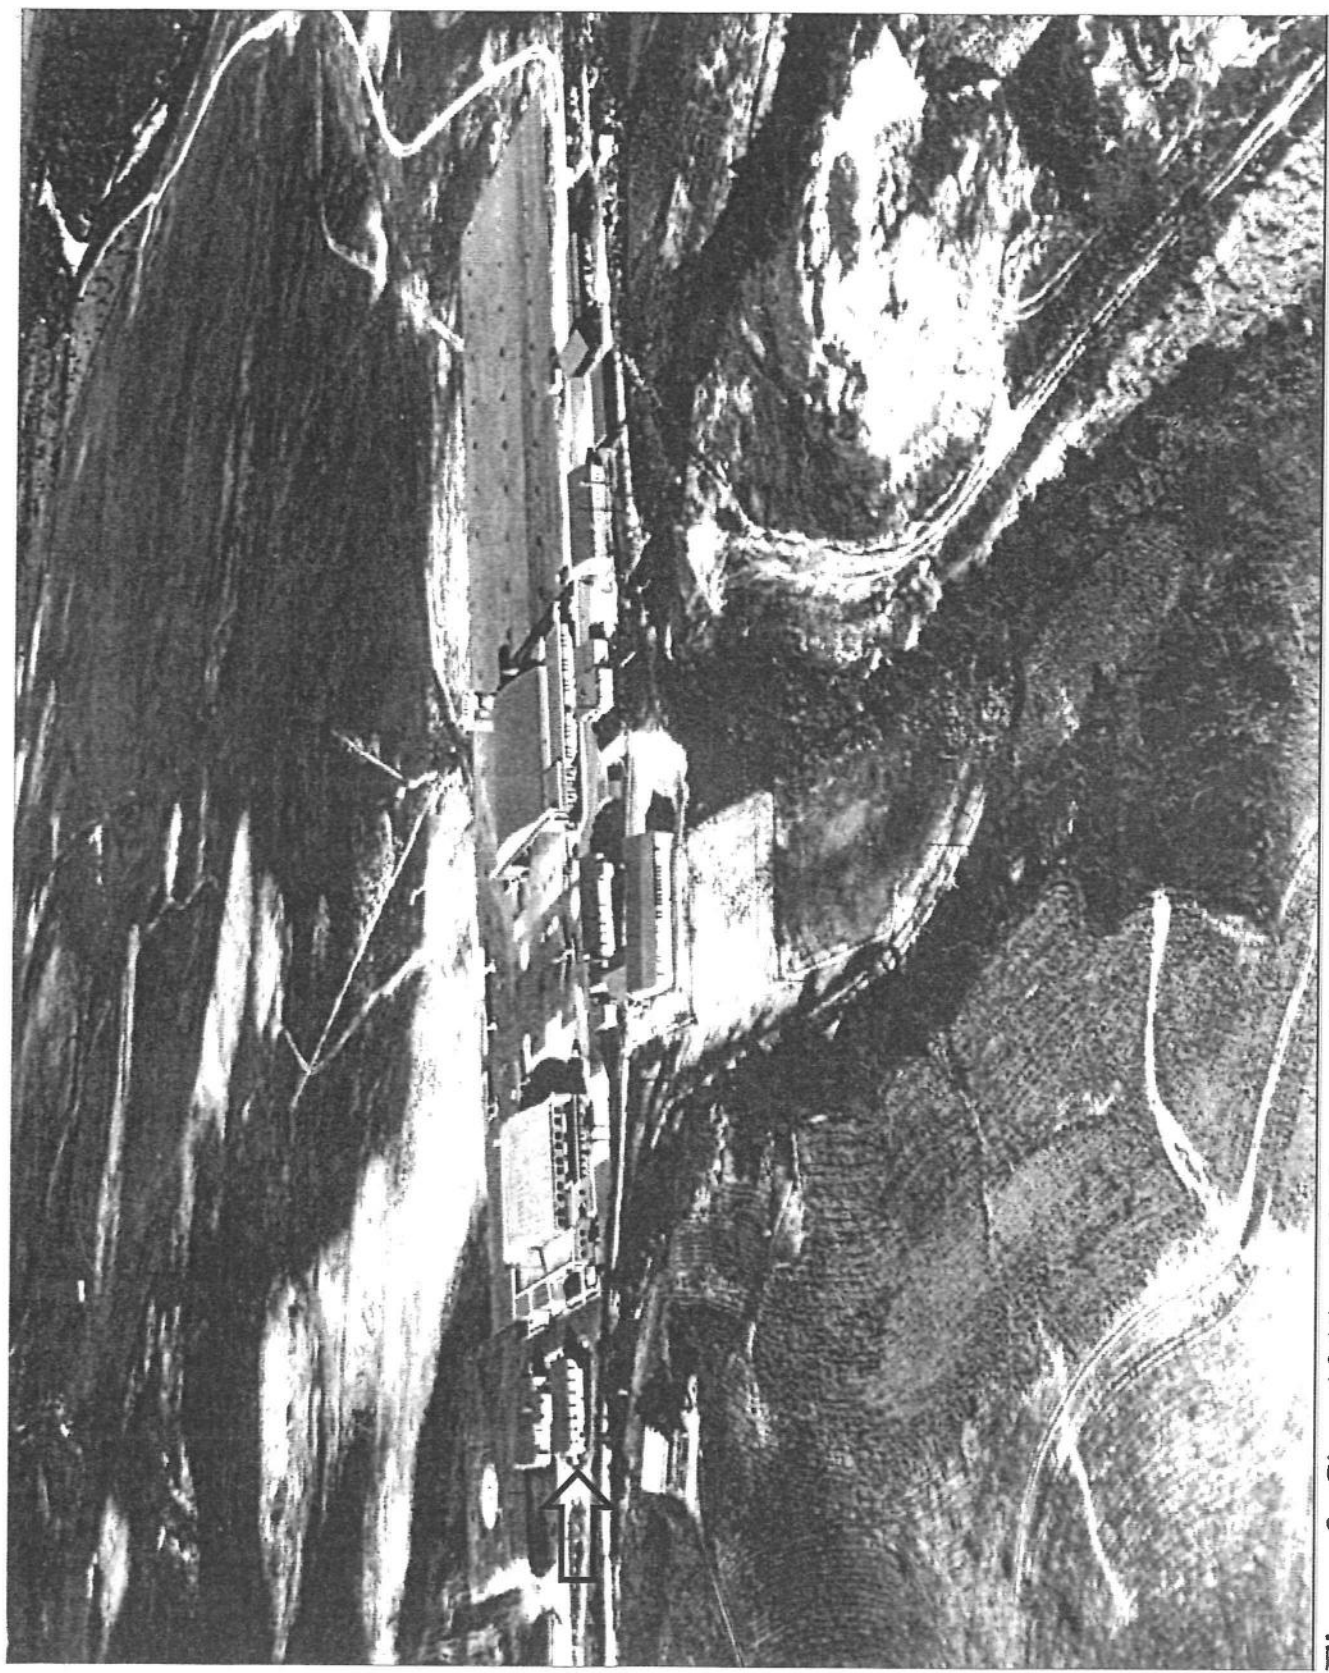
**Figure 3:** Circa 1945 aerial photograph of Moton Field showing the Army Supply Building west of Hangar Number One. Historic Photograph Collection, National Park Service Curatorial Storage Facility, Tuskegee Institute NHS.

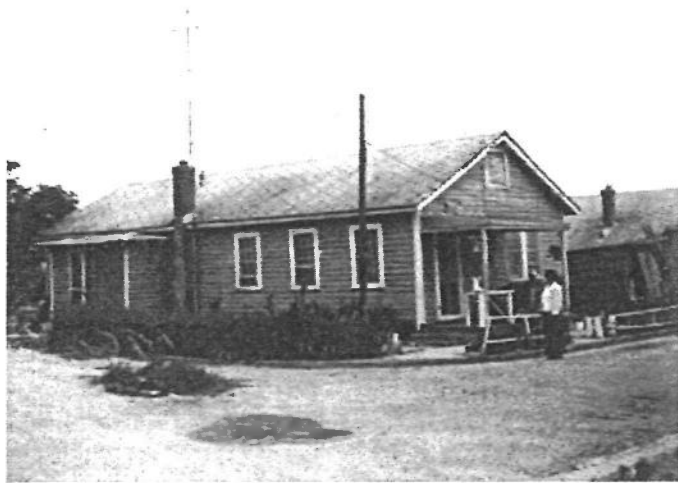
**Figure 4:** 1977 photograph of the east front and south side facades of the Army Supply Building. Booker Conley's Files, Physical Plant, Tuskegee University.

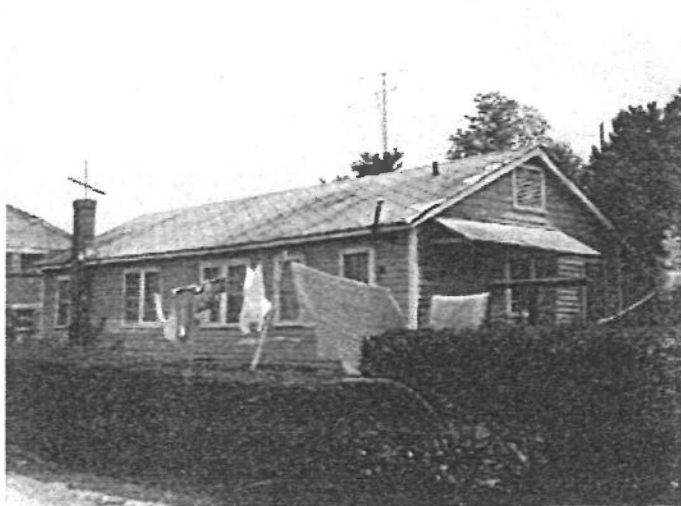
**Figure 5:** 1977 photograph of the west rear and north side facades of the Army Supply Building. Booker Conley's Files, Physical Plant, Tuskegee University.
