**Memorandum – Coastal Engineering Review  
GOGA Baker Beach Boardwalk and Stair Extension Review (Baker Beach,  
California)  
TAR 15460**

**12 November 2020, Revised 02 December 2020**

GOGA - Coastal Engineering Review of Proposed Design of Boardwalk and Stair Extensions to Baker Beach Accessible Ramp

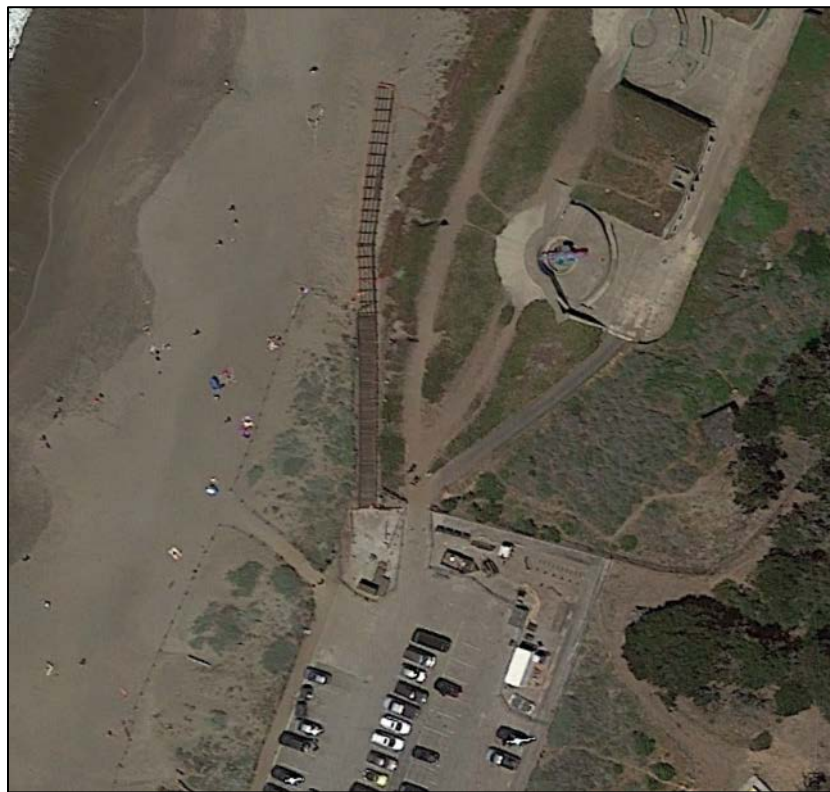
This memorandum presents comments regarding the evaluation of the proposed boardwalk and stair extension at the Baker Beach parking lot. Included in the proposed design is an extension of the stairs leading to the beach as well. The original structures were constructed from approximately March to June 2018 per review of Google Earth aerial imagery (refer to image below).

**Figure 1 - Google Earth Aerial Imagery from May 2018  
Showing In-progress Construction of Accessible Ramp**

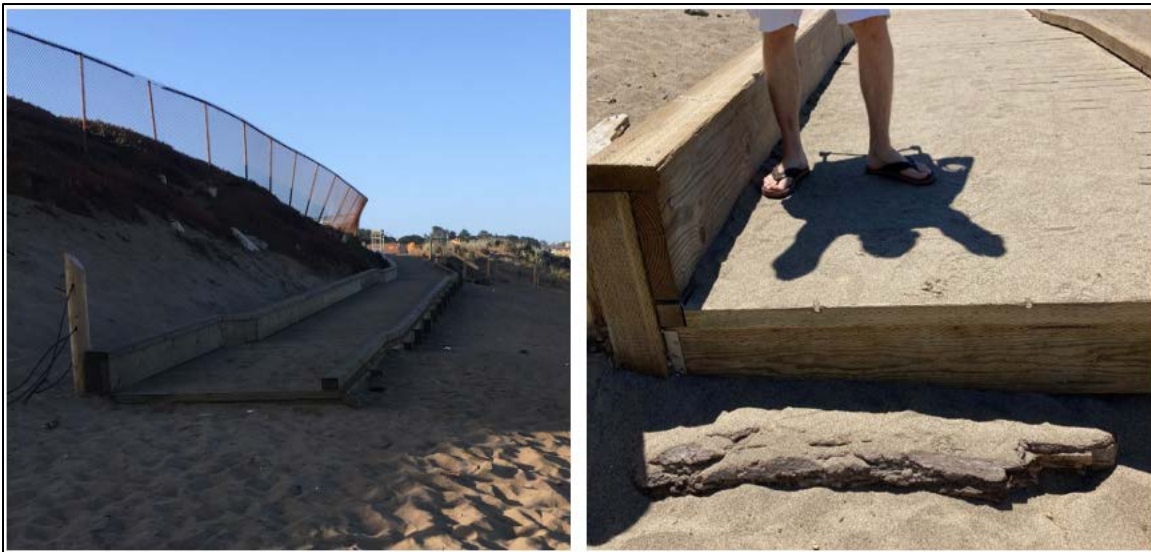
The accessible ramp is currently approximately 230 feet in overall length and at a slope up to but not exceeding 8 percent, in compliance with the Architectural Barriers Act Chapters 1-2 and 3-10 of the Americans with Disabilities Act and Architectural Barriers Act Accessibility Standards. When originally constructed, both the accessible ramp and stairs transitioned onto the beach smoothly. Since construction (per file *10-10-2020 SOW\_R1 ramp & stairs.docx*) the sand has eroded, principally through daily wind action and storm events (per files *MChasse\_email.pdf* and *waves\_reaching\_Baker\_Beach\_boardwalk\_11-28-18.JPG*), leading to dangerous conditions for public beach access. According to park personnel sand is moved by maintenance staff to replenish these areas on a regular basis. However, once the sand erodes again, the conditions are severe enough that the beach is no longer in compliance with the ADA accessibility standards, and public complaints have been filed despite the ongoing maintenance efforts. The existing ramp transition and current conditions are shown in the figure below.

**Figure 2 - Original 2018 (left) and Current 2020 (right) condition of the accessible ramp transition**

NPS has requested that the proposed accessible ramp and stair extension designs be reviewed from a resiliency standpoint in order to assess the risk of similar erosion patterns rendering the proposed extension possibly dangerous to beach accessibility in the near future. For this review EA was not tasked with nor did the team review calculations or other background design information in detail but performed a cursory review to assess the resiliency and possible erosion risk for the accessible ramp and stair extensions.
