# NPS Wildfire Risk Assessments Assessment Locations

Basswood Island  
APIS - Apostle Islands National Lakeshore

# NPS Wildland Fire Risk Assessment - Facility Assessment

**Facility Name:** BAV01 Campground Vault (Dock and Group Site)

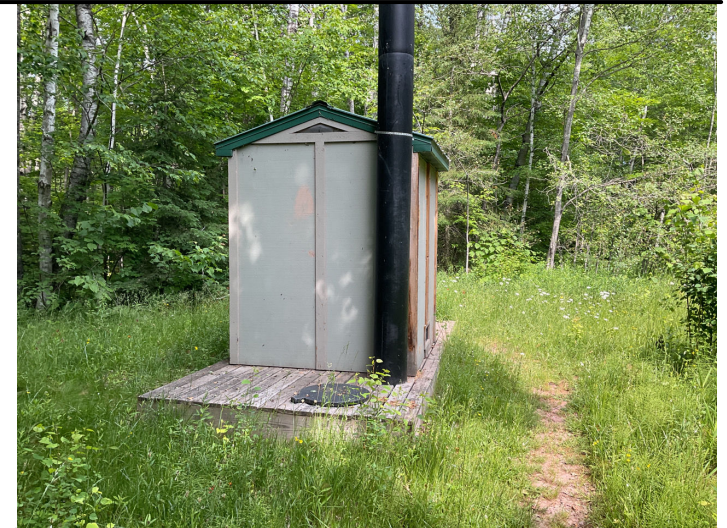
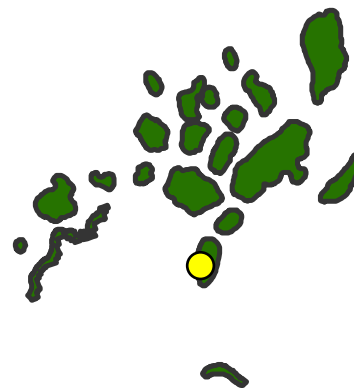
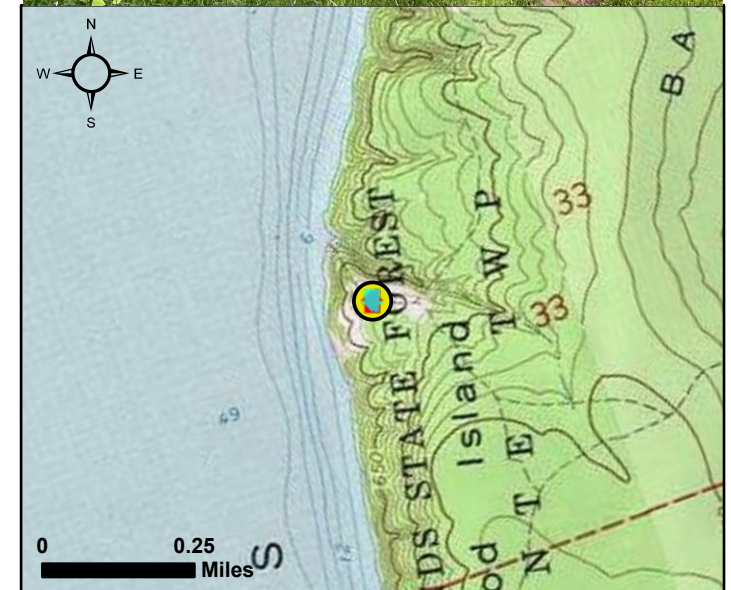
**Facility Number or Sign:** None or not clearly visible

**Fuel Type:** Shrub or timber

**Fuel Load:** Moderate

**Defensible Space:** Less than 30 ft treated

**Siding Material:** Vinyl

**Foundation:** Closed, Less than 6in masonry exposed
