# Cesar E. Chavez National Monument

CECH - Cesar E. Chavez National Monument

# NPS Wildland Fire Risk Assessment - Facility Assessment

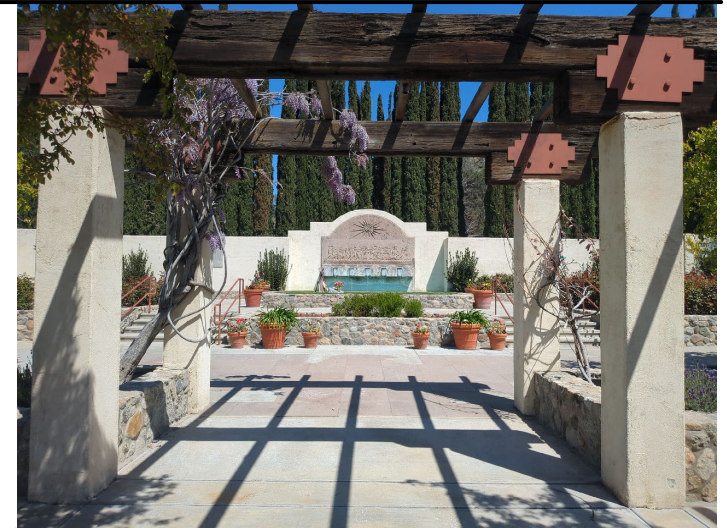
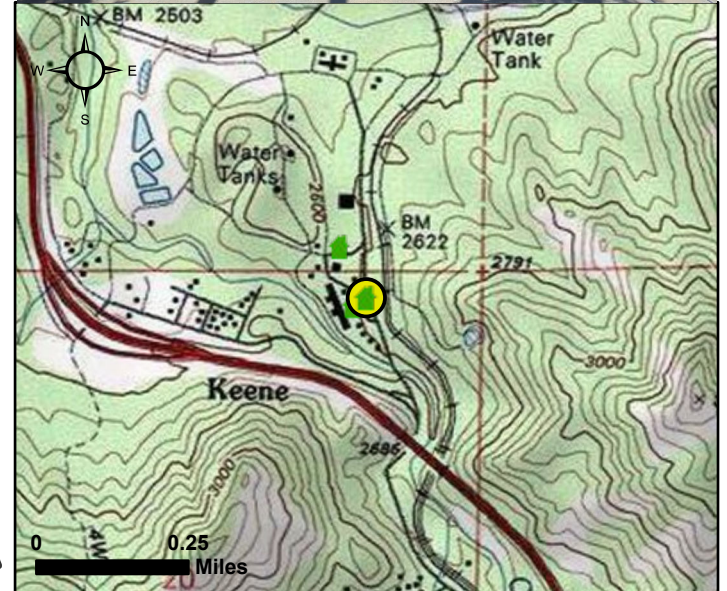
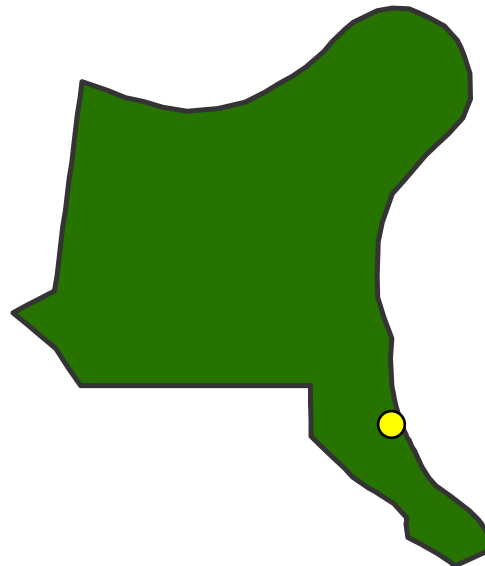
**Facility Name:** Chavez Burial Site

**Rating:** Low

**Fuel Type:** Grass/tundra,northern hardwood litter

**Fuel Load:** Light or no wildland fuels

**Defensible Space:** 100 ft treated

**Roof Material:** Noncombustible or not applicable

**Overhead Hazards:** Overhead hazards will limit aircraft

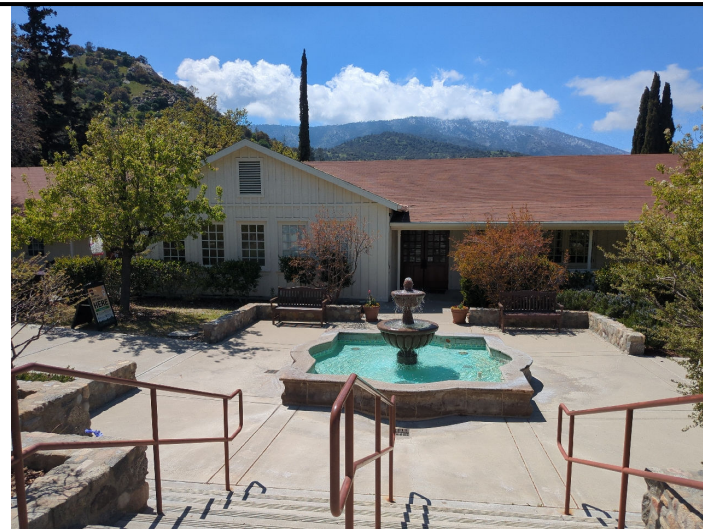
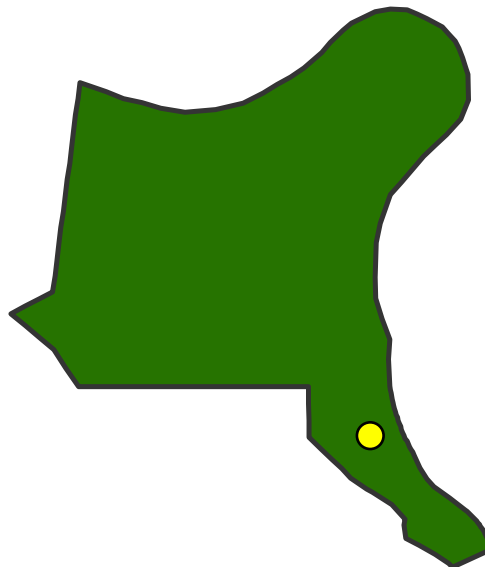
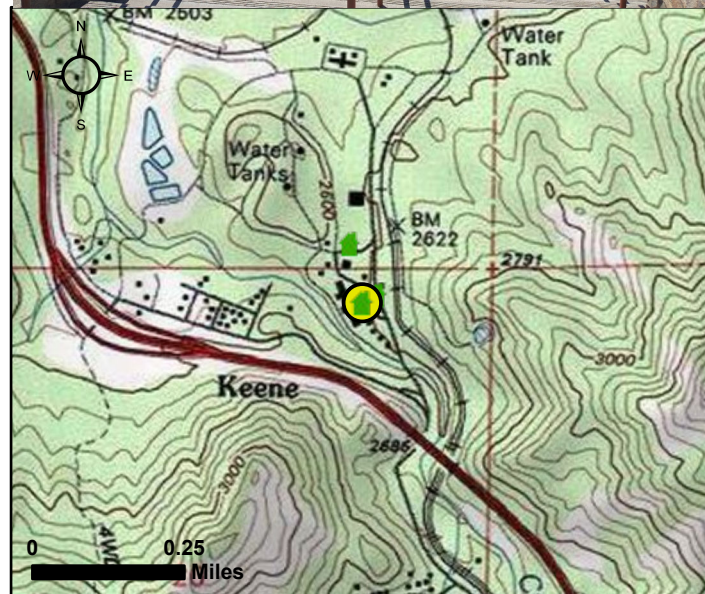
**Facility Name:** CECH 401 Visitor Center

**Rating:** Low

**Fuel Load:** Light or no wildland fuels

**Defensible Space:** 100 ft treated

**Roof Material:** Fire resistant- tar,rubberized

**Siding Material:** Wood or open sided

**Propane:** Present and fuels clearance

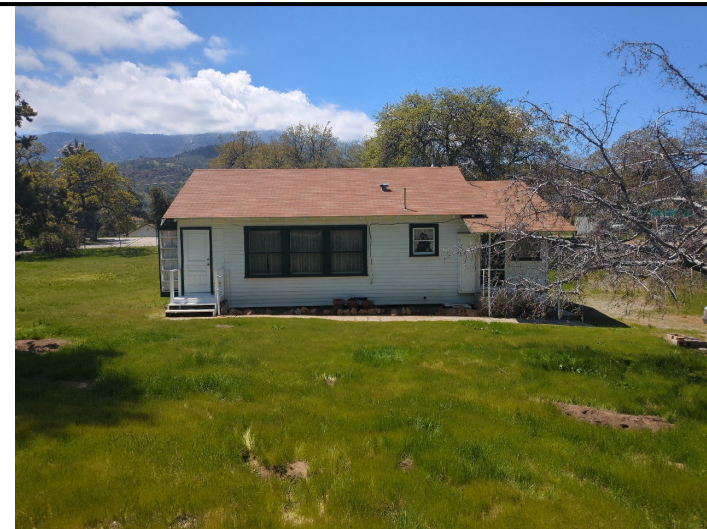
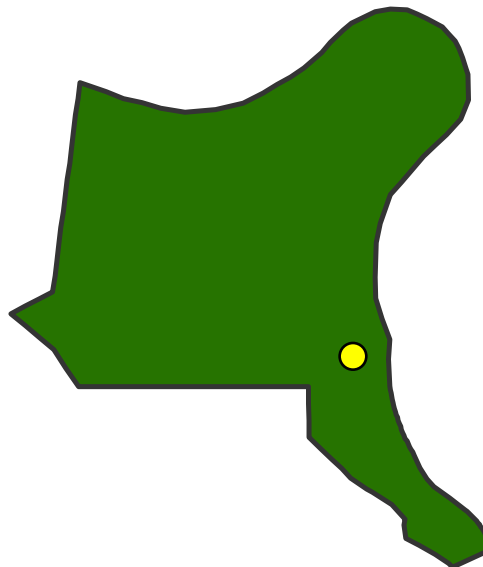
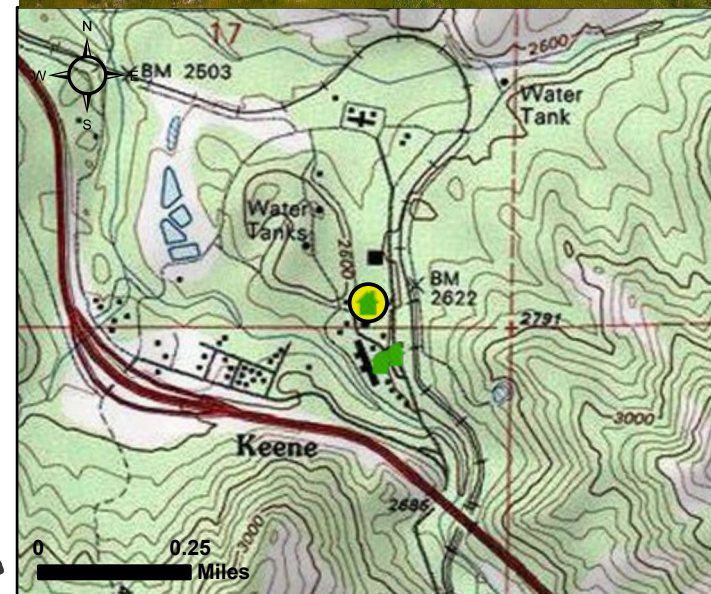
**Facility Name:** César Chavez Home

**Rating:** Low

**Fuel Load:** Light or no wildland fuels

**Defensible Space:** Greater than 100ft treated

**Siding Material:** Wood or open sided

**Foundation:** Closed, Less than 6in masonry exposed

**Firewood:** 5ft to 30ft from facility
