## National Register of Historic Places Registration Form

Historic name East Plaza Apartments Historic DistrictOther names/site number N/AName of related Multiple Property Listing Working-Class and Middle-Income Apartments Buildings in Kansas City, Missouri

Street & number 205-323 Emanuel Cleaver II Boulevard, 127-237 East 46<sup>th</sup> Street,  
4618 Warwick Boulevard

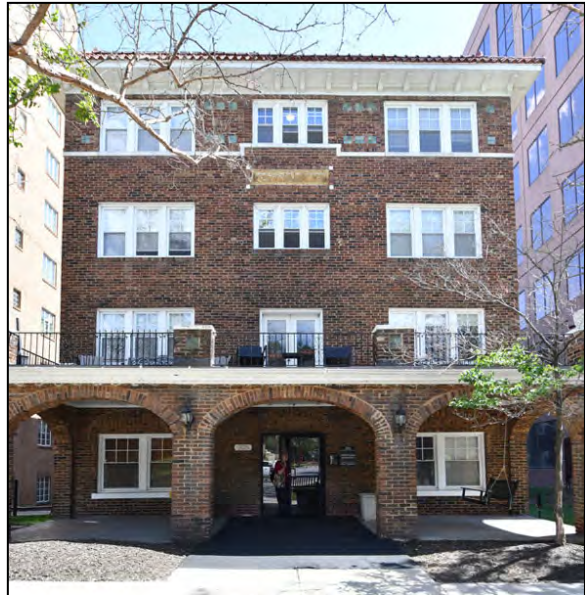
Photo 12; Figure 4

The Rockhill Plaza Apartments is a four-story building with a rectangular footprint, flat roof, concrete structural system with a quarry faced stone foundation wall, brick cladding, and restrained Spanish Colonial Revival elements. The east, south, and west edges of the parcel abut neighboring parcels; a narrow lawn lines the south and west elevations, and a driveway associated with the neighboring building (Plaza Towers, Resource 2) sits close to the east elevation.

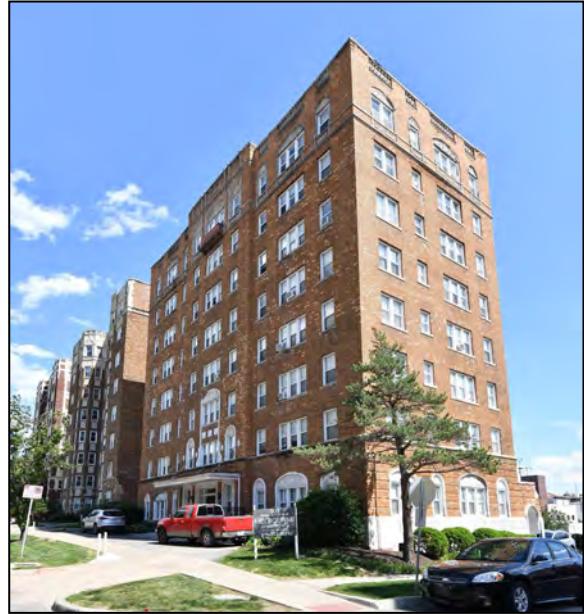
**303 Emanuel Cleaver II Boulevard**

The eight-story Melbourne Apartments has a rectangular footprint, flat roof, concrete structural system, brick cladding, and restrained Spanish Colonial Revival elements. The current parcel contains the building, as well as a small parking lot to the rear (Resource 5, contributing structure). The primary elevation faces north, towards Emanuel Cleaver II Boulevard. McGee Street, which begins at Emanuel Cleaver II Boulevard and runs south before it ends into a private parking lot, is to the west. A narrow alley to the east separates the Melbourne Apartments from another nearby apartment building (Park Castles, Resource 6). A short concrete-paved elliptical driveway leads up to the main central entrance from Emanuel Cleaver II Boulevard.

Most of the Spanish Colonial Revival elements such as stone surrounds and decorative panels, are present on the first and eighth (top) stories of the north, east, and west elevations. The second through seventh stories are generally void of decoration. Stone bands line the bottom of the second story openings and the eighth story openings on the primary (north), east, and west elevations. First- and eighth-story openings on those walls (except for the three center bays of the north elevation of the first story) have narrow decorative stone surrounds and stone arches with floral designs. The eighth story features more elaborate detailing than the first, with a stone panel set into the brick below each window, and decorative stone balustrades are set into the parapet wall above each opening. A metal Juliet balcony sits below the center opening on the eighth story of the north elevation, and additional decorative stone panels are above the center three

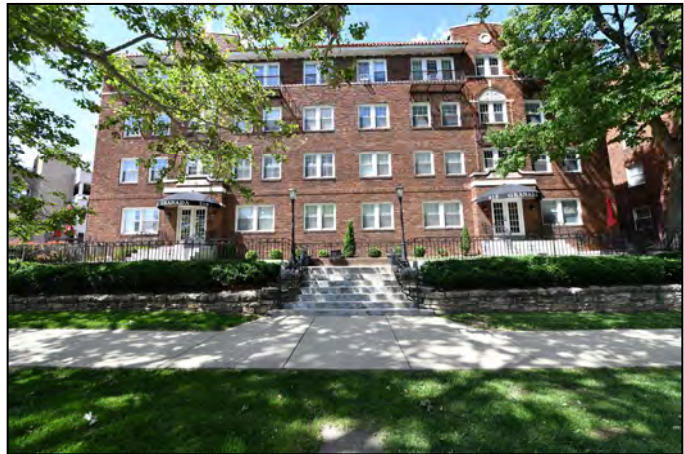
Photo 15

The Granada Apartments is located at the west edge of the District. The four-story building has a C-shaped footprint, flat roof, and brick cladding. Most windows are non-historic 6/1 (primary south elevation) or 1/1 (all other elevations) hung aluminum or vinyl replacements within the historic openings. Historic hung 6/1 wood-framed windows fill the openings that correspond to the stair enclosures (discussed below). Along the east and west elevations, glass blocks fill the basement level openings. A thin terra cotta stringcourse lines the upper story of the south, east, and west elevations at the windowsills. A hipped overhang roof with red clay tiles lines most of the south parapet and wraps around the east and west elevations for one bay. Two stair enclosures rise above the parapet near the east and west ends of the primary south elevation. A half round terra cotta panel is set into the wall above the third story opening that corresponds to each enclosure, and a wrought iron grill is affixed to the masonry below the opening. Above the fourth story opening, a round panel fills the upper part of the parapet. Historic wrought iron balconies extend out below the window at each opening adjacent to the stair enclosures. A set of concrete steps with wrought iron railing leads up from the sidewalk, interrupting the stone wall, and splits off to the identical entrances. A second set of concrete steps leads up to the entrances, which step out about one foot from the wall and contain a pair of multilight doors and a non-historic fabric awning.

*Integrity:* The Granada Apartments has seen few changes since it was completed. It retains its character defining red clay tile roof, shaped parapets at the stair enclosures, terra cotta panels, and wrought iron balconies. Replacement windows do not significantly detract from the building's overall integrity, and all historic openings are apparent.

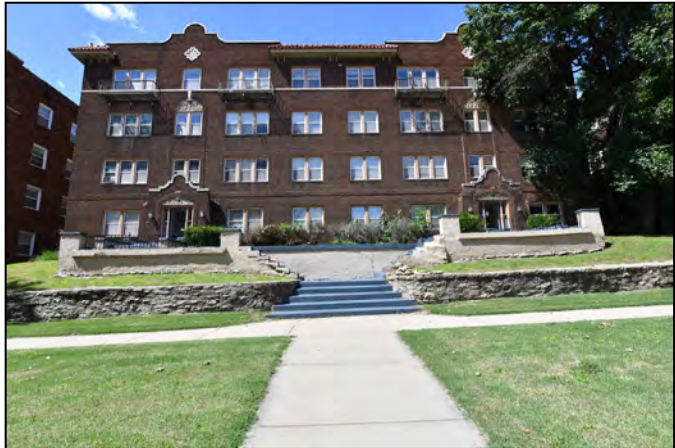
*Photos 2 & 3*

The Madrid Apartments is located in the middle of the block. The four-story building has a C-shaped footprint, flat roof, and brick cladding. A narrow concrete driveway lines the west side of the building and leads to the East Parking Lot (Resource 27). All windows are non-historic 1/1 aluminum or vinyl replacements. Wide mullions separate either a pair or three typical windows within the historic openings. A pair of curvilinear gables with a terra cotta panel corresponds with the entrances and stair enclosures near the east and west ends of the south elevation. The parapet steps down slightly away from the gables. A hipped clay tile roof with a bracketed overhang extends out from the face of the wall in the center two bays of the primary south elevation and at the southeast and southwest corners. Between the first and second stories, a brick belt course lines the north, south, and east elevations. A narrow terra cotta belt course lines the bottom of the fourth story windowsills of those elevations. A set of concrete steps leads up from the sidewalk to a small landing in front of the building. A second set of concrete steps leads up east and west from the landing to the main entrances. A one-story brick-clad entrance projection with a flat roof and curvilinear gable extends out near the east and west ends of the

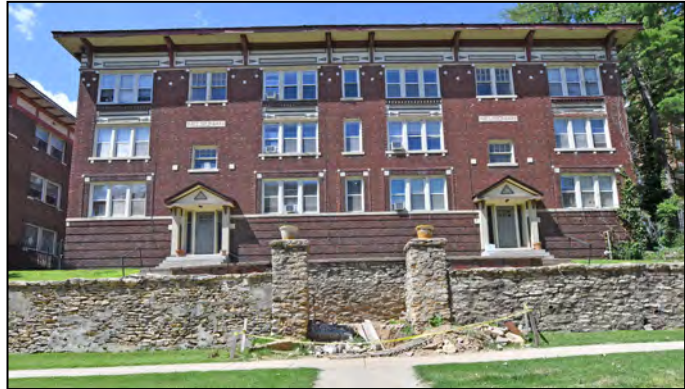
Photo 17

The three-story Nelsonian Apartments has a rectangular footprint, a stone foundation, brick cladding, and a flat roof. It is located near the east end of the District, near the Sophian Plaza Garage (Resource 25).<sup>10</sup> Given the slope of the land down from the north, the rusticated brick of basement level is completely exposed along the primary south elevation. Portions of the stone foundation are visible along the east and west elevations. The foundation is not visible along the rear north elevation.

Two concrete walkways lead from the sidewalk to entrances in bays 2 and 6, looking east to west. A concrete driveway leads from the street along the west elevation to the East Parking Lot (Resource 27). A four-car carport abuts the west half of the south basement level. The carport has painted brick walls and a flat roof with brick walls between each stall. A wood-framed stair accesses the top of the carport and leads to a larger stair in the corresponding bay (discussed below). All windows appear to be non-historic aluminum or vinyl replacements within the historic openings. Unless otherwise noted, windows have a 1/1 configuration. Basement-level openings along the east, south, and west elevations have a wood-framed four-light hopper window that opens inwards. A wide overhanging eave with brackets lines the primary north elevation and wraps around for one bay along the east and west elevations. Decorative panels fill

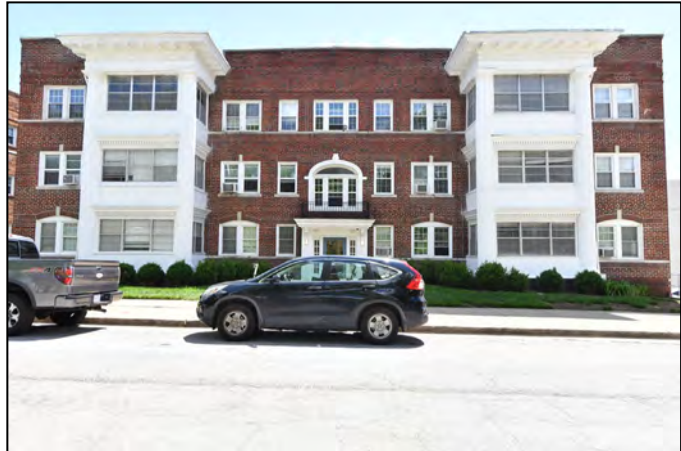
Photo 18, Figure 10

The three-story colonnade apartment building at 127-129 East 46<sup>th</sup> Street is located at the northwest corner of the District.<sup>11</sup> It has a roughly rectangular footprint, brick cladding, a flat roof, and restrained Classical Revival styling. The west elevation abuts a neighboring parking lot (outside of the District), and the east elevation sits close to the building at 131-133 East 46<sup>th</sup> Street (Resource 17). Due to the slope of the site, more of the building's cut stone foundation is more visible along the rear south elevation than the east and west elevations; the basement is not visible along the primary north elevation. A narrow stone belt course wraps around the entire building at the first story windowsills. A stringcourse lines the third story openings. Second-story openings along the primary north elevation have individual stone sills; openings on the other walls have brick sills. Two enclosed full-height colonnaded porches, each located one bay in

*Integrity:* The building at 127-129 East 46<sup>th</sup> Street retains integrity. Exterior alterations have largely been limited to window replacement within the historic openings. The porches were historically open and had a wood railing. It is not known when the porches were enclosed, but the distinctive columns and dentiled cornices are still apparent. The building's historic residential use is still apparent.

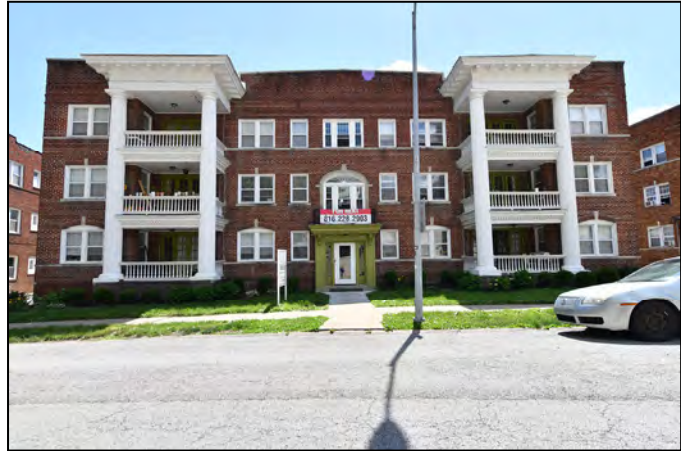
Photo 7

The three-story building at 209-211 East 46<sup>th</sup> Street is located along the north edge of the District. It has a roughly rectangular footprint, brick cladding, a flat roof, and restrained Classical Revival styling.<sup>13</sup> A historic paved driveway lines the east and west elevation. The east drive leads down to a small, paved landing that is too small to be counted individually. The west drive leads to the West Parking Lot (Resource 28). Due to the slope of the site, more of the building's cut stone foundation is more visible along the rear south elevation than the east and west elevations; the basement is not visible along the primary north elevation. A narrow stone belt course wraps around the entire building at the first story windowsills. A stringcourse lines the third story openings. Second story openings along the primary north elevation have individual stone sills; openings on the other walls have brick sills. Two full-height colonnaded porches with painted wood railing, each located one bay in from the outside edge of the wall, extend out from the north and south elevations. Two fluted columns with Doric capitals support each porch. A wide bracketed overhanging roof lines the top of the upper porch; a dentiled cornice lines the top of the lower two porches, and painted wood railing lines all porches. A pair of multilight painted

*Integrity:* The building at 209-211 East 46<sup>th</sup> Street retains integrity. Exterior alterations have largely been limited to window replacement within the historic openings. The distinctive historic porch railings are intact throughout and the building's historic residential use is still apparent.

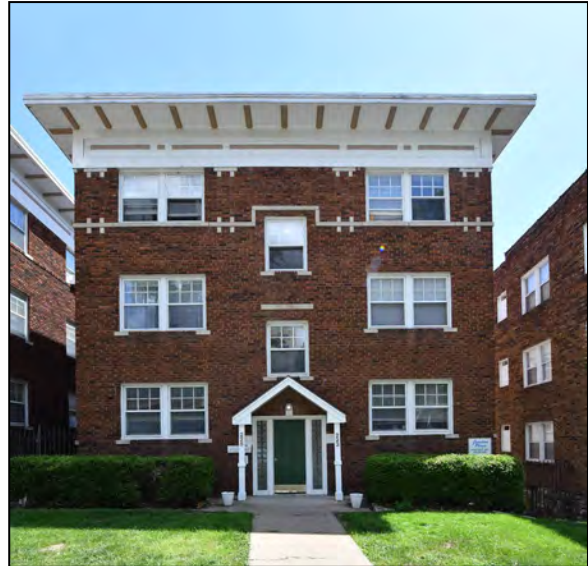
*Photo 21*

The three-story apartment building at 223-225 East 46<sup>th</sup> Street has a roughly square footprint, a stone foundation, brick cladding, and a flat roof behind a parapet.<sup>16</sup> The building is located near the center of the north boundary. A concrete walkway leads south from the sidewalk to the center of the north elevation; narrower walkways lead from the sidewalk to the east and west sides. The north elevation and the north two bays of the east and west elevations are clad with red brick; the rest of the walls have painted stucco (or similar) covering. A wide overhang eave with a painted entablature lines the north elevation and the north half of the east and west elevations. All windows are non-historic aluminum or vinyl replacements within the historic openings. They either have a 1/1 or 6/1 single-hung configuration. Most windowsills on the north elevation and the north half of the east and west walls have a mix of brick and cast stone. At the north elevation, a thin stringcourse lines the bottom of the third story window openings. The stringcourse wraps around for about a foot on the east and west elevations; a brick stringcourse continues along most of the rest of those walls.

The east and west elevations are nearly mirror images of one another. Given the slope of the surrounding land, more of the stone foundation is exposed looking to the south. The north bays each contain a pair of windows; at the basement level, glass blocks fill a smaller rectangular opening. The second bay from the north contains a single window and a similar basement-level opening in the stone foundation. Painted stucco covers the windows in the third bay from the north, which extends out slightly from the wall. An entrance with a small wood deck is located at the basement level of the west elevation. Each story of the south bay has a pair of windows. A non-historic wood stair covers most of the center of the east elevation. The center bay projects out around the stairs. A pair of windows fill each story of the flanking bays. A single square window fills the east and west basement-level openings.

*Integrity:* The building at 223-225 East 46<sup>th</sup> Street has seen few alterations of note and retains integrity. Although some window openings on the secondary east and west elevations have been filled, the primary north elevation openings are intact. It is not known when the stucco cladding was added. The stucco is noted on the 1950-1951 Sanborn Fire Insurance map, which is the earliest available map that shows the building. The building permit describes the building simply as having “brick & stone” construction. Despite this, the stucco is not easily visible from the primary north elevation and does not detract from the building’s overall appearance. The building at 223-225 East 46<sup>th</sup> Street retains its historic residential use.

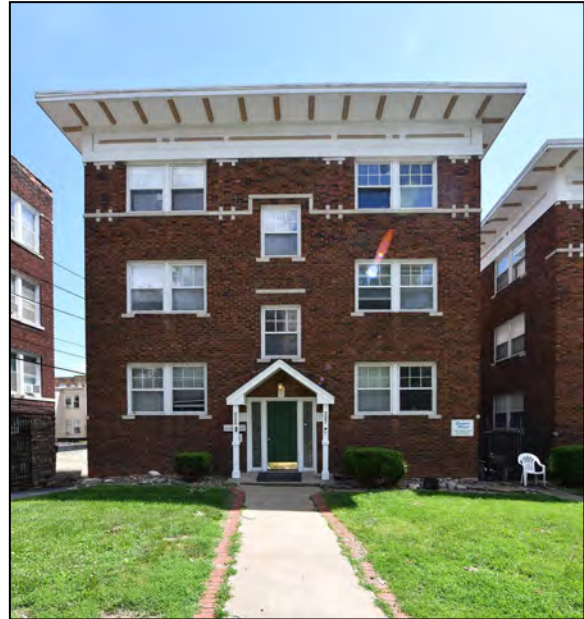
Photo 21, Figure 14

The three-story building at 227-229 East 46<sup>th</sup> Street has a roughly square footprint, a stone foundation, brick cladding, and a flat roof behind a parapet.<sup>18</sup> The building is located along the north boundary, near the center. A concrete walkway leads south from the sidewalk to the center of the north elevation; a narrower walkway leads from the sidewalk to the west side of the building. A concrete driveway along the east elevation leads south to the East Parking Lot (Resource 27). The west elevation closely abuts a neighboring building (Resource 21). The north elevation and the north two bays of the east and west elevations are clad with red brick; the rest of the walls have painted stucco (or similar) covering. A wide overhang eave with a painted entablature lines the north elevation and the north half of the east and west elevations. All windows are non-historic aluminum or vinyl replacements within the historic openings. They either have a 1/1 or 6/1 single-hung configuration. Most windowsills on the north elevation and the north half of the east and west walls have a mix of brick and cast stone. At the north elevation, a thin stringcourse lines the bottom of the third story window openings. The stringcourse wraps around for about a foot on the east and west elevations; a brick stringcourse continues along most of the rest of those walls.

The east and west elevations are nearly mirror images of one another. Given the slope of the surrounding land, more of the stone foundation is exposed looking to the south. The north bays each contain a pair of windows; at the basement level, glass blocks fill a smaller rectangular opening. The second bay from the north contains a single window and a similar basement-level opening in the stone foundation. Painted stucco covers the windows in the third bay from the north, which extends out slightly from the wall. An entrance with a small wood deck is located at the basement level of the west elevation. Each story of the south bay has a pair of windows. A non-historic wood stair covers most of the center of the east elevation. The center bay projects out around the stair. A pair of windows fill each story of the flanking bays. A single square window fills the east and west basement-level openings.

*Integrity:* The building at 227-229 East 46<sup>th</sup> Street has seen few alterations of note and retains integrity. Although some windows on the secondary east and west elevations have been filled, the primary north elevation openings are intact. It is not known when the stucco cladding was added. The stucco is noted on the 1950-1951 Sanborn Fire Insurance map, which is the earliest available map that shows the building. If it is not a historic condition, the stucco is not easily visible from the primary north elevation and does not detract from the building's overall appearance. The building at 227-229 East 46<sup>th</sup> Street retains its historic residential use.

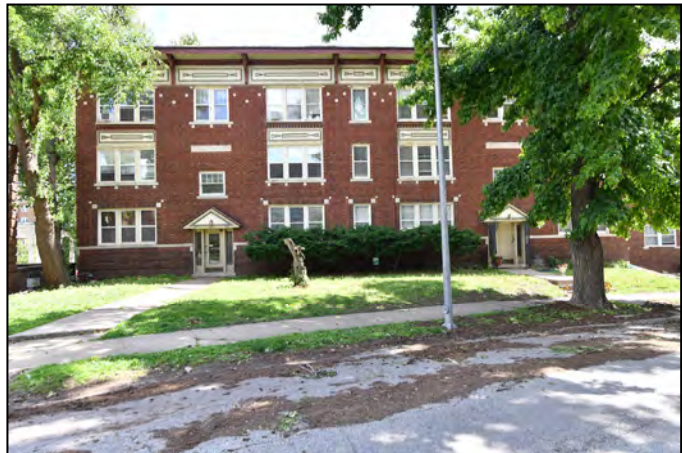
Photo 22, Figure 15

The three-story Rockhurst Apartments has a rectangular footprint, a stone foundation, brick cladding, and a flat roof.<sup>19</sup> It is located near the northeast corner of the District, near the Sophian Plaza Garage (Resource 25). Given the slope of the land, more of the basement level stone is visible moving north to south along the east and west elevations; the full stone foundation is visible along the south elevation. Two concrete walkways lead from the sidewalk to entrances in bays 2 and 6, looking east to west. A concrete driveway leads from the street along the west elevation to the East Parking Lot (Resource 27). A four-car carport abuts the west half of the south basement level. The carport has painted brick walls and a flat roof with brick walls between each stall. A wood-framed stair accesses the top of the carport and leads to a larger stair in the corresponding bay (discussed below). All windows appear to be non-historic 1/1 aluminum or vinyl replacements within the historic openings, unless otherwise noted. Basement-level openings along the east, south, and west elevations have a wood-framed four-light hopper window that opens inwards. A wide overhanging eave with brackets lines the primary north elevation and wraps around for one bay along the east and west elevations. Decorative panels fill the entablature between each bracket, which generally correspond to the bays below. A narrow stone belt course lines the first story windowsills along the north, east, and west elevations. A

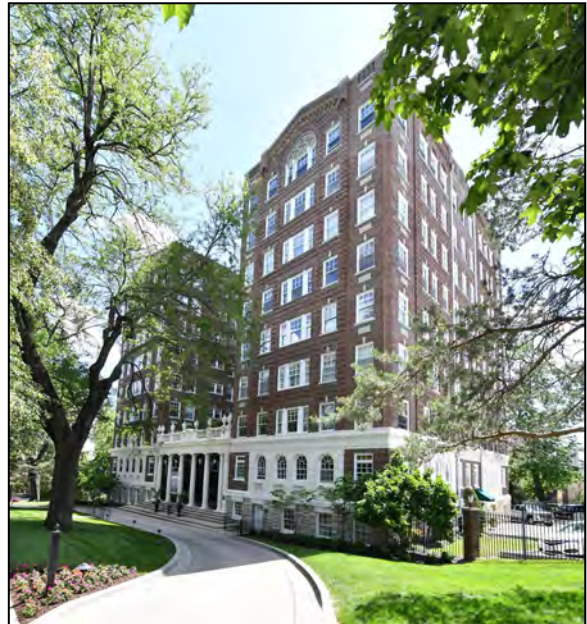
**4618 Warwick Boulevard**

The Sophian Plaza is located on a large irregularly shaped parcel at the intersection of Warwick Boulevard and Emanuel Cleaver II Boulevard, in the northeast corner of the District. The eight-story building has a raised basement level, steel structural system, brick cladding, Beaux Arts terra cotta detailing, a flat roof, and an H-shaped footprint. The building sits near the southeast end of the parcel, which generally slopes to the south and west. A wide semicircular concrete drive along Warwick Boulevard leads to the primary east elevation. Grassy lawns generally line the east, south, and west sides of the building. The area to the north contains an associated parking lot and garage (same parcel, Resource 25 and Resource 26, discussed below). A narrow concrete walk lines the south and west edges of the building; a second walk connects the driveway to the parking lot to the north. The associated lawn and sidewalks are not counted separately due to their size. Most windows are non-historic 6/1 or 6/6 aluminum units that are installed within the historic openings. A corbeled brick parapet lines the building. A monumental concrete staircase spans three bays along the center of the primary east elevation. The stair leads

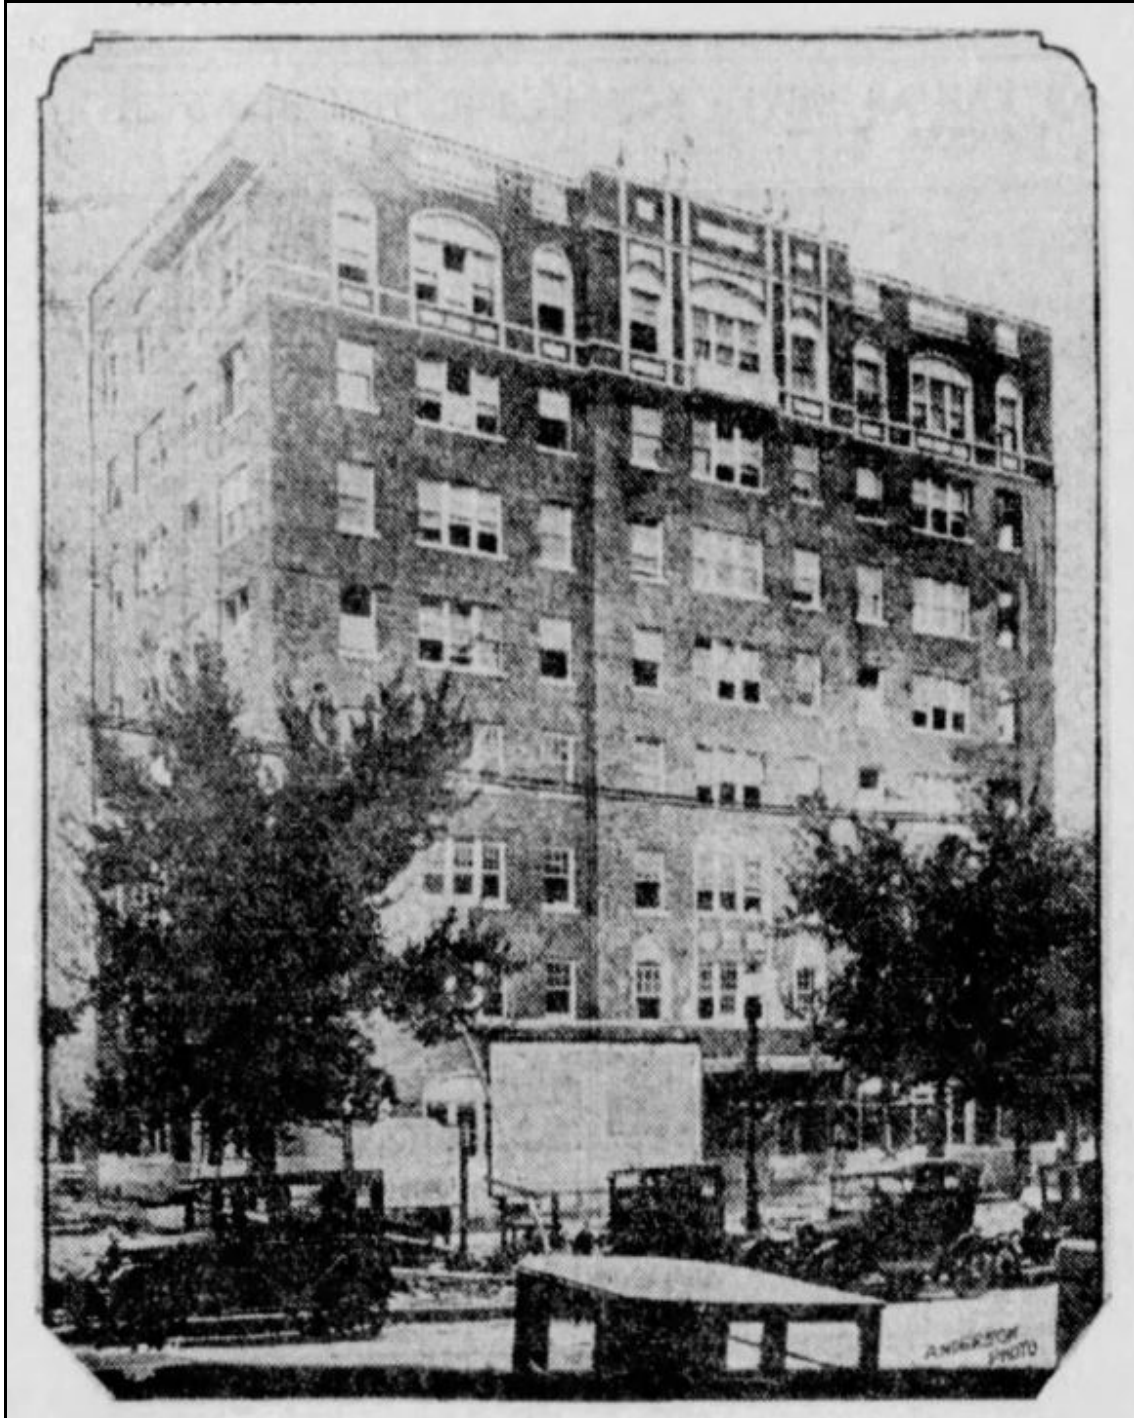
**Figure 5:** Photograph of the Melbourne Apartments (Resource 4) taken shortly after completion ("The Melbourne Hotel Passes to a New Owner, Although it is a Month Short of Completion, *The Kansas City Star*, August 21, 1927, 58, newspapers.com (accessed September 2023)).

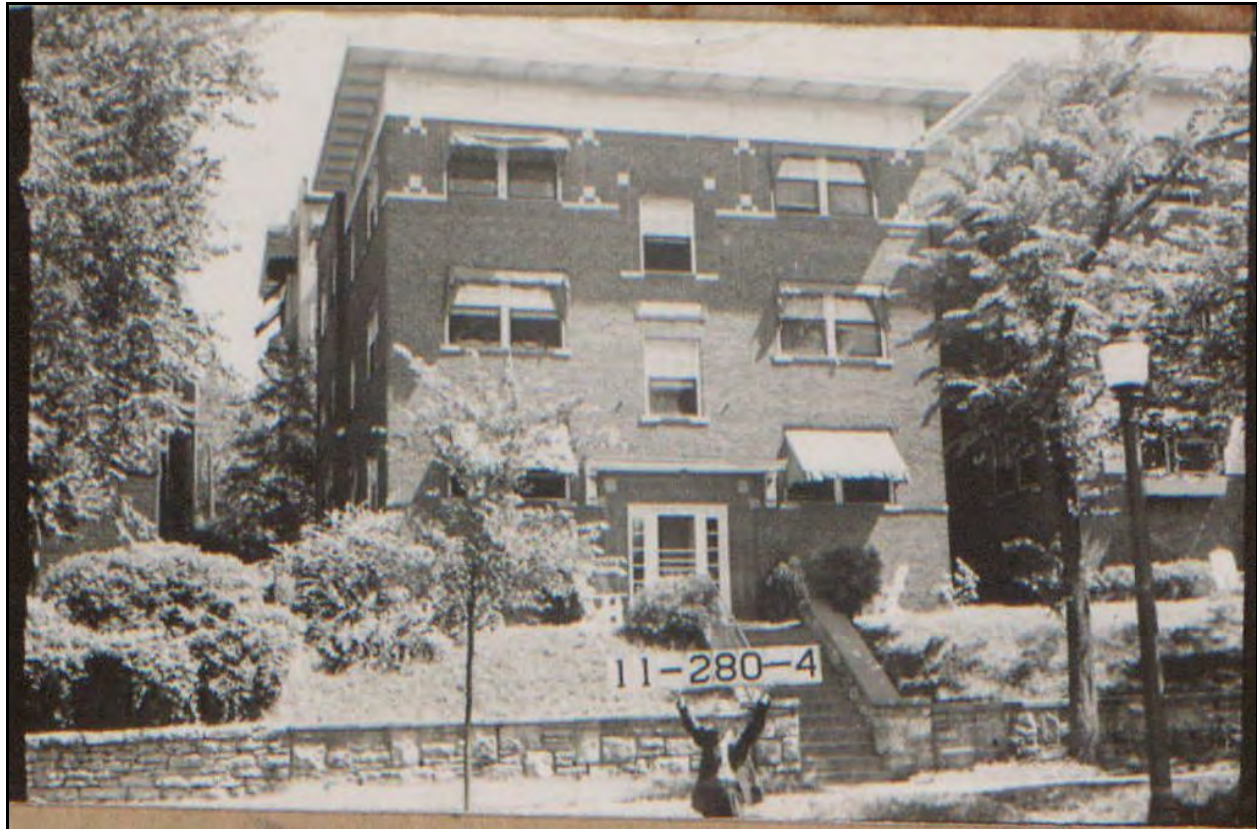
**Figure 8:** Building at 222-224 Emanuel Cleaver II boulevard (Resource 13) 1940 tax assessment photograph (Kansas City 1940 Tax Assessment Photographs, Lot 11, Block 280, Parcel 4, Missouri Valley Special Collections, Kansas City Public Library, Kansas City, Missouri, <https://cdm16795.contentdm.oclc.org/digital/collection/kcpltax> (accessed July 2024).

Painted stucco clads the north half of the east elevation. A pair of windows pierce each story of the north bay. Two openings pierce each story of the brick clad south half. A slight stucco bump-out in the center of the wall contains a narrow rectangular opening at each story. The stone foundation is exposed along the west elevation. Window openings pierce all stories and divide the elevation into four bays. The outside bays each contain a pair of windows. Bay 3, looking north to south, has a single window. Bay 2 has a shorter opening that sits up higher on the wall. The center bay of the rear north elevation is deeply recessed into the wall. A wood-framed switchback stair accesses all stories along the bay. Each story generally contains an aluminum-framed door and a window opening. The flanking bays do not have any openings.

*Integrity:* The building at 222-224 Emanuel Cleaver II Boulevard has seen few alterations of note and retains integrity. The primary north elevation openings are intact. It is not known when the stucco cladding was added or if it is a historic condition. The stucco is noted on the 1950-1951 Sanborn Fire Insurance map (*Figure 9*), which indicates that it is a historic material. The building permit describes the building simply as having “brick & stone” construction. The Sanborn also depicts a different north elevation configuration, with two short bump-outs to the north instead of the current deeply recessed center bay. Despite this, the north elevation and stucco is not easily visible from the primary south elevation and does not detract from the building’s overall appearance.

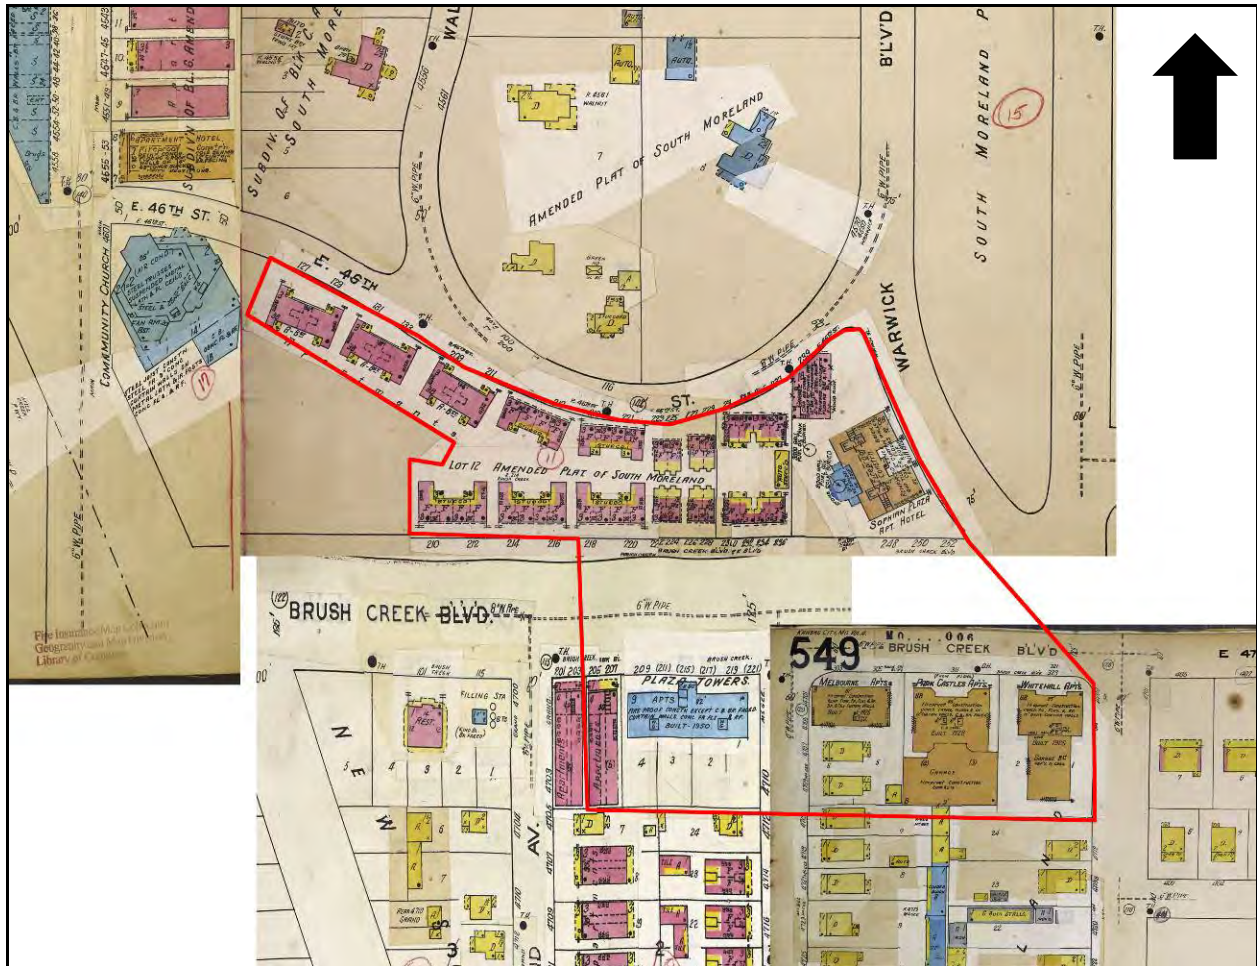
**Figure 9:** 1950-1951 Sanborn Fire Insurance Map, combined to show approximate District boundaries (outlined in red). Map not to scale (Sanborn Map Company. "Insurance Maps of Kansas City, Missouri." New York: The Sanborn Map Company, 1950-1951, sheets 549, 573, and 574).

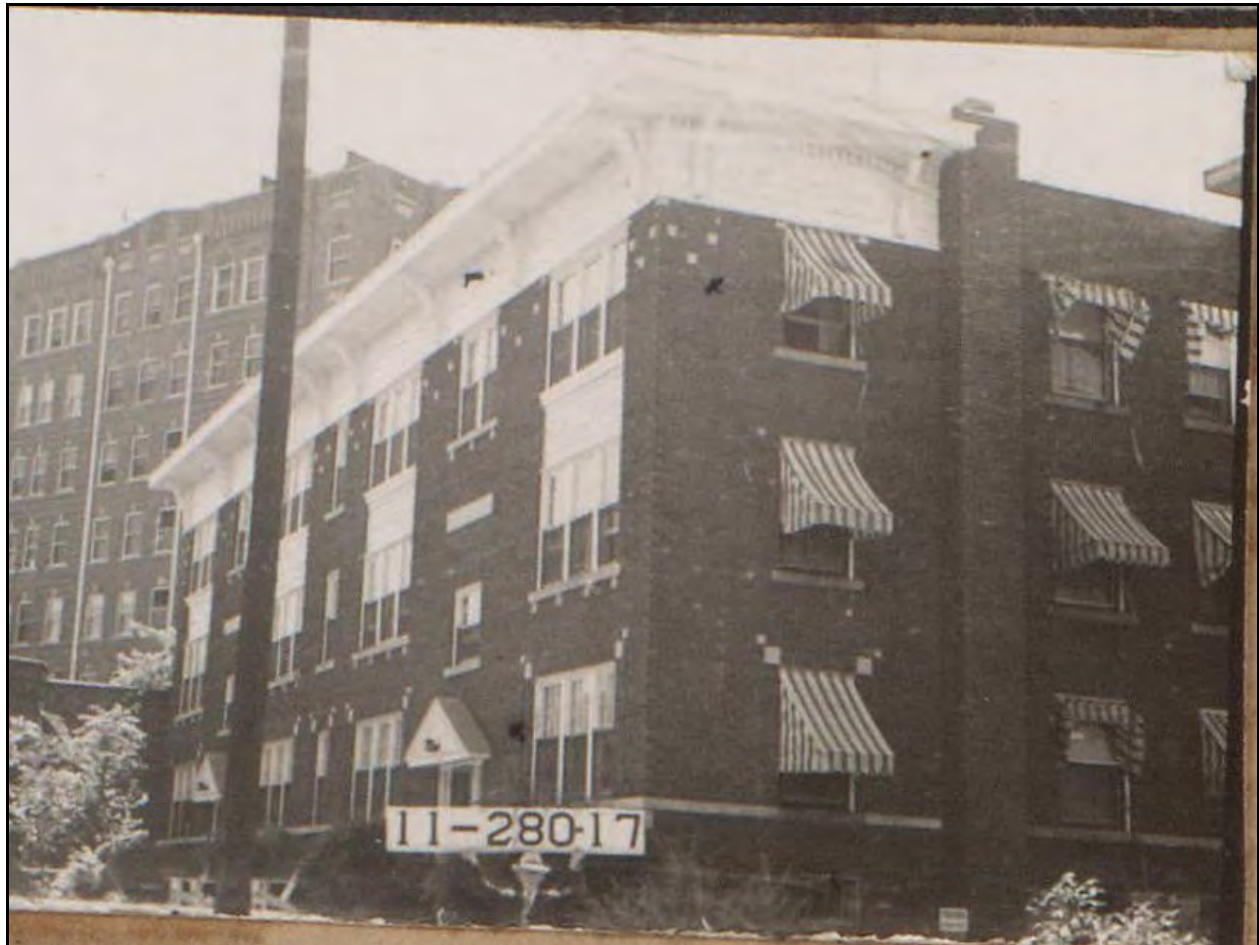
**Figure 15:** Rockhurst Apartment (Resource 23) 1940 tax assessment photograph. The north (rear) elevation of Sophian Plaza is visible in the background, left (Kansas City 1940 Tax Assessment Photographs, Lot 11 Block 280, Parcel 17, Missouri Valley Special Collections, Kansas City Public Library, Kansas City, Missouri, <https://cdm16795.contentdm.oclc.org/digital/collection/kcpltax> (accessed July 2024).
