# **DEBRIS FLOWS FROM TRIBUTARIES OF THE COLORADO RIVER, GRAND CANYON NATIONAL PARK, ARIZONA**

U.S. GEOLOGICAL SURVEY

Open-File Report 87-118

Prepared in cooperation with the  
U.S. BUREAU OF RECLAMATION

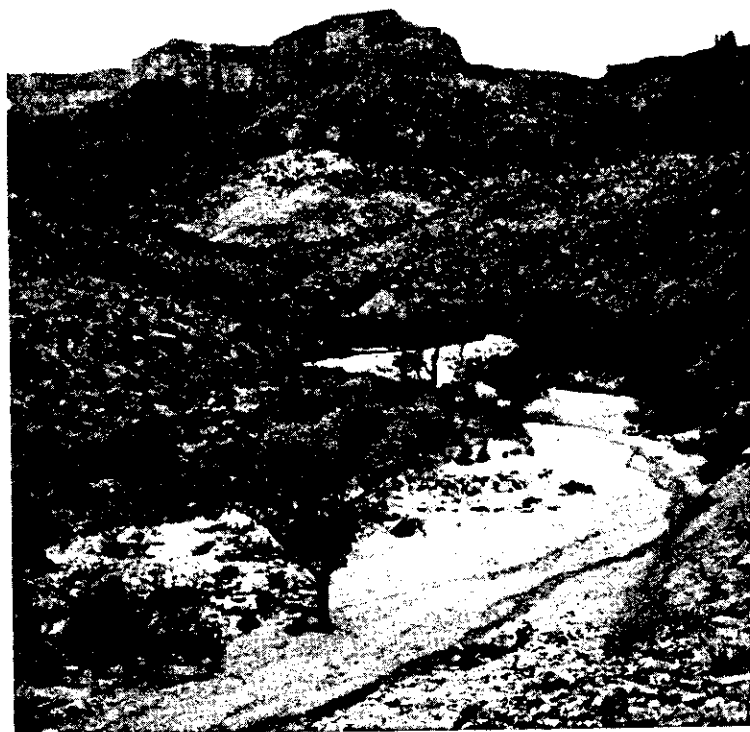
Figure 3.--Lava Creek at the confluence with Chuar Creek, 3.8 miles upstream from the Colorado River. View B is slightly different from A and shows significant channel alteration following the 1966 debris flow. View C matches B and shows revegetation and entrenchment of the channel after the 1966 and subsequent debris flows.

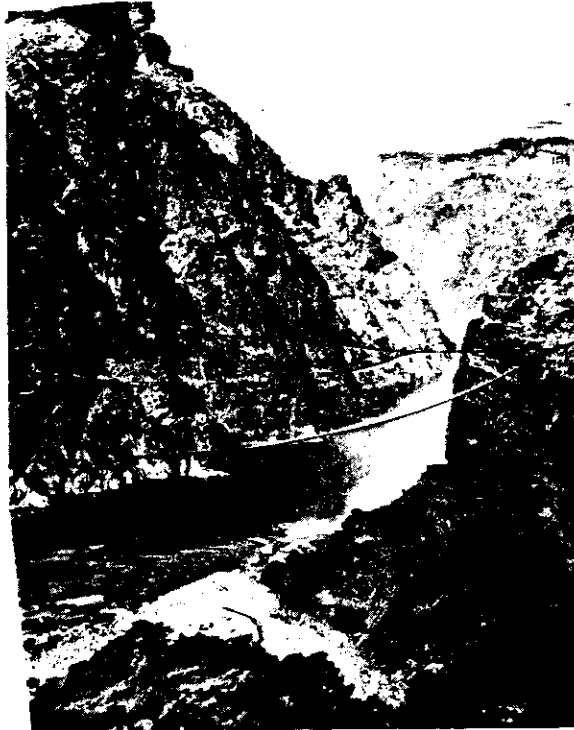
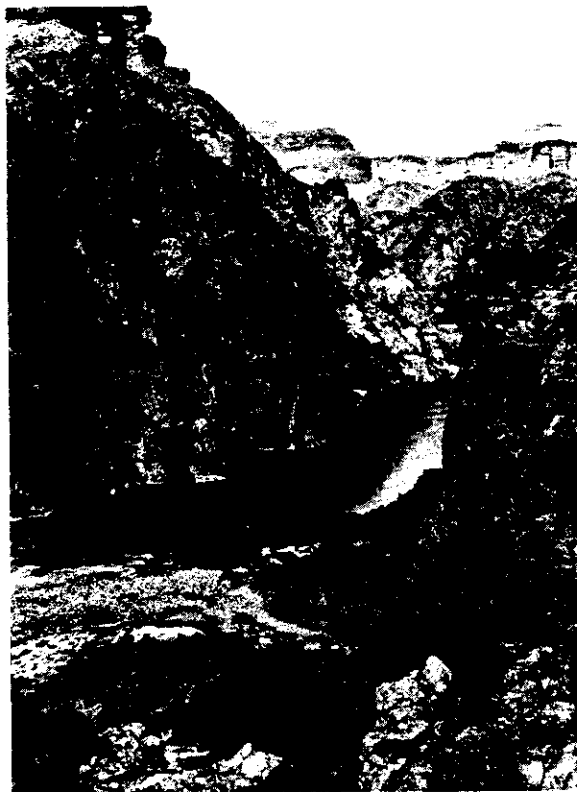
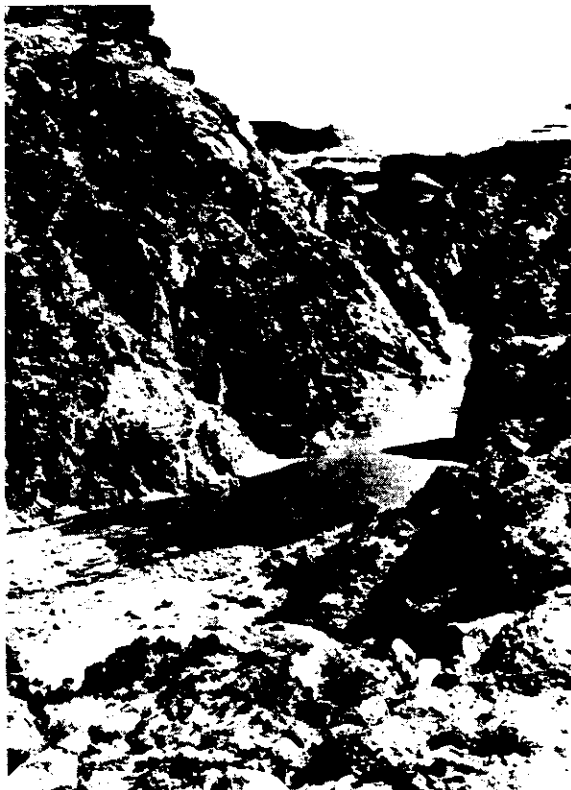
Figure 8.--The mouth of Monument Creek. In view A, the discharge in the Colorado River apparently is between 20,000 and 25,000 cubic feet per second. Curved lines in the center of the photograph are cracks in the original glass-plate negatives. In view B, the discharge in the Colorado River is about 8,000 cubic feet per second. The river appears to be more constricted than in 1872 despite differences in discharge, and a debris flow that occurred 2 to 7 years prior to the photograph date may have contributed to the constriction. In view C, the discharge in the Colorado River is 28,500 cubic feet per second. The 1984 debris flow has constricted the river significantly, especially in comparison with 1872 conditions.

Photographs B and C are reversed. Photograph on left was taken April 1986; photograph on right was taken September 1968.

Near the Colorado River, the deposits in the center of the channel abruptly change to well-sorted and imbricated boulder bars (fig. 8C) superficially resembling sieve deposits (Hooke, 1967). The debris flow at this point was confined and deposition occurred to an average depth of 5 ft. At locally unconfined sites, the critical thickness of the debris flow was 3 ft. The particle-size distribution (fig. 10D) shows a well-sorted cobble deposit with a median diameter of 32 mm, although poorly sorted matrix was found on the channel margin. We speculate that either recessional or post-event streamflow, dewatering of the deposit after deposition, or positive pore pressures from springs in the channel bed caused the nearly complete removal of the debris-flow matrix from the boulders and its subsequent transport into the Colorado River.

The new debris fan at the Colorado River (fig. 8) was surveyed to estimate the volume of material deposited during the debris flow of 1984. The debris flow entered and partially dammed the Colorado River (Mike Yard, boatman, Humphry's Summit Adventures, Flagstaff, Arizona, oral commun., 1986), which had a mean discharge of about 24,000 ft<sup>3</sup>/s on July 25. Observers noted that the newly formed fan contained significant amounts of matrix immediately after the debris flow, but that the mud was quickly eroded from the fan. Higher discharges on the Colorado River in

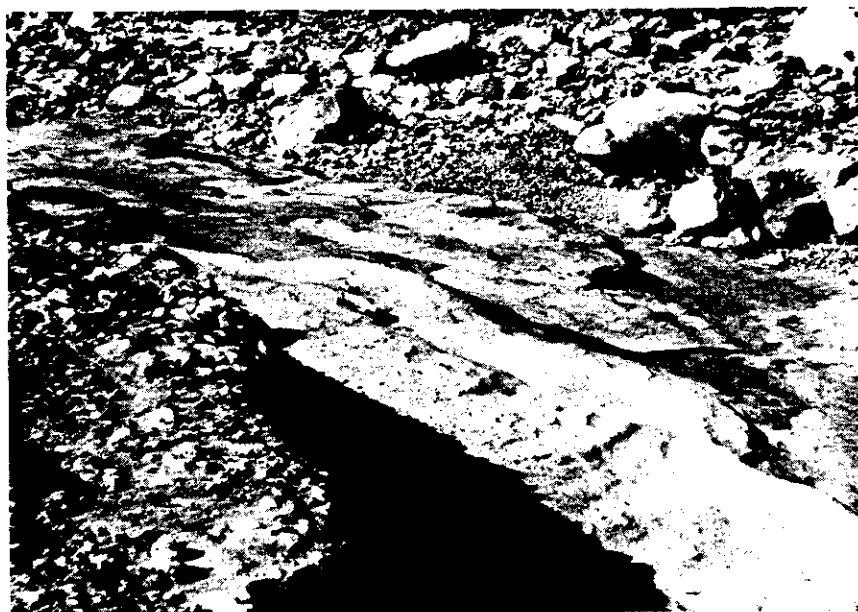
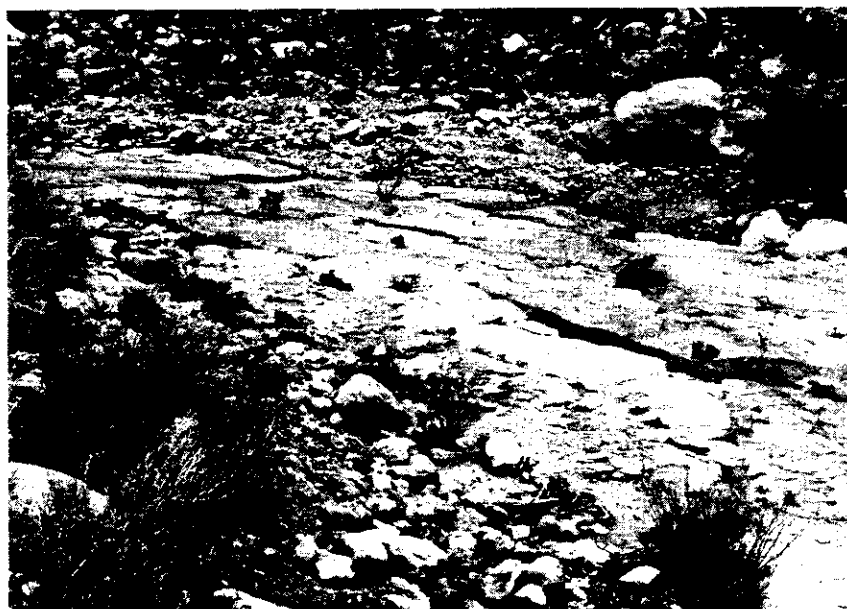
Figure 15.--Dragon Creek, 6.2 miles upstream from the Colorado River. The piece of driftwood at the left center of view B is not the same piece as in view A. Note in view B that the large rocks at the upper left and right have been moved downstream and the bank has collapsed in the foreground. Flow in the channel moves right to left.
