**Water Quality Monitoring Program 1998-2000**  
**New River Gorge National River**  
**Bluestone National Scenic River**  
**Gauley River National Recreation Area**

March 2003

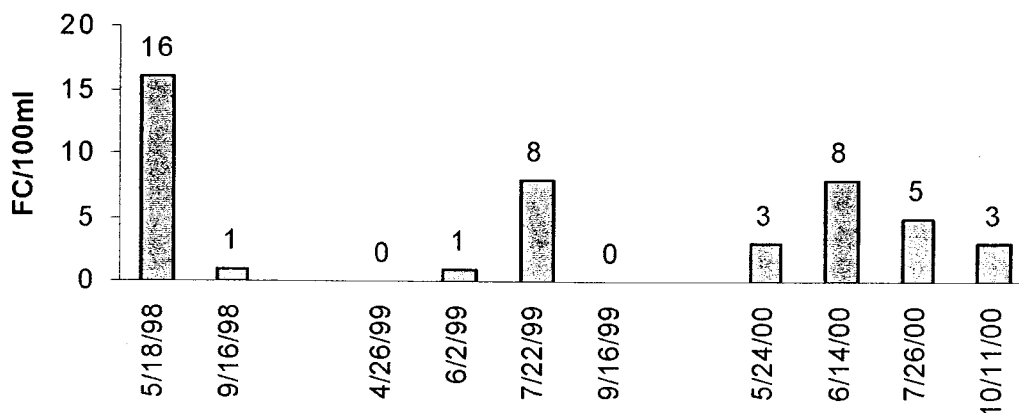
**Figure 33. Summersville Dam**

Bacteria densities for all samples were well below the fecal coliform standard. The highest bacteria density (16 FC/100 ml on 5/18/98) coincided with moderate turbidity (3.5 NTU), nil 48-hour precipitation (0.00 in), and discharge (705 cfs) within the normal range for the season.
