# DRINKING WATER SOURCE PROTECTION PLAN

## Arches National Park Headquarters Well No. 3

August 2001

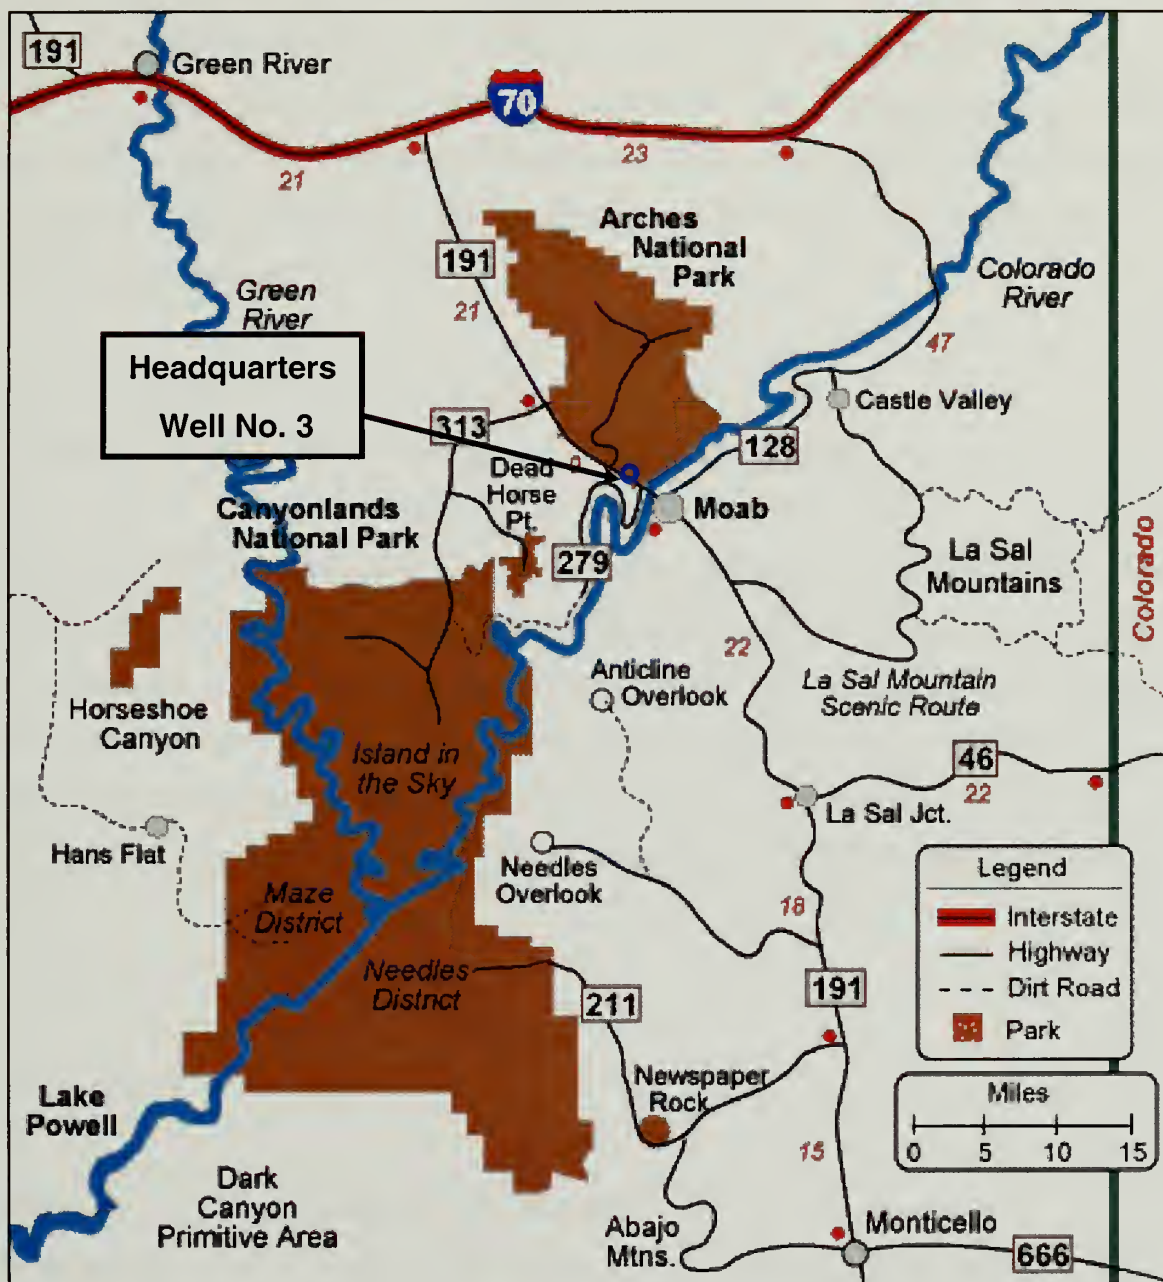
Figure 1. General Location Map

The Headquarters Area of Arches National Park is about 4 miles north of Moab, Utah. The Headquarters Area is the main park entrance and includes a visitor center, maintenance yard, employee housing, and offices. The general location is shown on the map in Figure 1.

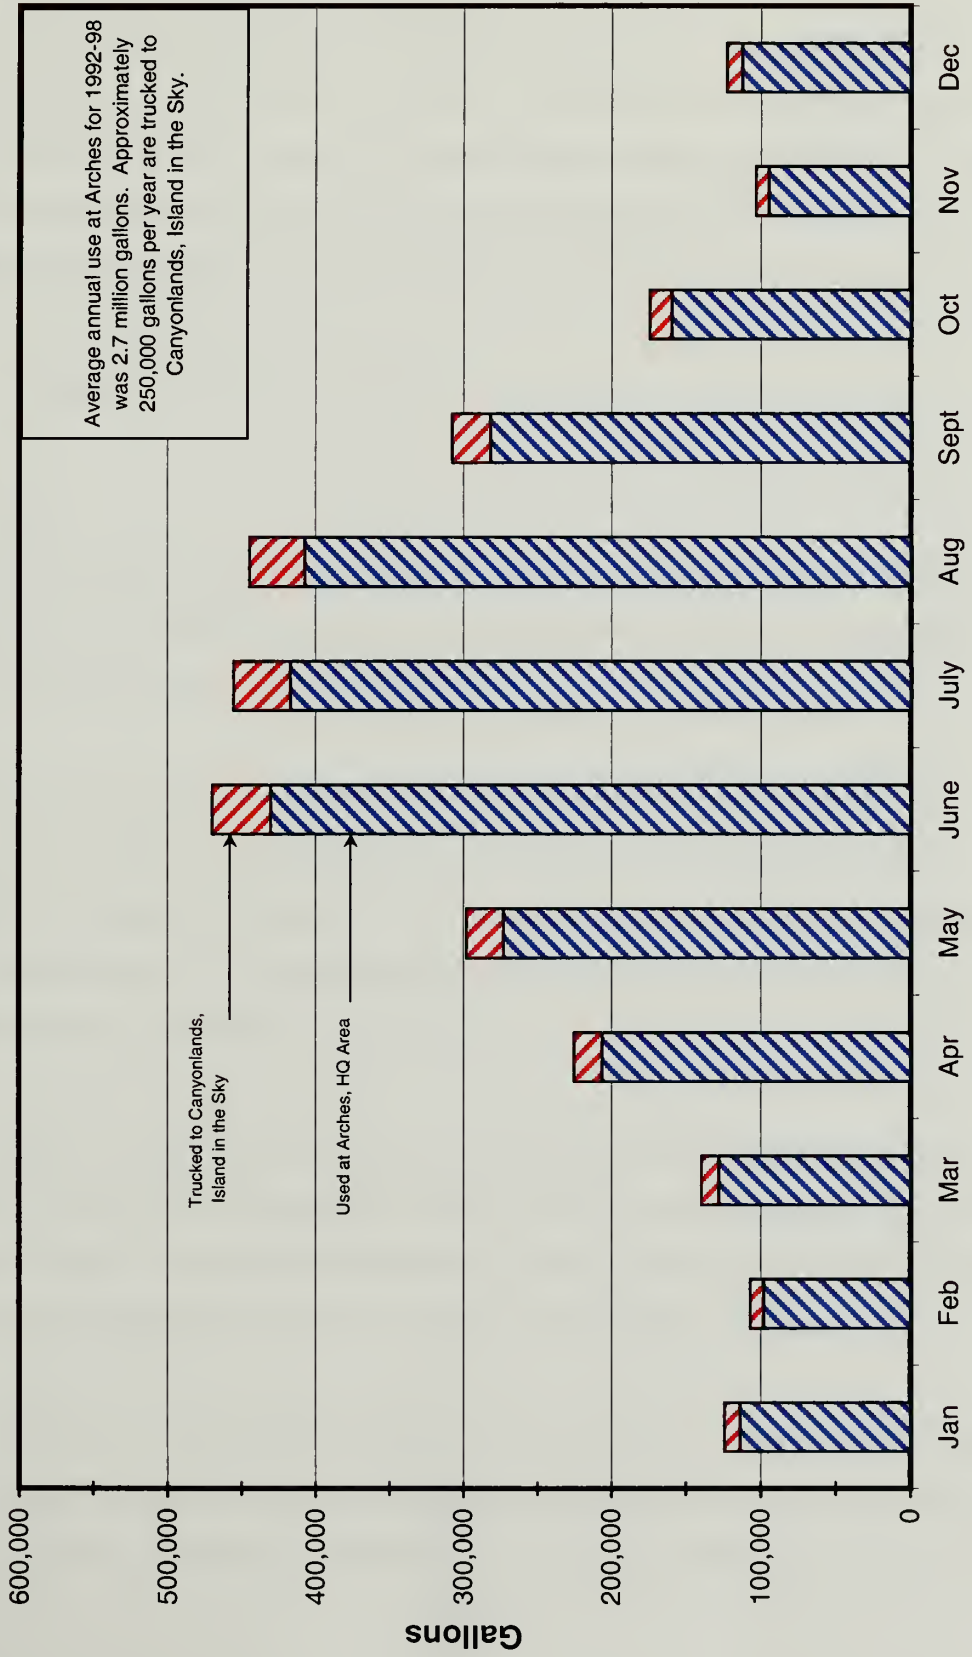
Figure 2. Average monthly water use.

Water is used primarily for drinking and restroom facilities by park visitors and staff at the visitor center, maintenance area, park offices, and the housing area. Some water is used for irrigation of landscaped areas. Approximately 250,000 gallons per year are trucked to the Island in the Sky area of Canyonlands National Park. Water use generally ranges from about 100,000 gallons per month in the off-season to about 450,000 gallons per month in the summer. Average monthly water use is shown in Figure 2.

# Average Monthly Water Use from Headquarters Well, Arches National Park, 1992-98

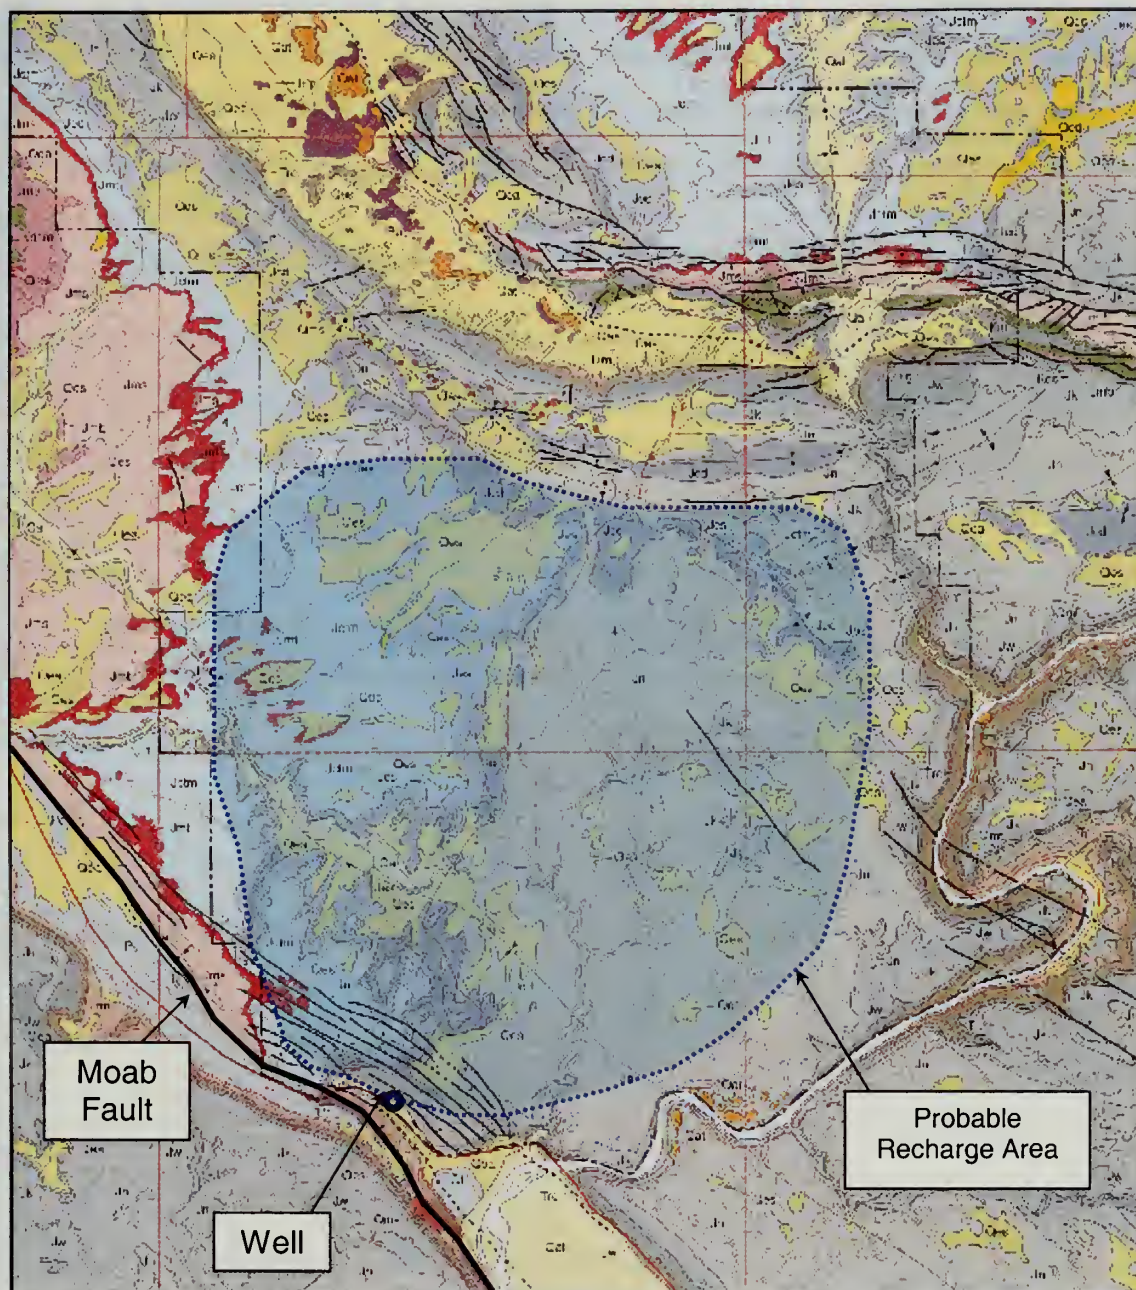
Figure 3. Geologic map of Southern Part of Arches National Park showing probable recharge area for Headquarters Well No. 3

Most of the recharge and groundwater flow contributing water to Well No.3 probably occurs in the area of the park northeast of the Headquarters Area, between Moab Wash and Salt Valley. Navajo Sandstone and younger formations outcrop in most of

the area between Salt Valley and Moab Wash. Infiltration of precipitation in this area is likely the source of groundwater pumped from Well No. 3. The area of probable groundwater recharge is shown on Figure 3.

Geologic map from Doelling (2000)  
 Geology of Utah's Parks and Monuments  
 Utah Geological Association Publication 28

The Moab Fault trends NW-SE in this area forming the valley of Moab Wash. Numerous small faults are mapped in the Headquarters Area (Doelling, 1985) approximately parallel to the Moab Fault. These faults, and associated secondary fractures, probably act as a collection system for groundwater in the Navajo Sandstone, resulting in the large production from Well No. 3.

Older rocks have been uplifted southwest of the Moab Fault. These formations probably form a relatively impermeable barrier to ground water flow from the northeast in the Navajo Aquifer. The older formations southwest of the Moab Fault probably do not contribute groundwater to Well No. 3 in the Headquarters Area.

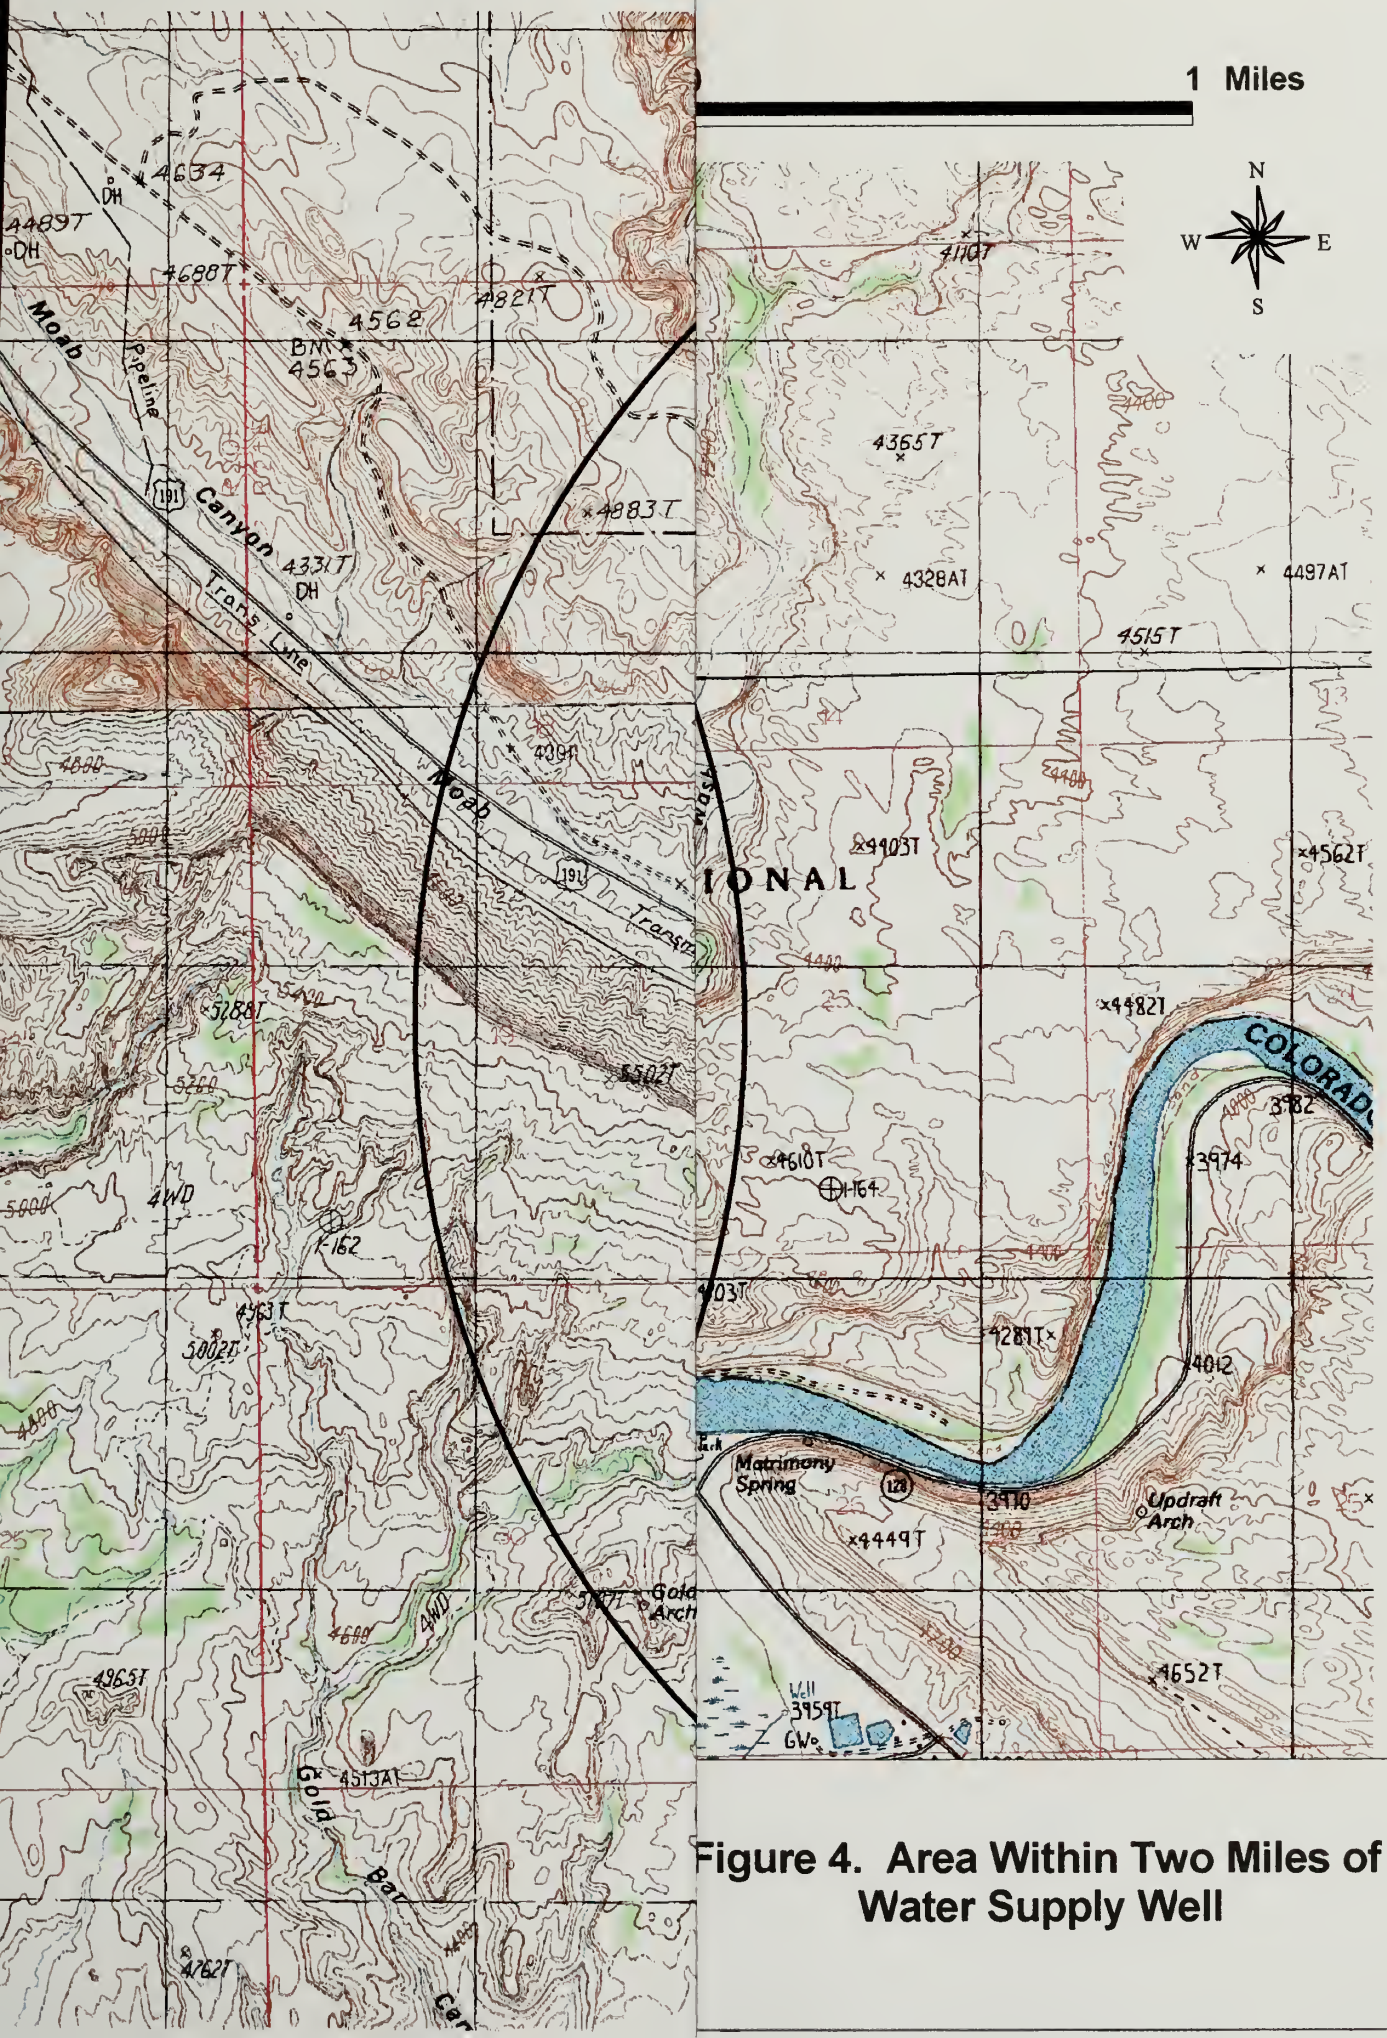
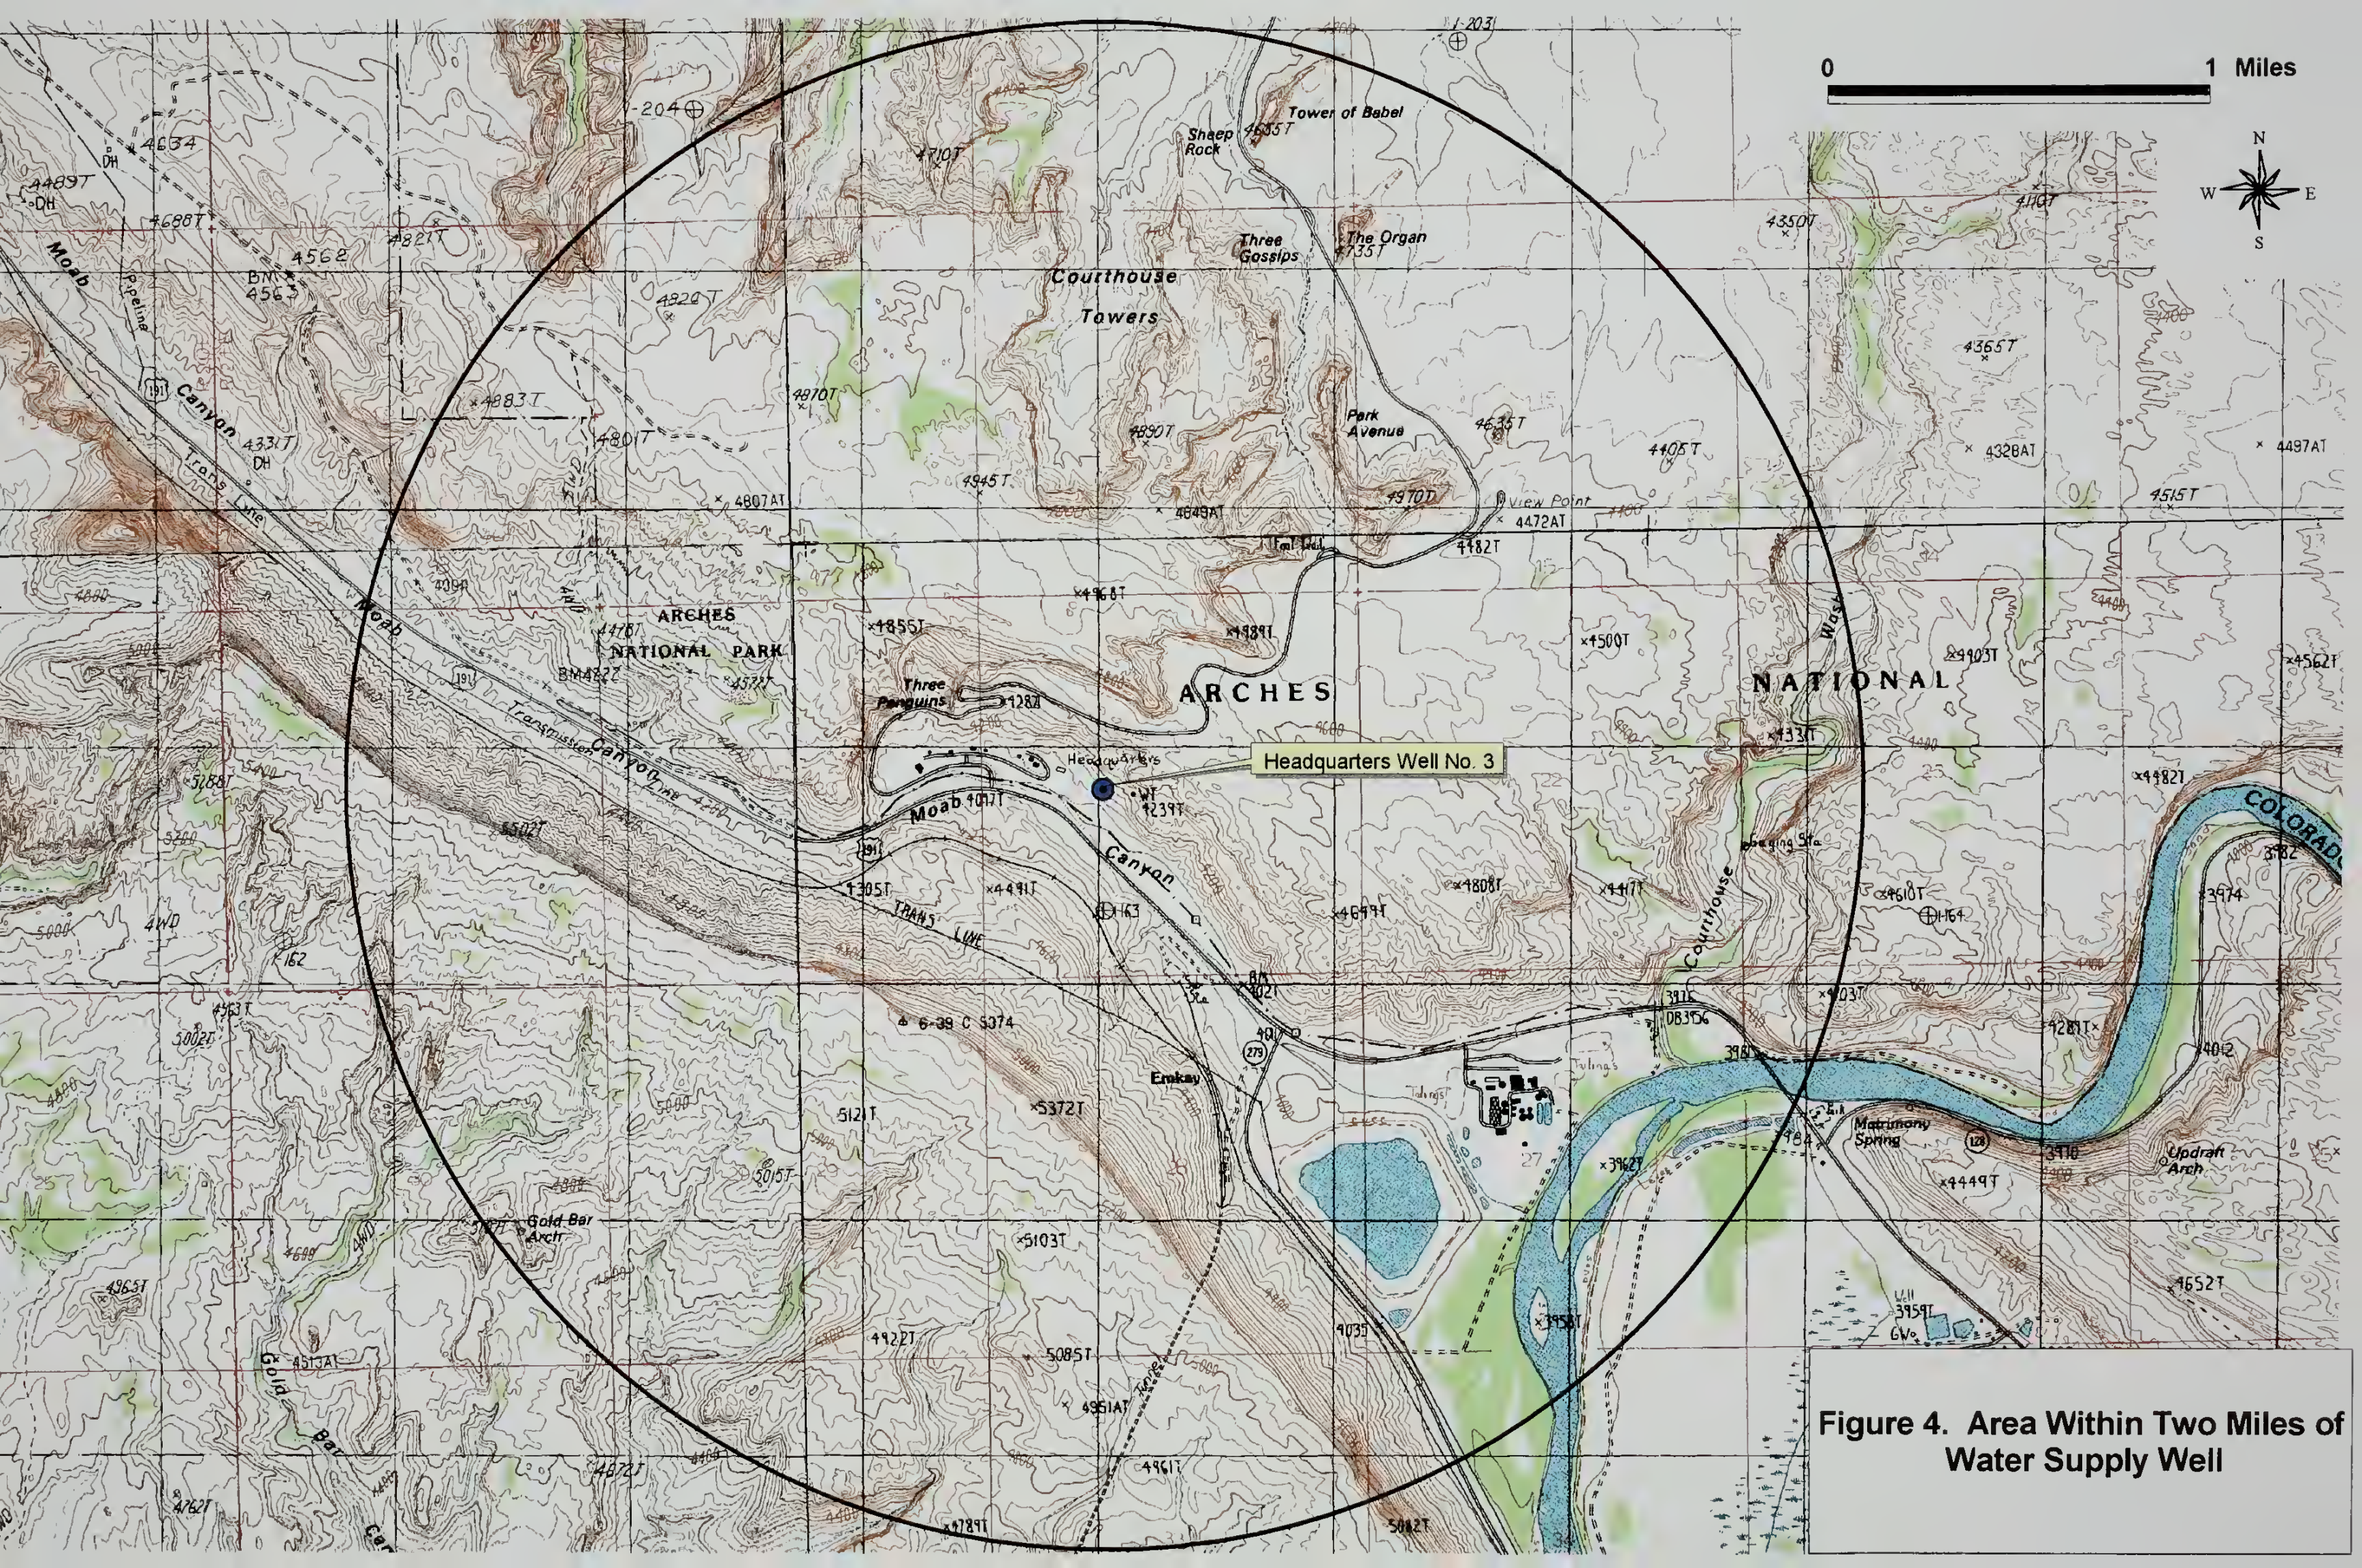
Figure 4. Area Within Two Miles of Water Supply Well

Figure 4 is a map showing the area within two miles of the supply well.

We have insufficient data to make predictions for groundwater travel times to the Headquarters Area Well No.3. Therefore, the optional two-mile radius delineation will be used to delineate the wellhead protection area.

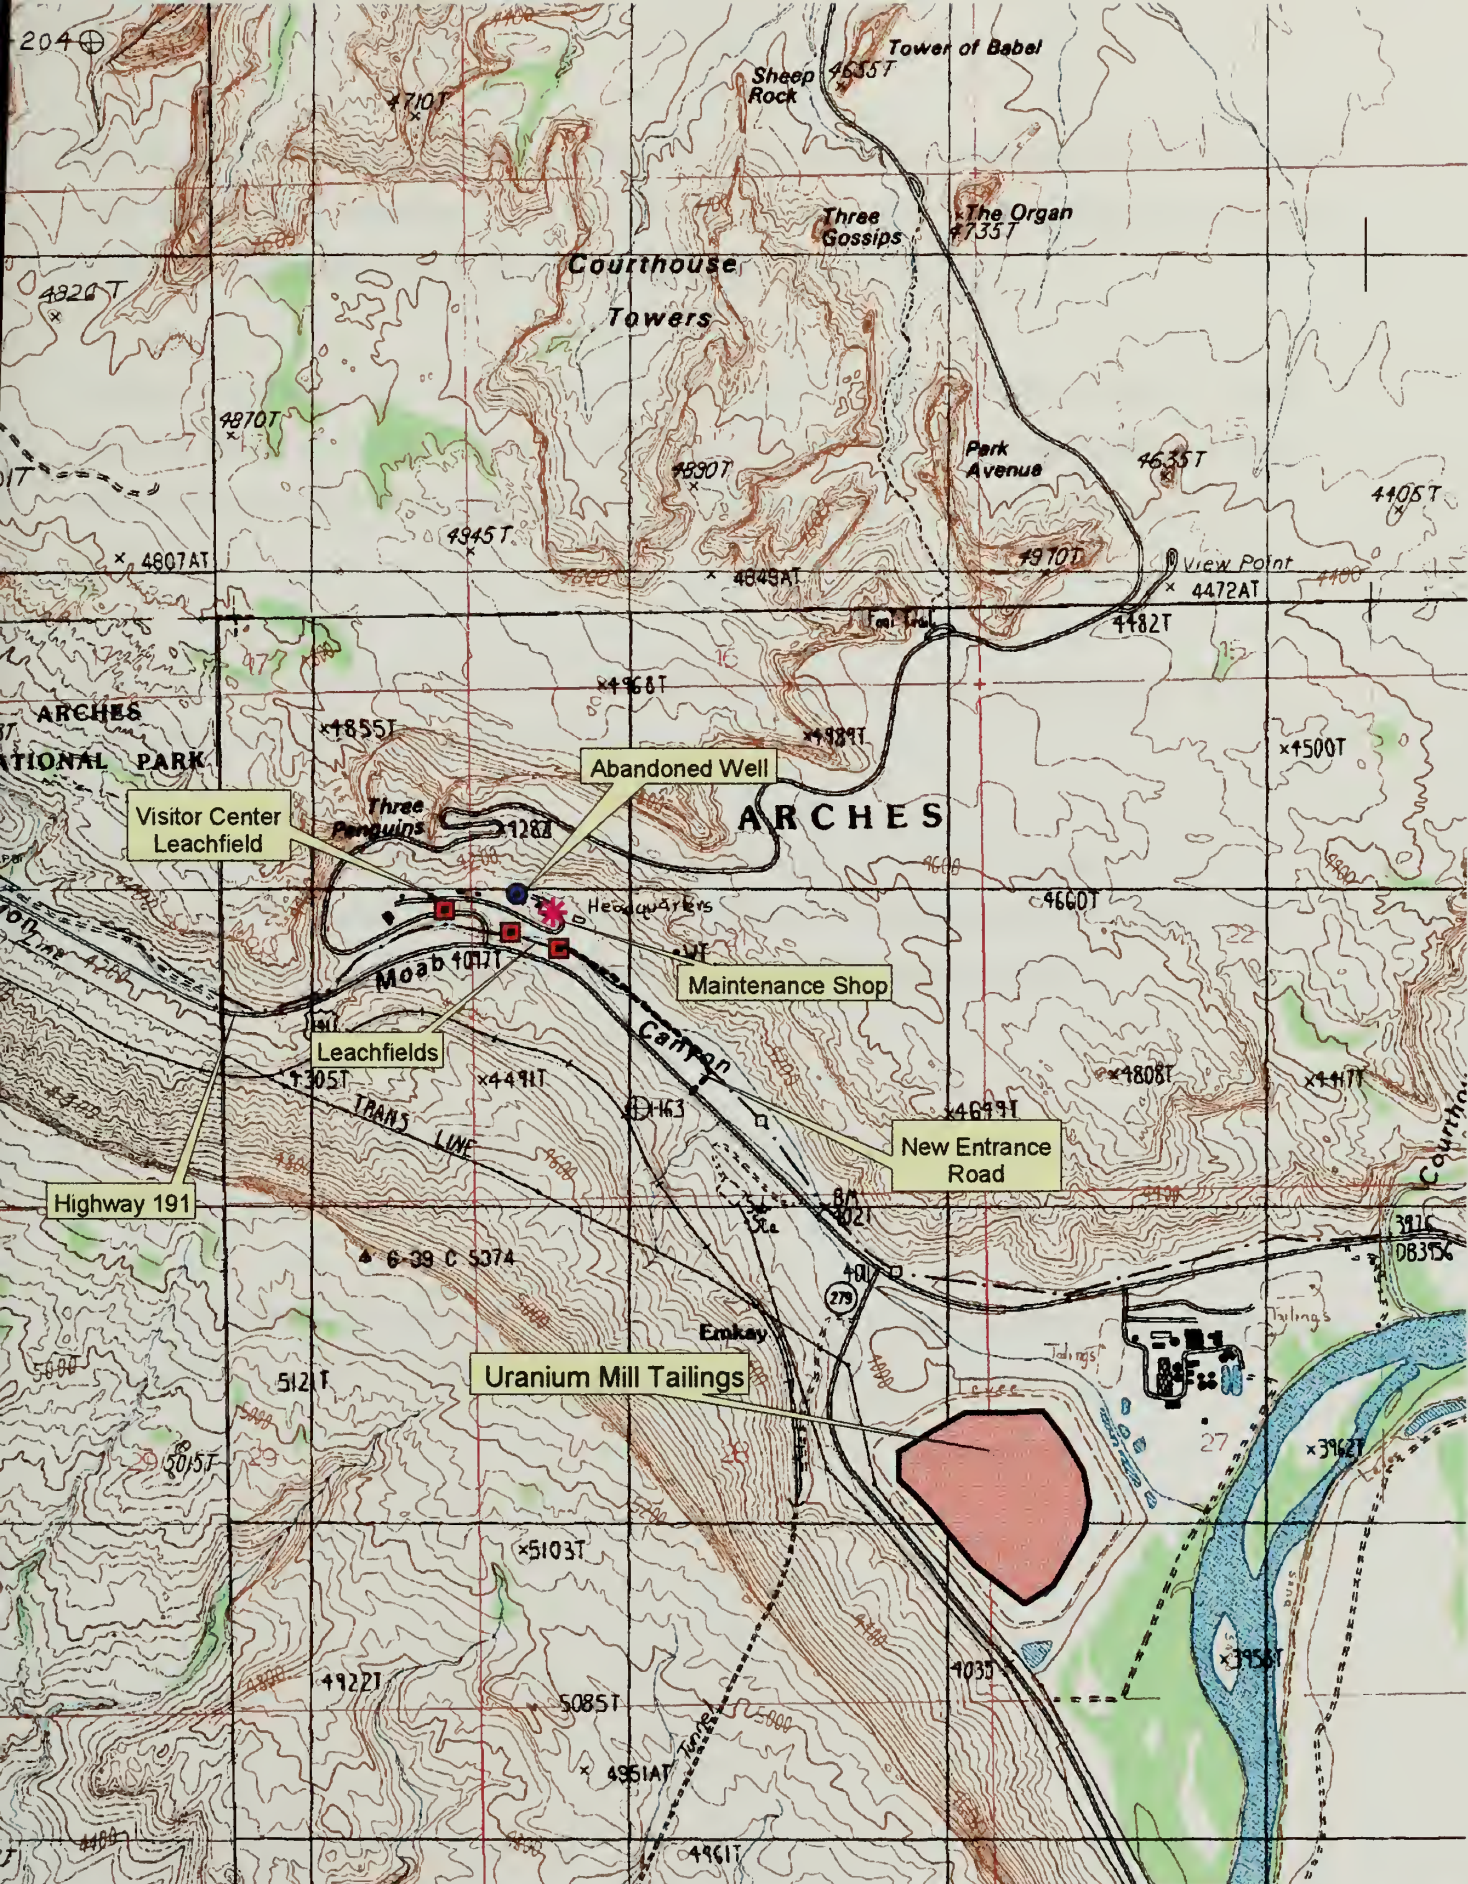
**Figure 5. Potential Contaminant Sources in the Headquarters Area**

Potential contamination sources are plotted on the map in Figure 5.

The uranium mill tailings pile is approximately 1 mile southeast from Well No. 3. Chemicals, paint, cleaners, solvents etc. in the maintenance area are stored in a building about 1000 feet northwest from the well. The septic leachfields are 1000-2000 feet northwest, upgradient, from the well. The abandoned well is about 2000 feet northwest from Well No. 3.

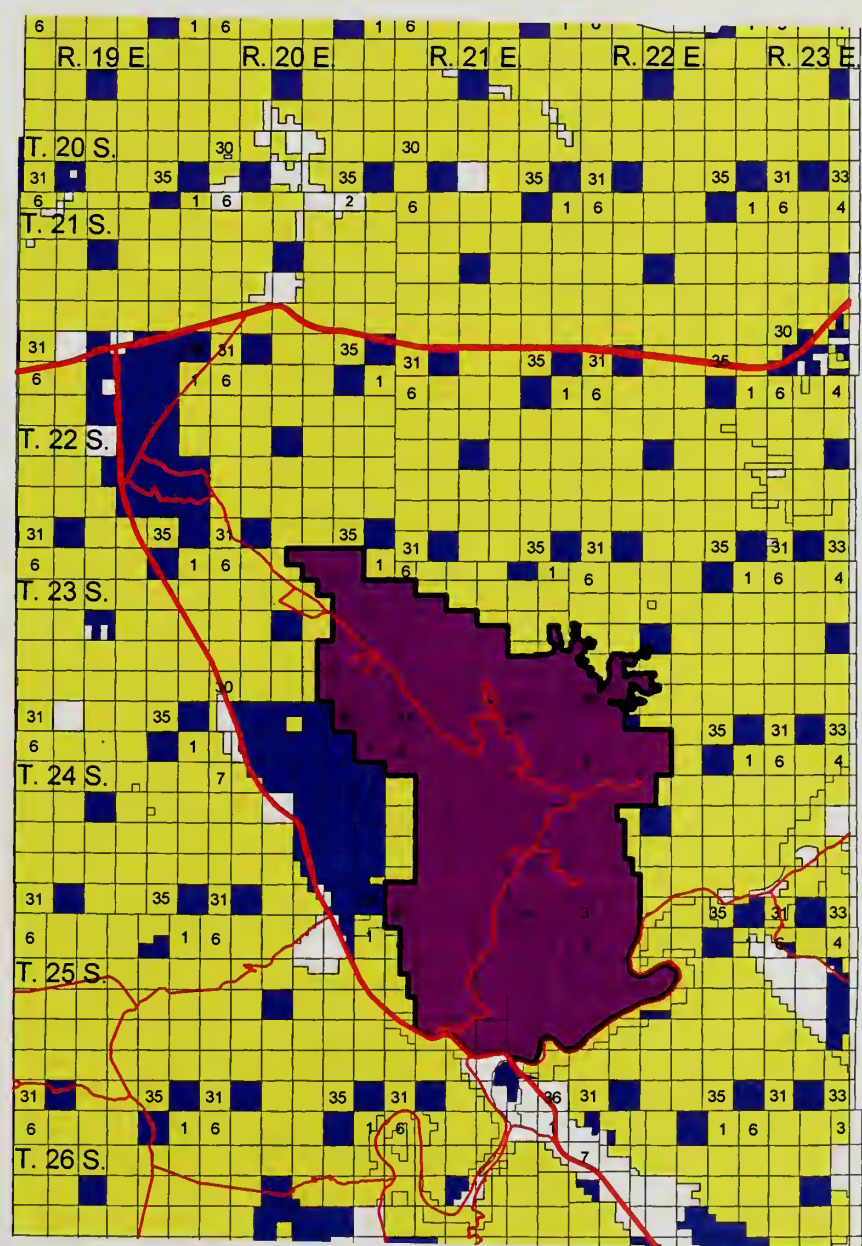
Figure 6. Arches National Park Property Ownership

All land for several miles to the north and east of the Headquarters Well No. 3 is owned and controlled by the National Park Service. Land to the west and southwest of the well is under the control of the U.S. Bureau of Land Management or the State of Utah. The only land available for private development is a narrow strip, about two miles wide, extending southeasterly starting about one mile southeast of the well. This strip comprises the Moab Valley. Only a small part of this private land lies north of the Colorado River. Land use activities south of the river will not affect water quality at the Headquarters well. The Colorado River is a regional groundwater discharge zone and acts as a hydrologic barrier to groundwater flow. Property ownership near Arches National Park is shown in Figure 6.

- ARCHES NATIONAL PARK
- BLM
- STATE
- PRIVATE

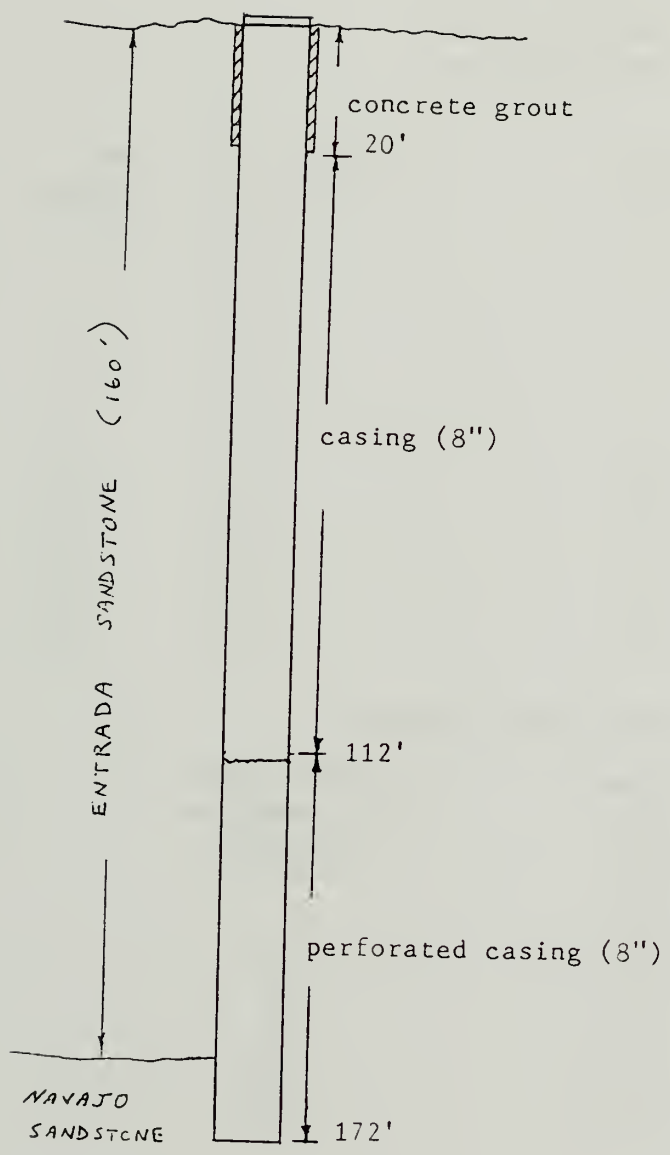
WELL SPECIFICATION (as built)

A copy of the well construction log is included in the Appendices of this report. The well was constructed in May 1978. It is 172 feet deep and was constructed entirely in the Navajo Formation. The well was completed with 8-inch casing through its entire depth. Casing in the lower 60 feet of the well was perforated with 16 cuts per foot, each perforation is 2" x ½". The well has a surface seal of 20 feet of concrete grout.

Well No. 3 is 172 feet deep with 8-inch casing. The casing is perforated from 112-172 feet. Static water level in the well is about 114 feet below ground surface. The well was test pumped at 30 gpm for 24 hours, resulting in 2 feet of drawdown. The specific capacity of the well was 15 gpm/ft of drawdown. A copy of the well log and drawdown and yield test data are included in the appendices of this report. The well, with its current pump, produces 11-12 gpm.

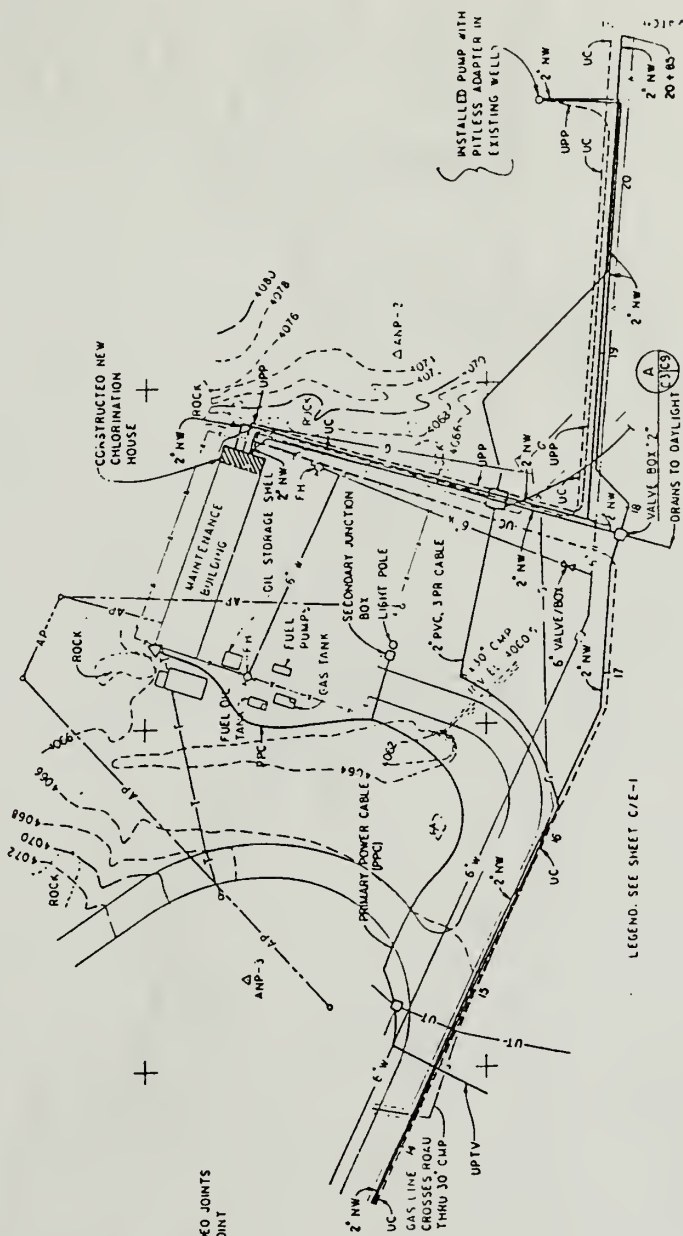
| DE-66-140<br>LIPPA<br>CROSS BOND<br>TECH SERVICE<br>WENDELTON<br>DATE 3/84 | SUB SHEET NO<br>C3. | TITLE OF SHEET<br>HEADQUARTERS<br>PUMP AND PITLESS ADAPTER | DRAWING NO<br>138<br>41,008C | PIC<br>102 | SHEET<br>5 | OF<br>19 |

NO SCALE  
NO PUMP IN EXISTING WELL  
NO SCALE

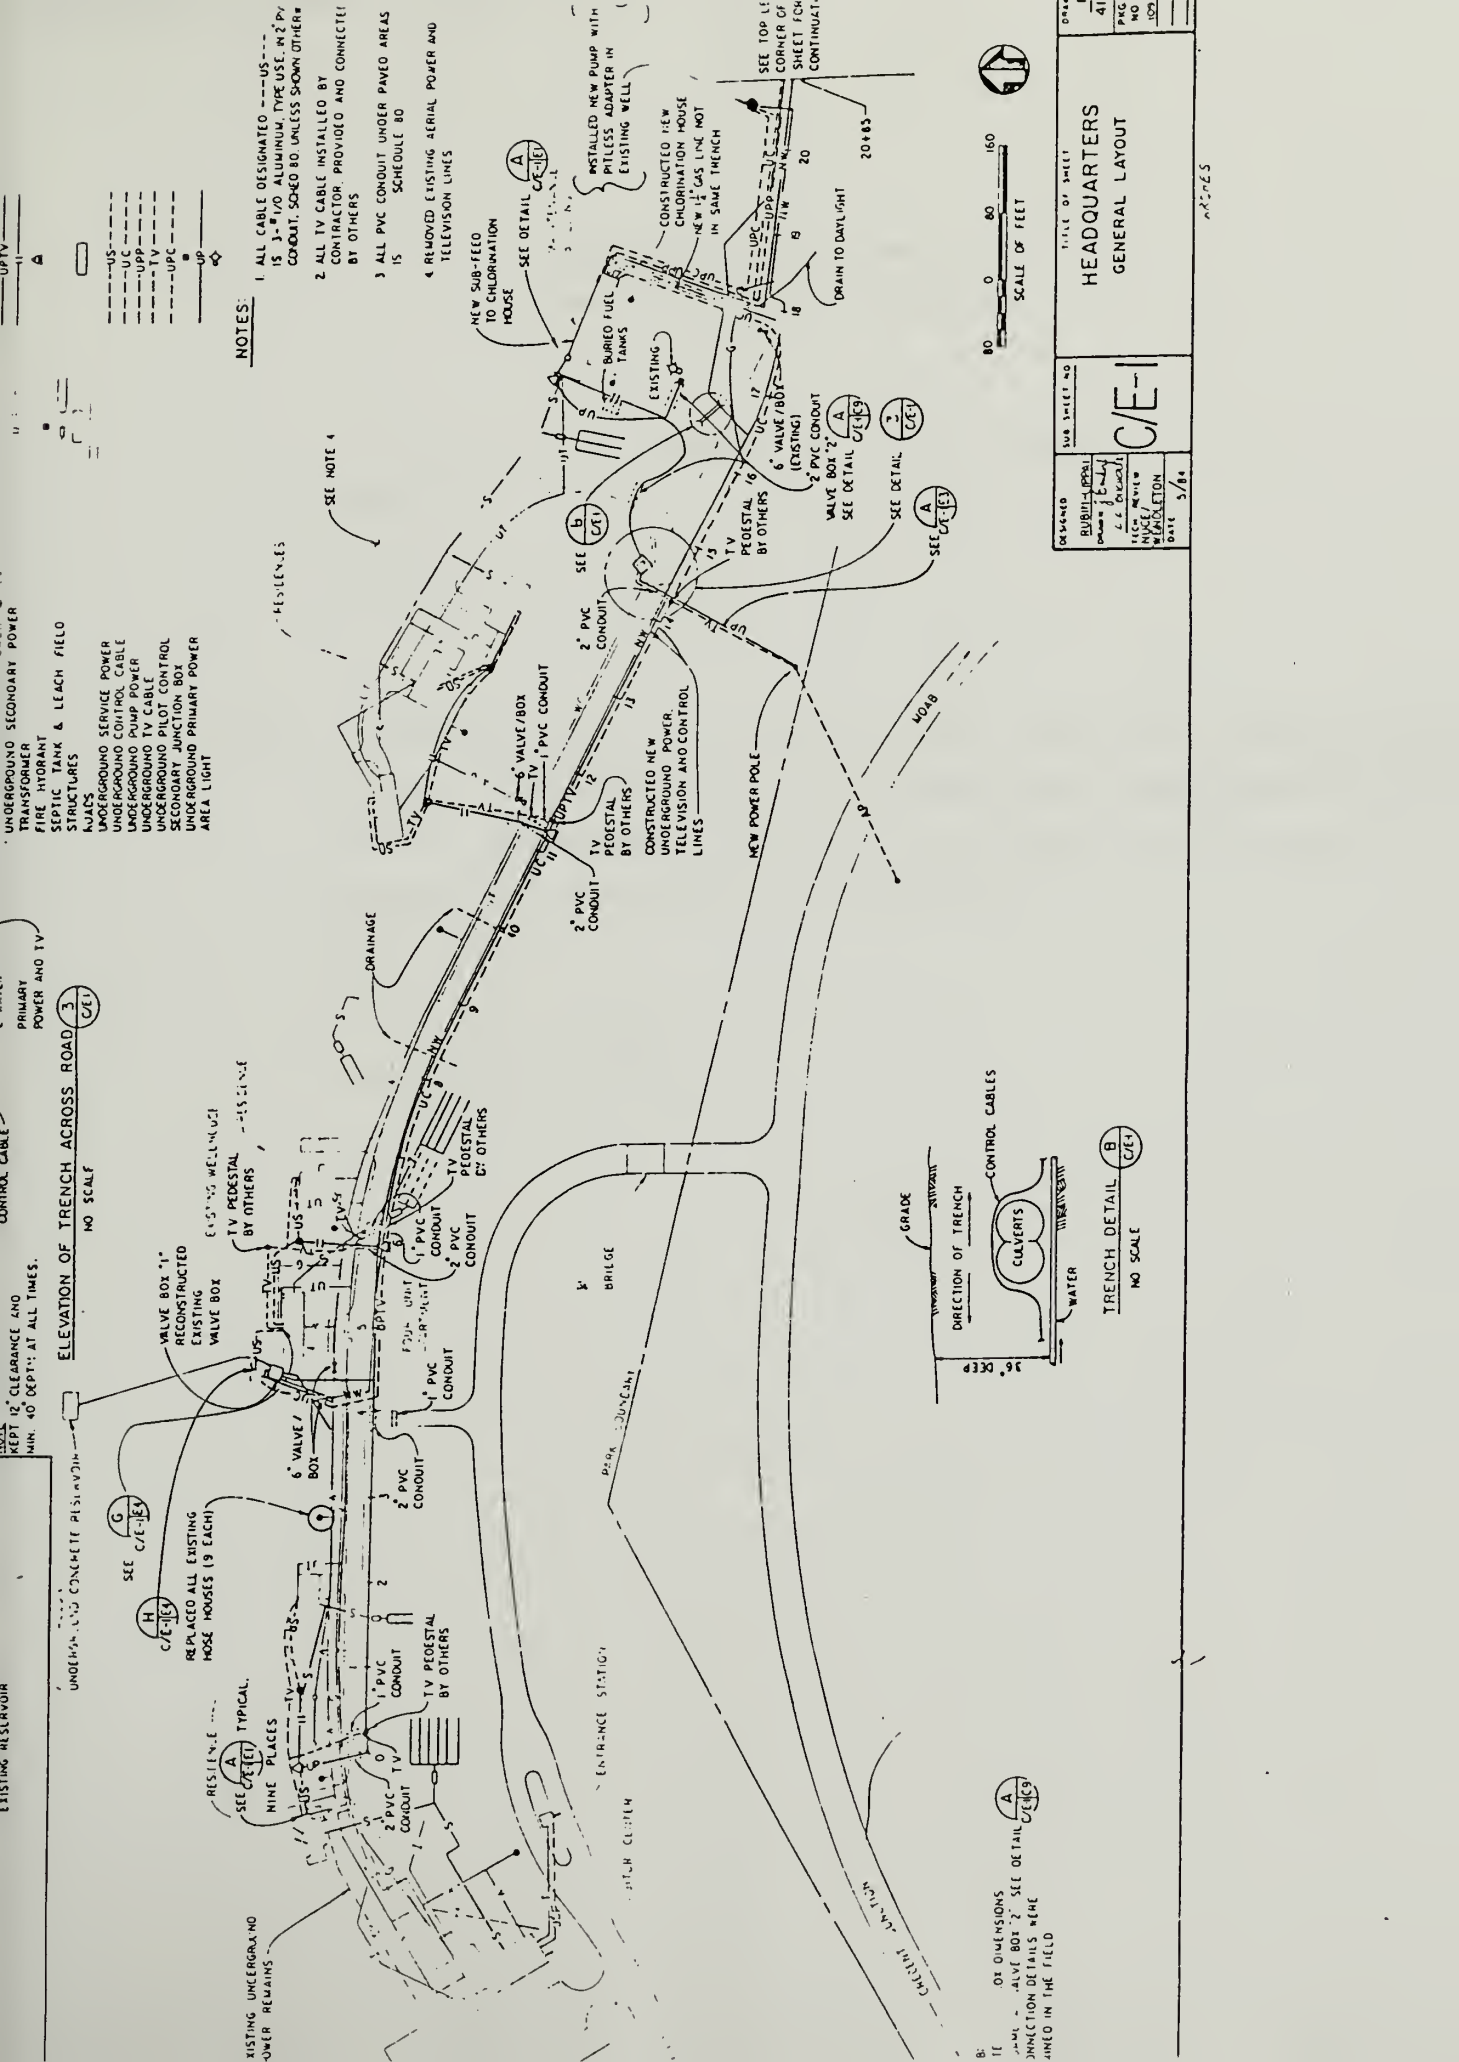
MAINTENANCE AREA
