# DRINKING WATER SOURCE PROTECTION PLAN

## Arches National Park Devils Garden Well

August 2001

Prepared by:  
Larry Martin  
National Park Service  
Water Resources Division  
1201 Oakridge Drive, Suite 250  
Ft. Collins, CO 80525  
(970)-225-3515

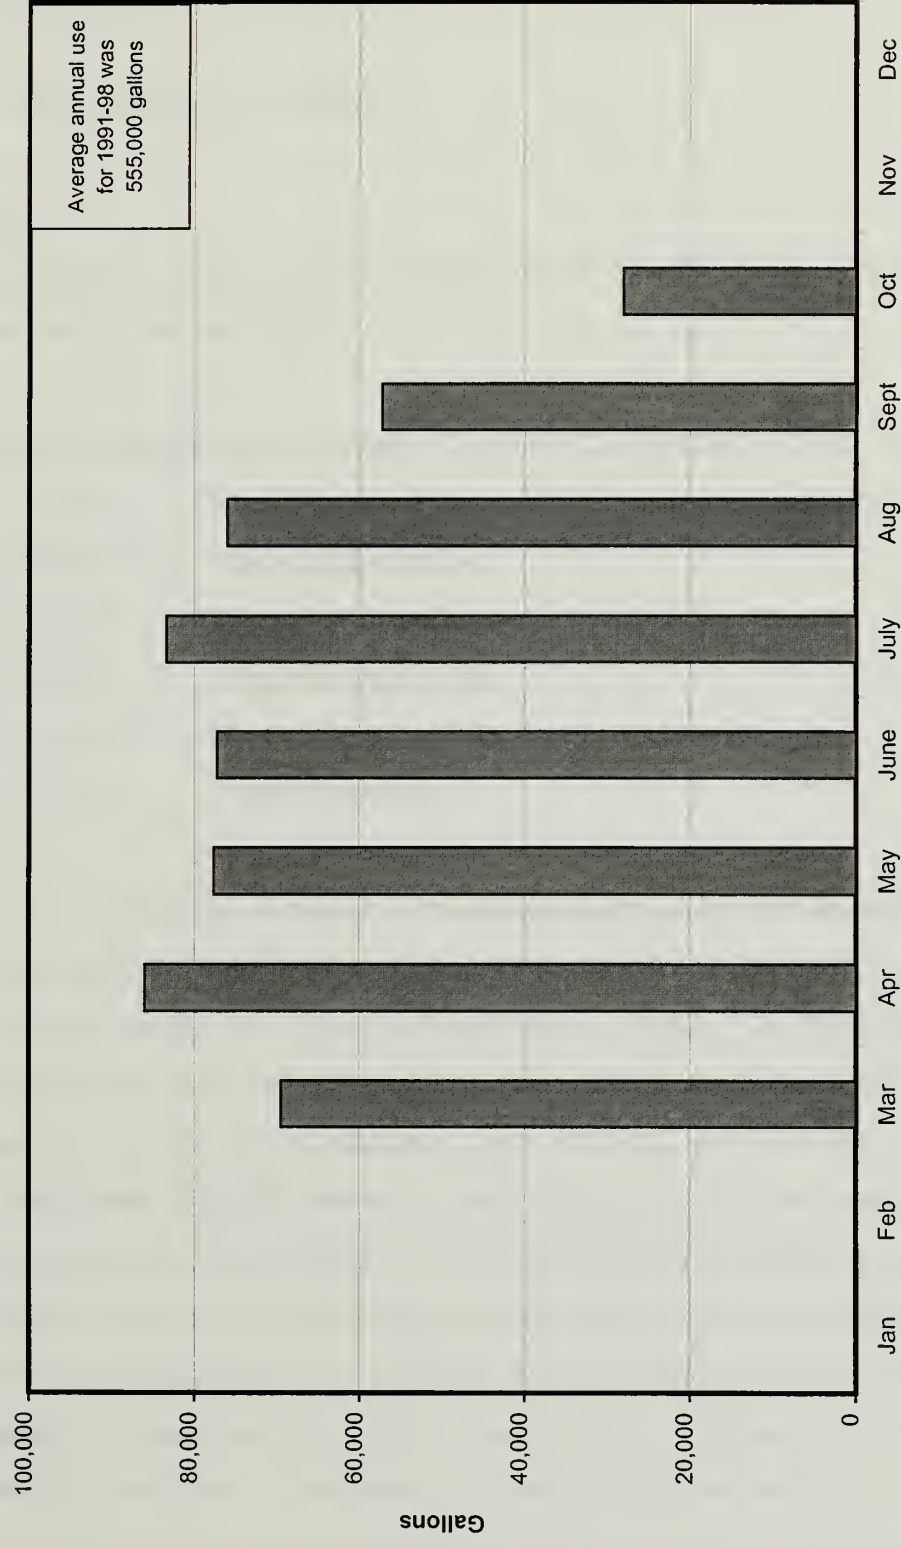
Figure 2. Average monthly water use.

Water is used for drinking and restroom facilities by park visitors and staff at the Devils Garden Campground and trailhead. There is a Ranger Station at Devils Garden. Water use generally ranges from about 60-80,000 gallons per month from March-October. Water use at Devils Garden for 1991-98 is shown in Figure 2. New water lines were installed below the frost line in 2001 to allow year round use of the campground.

**Average Monthly Water Use at Devils Garden,  
Arches National Park  
1991-98**

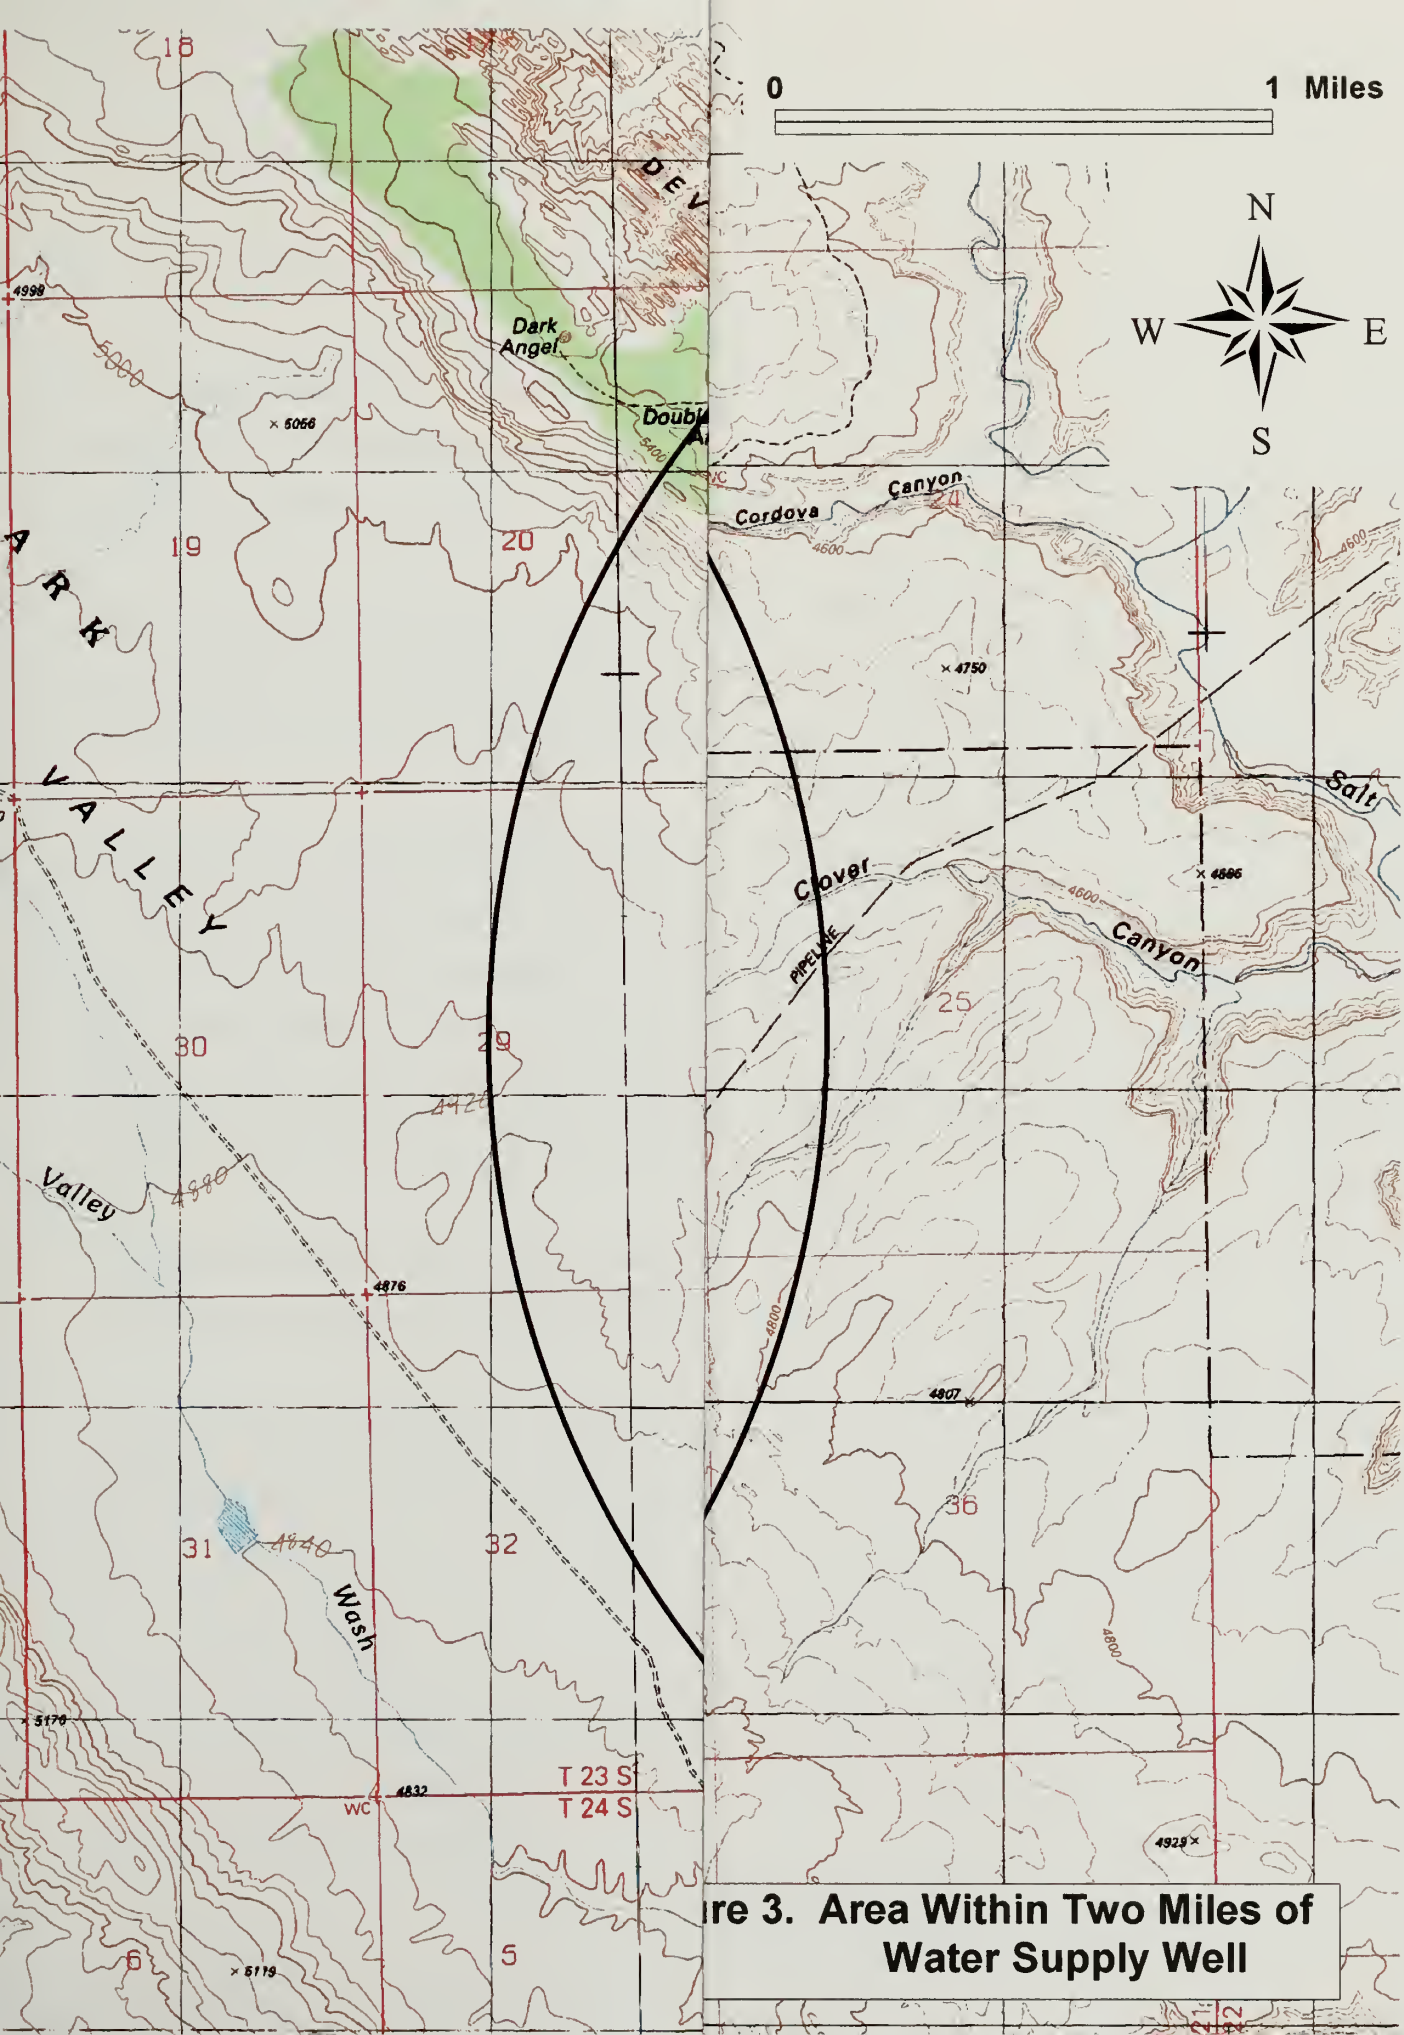
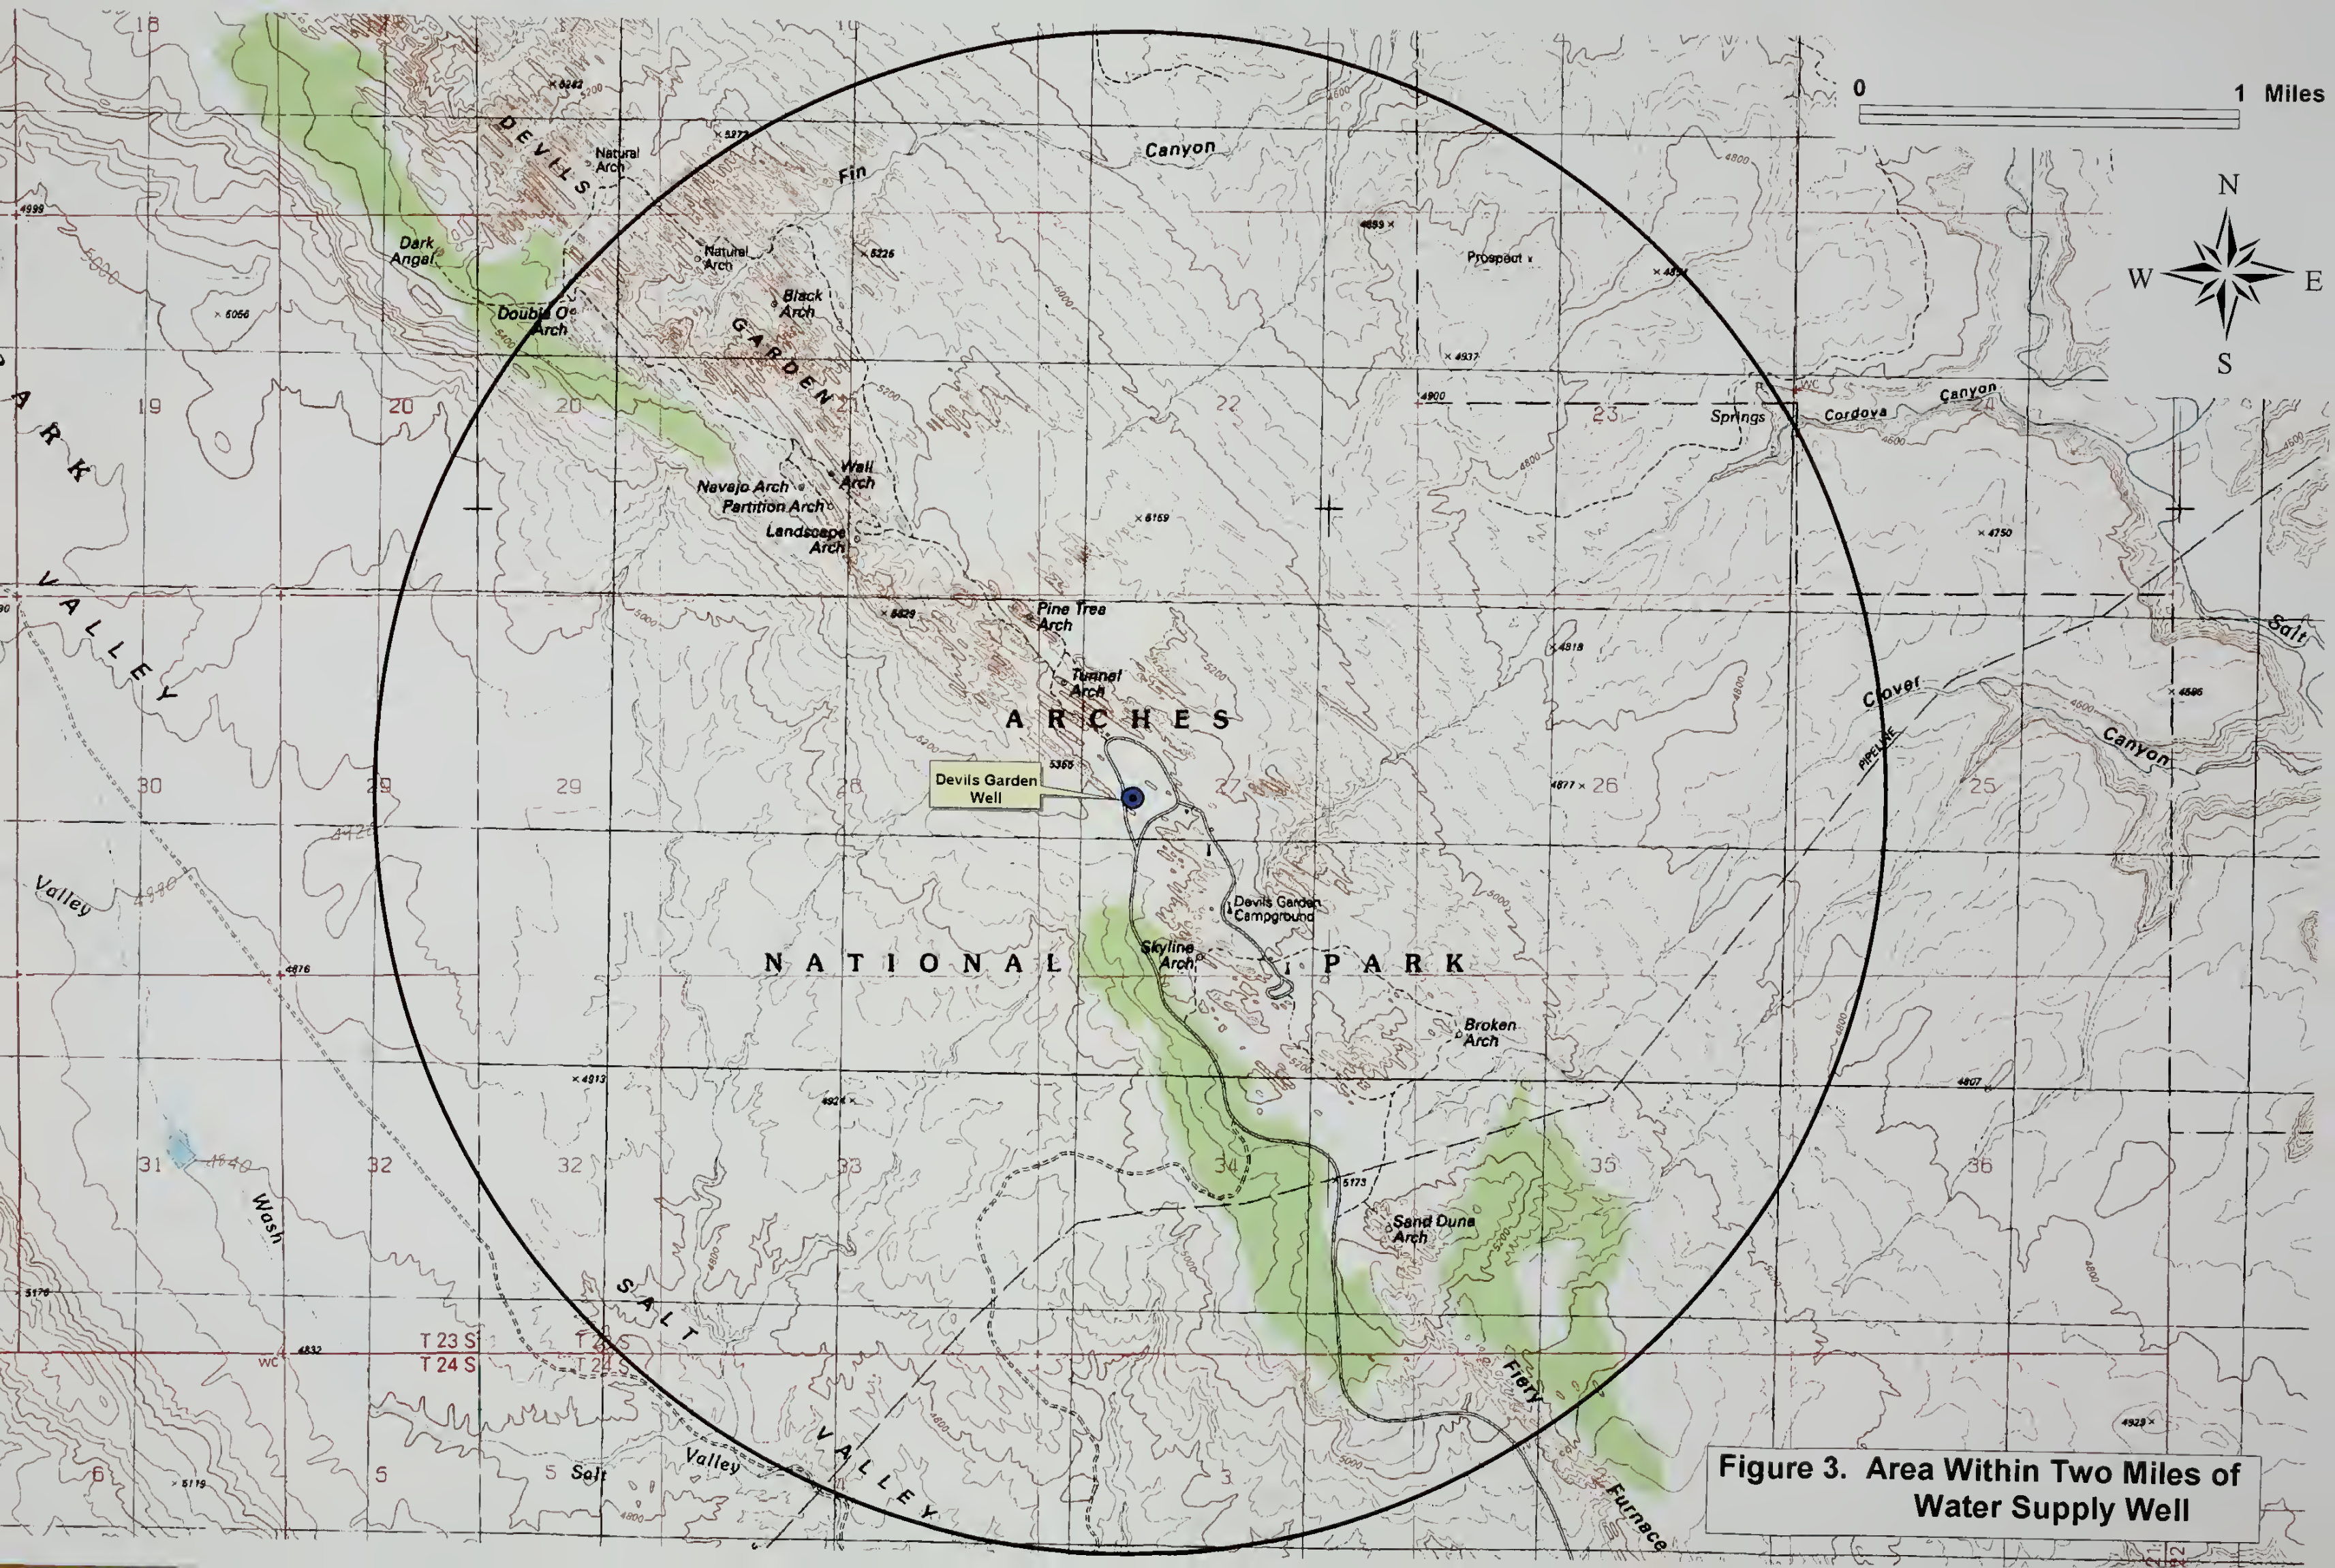
Figure 3. Area Within Two Miles of Water Supply Well

We have insufficient data to make predictions for groundwater travel times to the Devils Garden Well. Therefore, the optional two-mile radius delineation will be used to delineate the wellhead protection area. The only potential contaminant sources within several miles of the well are those associated with National Park Service developments and activities in the Devils Garden area.

Figure 3 is a map showing the area within two miles of the supply well.

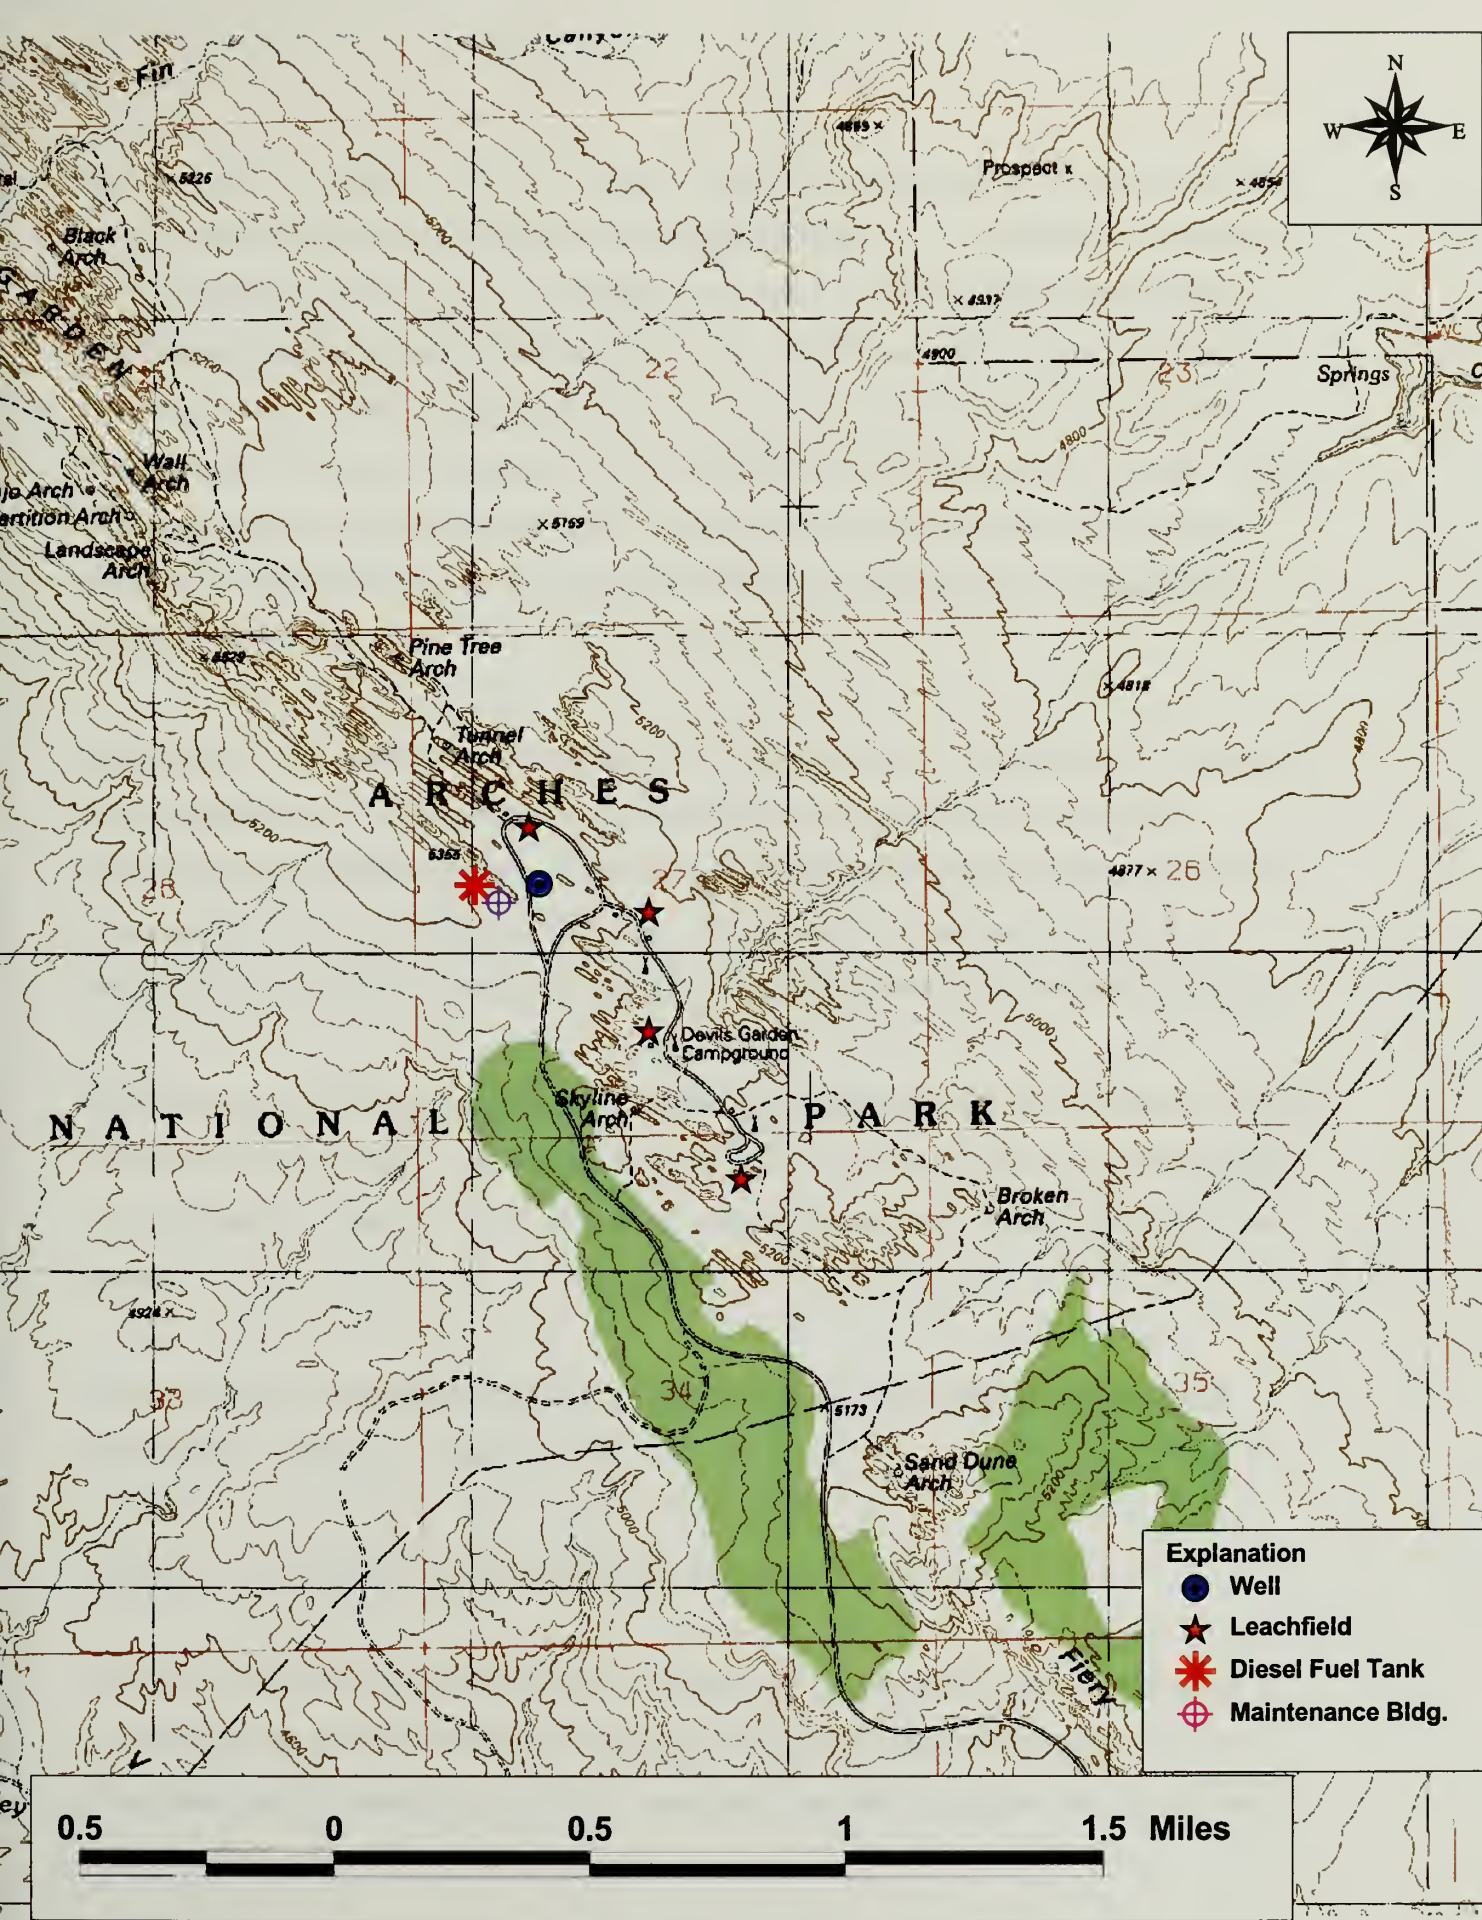
Figure 4. Potential Contaminants in the Devils Garden Area

None of the potential contaminant sources are within the Zone 1 protection zone, 100-foot radius from the well. The nearest potential contaminant source is the diesel fuel storage tank, about 400 feet southwest of the well. Fuel, oil, paint, solvents, etc. stored at the maintenance and generator buildings are about 400 feet southwest of the well. The new septic tank and leachfield constructed to serve the comfort station at the Devils Garden trailhead is planned to be located within the Loop Road, but more than 300 feet from the well. The septic tanks and leachfields for comfort stations at the campground are more than 800 feet south of the well.

Potential contamination sources are plotted on the map in Figure 4.

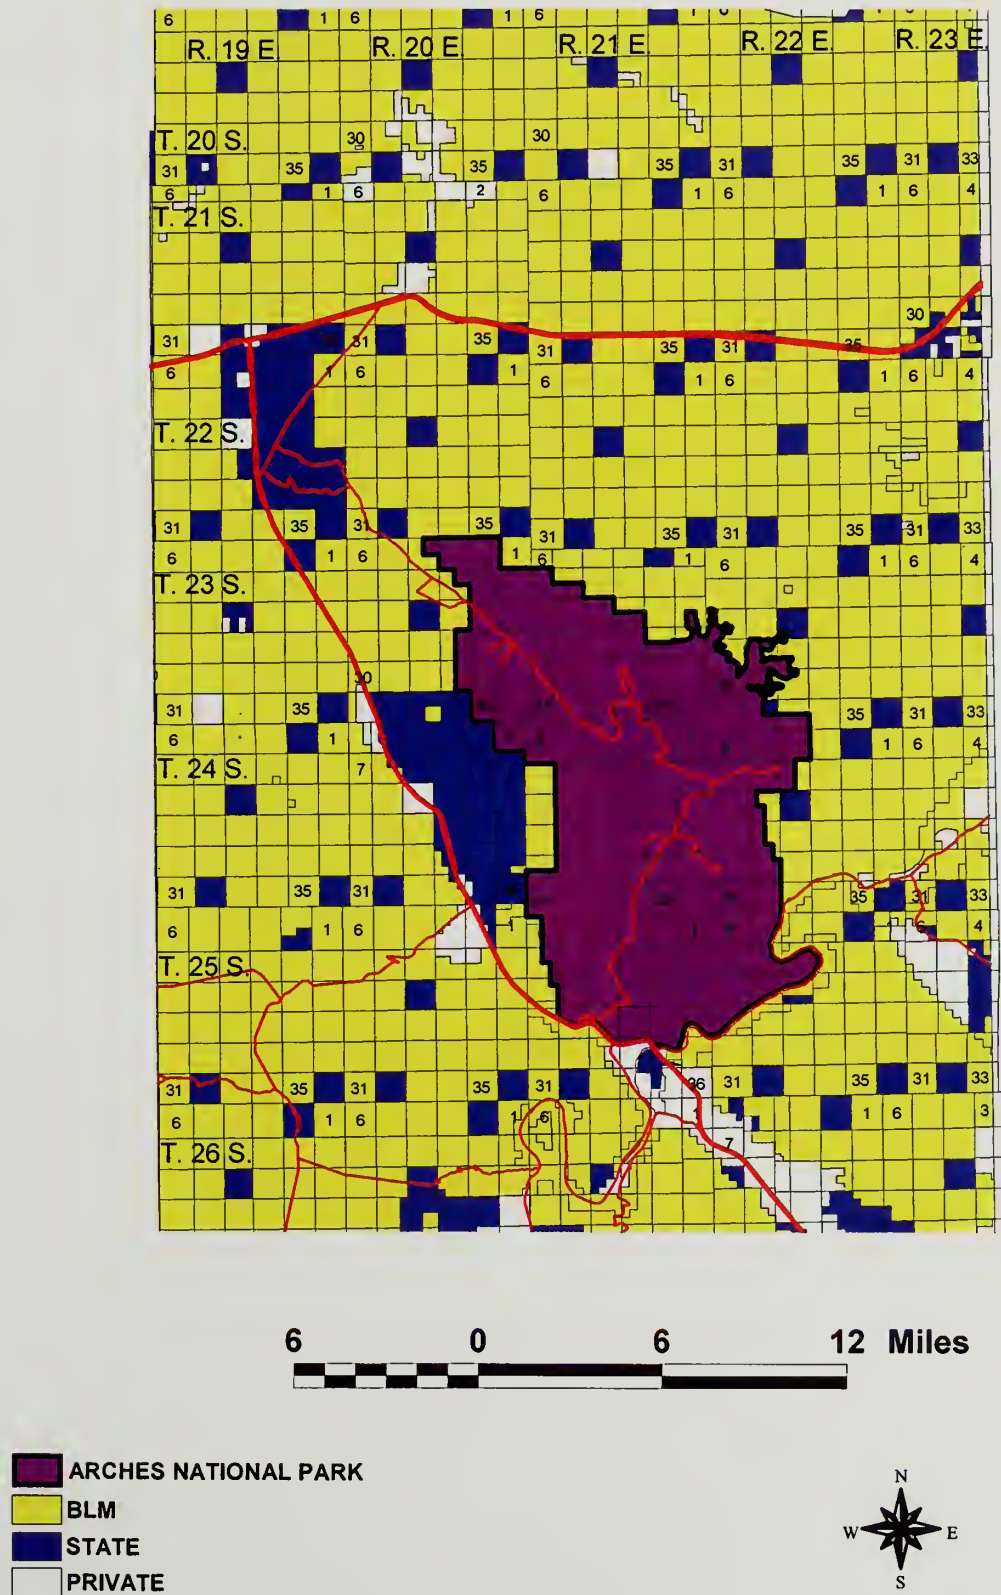
**Figure 5**  
**Arches National Park**  
**Property Ownership**

All land within six miles west, south, and east of the Devils Garden Well is owned and managed by the National Park Service. The park boundary is approximately two miles north of the well. Most of the land beyond the park boundary is managed by the Bureau of Land Management and used for cattle grazing. Property ownership near Arches National Park is shown in Figure 5.

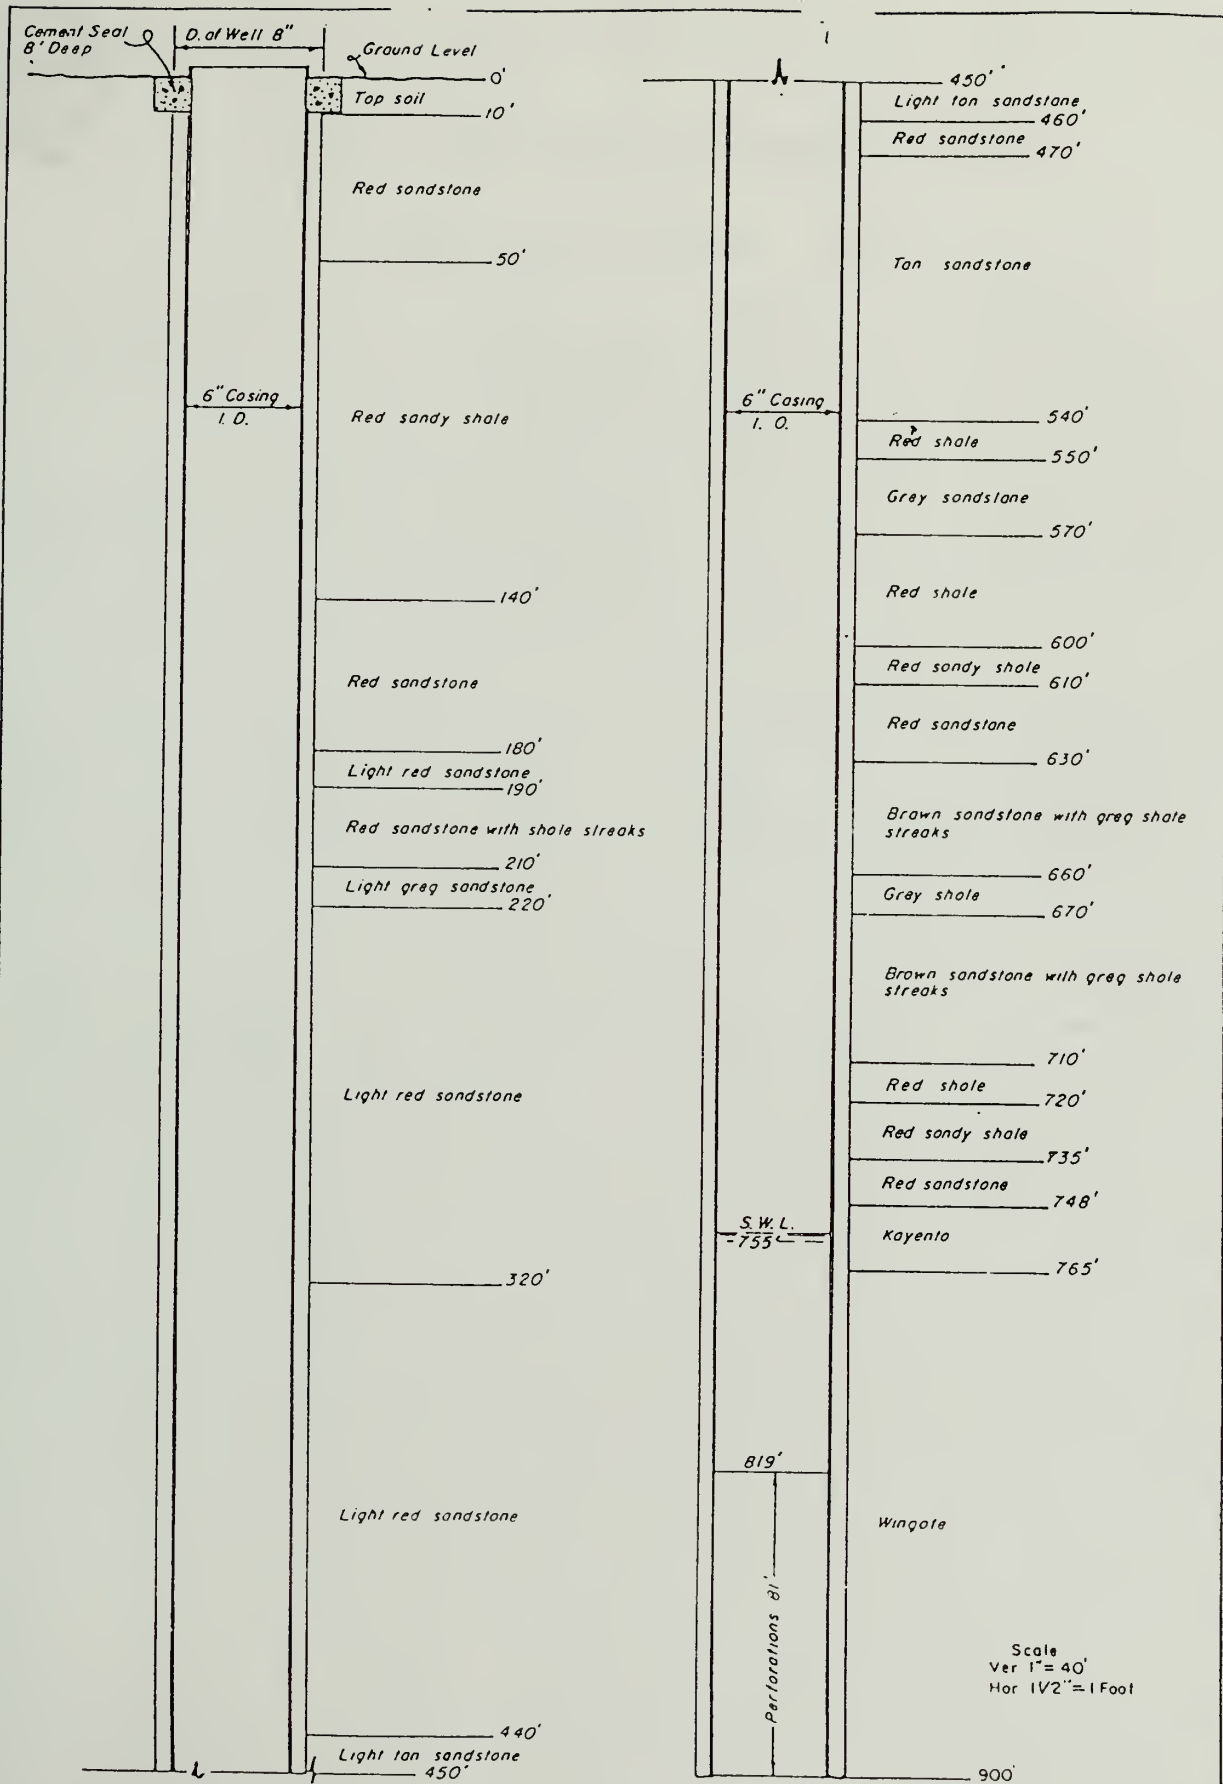
## WELL LOG

Devil's Garden Well

Started July 6, 1962 & Completed Nov. 5, 1962

By Sexton Bros. Drilling Company

A copy of the well construction log is included in the Appendices of this report. Well drilling started in July 1962 and was completed in October. The well was drilled to a total depth of 900 feet using a cable-tool rig. It was cased with 8-inch steel casing that was slotted from 819-900 feet. The well was dry until it encountered water in the Wingate Sandstone at 790 feet. The water in the Wingate was under pressure and rose to a level of 745 feet below ground surface (Arnow, 1963).
