# DRINKING WATER SOURCE PROTECTION PLAN

## Natural Bridges National Monument

December 2000

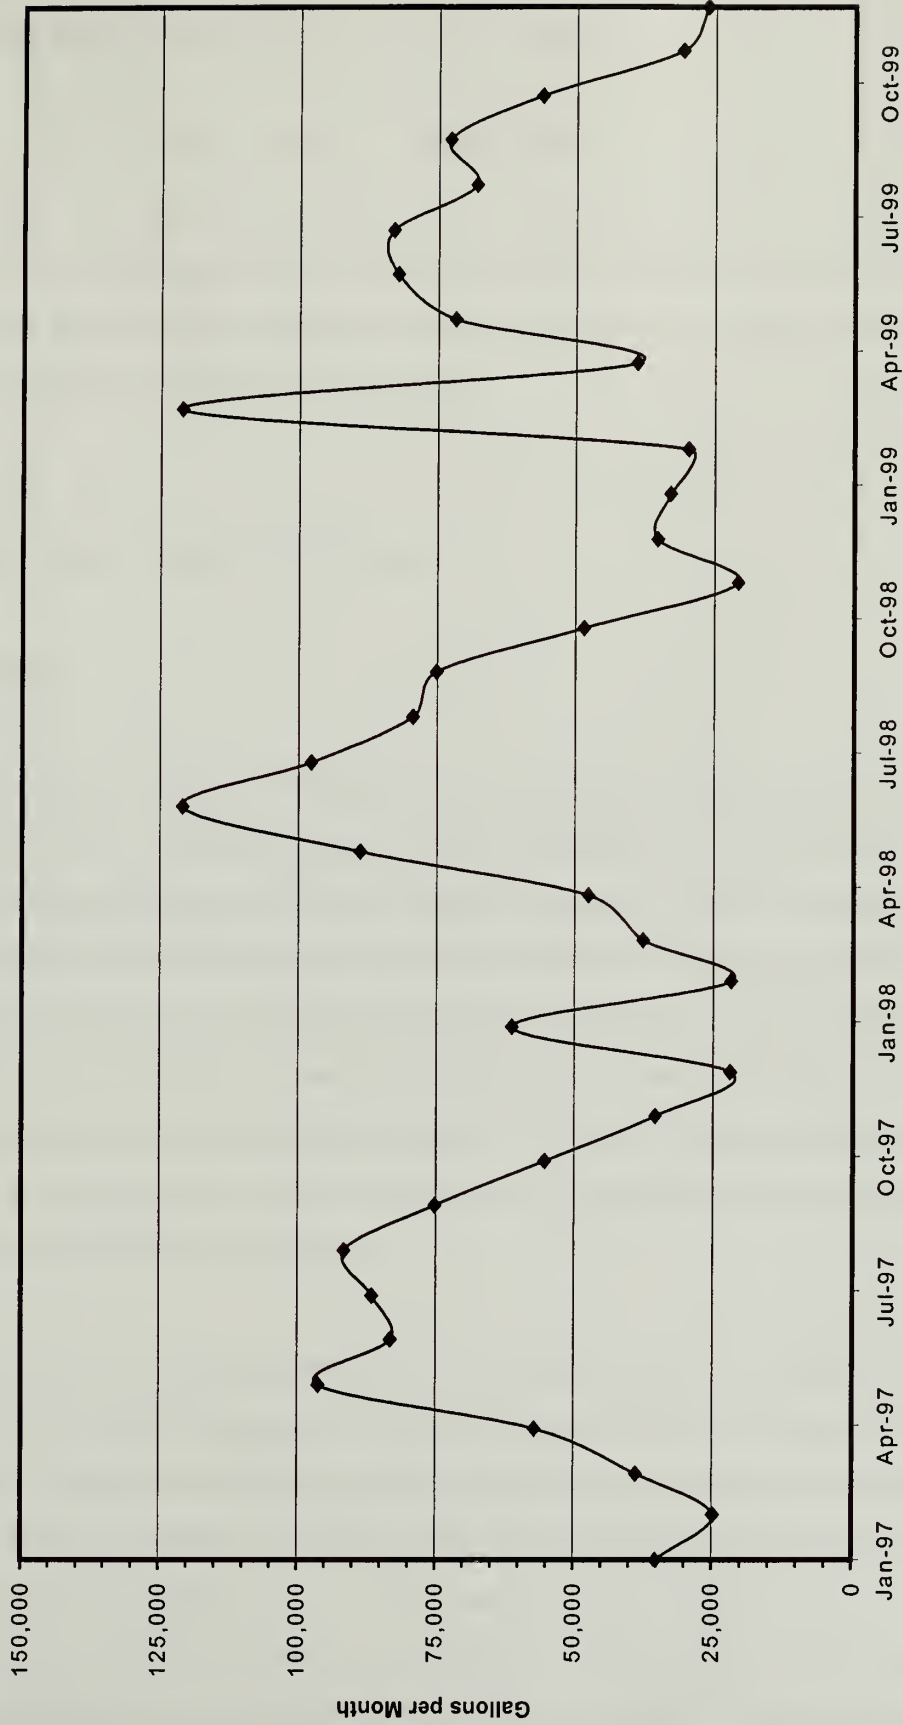
Figure 3. Average Monthly Water Use at Natural Bridges National Monument

Water is used for drinking and restroom facilities for approximately 130,000 visitors per year. There are 10 employee residences at the park, including single-family and multiple unit dwellings. The wells also supply water for a campground and visitor center. Water use ranges from about 700,000 to 850,000 gallons per year. In winter months, when visitation is low, demand is about 25,000 gallons per month. In summer months, when visitation increases, water demand is about 75,000 to 125,000 gallons per month. Monthly water use at Natural Bridges for 1997-99 is shown in Figure 3.

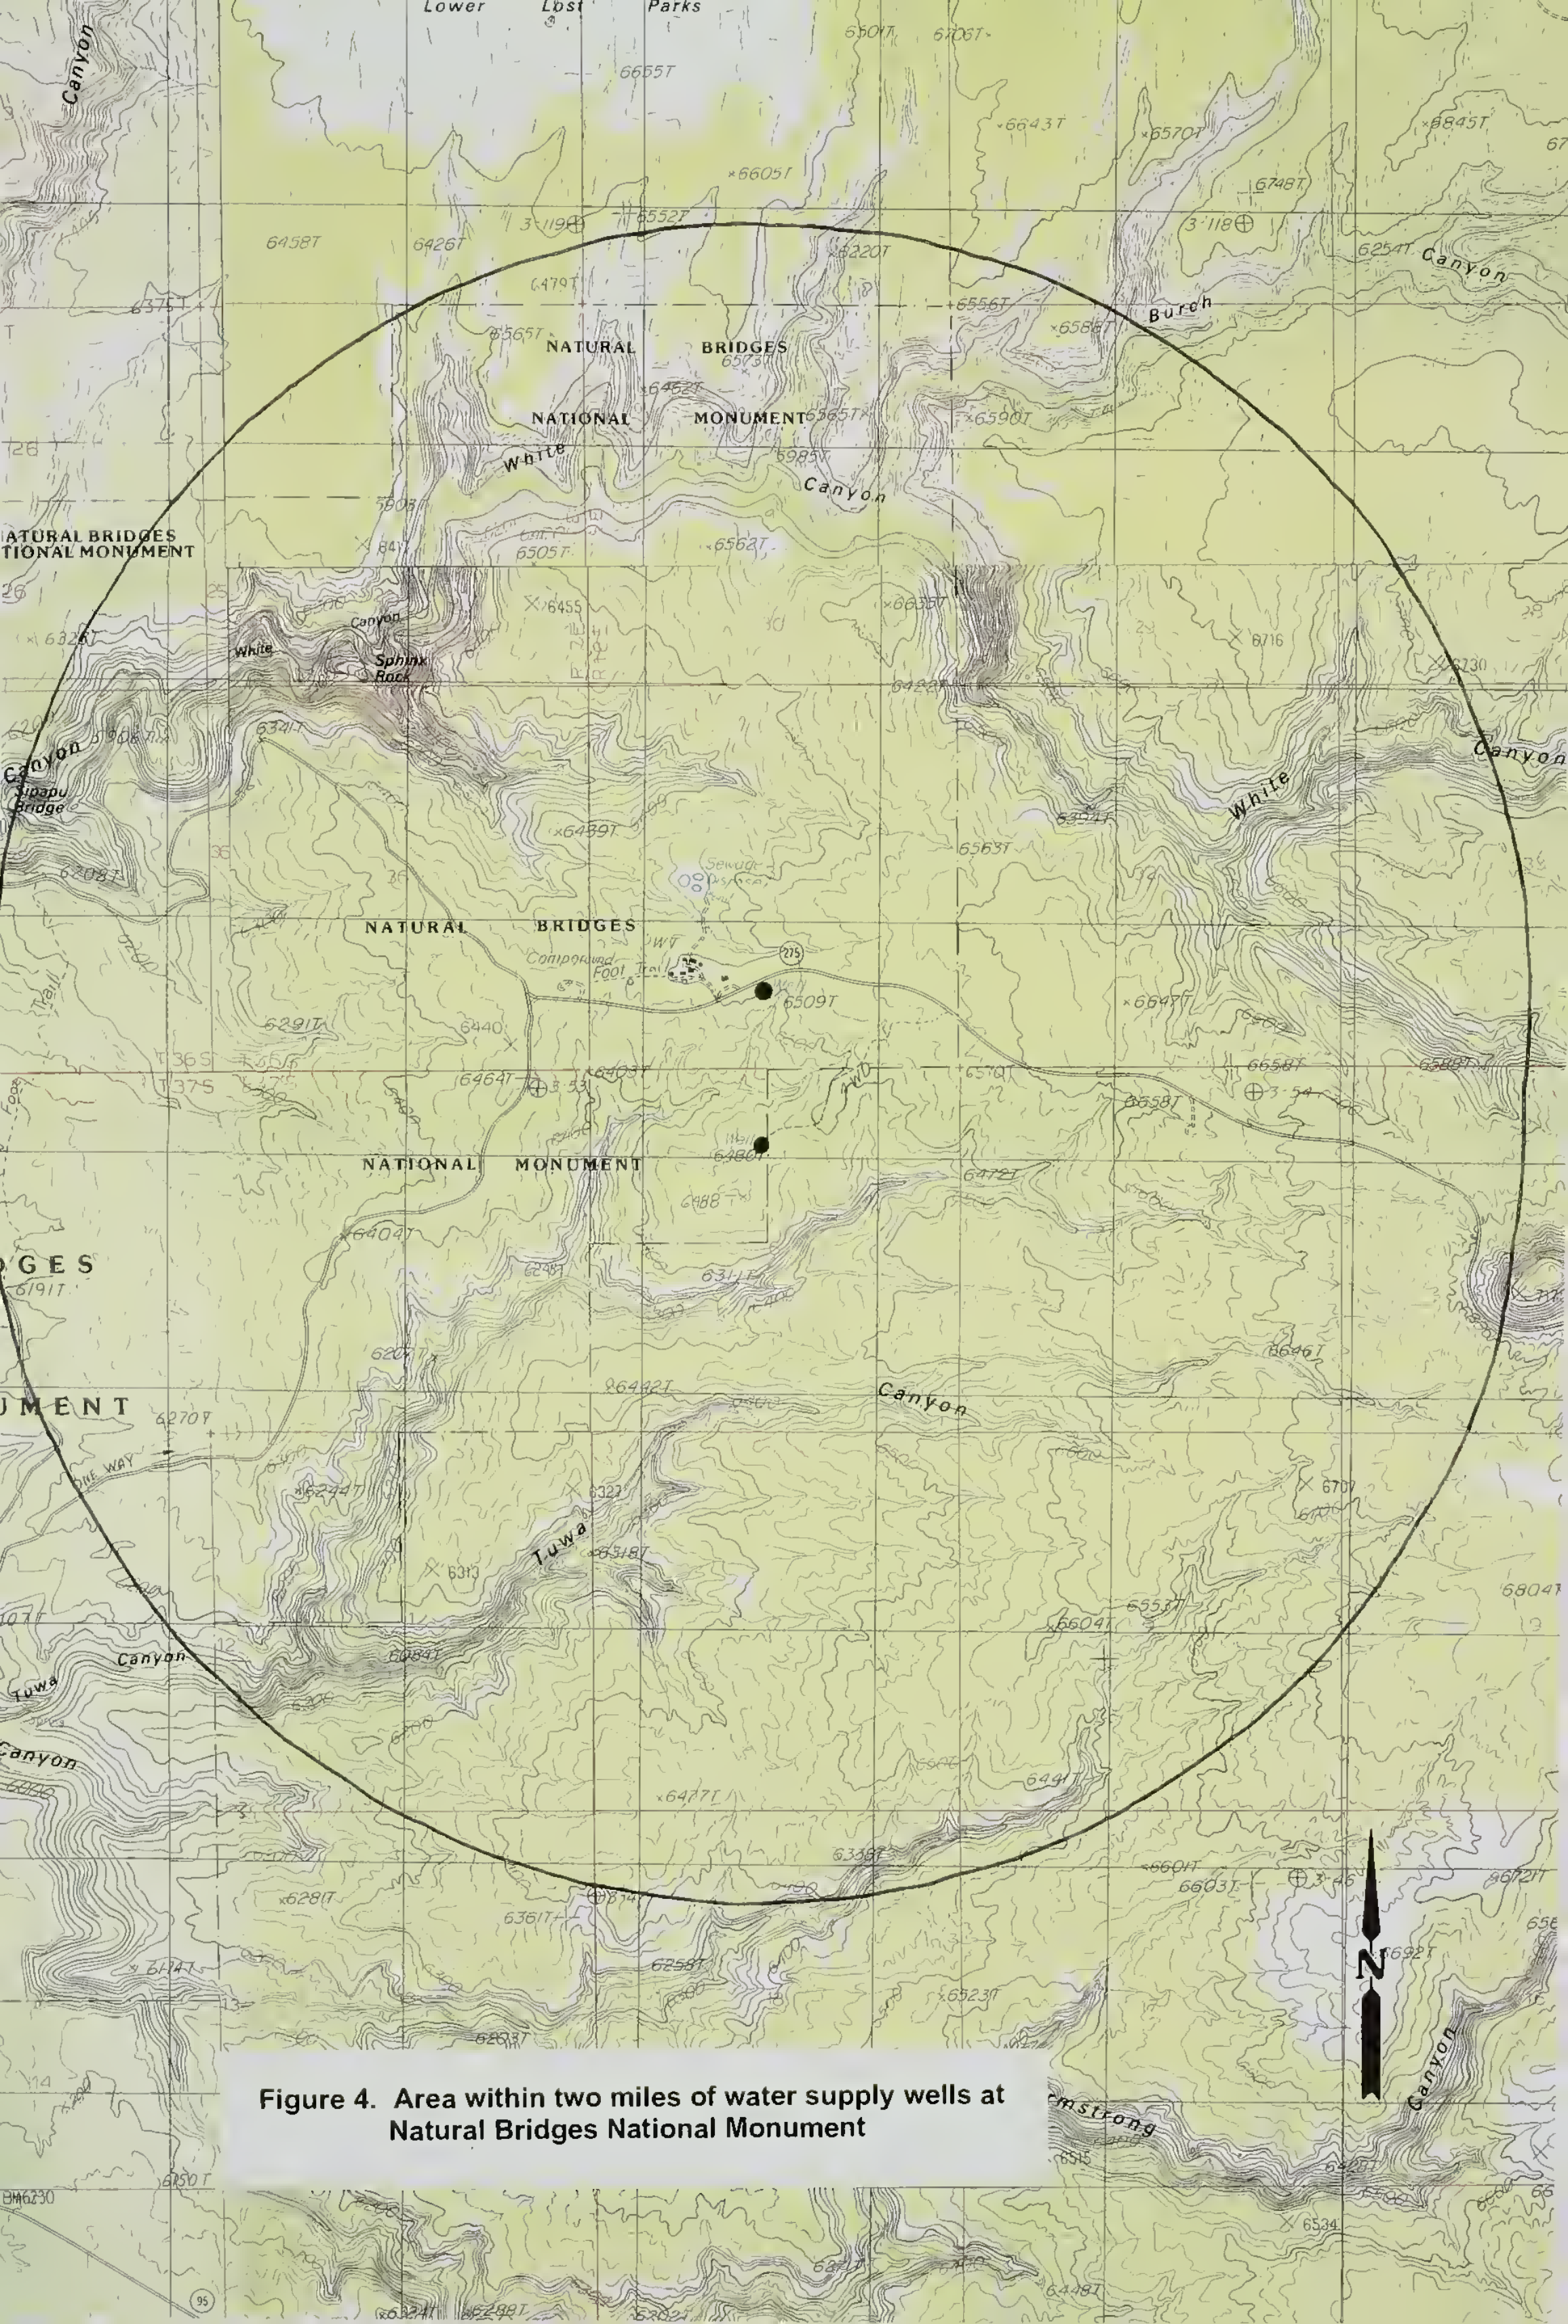
Figure 4. Area within two miles of water supply wells at Natural Bridges National Monument

Hydrologic data is inadequate to determine even the direction of groundwater flow, although it is generally believed that groundwater flow is westerly, toward White Canyon. Therefore, we used the optional two-mile radius for developing this drinking water source protection plan.

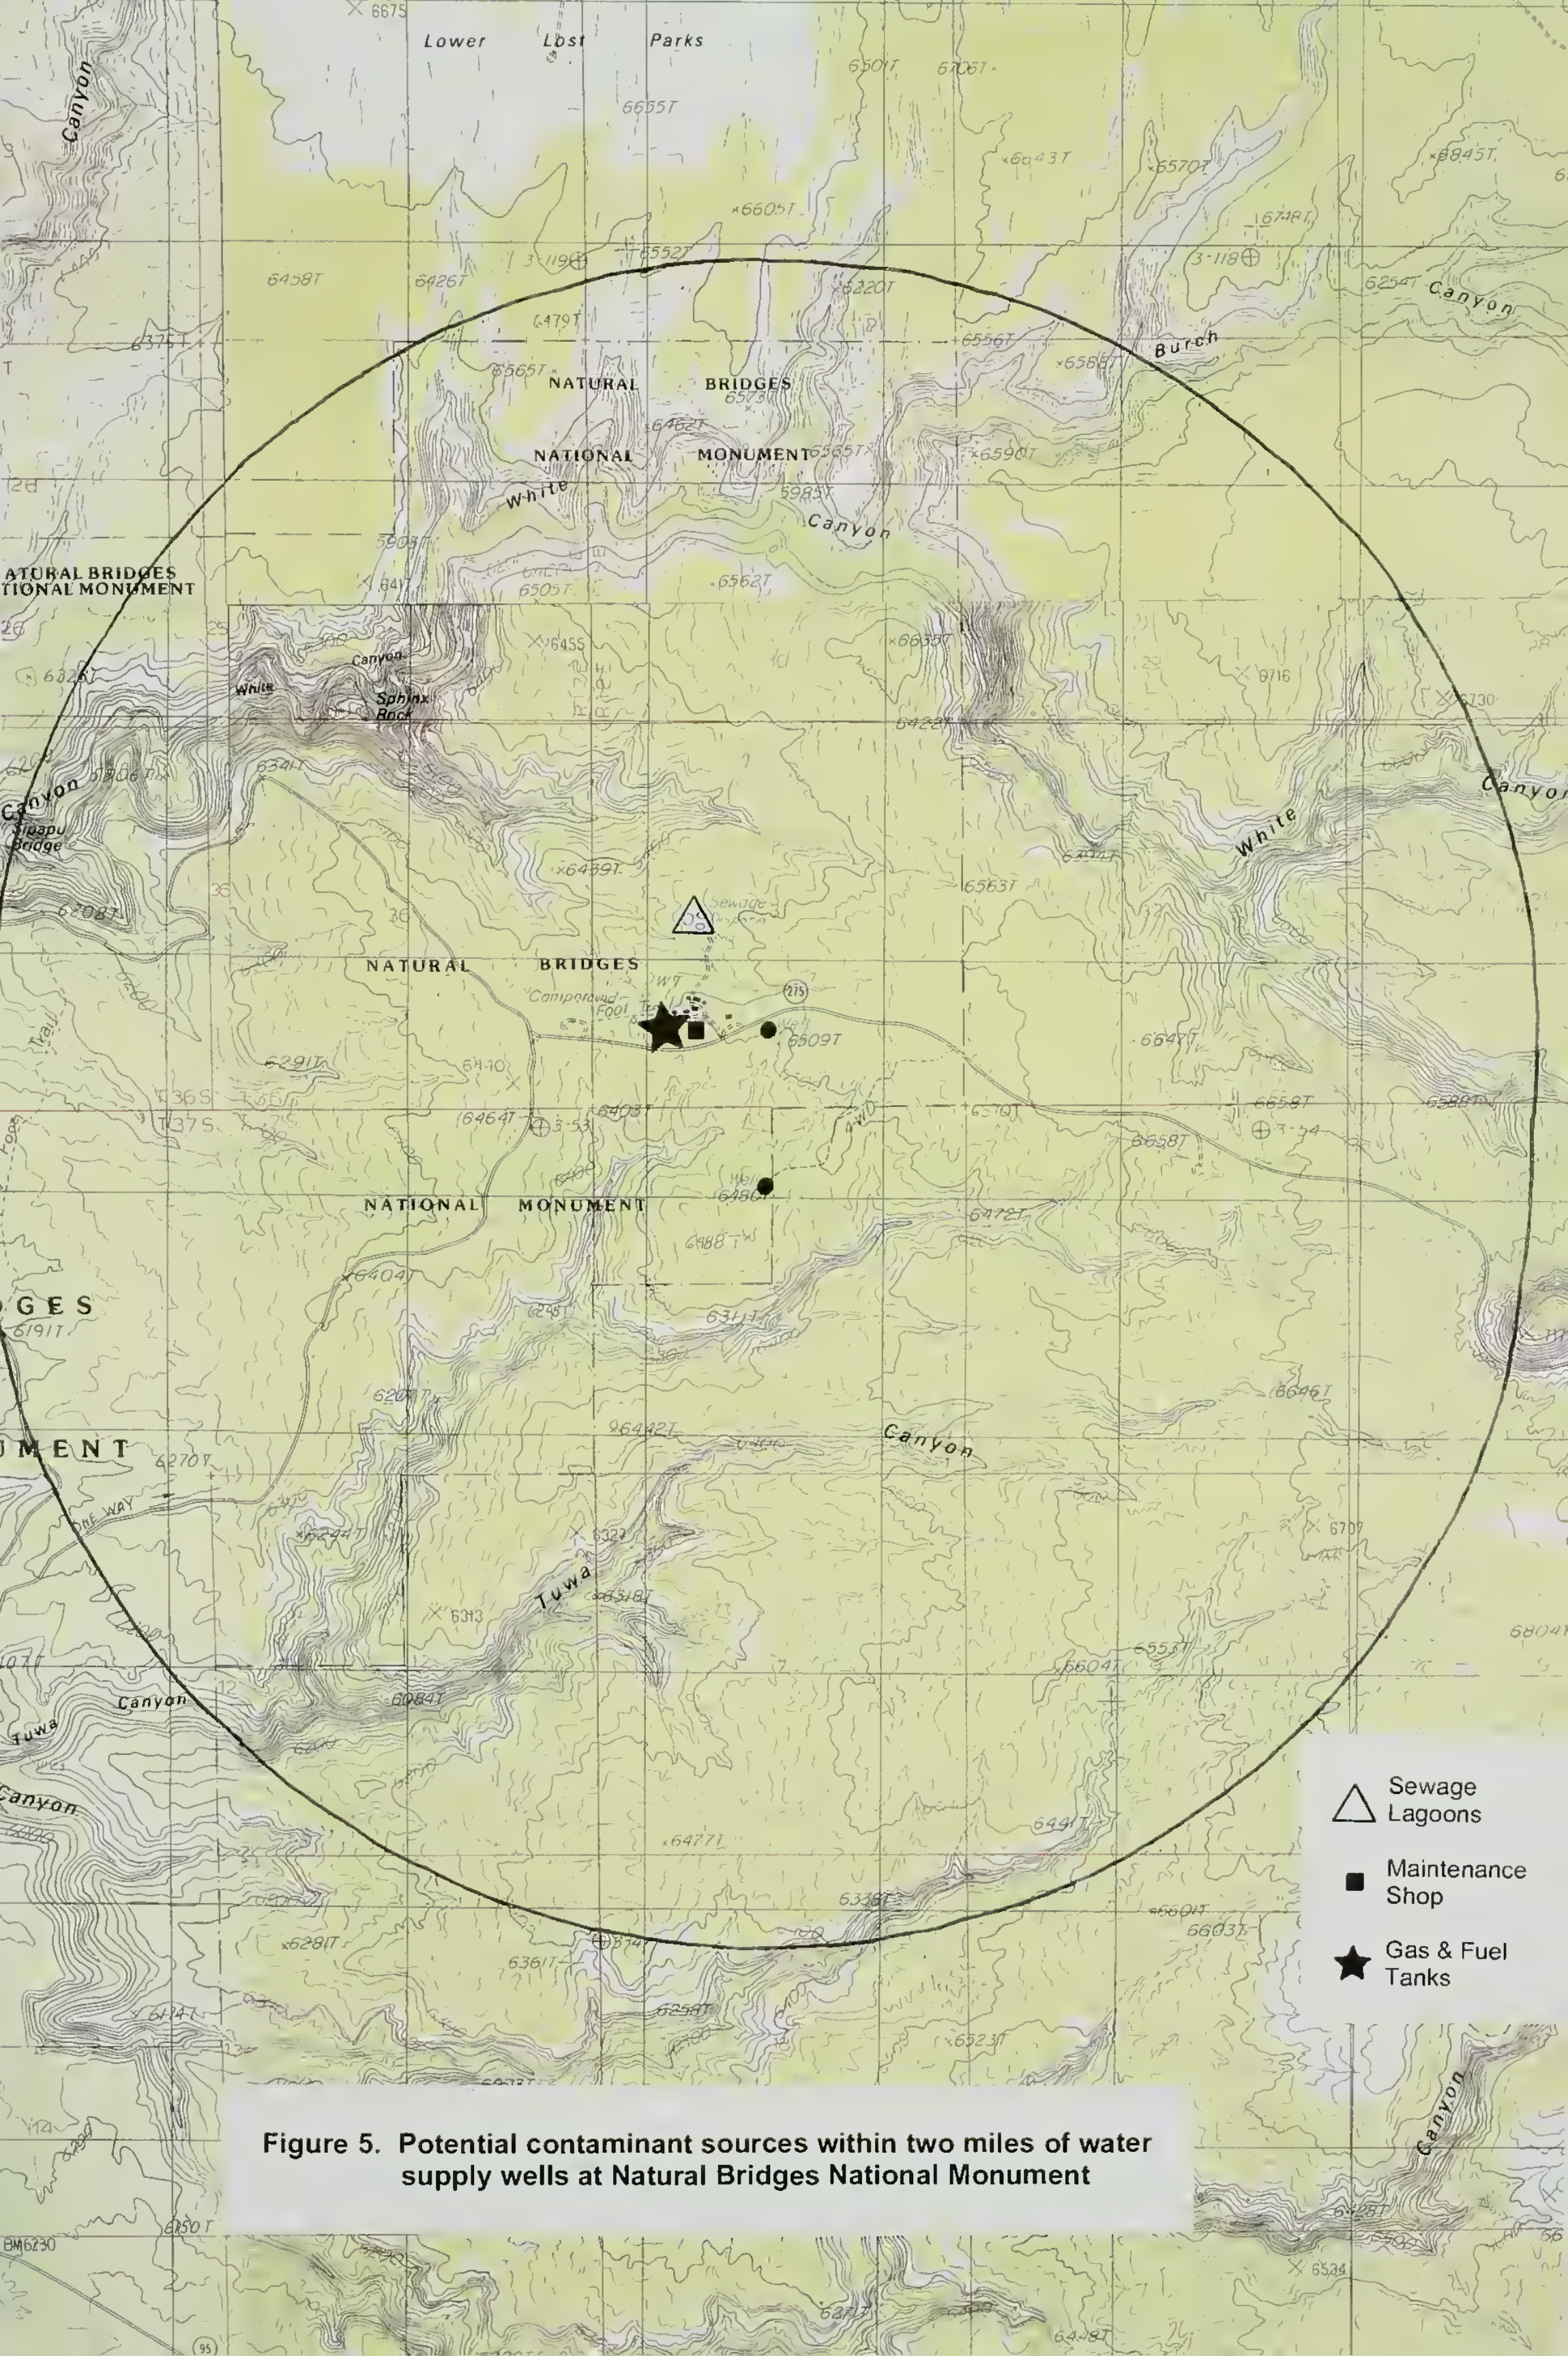
Figure 5. Potential contaminant sources within two miles of water supply wells at Natural Bridges National Monument

The 3000-gallon diesel fuel storage tank presents the greatest threat to the public water supply at Natural Bridges. The tank is a standard propane type tank converted to use as a fuel storage tank. The monument is planning to replace the tank, upgrading to a double-wall storage tank designed for fuel storage. Discharge lines should also be upgraded to double wall lines as part of that project.

Sewage lagoons are located about 2000 feet northwest of the nearest well and are topographically about 30 feet lower. Surface drainage at the lagoons is away from the wells. A major break in a sewer line could result in infiltration of sewage into the Cedar Mesa Sandstone. Impacts from such a leak would probably not affect water quality at either well due to the lateral distance between the wells and the administrative areas, depth to water, and the low pumping rates of the wells. Groundwater flow in the monument is probably westerly. The general direction of groundwater flow would transport any contaminants in the administrative area toward White Canyon, away from the water supply wells.

There are no concentrated sources or large volumes of potential contaminants within two miles of the well. The area is remote and rural. Land use is primarily grazing and visitor use at the monument. Potential contaminants at the park are primarily associated with the maintenance shop, including fuel storage tanks. Solvents, degreasers, paint, and similar materials (which might be classified as hazardous) are purchased and stored in small quantities, reducing the potential for release of large quantities of contaminants.

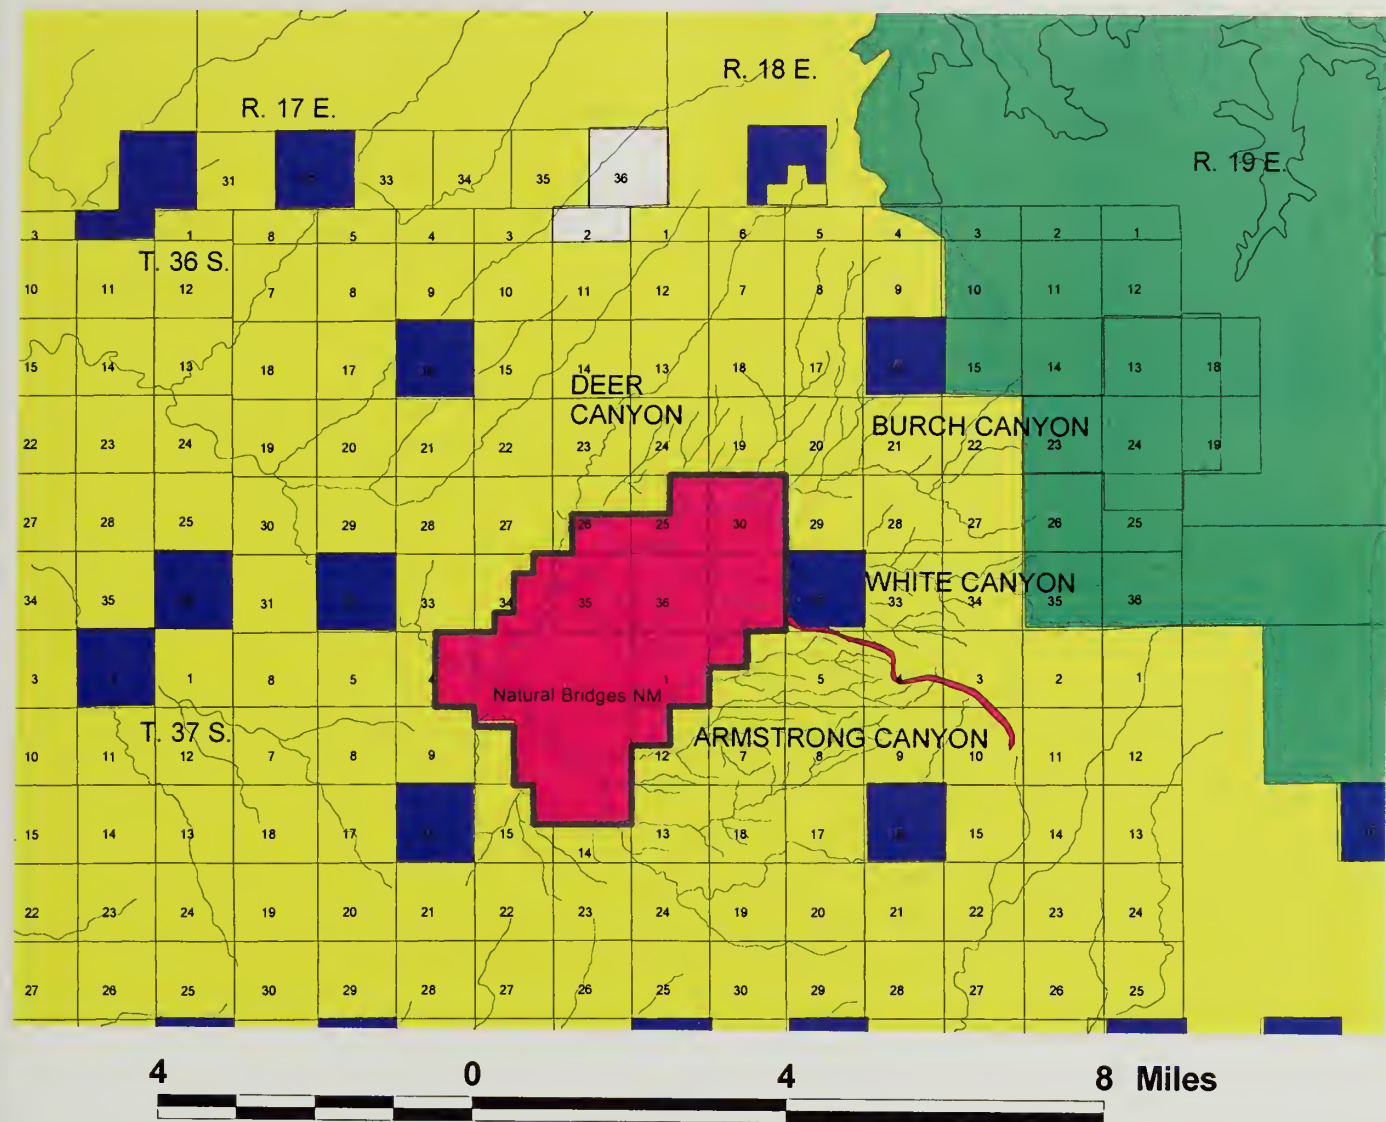
**Figure 6**  
**Natural Bridges National Monument**  
**Property Ownership**

The monument is surrounded for several miles in all directions by public land. Most of the adjacent public land is federally owned and managed by the BLM. There is also some state-owned land. Land ownership in the surrounding area is shown on Figure 6.

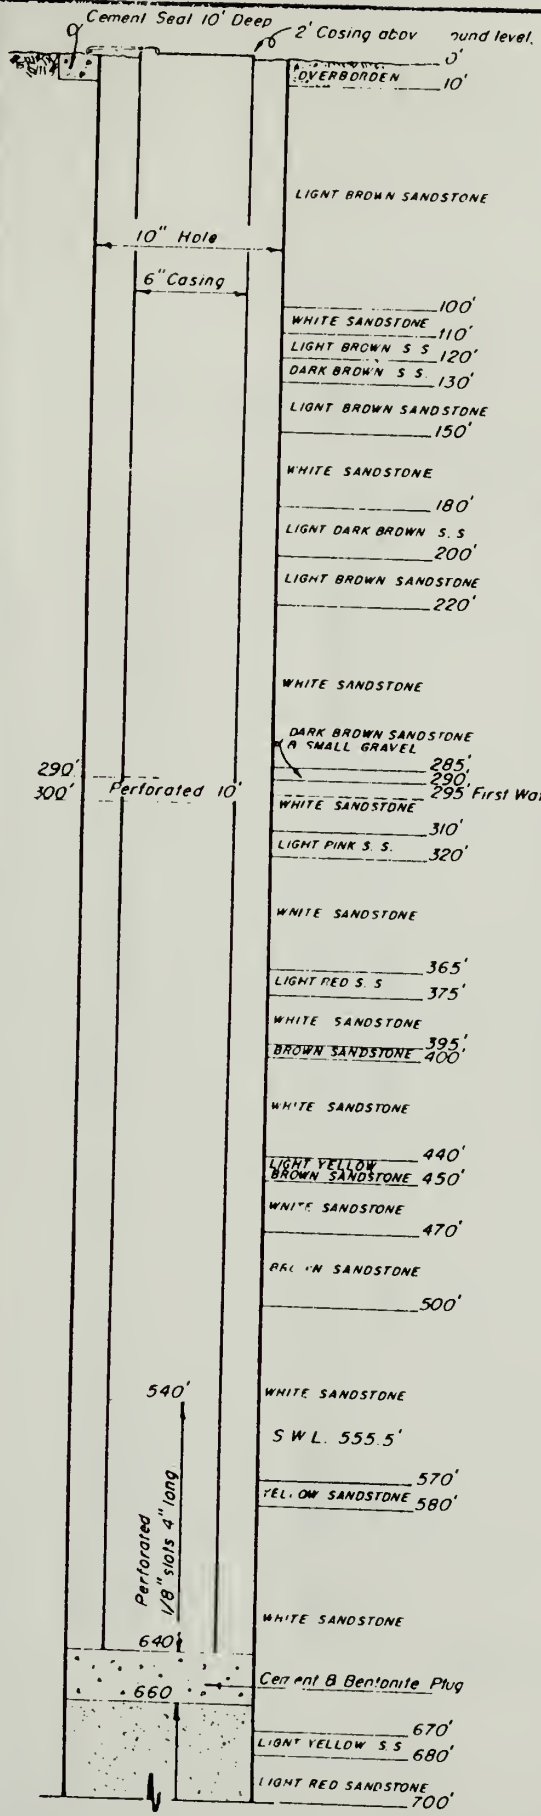
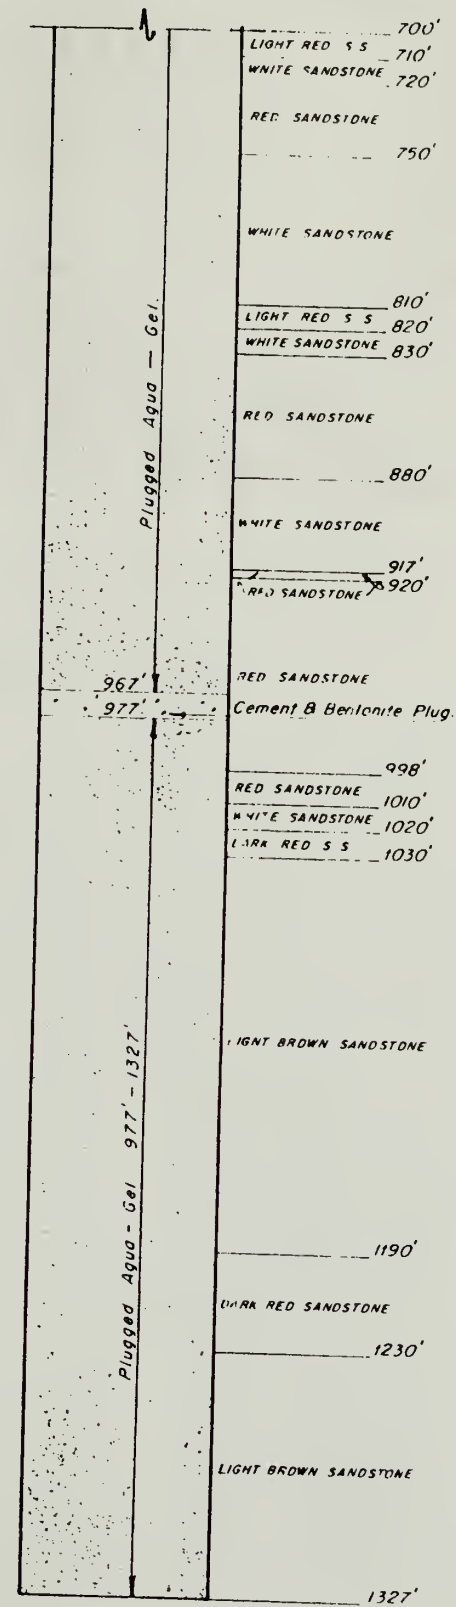
WELL LOG  
Well No. 1  
By Perry Brothers Drilling Company  
NATURAL BRIDGES, NATIONAL MONUMENT

The original water supply well for the monument (Well No. 1) was constructed in 1964. It was 10-inch hole drilled to a depth of 1327 feet below ground surface. Saline water was encountered in the deeper formations and the well was plugged back to 640 feet below ground surface. The 6<sup>5</sup>/<sub>8</sub>" casing was perforated from 285-300 and 532-632 feet below ground surface. The well yielded 2½ gpm with 55 feet of drawdown after 48 hours of pumping. The pump became inoperative after a few months. The pump was pulled and found to be packed with sand. Subsequent work on the well determined that

it had gone dry for some unexplained reason. The well was abandoned, but there is no information regarding whether it was properly plugged and sealed. Park staff have not been able to locate the well.

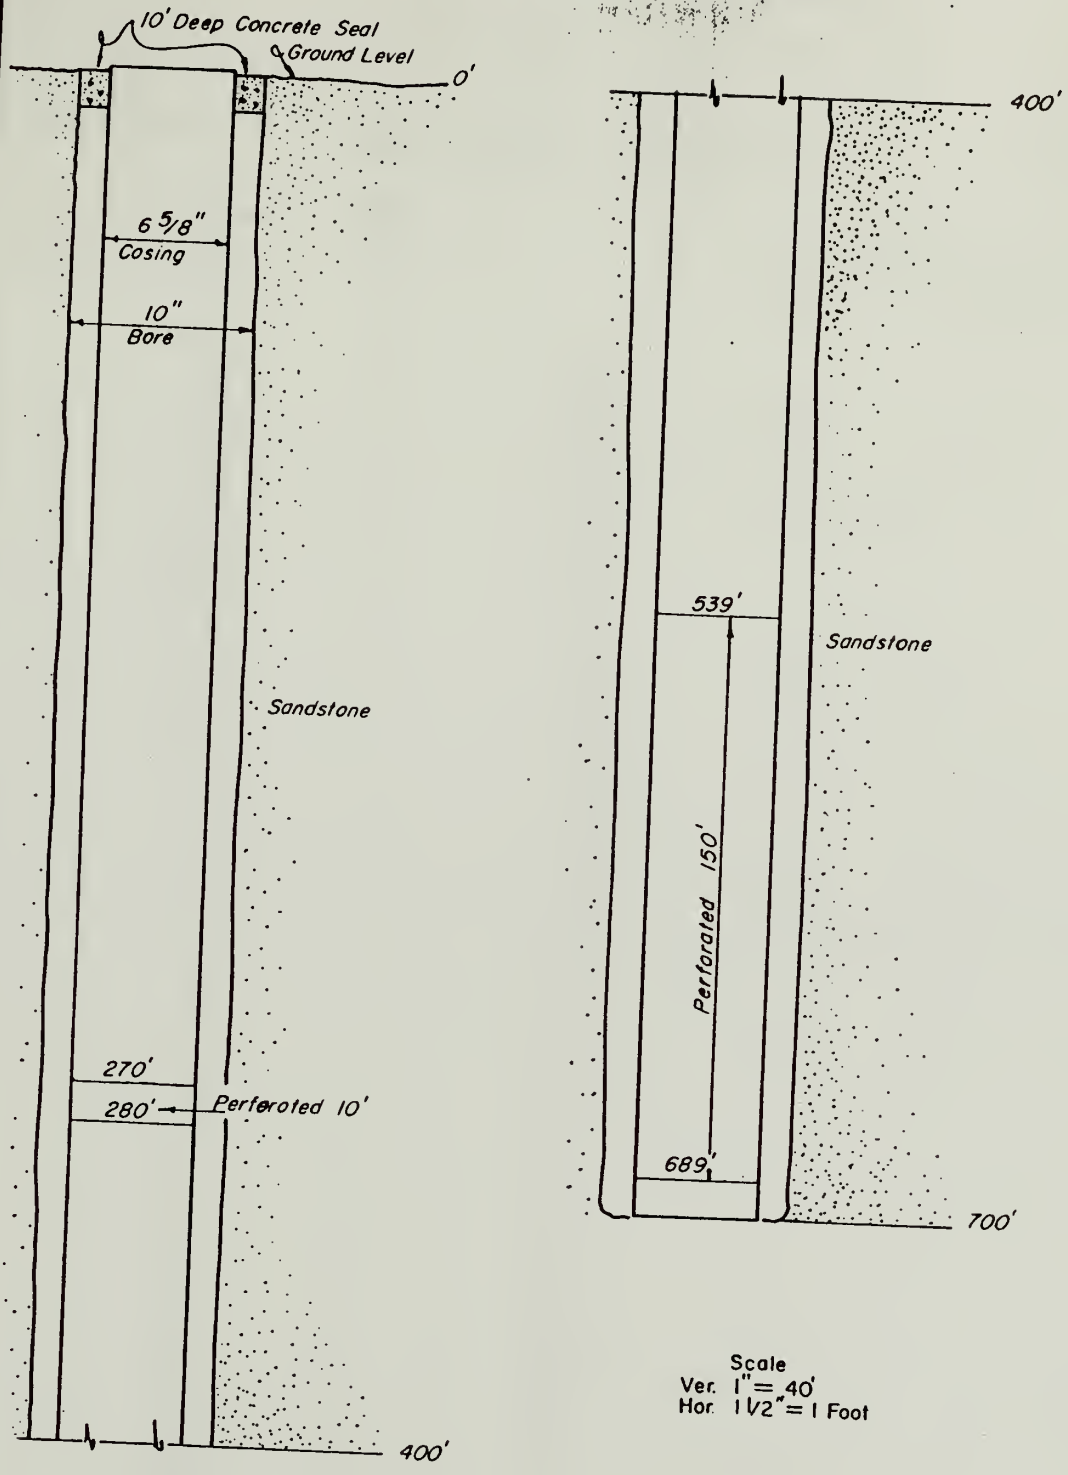
# Well No. 2

Well No. 2 is 700 feet deep. It was constructed in 1964 by drilling a 10-inch borehole and installing 6<sup>5</sup>/<sub>8</sub>" casing for the entire depth. The casing was perforated from 270-280 feet and 539-689 feet below ground surface. Well No. 2 produces 8 gpm with about 85-90 feet of drawdown.

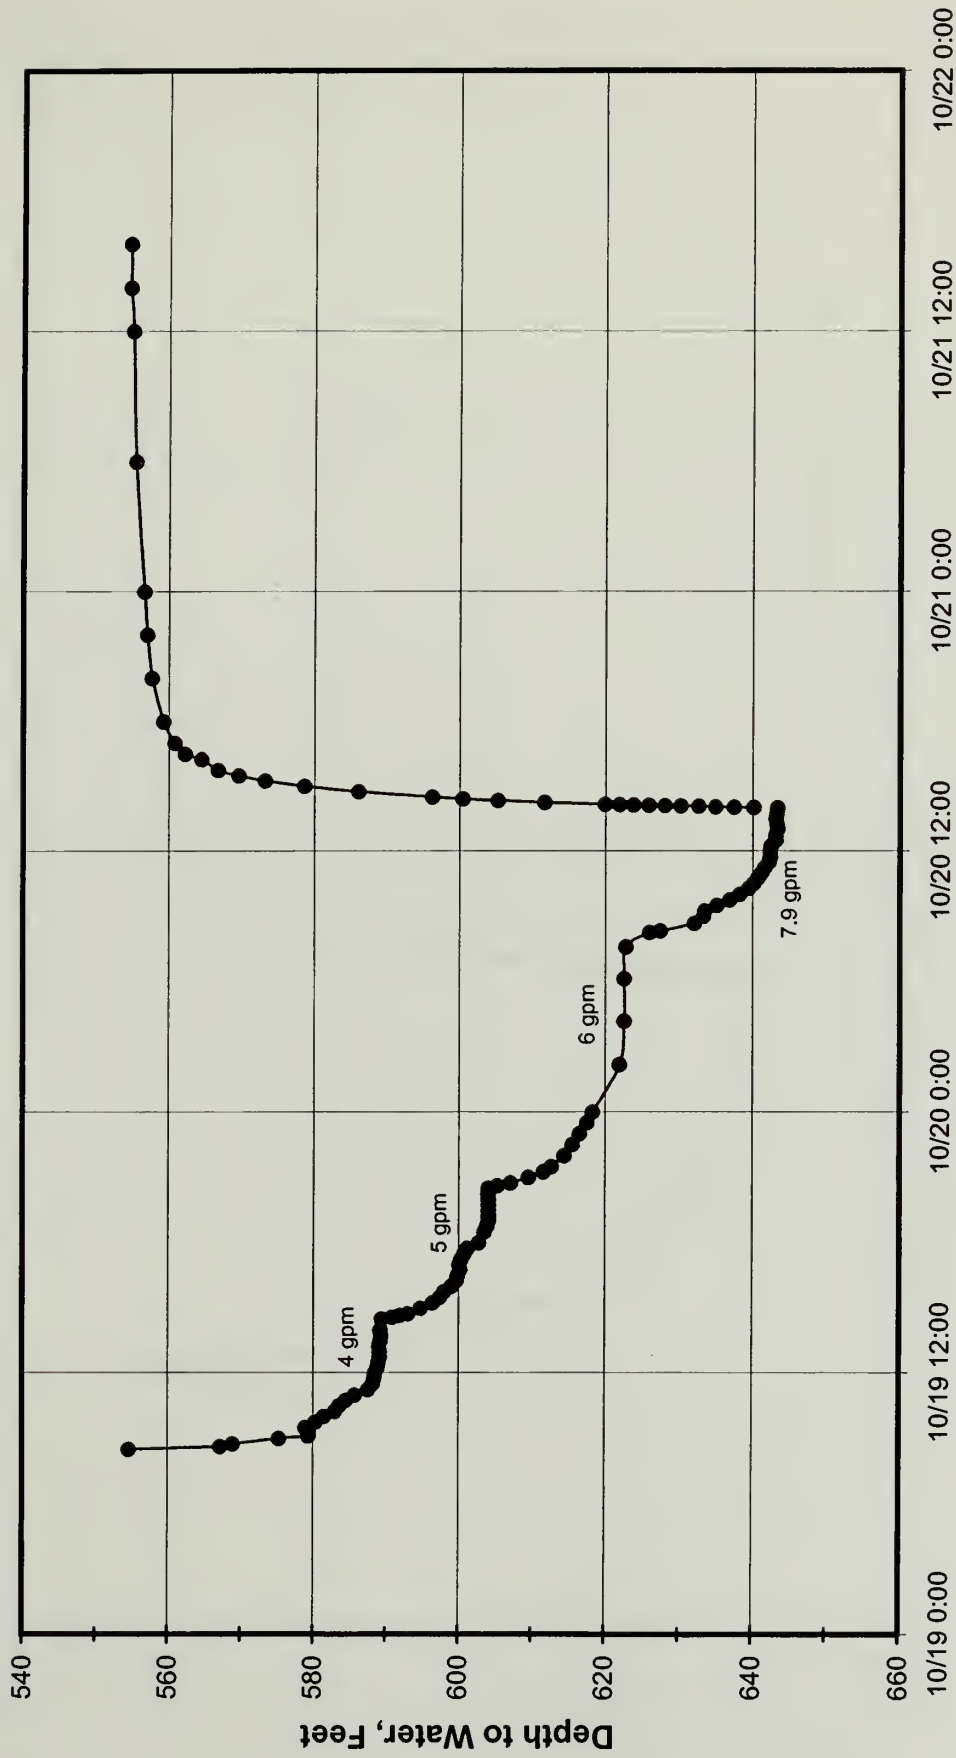
# Natural Bridges National Monument Well No. 2

8 feet of static level within 2 hours, to within 3 feet of static level in 4 hours, and to within 6 inches of static level after 10 hours of recovery.
