MONITORING THE EFFECTS OF FLOWS FROM GLEN CANYON DAM  
ON SAND BAR DYNAMICS IN THE COLORADO RIVER CORRIDOR,  
GRAND CANYON NATIONAL PARK, ARIZONA

Final Report: 1 February 1996

Joseph E. Hazel Jr., Matt Kaplinski, Rod Parnell, Mark Manone, Alan Dale  
Geology Department  
Northern Arizona University, Campus Box 4099  
Flagstaff, AZ 86011

Project Name: COLORADO RIVER SAND BAR SURVEY

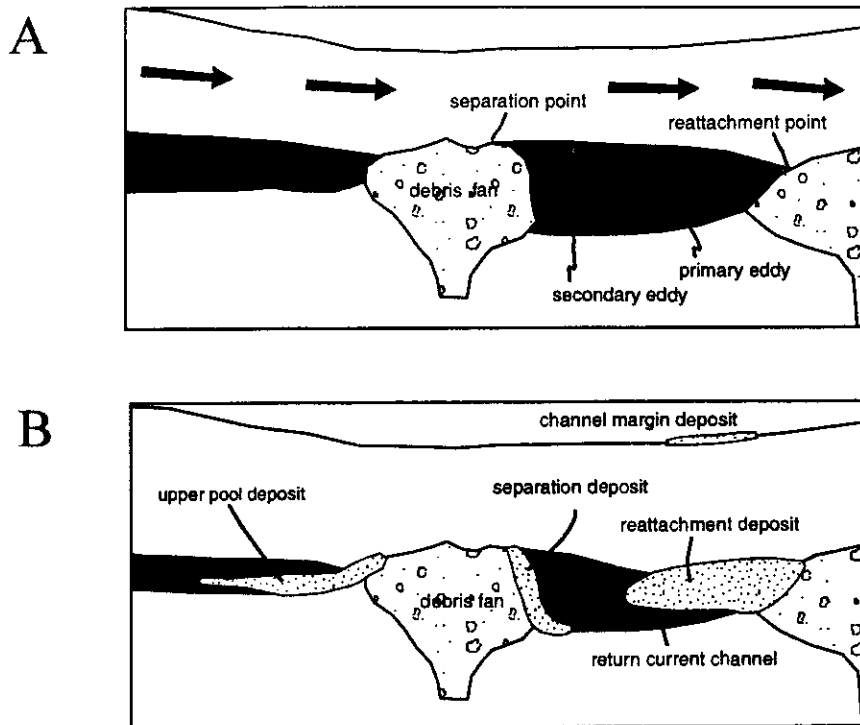
Figure 2. Schematic diagram showing flow patterns and configuration of bed deposits in a typical recirculation zone. A) flow patterns during higher volume flows. B) configuration of bed deposits during lower volume flows. Modified from Schmidt and Graf (1990).

The characteristic channel unit of bedrock canyon rivers with abundant debris fans has been termed the fan-eddy complex (Schmidt and Rubin, 1995). This is a geomorphic assemblage of river constricting debris fan, backwater (pool) above the debris fan constriction, associated eddies with debris fans, and downstream gravel bars. At nearly all tributary junctions, debris fans locally constrict the main river channel (Figure 2; Hamblin and Rigby, 1969; Howard and Dolan, 1981). In the channel expansion above and below the narrowed channel, a recirculation zone (eddy) forms where flow separates from and then reattaches to the bank (Schmidt, 1990). In reaches dominated by debris fans, as much as 75% of the sand-sized sediment load of the Colorado River is deposited within these debris fan-eddy complexes (Schmidt and Rubin, 1995). Water velocities within eddies are much lower than velocities in the main channel and therefore are sites of potential sand deposition by a variety of bar forms (Schmidt et al., 1993). Deposition is typically localized near the separation point, reattachment point, and eddy center (Schmidt, 1990).

Schmidt and Graf (1990) described and categorized several different types of alluvial sand deposits in Grand Canyon. These are:

Reattachment deposits form near the reattachment point of large primary eddies (Rubin et al., 1990). These bars are typically deposited along the downstream regions of the eddy by sediment swept across the eddy toward the shore, perpendicular to the main river current. This type of bar is characterized by a broad platform that extends upstream into the eddy. Return current channels form along the shoreward side of the reattachment bar platform where the eddy current is redirected along the shoreline. When a recirculation zone is present in the pool above the constriction an upper pool deposit is deposited that is similar to reattachment bar morphology or exists as a linear deposit along and parallel to the shoreline.

Separation deposits typically form immediately downstream of the debris fan constriction. They commonly mantle the downstream portion of the debris fan and are deposited in secondary eddies upstream of the larger primary eddy associated with the debris fan. This type of bar is typically steeper and of higher elevation than reattachment bars.

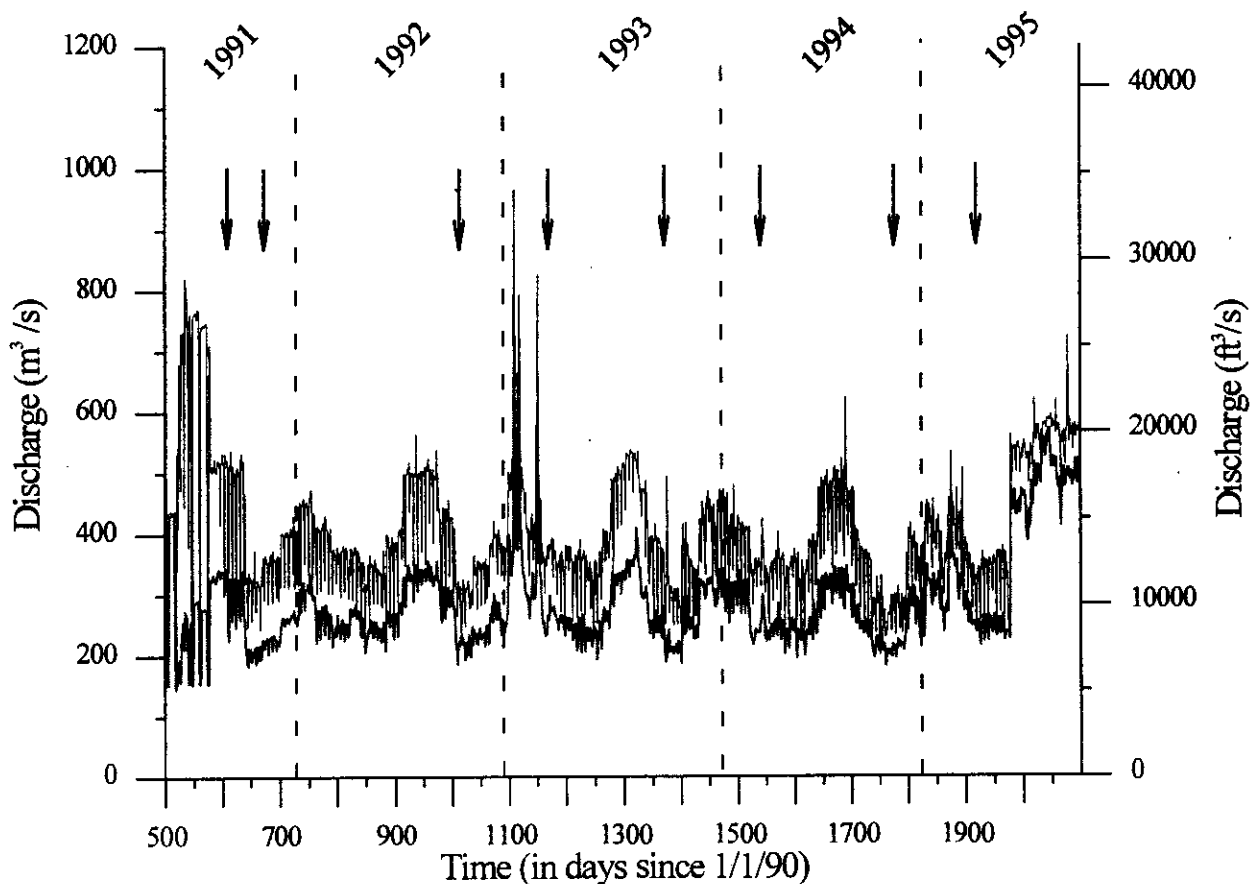
Figure 3. Daily minimum and maximum discharge hydrograph from Colorado River gage near Grand Canyon (RM 88) for the interval between September 1991 and June 1995. Arrows indicate time of sand bar survey conducted. Note seasonal variation in flows. Provisional USGS gage data.

Tributary flooding from the Little Colorado River (LCR) caused significant deviations from regulated flows during the winter of 1993 (Figure 3). Three separate floods, January 12-16, January 19-23, and February, 23-26, 1993, raised flows that peaked at Phantom Ranch (RM88) to approximately 966 m<sup>3</sup>/s (34,120 ft<sup>3</sup>/s), 793 m<sup>3</sup>/s (28,016 ft<sup>3</sup>/s), and 824 m<sup>3</sup>/s (29,100 ft<sup>3</sup>/s), respectively. By raising mainstem flows to slightly above powerplant capacity and delivering a significant amount of sediment, the 1993 winter floods provided an unexpected test-case of a bar-building flow event (Hazel et al., 1993).

Unusually high surface runoff throughout the upper Colorado River basin caused abnormally high flow releases from June 1995 to the present (Figure 3). Flows from GCD between June and October, 1995 have averaged 523 m<sup>3</sup>/s (18,520 ft<sup>3</sup>/s), compared with averages of 350 m<sup>3</sup>/s (12,390 ft<sup>3</sup>/s), 363 m<sup>3</sup>/s (12,882 ft<sup>3</sup>/s), 375 m<sup>3</sup>/s (13,286 ft<sup>3</sup>/s), and 412 m<sup>3</sup>/s (14,599 ft<sup>3</sup>/s) for the same period of time during 1991, 1992, 1993 and 1994, respectively. The effects of this major change in flow regime on the resources of the river corridor remains uncertain, but will be addressed by Fiscal Year 1996 transitional monitoring (Parnell et al., 1995).

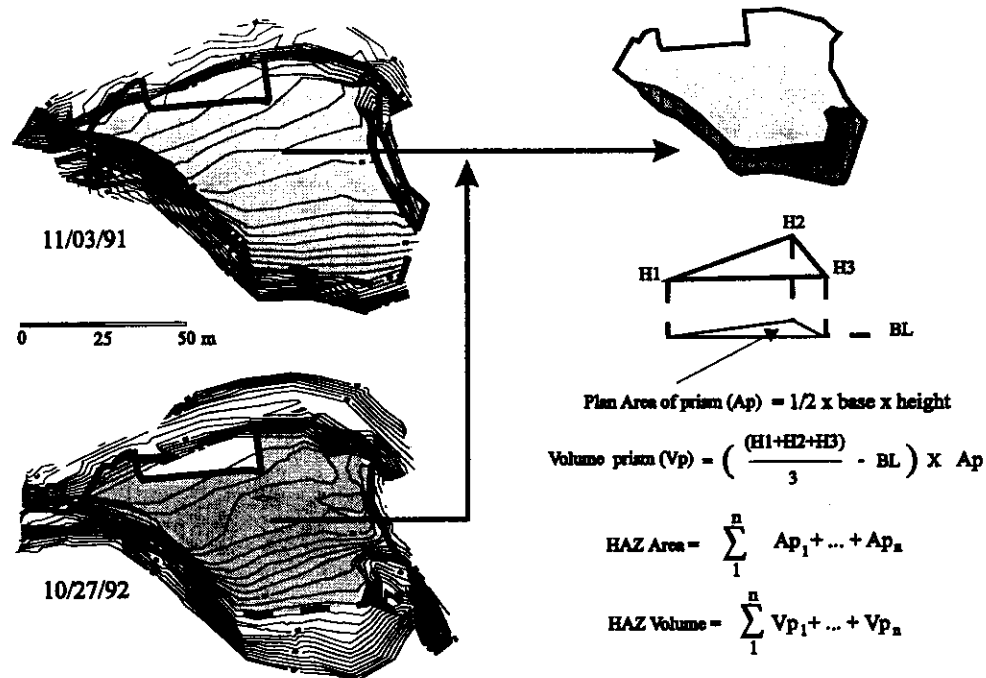
Figure 4. Topographic maps from RM122 showing HAZ boundary and area and volume calculations.

The HAZ boundary consists of two sections: a fixed upper and side section, and a mobile front section. Figure 4 shows an example HAZ zone constructed at RM122 for two different surveys. These segments are formed using the following general guidelines. The upper, or back HAZ boundary is placed at or slightly above (~0.5 m) the 850 m<sup>3</sup>/s stage elevation. While the survey coverage typically extends beyond this stage elevation, placing the HAZ boundary at this level isolates the region directly affected by dam operations. The side sections of the fixed boundary at reattachment bars were placed along the center of the return channel and downstream of the 850 m<sup>3</sup>/s reattachment point. In addition, the HAZ boundary typically excludes large boulders, armored areas, large groves of vegetation, and regions of poor survey accuracy. For example, the fixed section of the HAZ boundary in Figure 4 (solid black line) follows the approximate level of the 850 m<sup>3</sup>/s stage elevation (93-93.4 m) along the rear of the bar, excludes a large boulder and tamarisk trees (the large indentation), and follows the return channel. The lower HAZ boundary is defined by the 142 m<sup>3</sup>/s stage elevation contour in between the intersection with the fixed segment (Figure 4). We determined the total volume and area within the HAZ zone above the 142 m<sup>3</sup>/s elevation contour, and partitioned volumes from a lower HAZ section (between the 142 m<sup>3</sup>/s and the 410 m<sup>3</sup>/s elevation contour), and an upper section (above the 410 m<sup>3</sup>/s elevation contour) (Table 3, Figure 4).

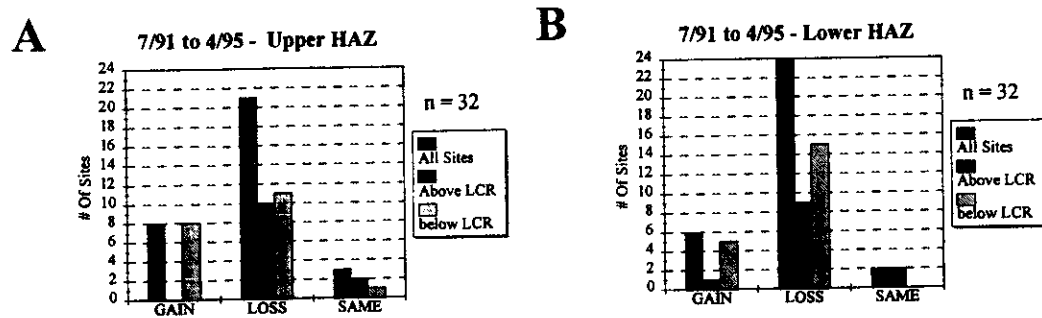
**Figure 5. Histograms of site response to interim flow period for both the upper and lower HAZ sections.**

Comparison of volume changes within the partitioned HAZ section from the beginning of interim flows (7/91) to the latest survey run (4/95) show that, within the upper HAZ section, sites above the LCR decreased an average of 32.3%, while sites below the LCR lost an average of 13.9% (Figure 5). In comparison, changes within the lower HAZ section show that sites above the LCR averaged a 21.3% loss, while sites below the LCR gained an

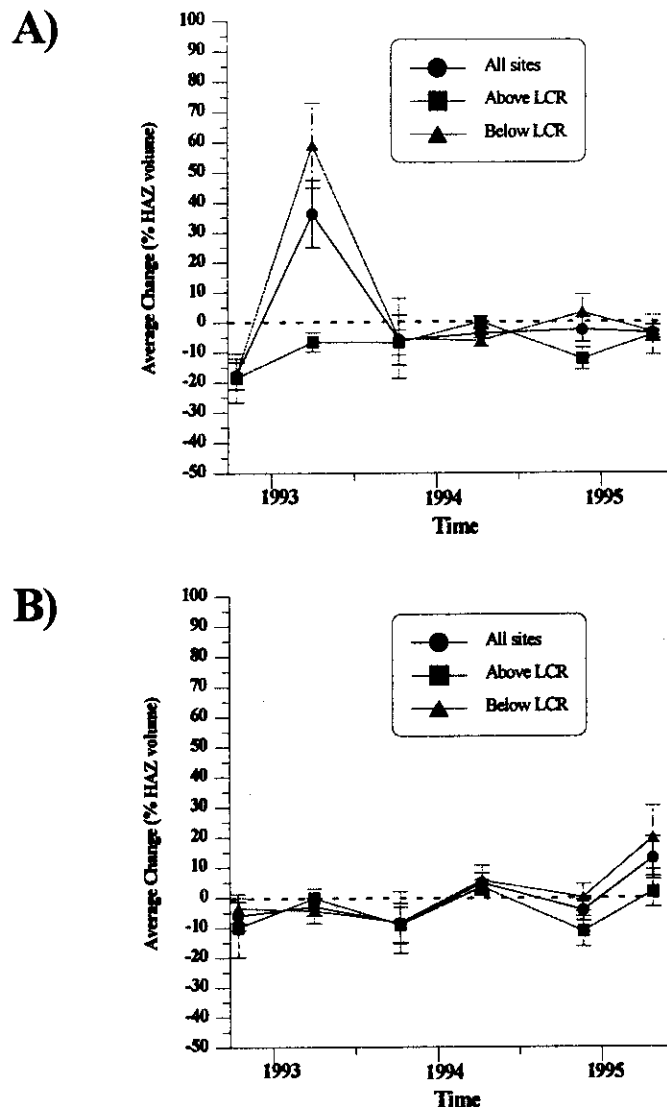
**Figure 6. Averaged percent change for each survey run (standard error about the mean error bars) vs. time for A) upper HAZ section, and B) lower HAZ section.**

average of 14.5%. The average percent change between each survey run is shown in Figure 6 for both the upper (Figure 6A) and lower (Figure 6B) sections. Negative values in Figure 6 are indicative of a system-wide or reach-wide loss in volume from within the upper or lower section of the HAZ boundary. This plot reveals that sand bars were eroded for the majority of survey comparisons in both the upper and lower sections but that there was a large positive percent change in sand volume below the LCR, the effects of which rapidly diminished in 1993 (Figure 6).

The most significant change within the lower HAZ section occurred during the most recent interim flow monitoring. The volume change from 11/94 to 4/95 in Figure 6b was significantly larger than comparisons of change from 7/91 to 10/92, 4/93 to 10/93, and 4/94 to 11/94 (difference in rank sums  $\leq 37.24$ ,  $p(0.05)$ ). This increase in the lower HAZ volume reflects the redistribution of sand along the lower bar elevations, either from eroded higher elevation sand or sediment transported by mainstem flows, or both. It is important to note that, while this survey shows a depositional response to GCD releases, the total increase is not substantial enough to offset the loss of sediment incurred during the previous four years of interim flows and the gross volume of sediment in the lower HAZ section shows a significant loss (Figure 5, Appendix A). Interestingly, the lower HAZ volume changes exhibit a fluctuating pattern of volume change (Figure 6b). This oscillation of change within

the lower zone suggests that sediment subject to daily inundation by the river is being reworked and transported into and out of the lower HAZ section. This trend also suggests that antecedent conditions may play an important role in determining whether a particular site loses, or gains sediment below the elevation reached by flow fluctuations. Conversely, this pattern could be a completely random phenomena and appears as a discernable pattern due to the fact that our sampling interval (approximately 6 months) is long, compared to the rate at which the process of erosion and deposition can occur at an individual sand bar, which is of the order of hours to days in some cases (Cluer, 1995).

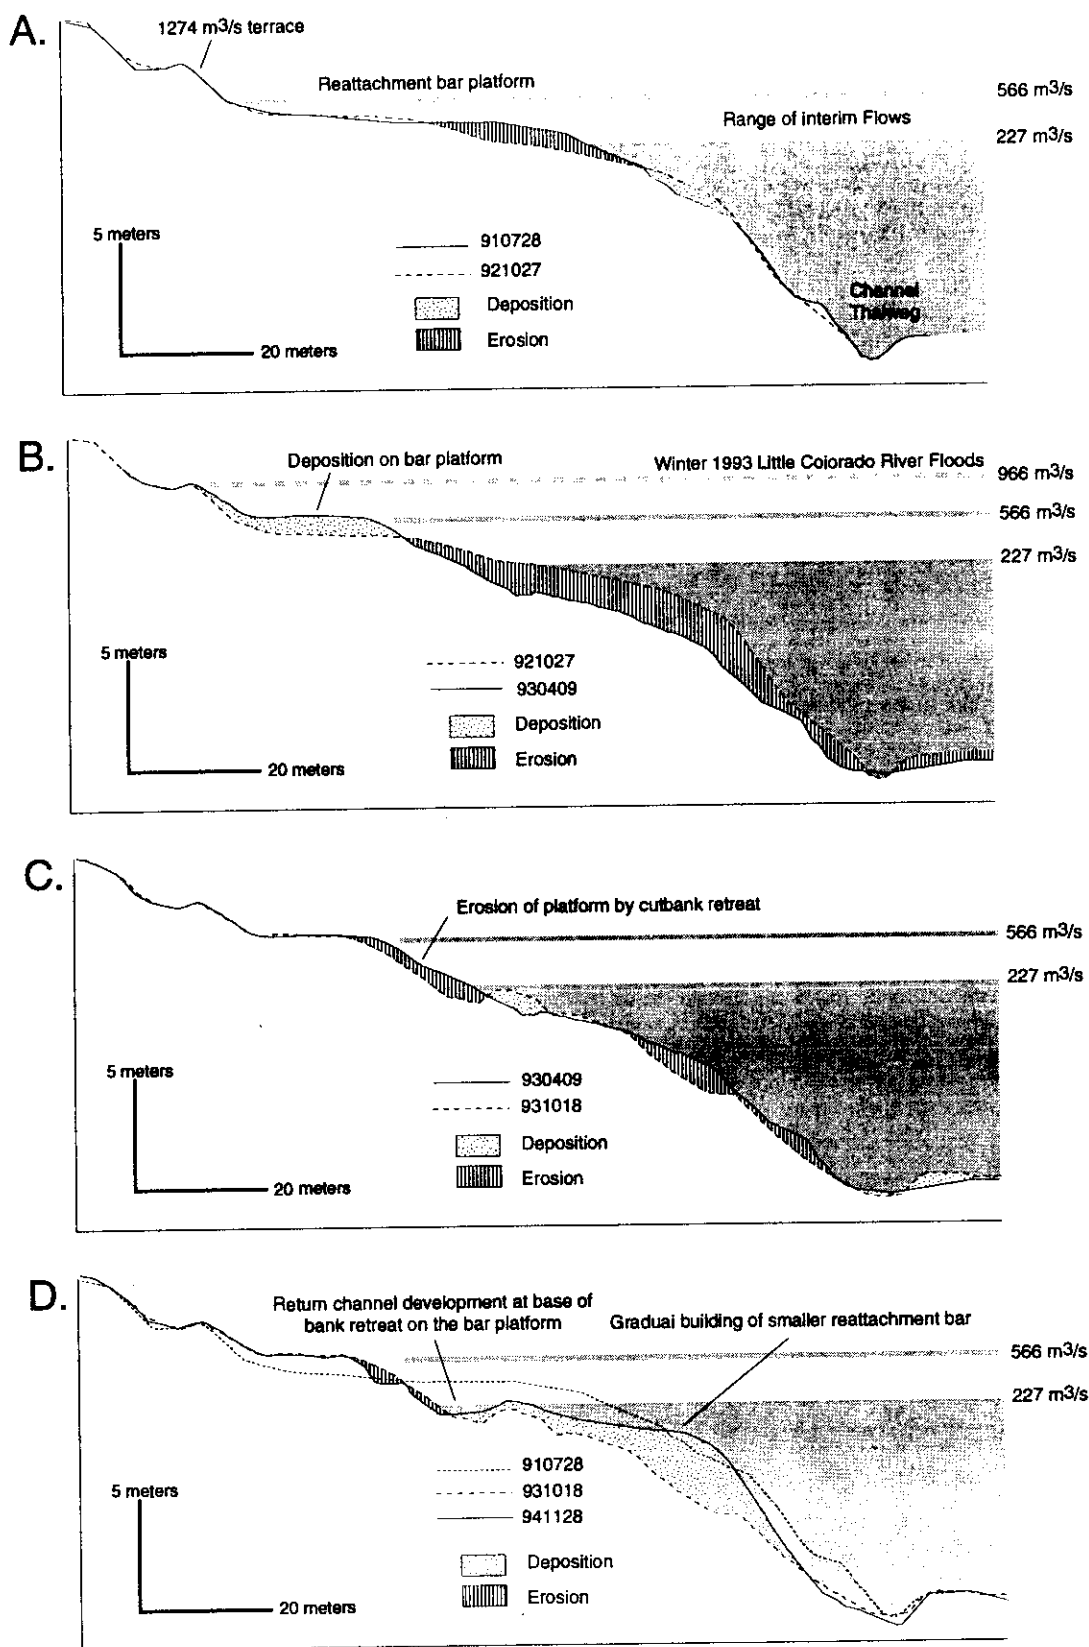
**Figure 7. Topographic profile comparisons from the RM 122 site demonstrating general patterns of sand bar changes between survey runs during the interim flow period. A) 7/28/91 to 10/27/92, B) 10/27/92 to 4/09/93, C) 4/09/93 to 10/18/93, D) 7/28/91 and 10/18/93 to 11/28/94.**

The following patterns of erosion and deposition of sand bars along the Colorado River have been recognized during the interim flow period. In Figure 7, a cross section from the 122 mile study site is used to illustrate the changes we have observed. The beginning of the interim flow period was characterized by system-wide erosion of both the upper and lower HAZ sections as the sand bars, following a year of test flows (see Beus and Avery, 1992), adjusted to the new, lower volume flow regime (Figure 7a). Surveys conducted in April 1993 indicated that the winter floods from the LCR deposited a significant amount of sediment at topographic levels not reached by interim flows. Near the LCR confluence, the flood deposits consisted mostly of sand delivered from the LCR drainage. However, further downstream (approximately 30 miles), comparison of cross-channel profiles suggest that the flood deposits were derived from the redistribution of the lower areas of sand bars and sediment stored in the main channel (Hazel et al., 1993; Kaplinski et al., 1995)(Figure 7b). Sand bars above the LCR confluence were not affected by the high flow events and continued to erode. Following the LCR high flow events, erosion rates increased significantly at bars affected by the flood, then decreased to "normal" rates within approximately nine months. After the LCR events, a consistent, system-wide pattern of erosion developed. The upper elevations of the study bars lost HAZ volume as sediment was distributed within and out of the lower HAZ zone. The sand storage capacity of eddys was lessened by interim flows because recirculation zones are smaller during low flows (Schmidt, 1990). Without restoration of sediment to the upper elevations of sand bars, the pattern of interim flow erosion will continue to adversely effect the riparian ecosystem. High flow events planned for Spring, 1996 have been designed to replace this eroded sediment and restore a seasonal high flow/bar building event to the system. We believe that the long-term effects of this high flow event will be beneficial to the ecosystem as a whole, and to the long-term maintenance of sediment along the river.
