**UNITED FIRST PARISH CHURCH (UNITARIAN)**

***CHURCH OF THE PRESIDENTS***

**HISTORIC STRUCTURE REPORT**

**Quincy, Massachusetts**

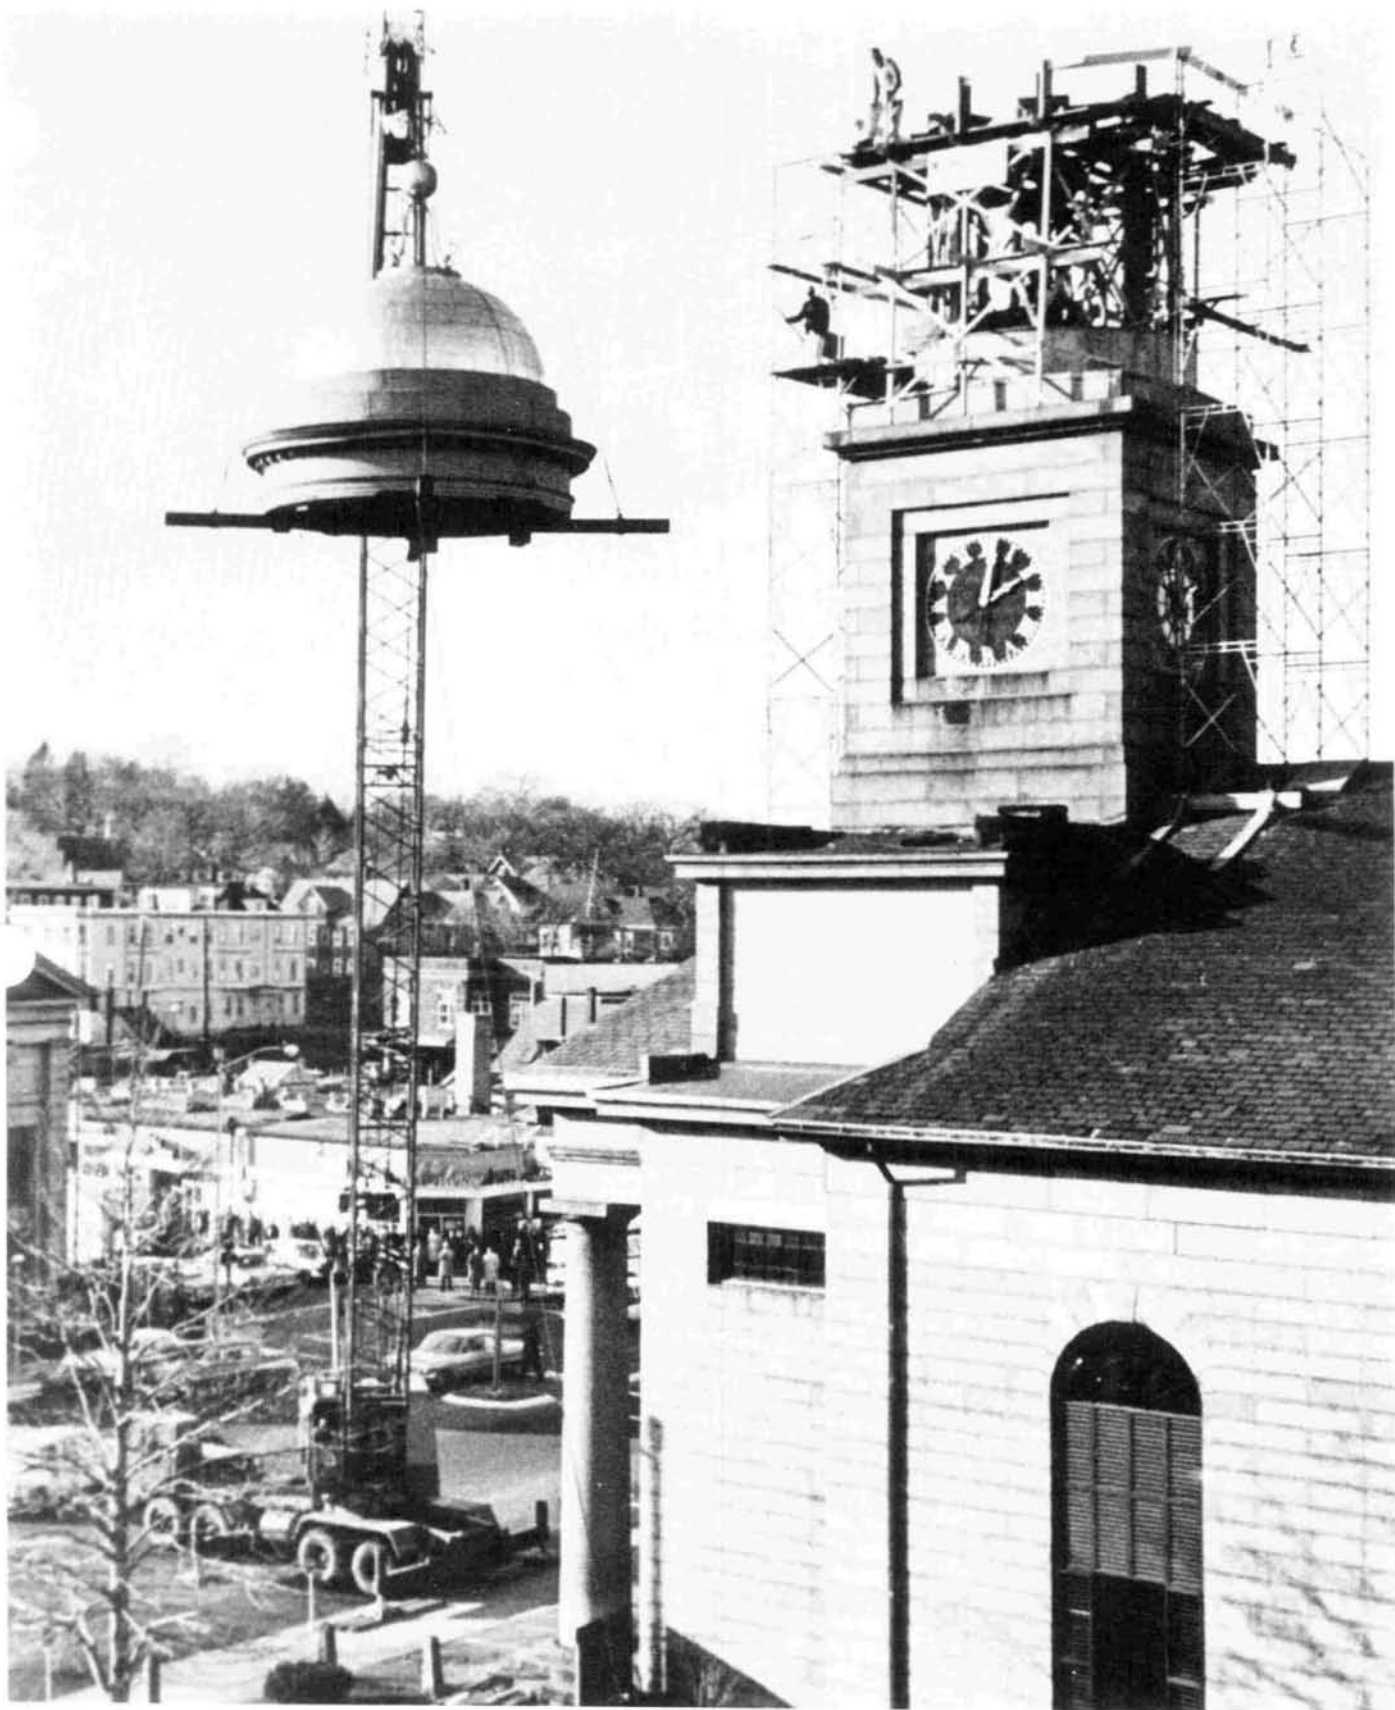
The church committee agreed to follow their suggestion.<sup>496</sup> MacLeod submitted a proposal to the engineering firm, outlining the removal of the dome, the placement of it on staging at least 6 feet above the ground (see figure 48), and the procedure for removing the wood columns and capitals.<sup>497</sup>

Figure 48. Belfry repairs and dome removal (photograph ca. 1964).

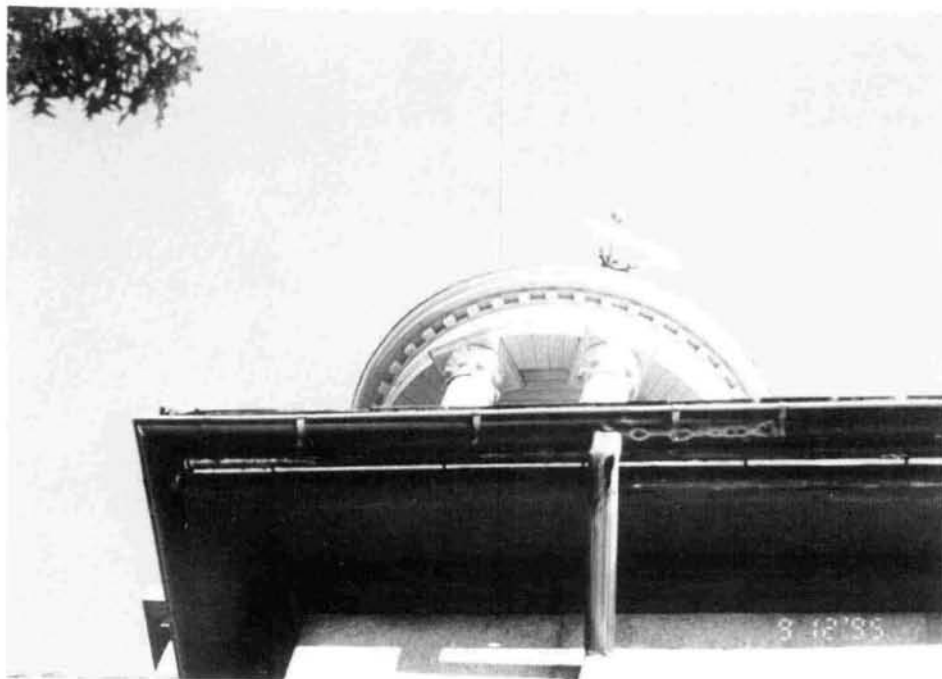
**Figure 75.** Church exterior: southwest corner of roof, showing hanging half-round copper gutter and rectangular downspout, with oxidation and pitting of the copper.

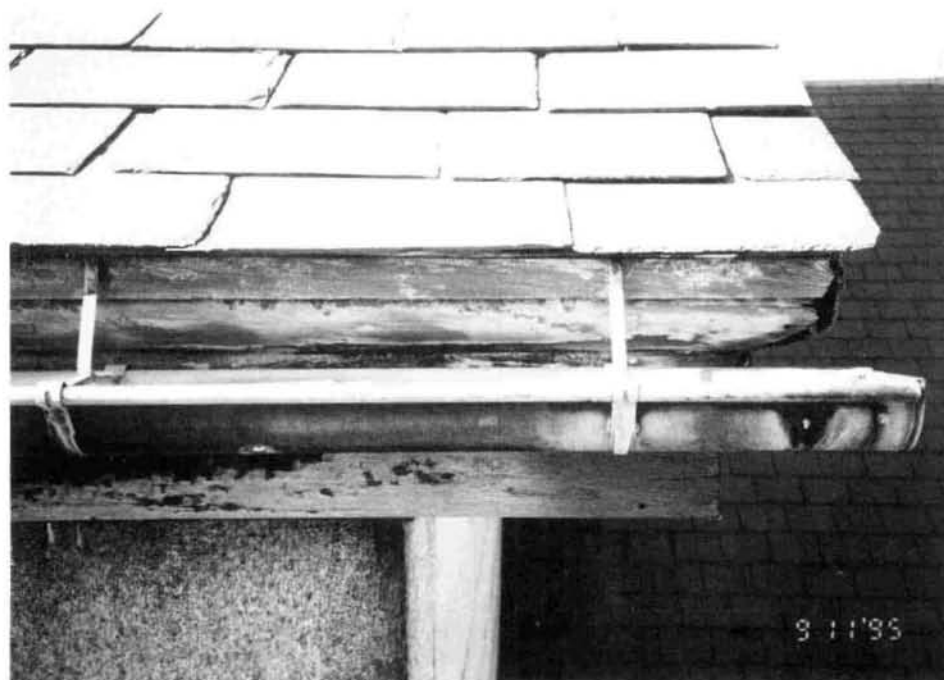
**Figure 76.** Church exterior: southeast corner of the roof, showing hanging half-round copper gutter with oxidation and pitting, and peeling paint and open joints of the wooden cornice moldings.

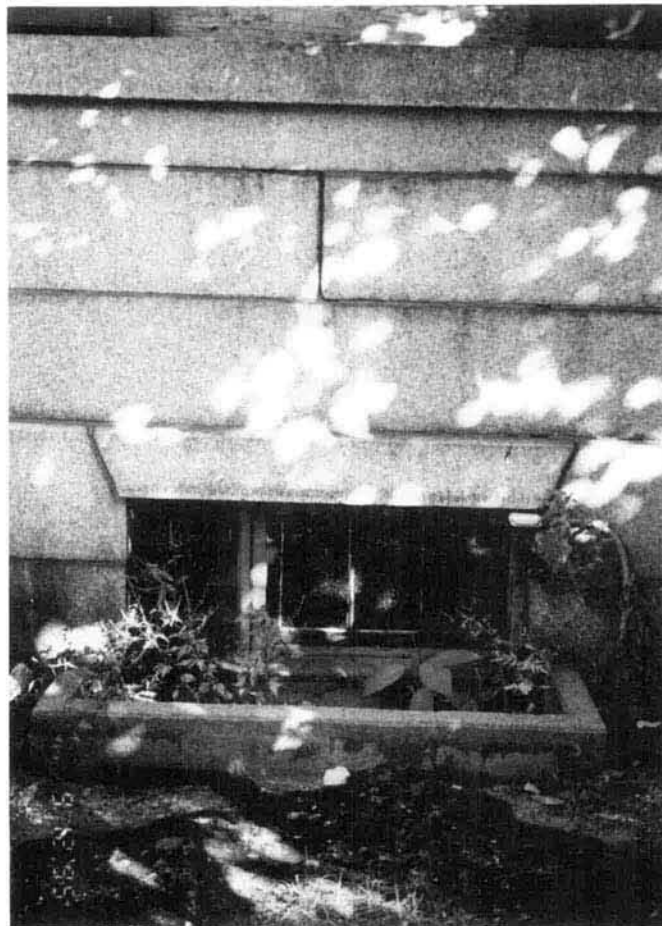
**Figure 88.** Church exterior: south wall, basement window (W004).

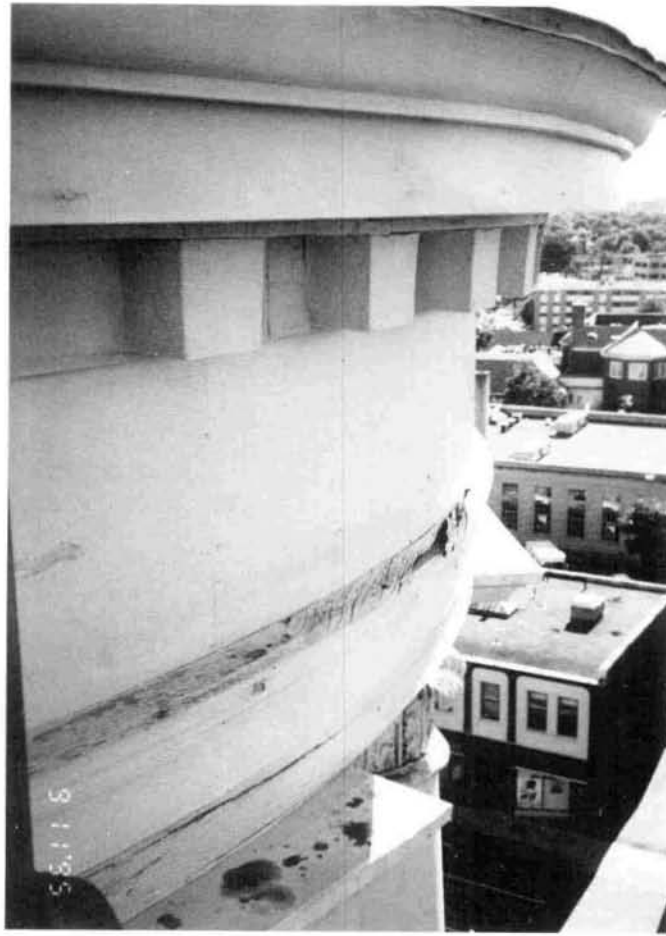
Figure 91. Tower exterior: belfry, modillioned cornice.

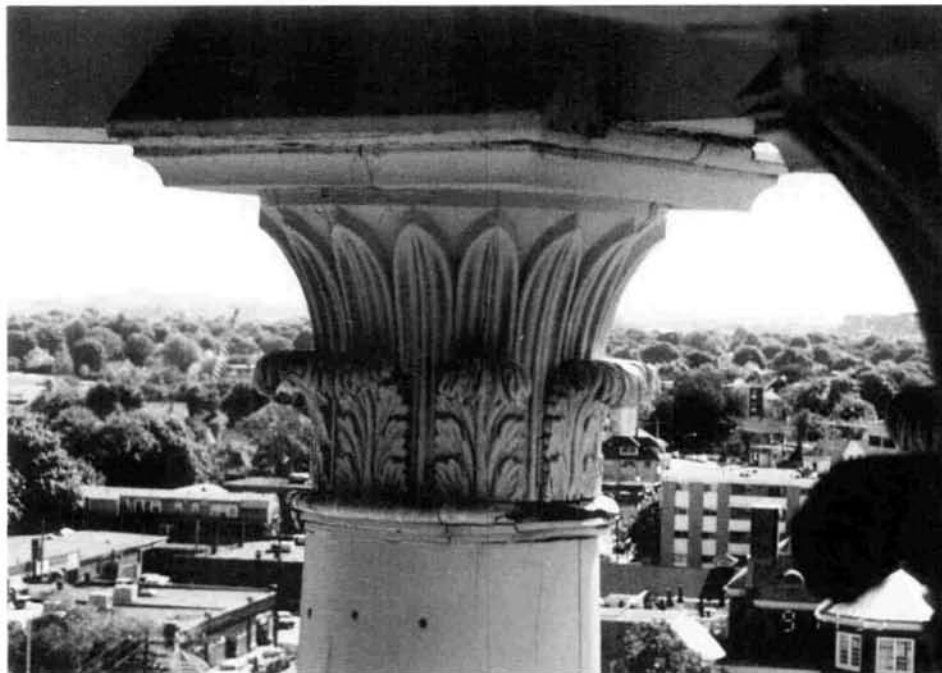
Figure 92. Tower exterior: belfry, capital of southeast column.

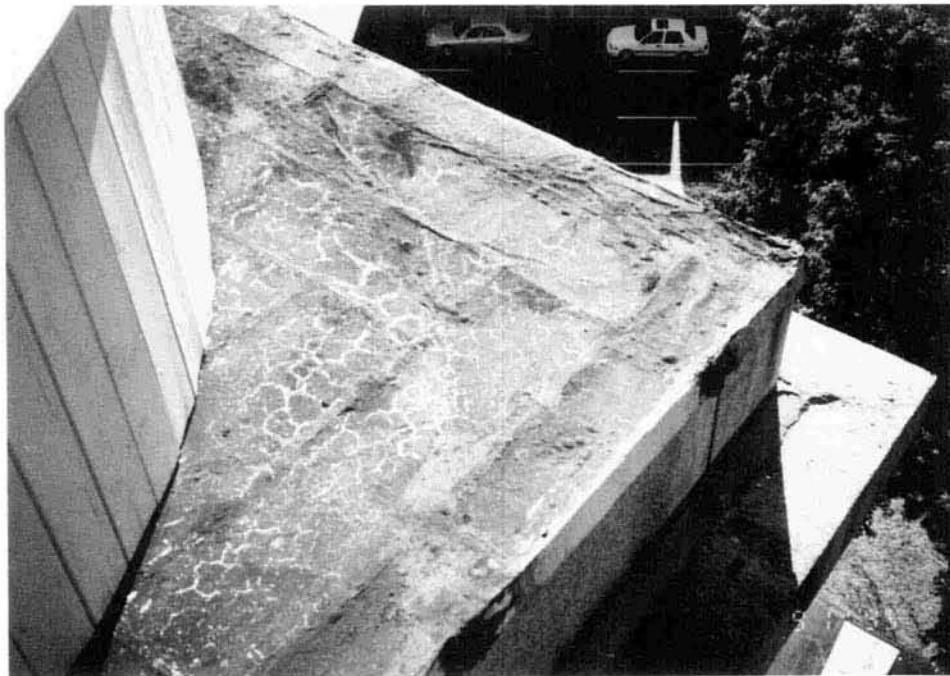
**Figure 93.** Tower exterior: belfry drum and roof of shaft at southwest corner. Roof of bituminous asphalt over flat-seam copper now weathered, dry, and brittle.

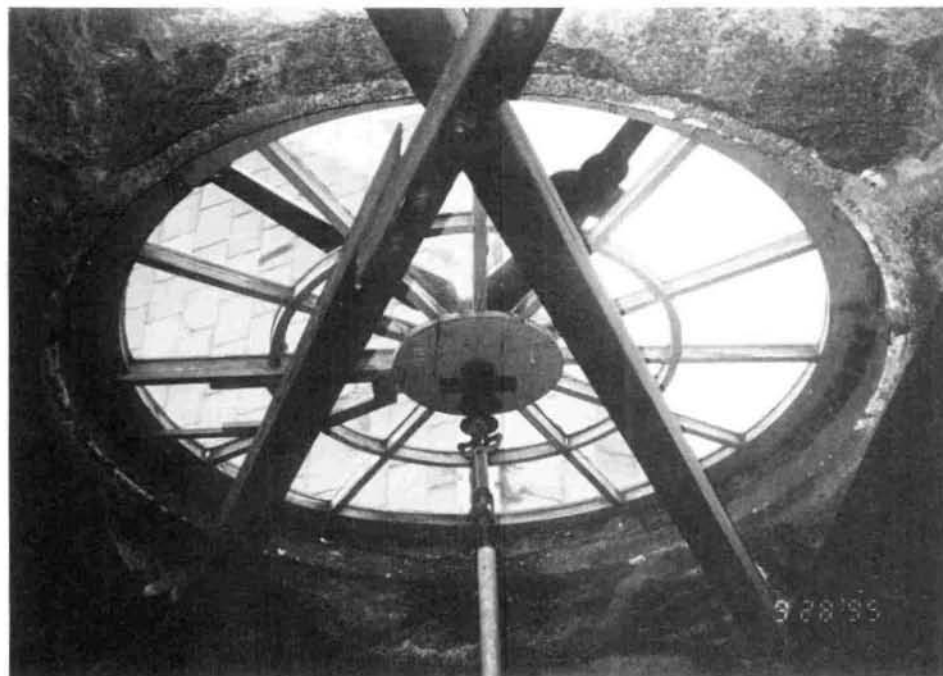
**Figure 96.** Tower interior: shaft, east clock face. Note lack of maintenance of wood elements, and modern interior tower support in foreground.

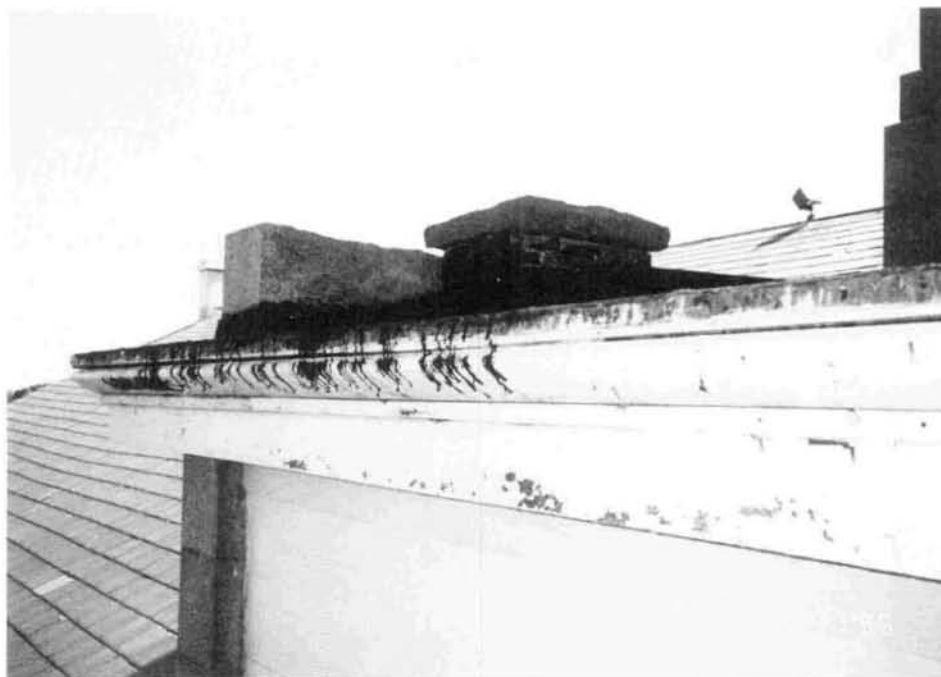
**Figure 97.** Tower exterior: base, cornice of north side of roof. Note careless application of bituminous asphalt over flat-seamed copper roof, and typical lack of maintenance of inaccessible areas.

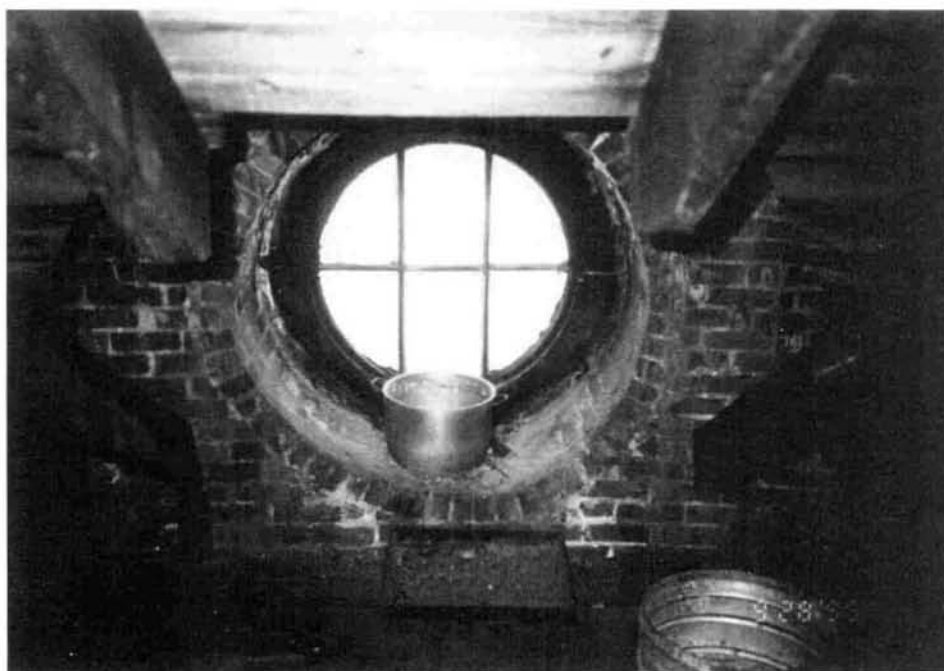
**Figure 104.** Addition interior: east wall, attic oculus (W202). Note effects of leaks through the flashing and/or the open joints of the sash and surround, and repointing of brickwork.

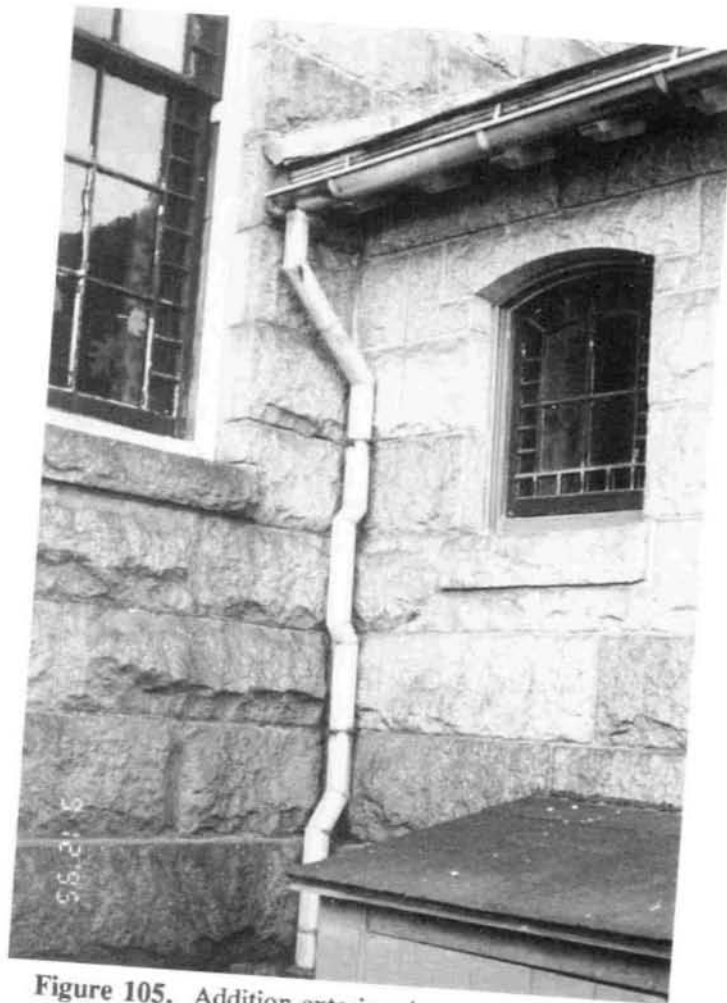
Figure 105. Addition exterior: intersection of north wall and north porch, showing gutter and downspout.

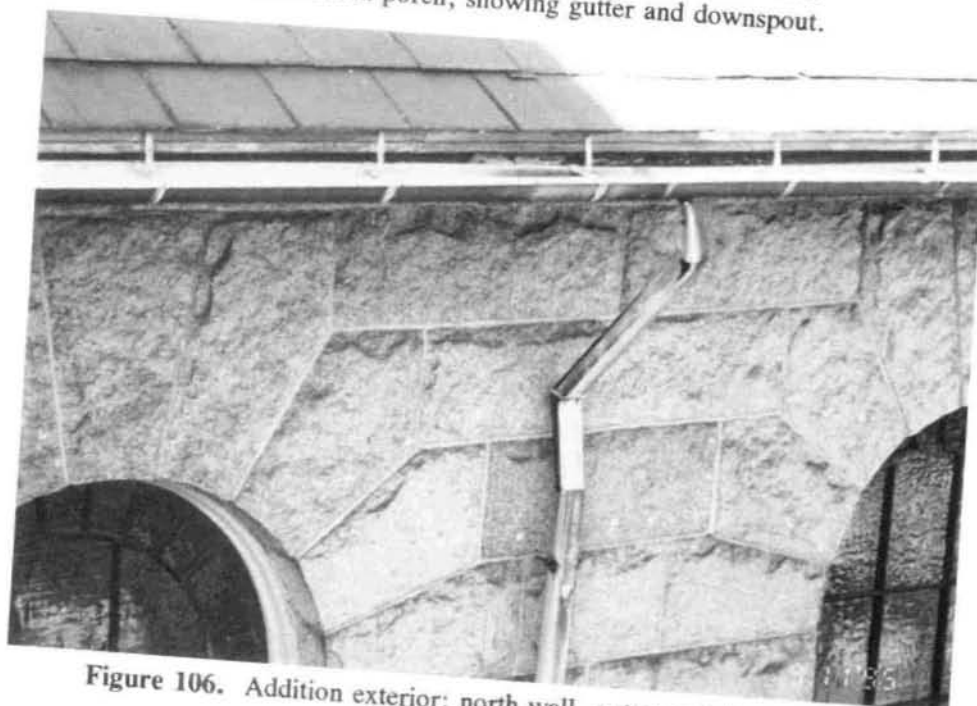
Figure 106. Addition exterior: north wall, gutter and downspout.

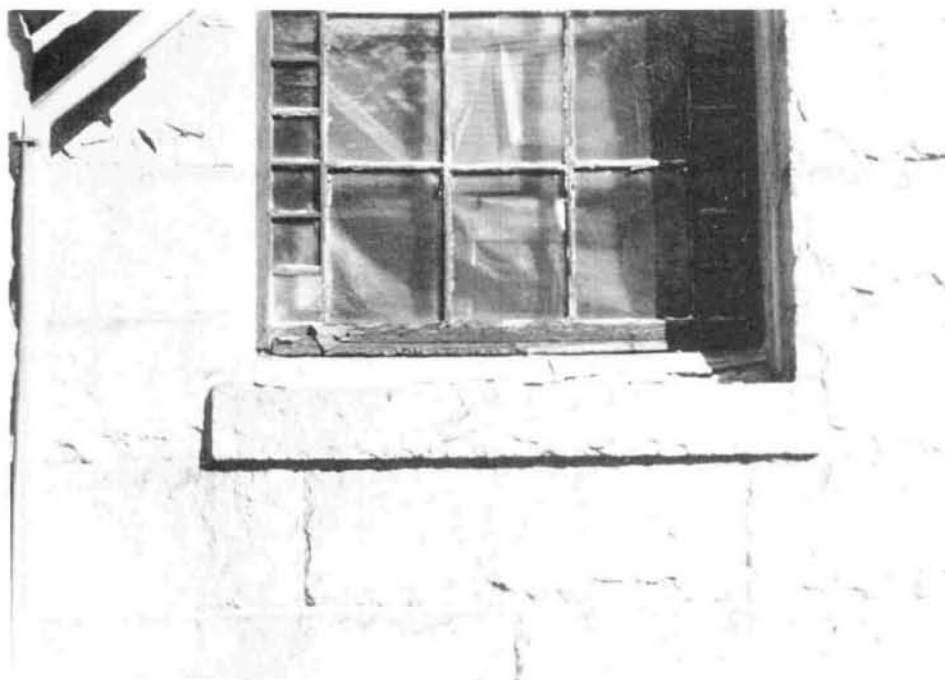
**Figure 107.** Addition exterior: south wall, bottom of center window (W108).  
Note dry wood, peeling paint, and open joints of both sash and surround.

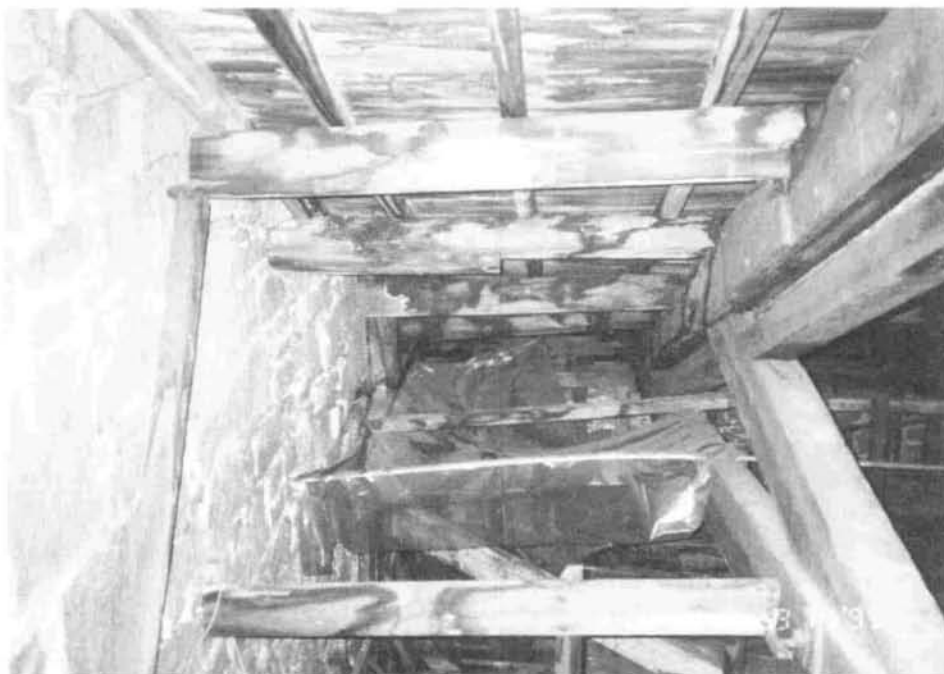
**Figure 113.** Church interior: attic, north end of west wall, at intersection with sanctuary ceiling.

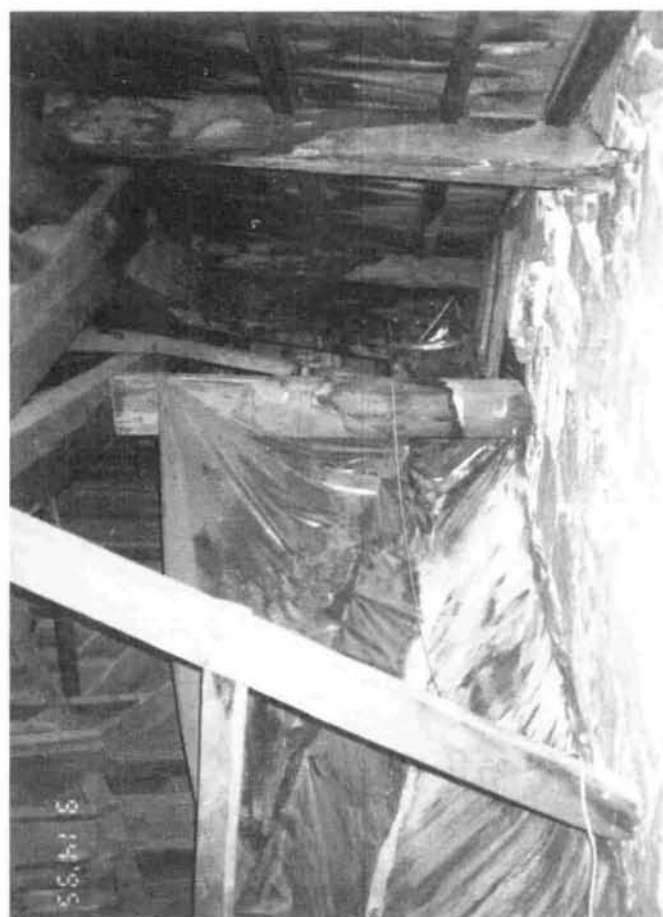
**Figure 114.** Church interior: attic, south end of west wall, at intersection with sanctuary ceiling.

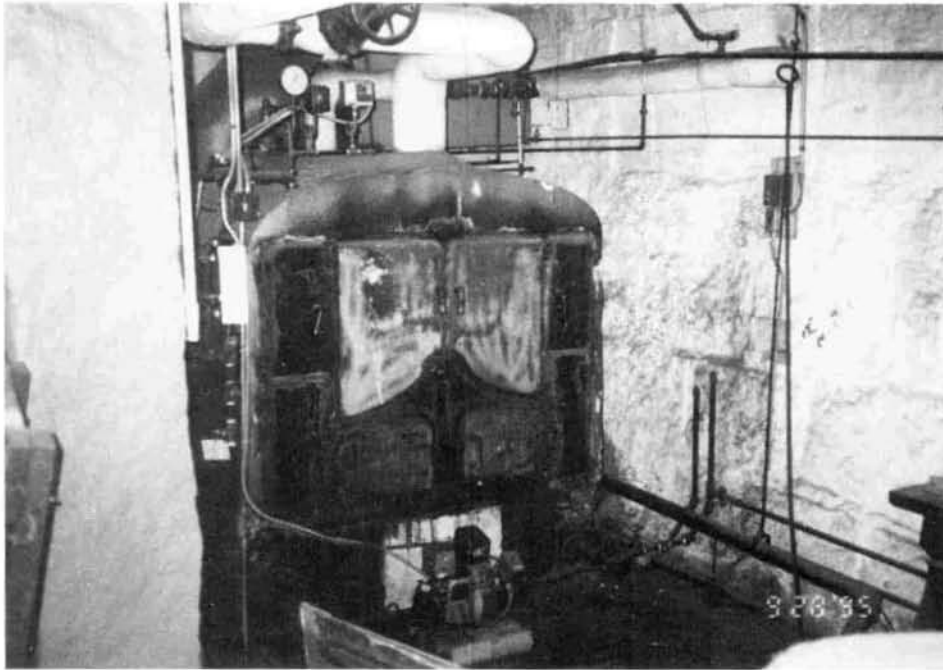
**Figure 117.** Church interior: basement furnace room.

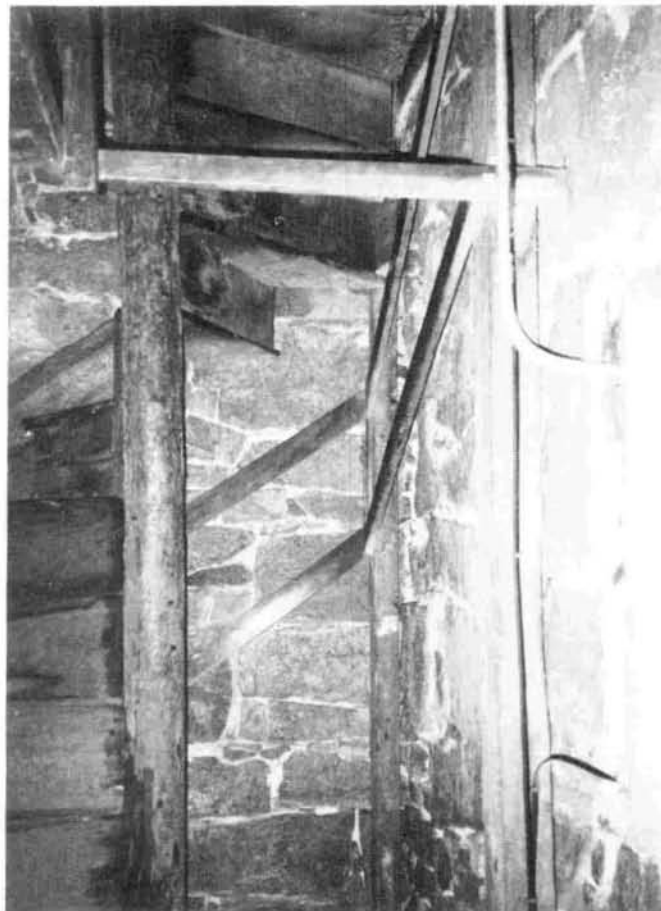
**Figure 118.** Tower interior: plinth room (Room 301),  
view northwest toward spiral staircase.

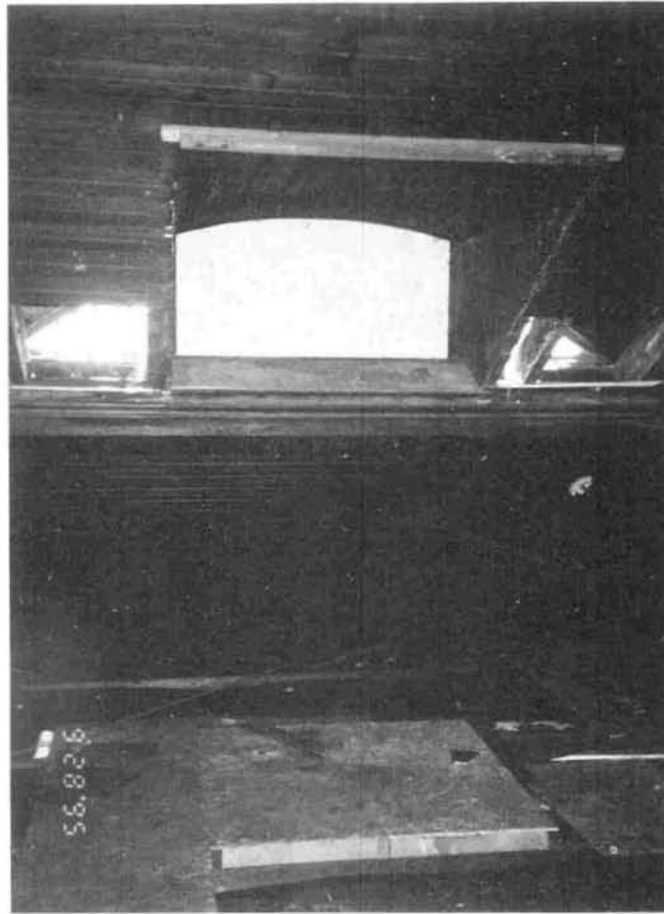
**Figure 121.** Addition interior: west attic (Room 204), south eyebrow window (W201).

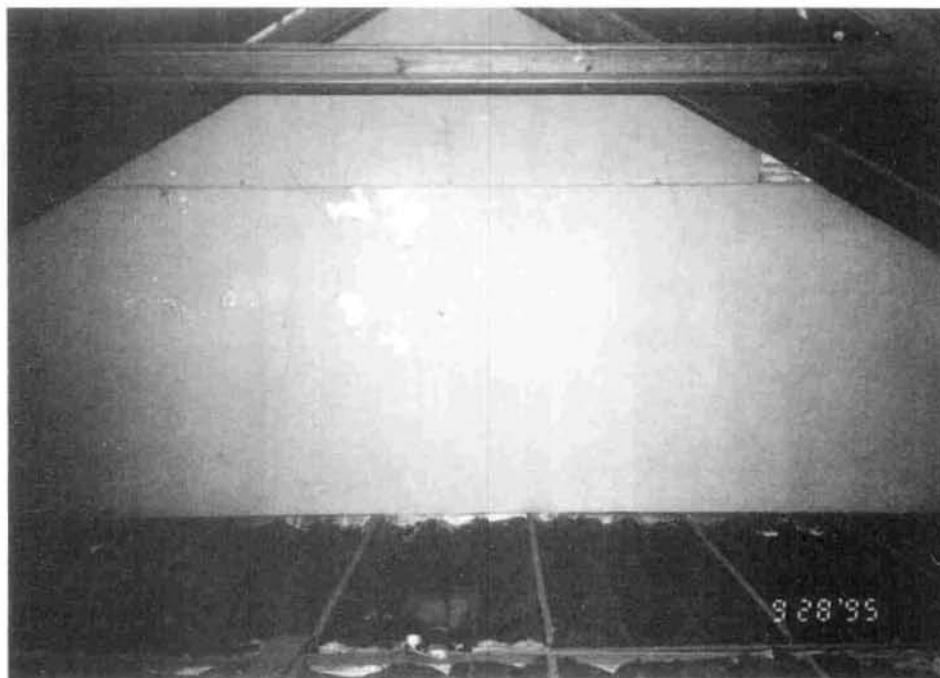
**Figure 122.** Addition interior: east attic (Room 205), west wall and suspended ceiling of the Parish Hall (Room 104) below.
