**ALANSON SWAN  
HOUSE**  
Cuyahoga Valley National  
Recreation Area  
**HISTORIC STRUCTURES  
REPORT  
ARCHITECTURAL DATA  
SECTION**

**Prepared by**  
**S. Elizabeth Sasser**  
Historical Architect

**March 1987**

National Park Service  
Denver Service Center  
Williamsport Preservation Training Center

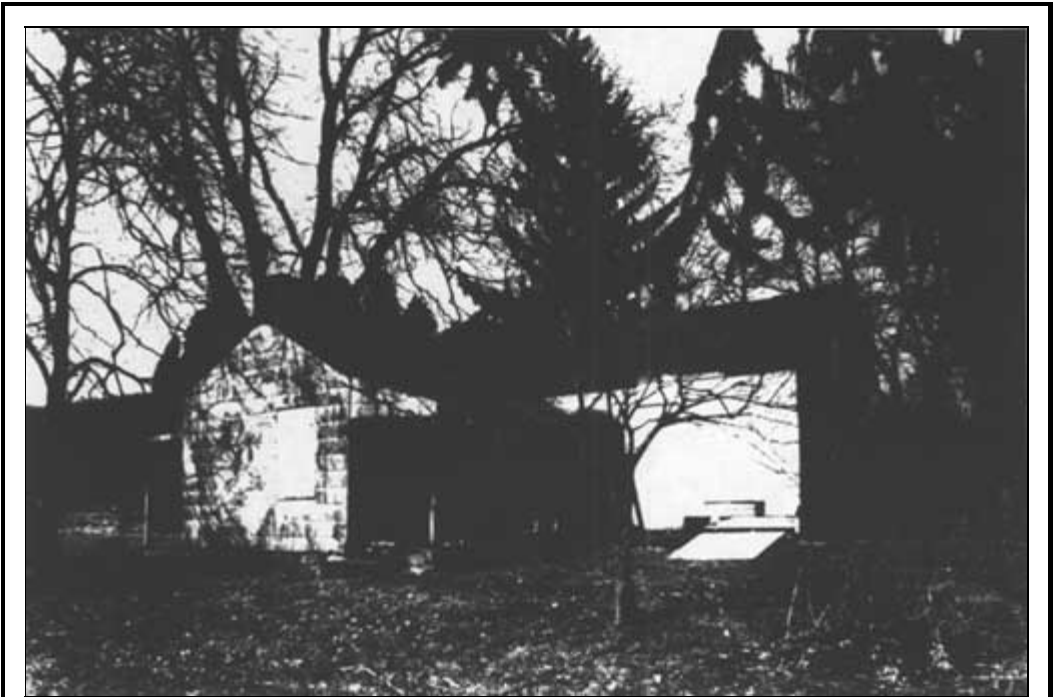
SOUTH AND EAST FACADES

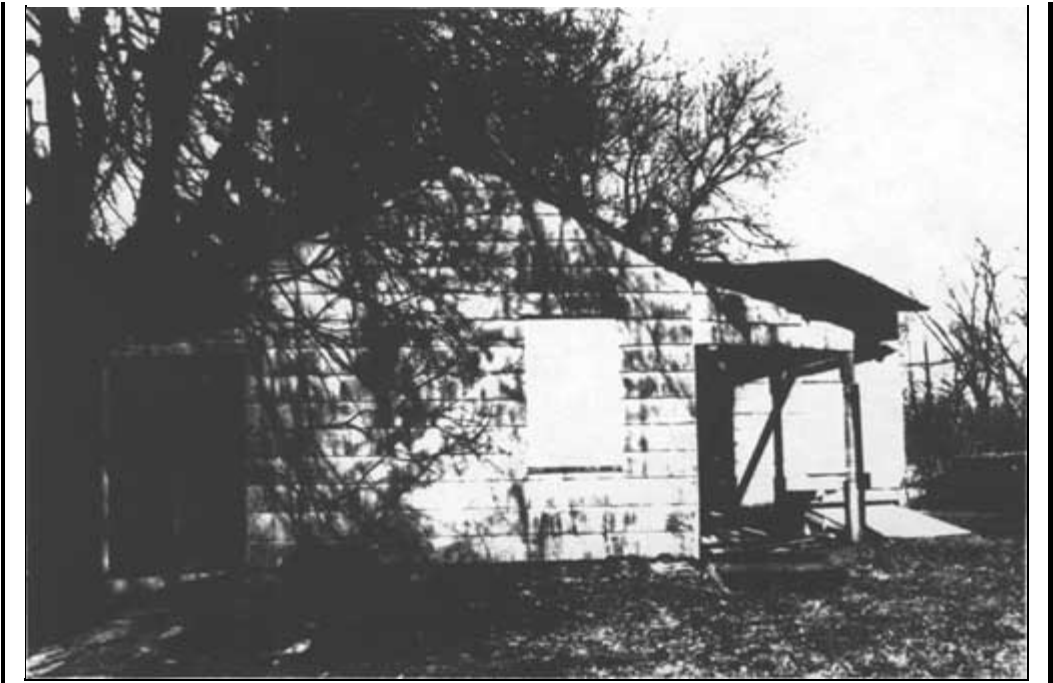
SOUTH ELEVATION OF KITCHEN ELL

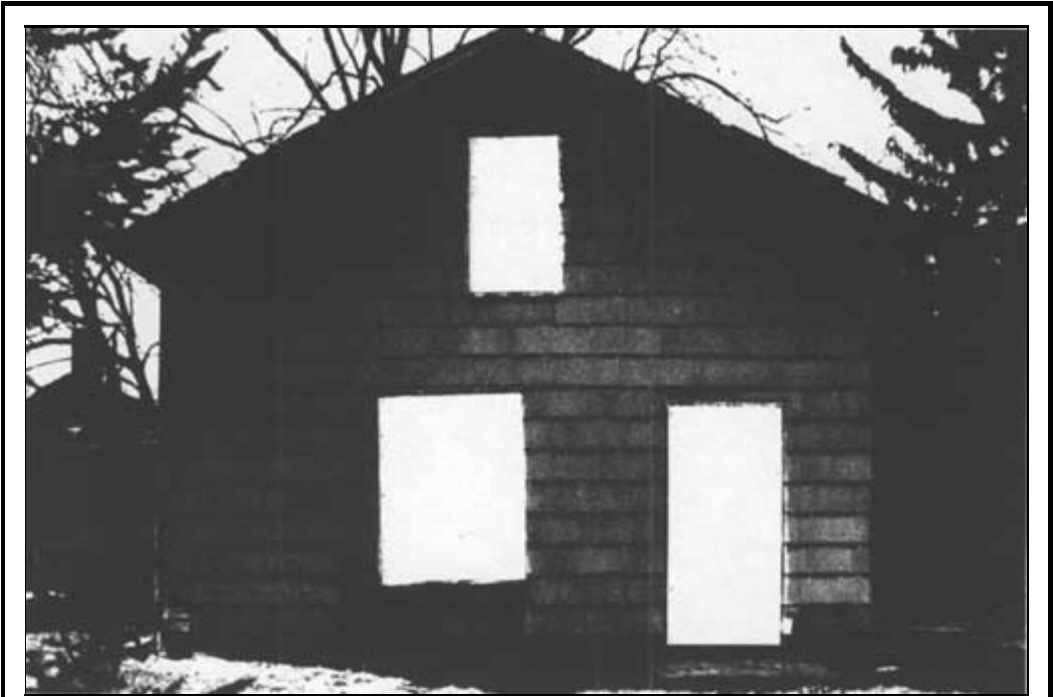
EAST ELEVATION OF MAIN WING

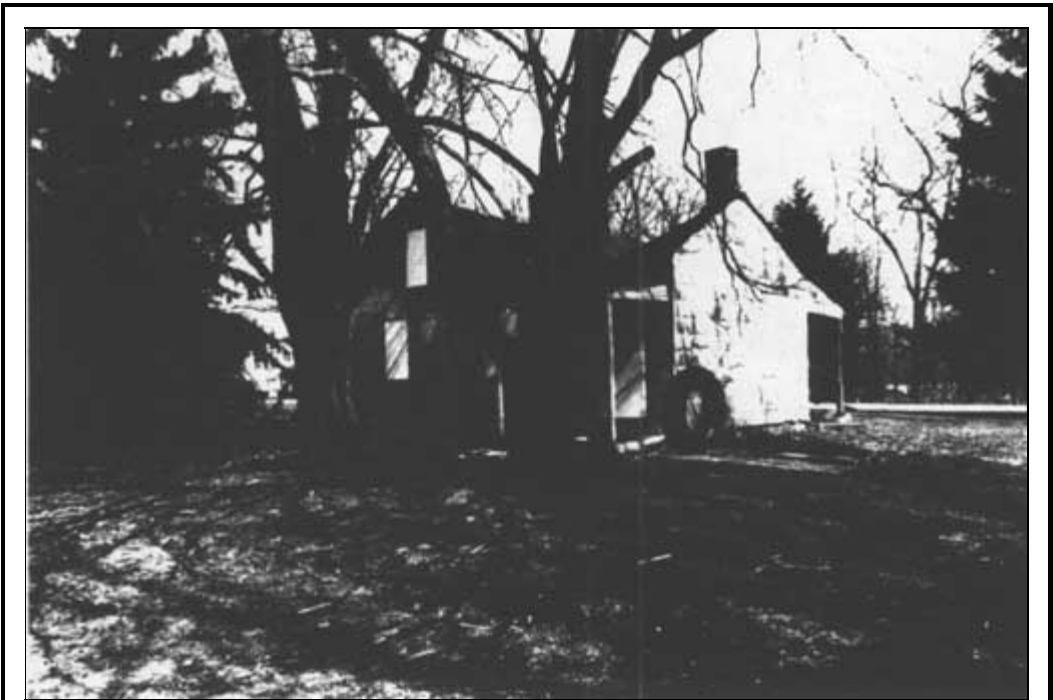
WEST AND SOUTH ELEVATIONS

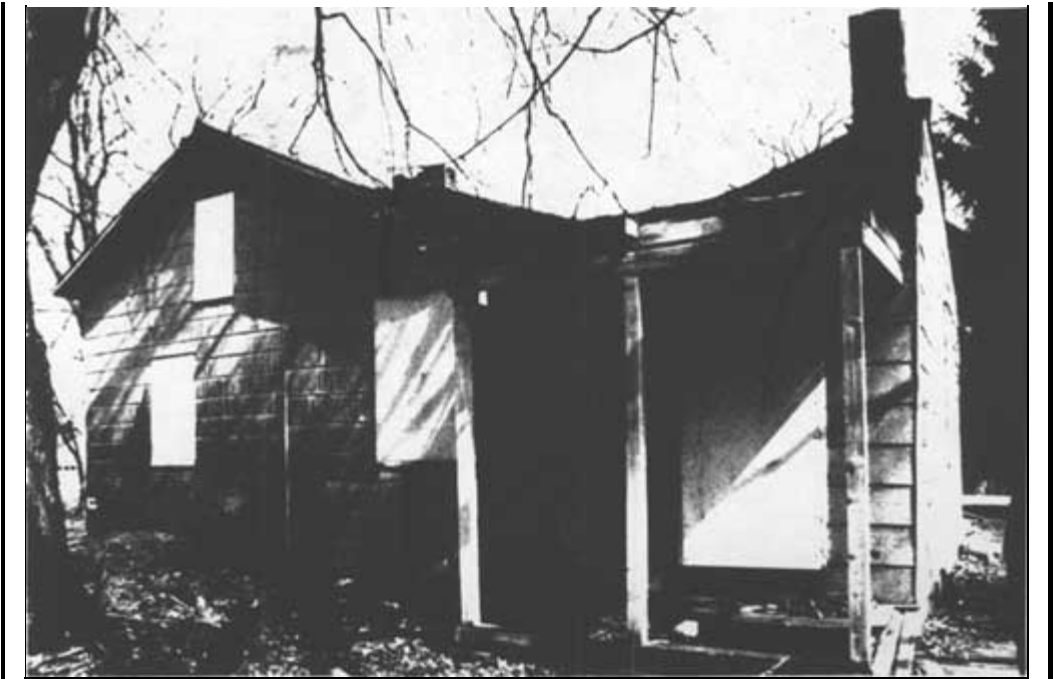
REAR PORCH

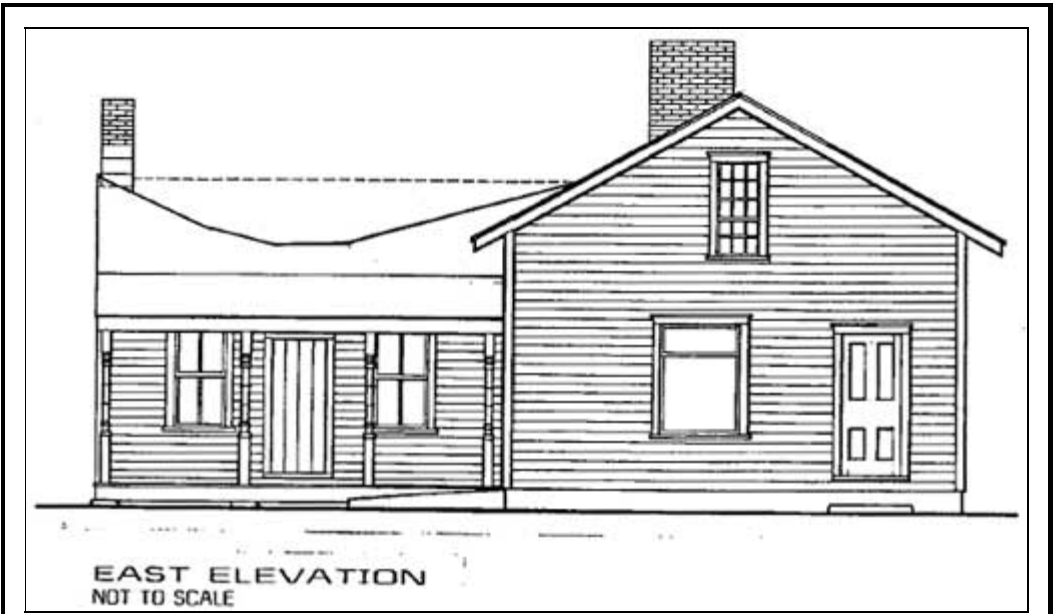
EAST ELEVATION

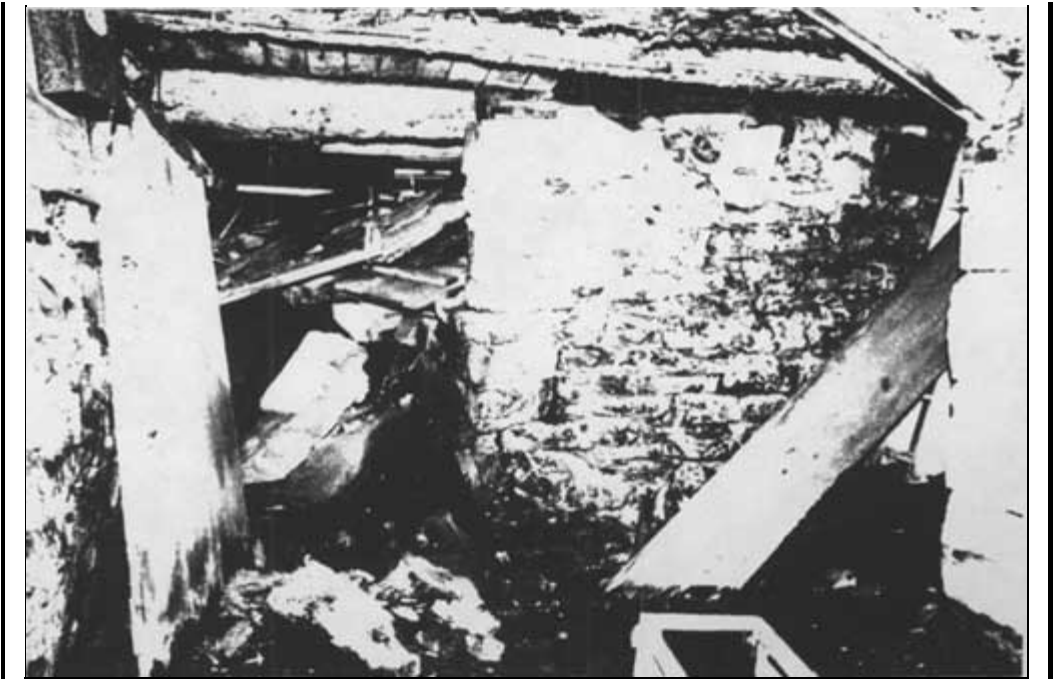
4. Room 001 South Wall of Cellar

Uncoursed rubble stone foundation wall, approximately 6 ft high. when this photograph was taken in March 1986, the wall had developed a bulge at its midsection, with a lateral displacement of about 2'-0". The upper third of the wall collapsed in September 1986, leaving the north sill beam unsupported except at its extreme ends over a span of approximately 9'-0".
