**VICKSBURG NATIONAL MILITARY PARK  
SHIRLEY HOUSE**

**HISTORIC STRUCTURE  
REPORT**

**Cultural Resources, Southeast Region  
National Park Service**

**2004**

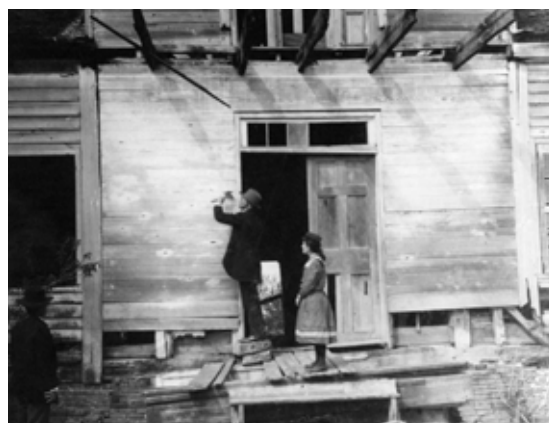
**Figure 6** View of front entrance, 1899. VICK Coll.

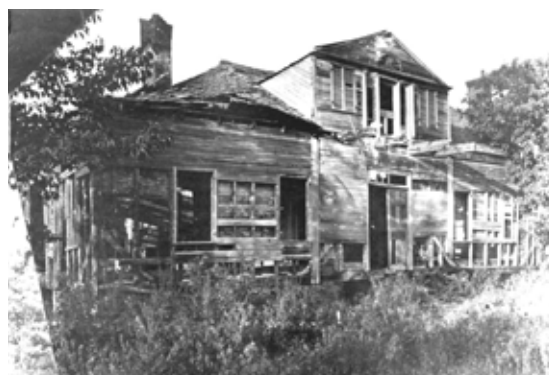
**Figure 7** View of front of house, 1900. HABS File No. MISS, 75-VICK. V. 3-5.

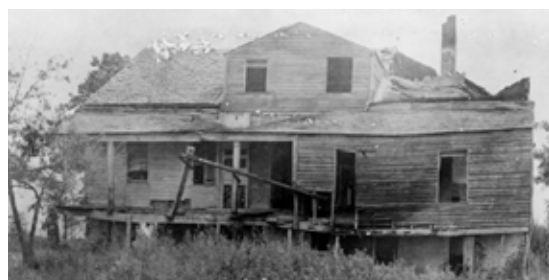
The condition of the Shirley House was very poor. In addition to loss from neglect and decay, scavengers had apparently stripped the house of most of its siding and windows and much of its interior woodwork as well. The front porch and balcony were completely missing and even the brick piers of the rear porch and much of the brick foundation were missing, presumably demolished in order to salvage the brick. The wood-shingled roof, which may not have been replaced since the house was built, had deteriorated as well, and the west gable and most of the roof on that side of the house had collapsed entirely. Even after creation of the park, vandalism and decay contin-

**Figure 8** View of rear of house, 1900. Note collapsed roof on west side. HABS File No. MISS, 75-VICK. V. 3-7.

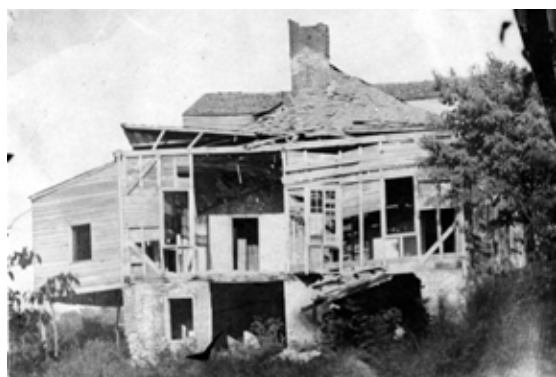
**Figure 9** View of west end of house, 1900. HABS File No. MISS, 75-VICK, V. 3-6.

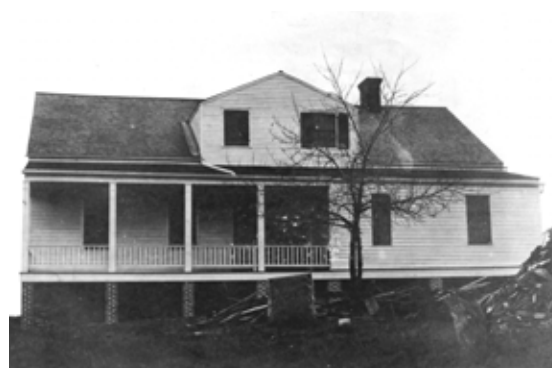
**Figure 12** North (rear) elevation after the restoration work accomplished September 26 to November 14, 1902. Note large pile of debris at lower right. HABS File No. MISS, 75-VICK, V. 3-11.

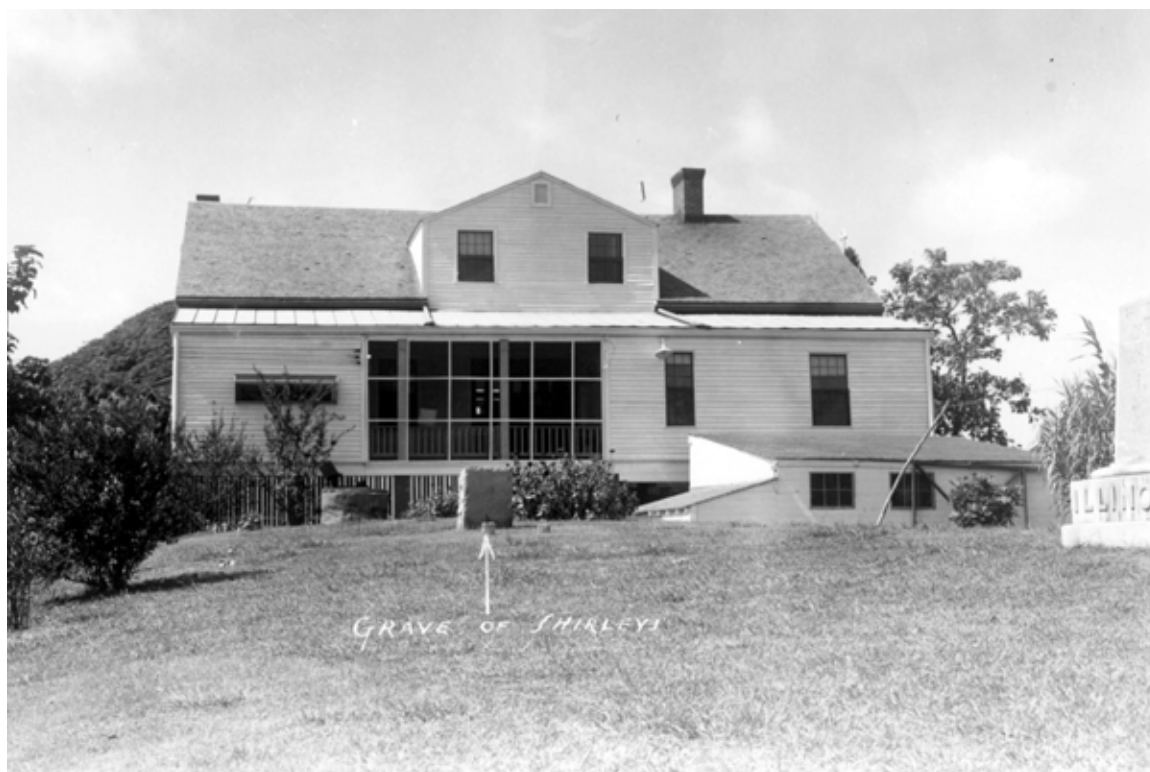
**Figure 15** .View from north, 1939, showing Major Holt's enclosure of the rear porch and garage addition. VICK Coll.

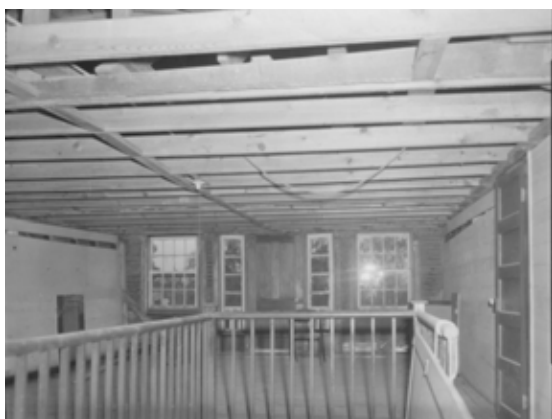
**Figure 25** View north in Room 200 after removal of fiber-board ceiling, November 1965. VICK Coll.

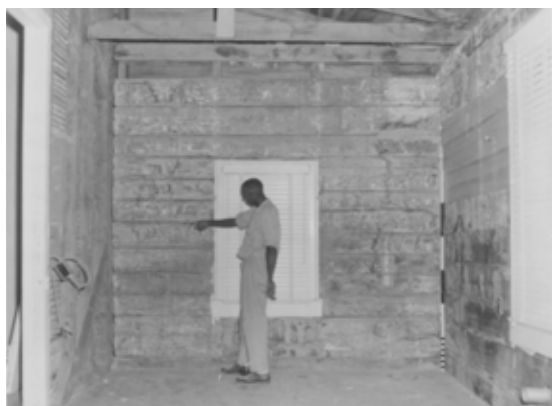
**Figure 26** View west in Room 103, with original board wall intact, pointing out Civil-War-era bullet hole. VICK Coll.

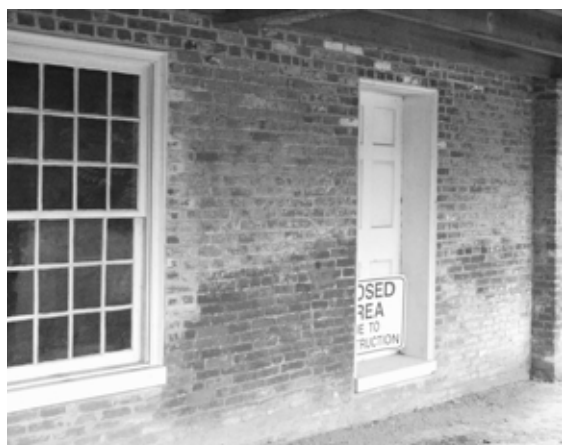
**Figure 39** View of historic masonry at dining room door. NPS SERO 2001.

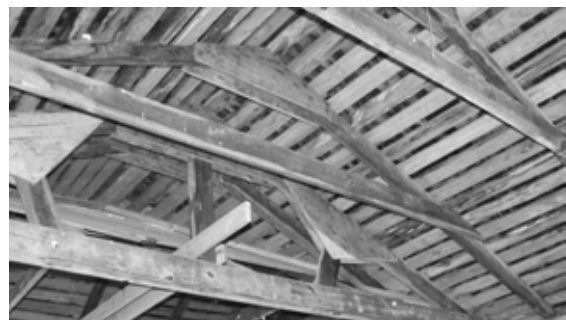
**Figure 42** View of roof framing showing added plywood reinforcement. NPS SERO 2001.

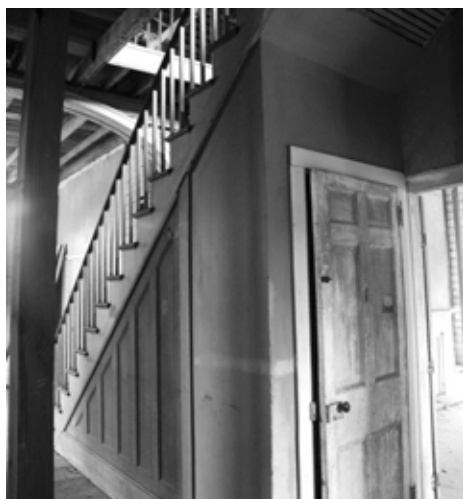
**Figure 51** View of rear of staircase and extension for 1932

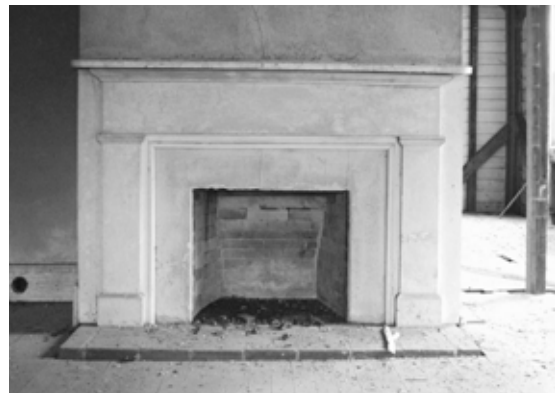
**Figure 56** View of reconstructed mantle in Room 102. NPS SERO 2001.

firebox is covered by modern dry wall and could not be examined but was probably rebuilt along with the modern brick hearth, as was done in Room 102.
