MELROSE ESTATE  
NATCHEZ NATIONAL HISTORICAL PARK

NATCHEZ, MISSISSIPPI

HISTORIC STRUCTURES REPORT  
VOLUME II  
PAINT AND CONCRETE ANALYSIS

ANN BEHA ASSOCIATES

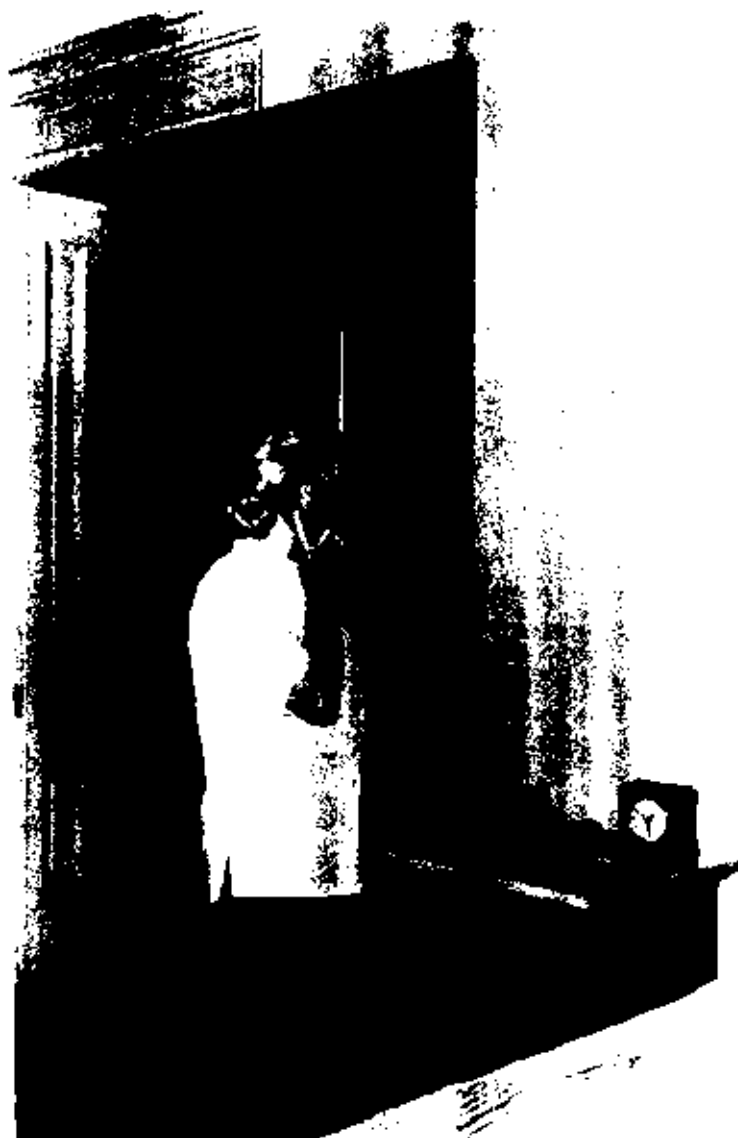
Photograph P22. This detail of a 1977 photograph shows the original maple graining on the door between Room 210 and Hall 211. (NATC Callon II.U.11)

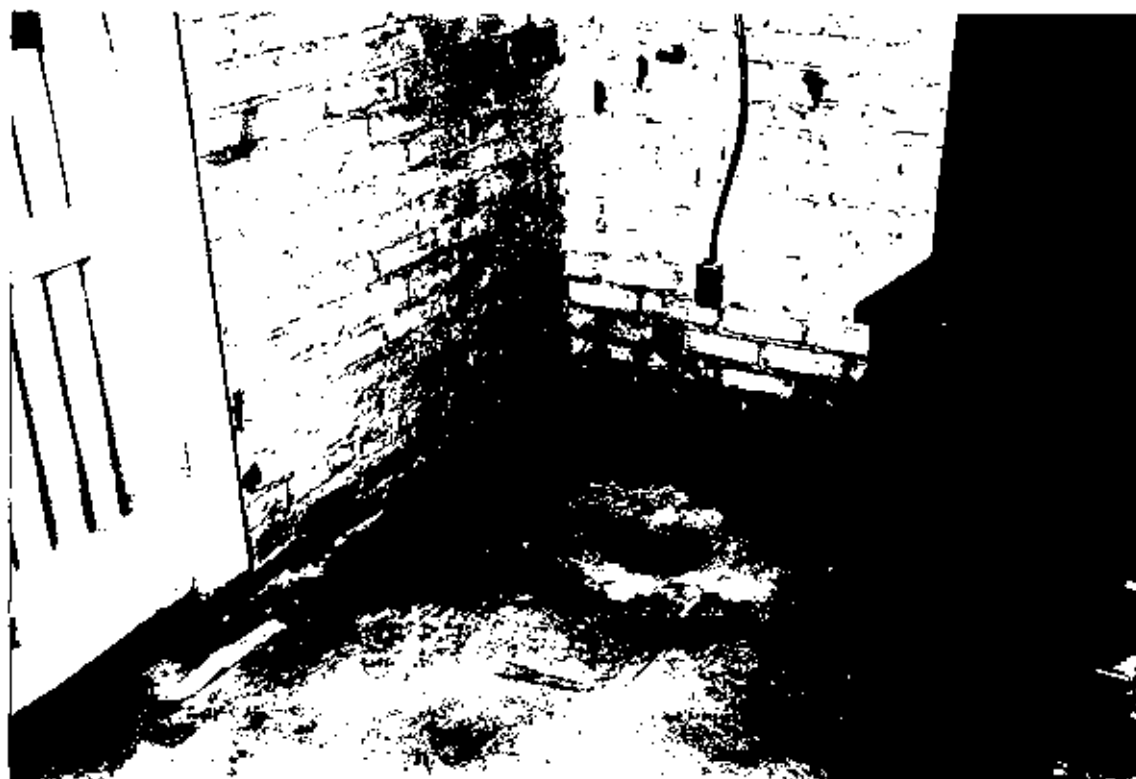
Photograph P41. Location of core sample in the southwest corner of Room 04 in the Melrose House.

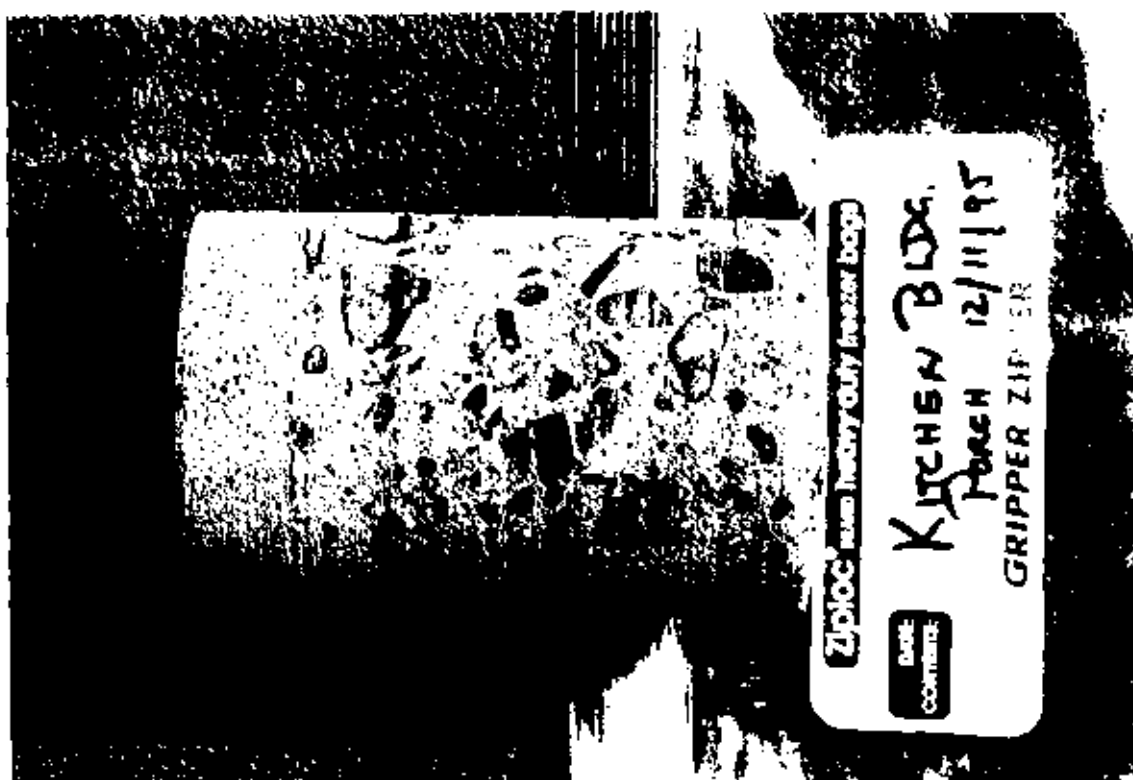
Photograph P44. Gallery core sample from the southeast corner of the Melrose Kitchen's gallery.

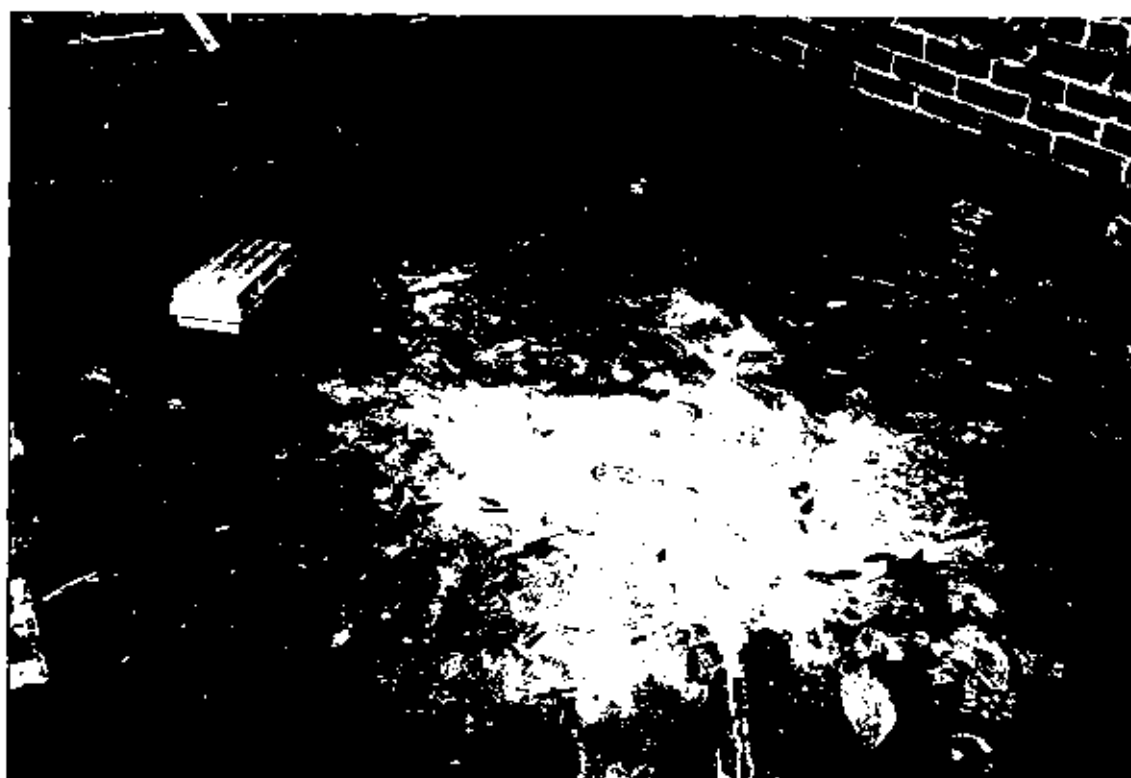
Photograph P51. Location of core sample in the interior of the Melrose Smoke House.

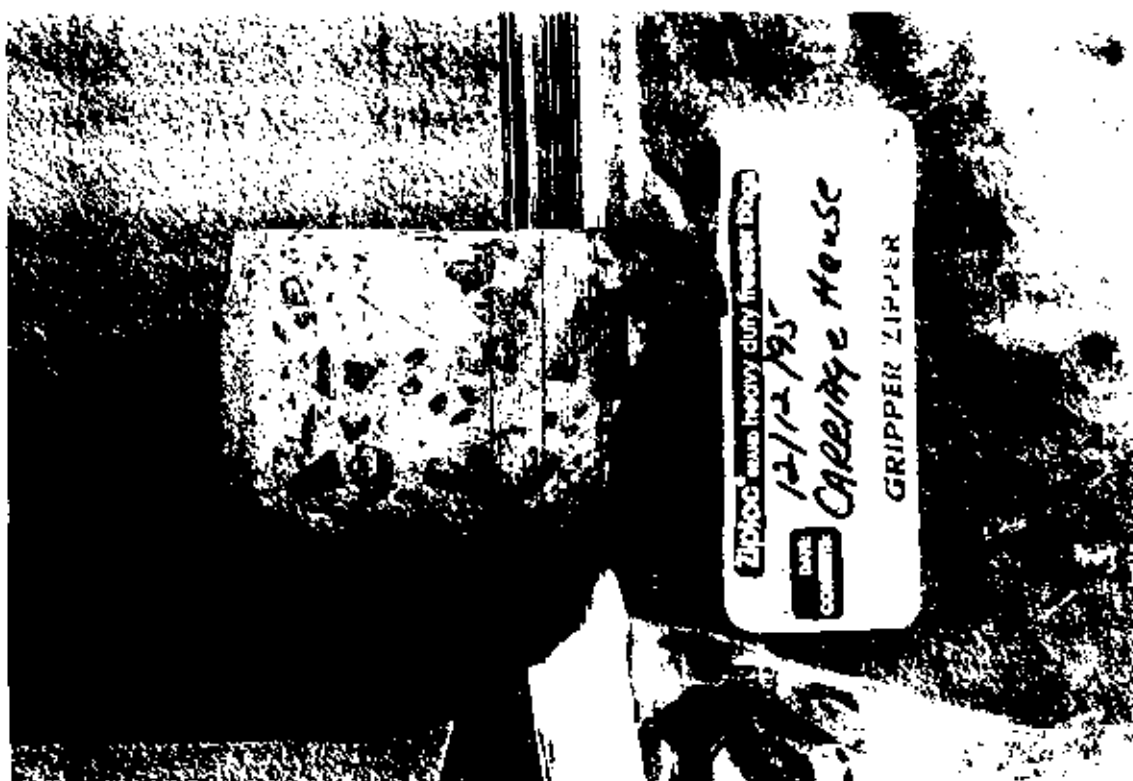
Photograph P52. Floor core sample from the northeast corner in the Melrose Carriage House.

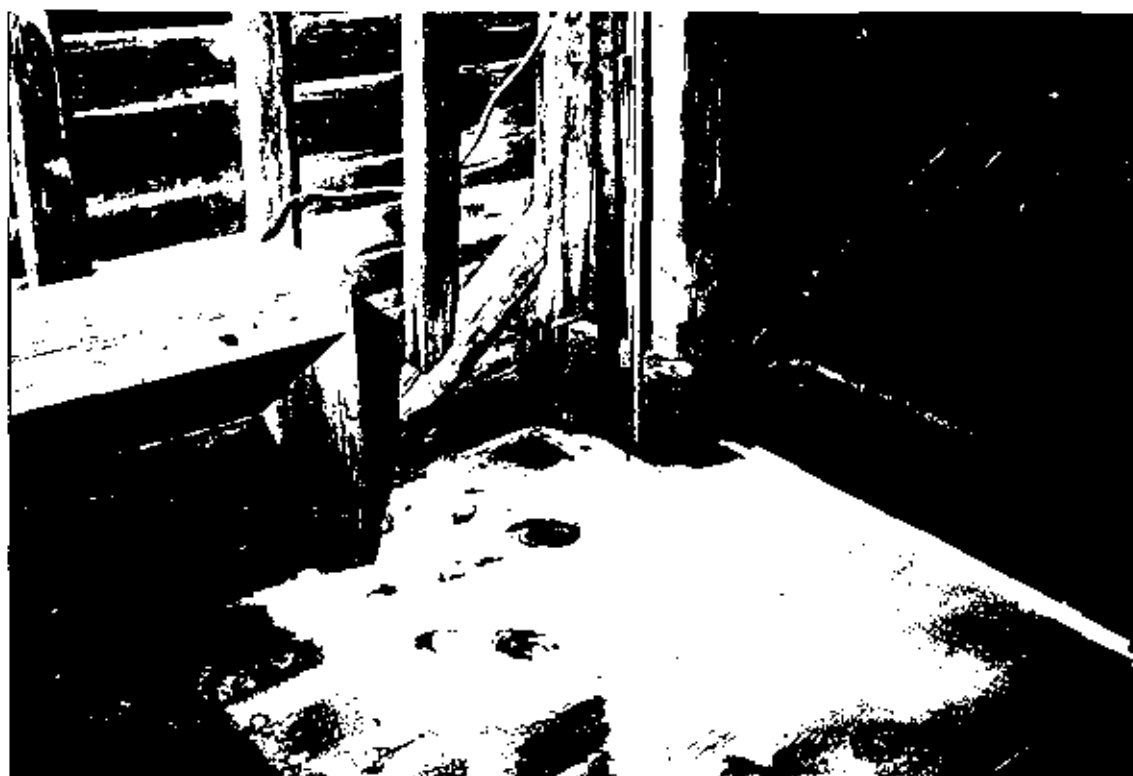
Photograph P53. Location of core sample in the northeast corner of the Melrose Carriage House.

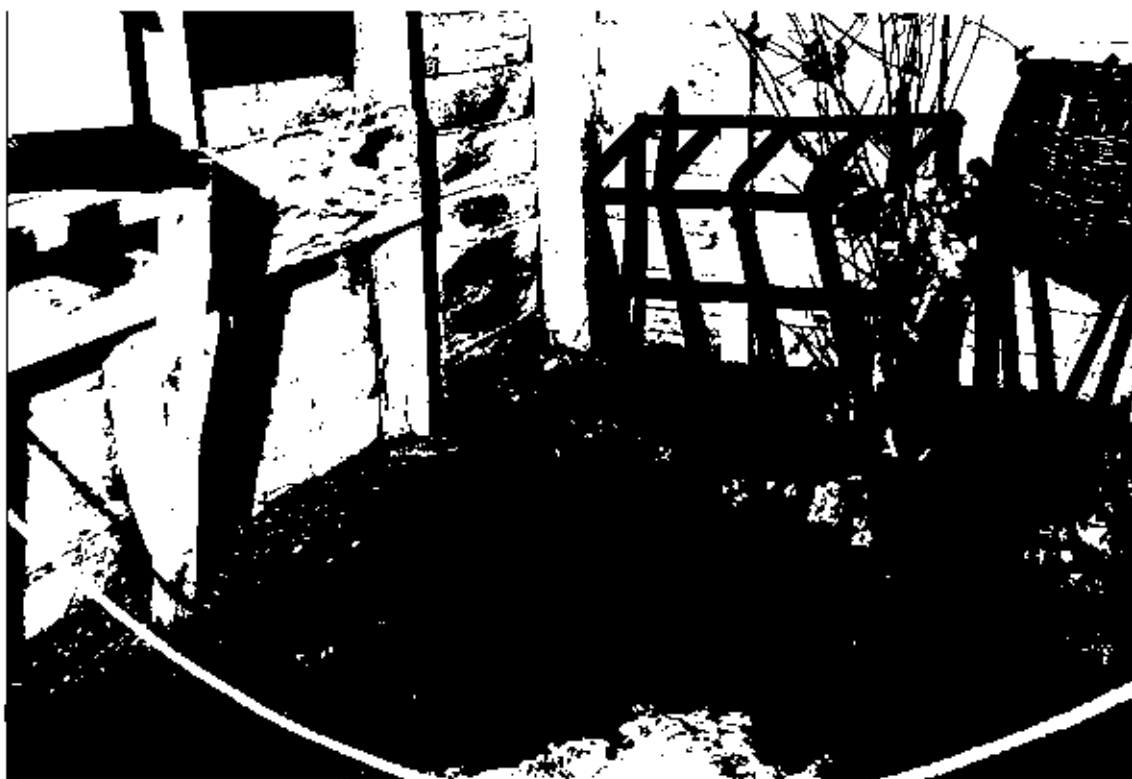
Photograph P55. Location of core sample in the southwest corner of the Melrose Stable.
