# Las Conchas Post-Fire Response Plan

Bandelier National Monument

AUGUST 2, 2011

**PREPARED BY:** National Park Service Las Conchas BAER Team

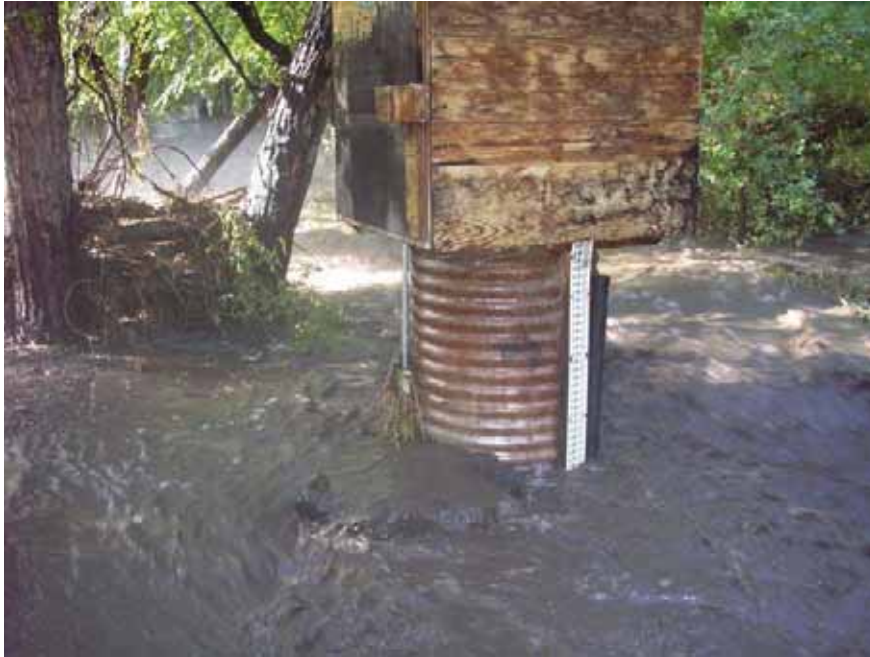
**Flood at streamflow gaging station in 2007.**

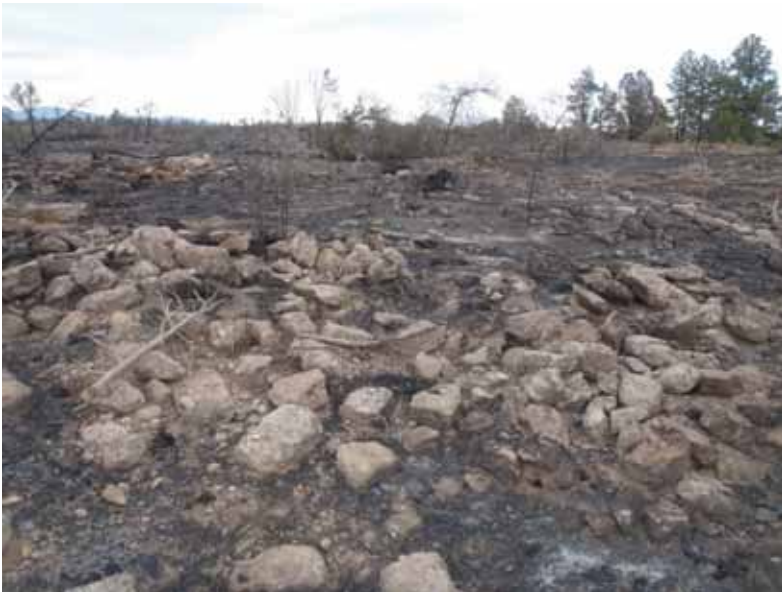
Pueblo cluster on South Frijoles Rim showing standing dead. LA3769 with LA3753 in background.

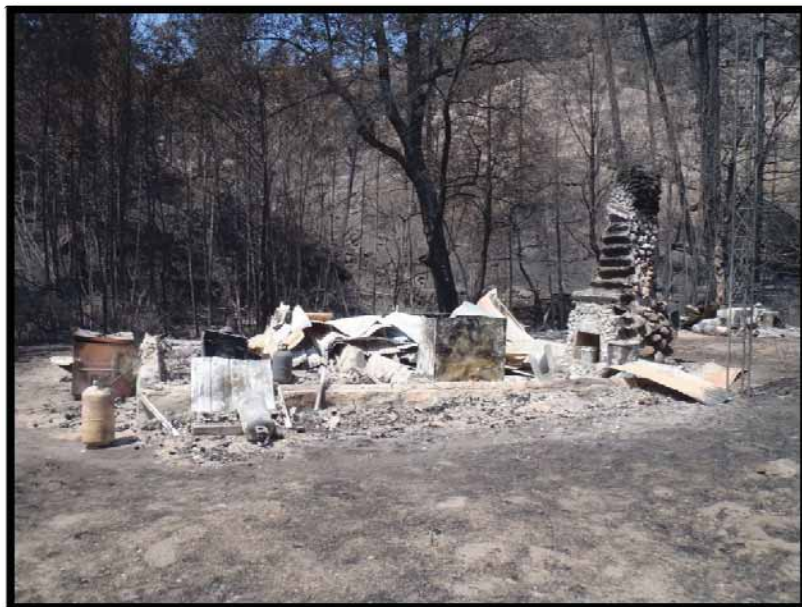
View of Backcountry Cabin debris.

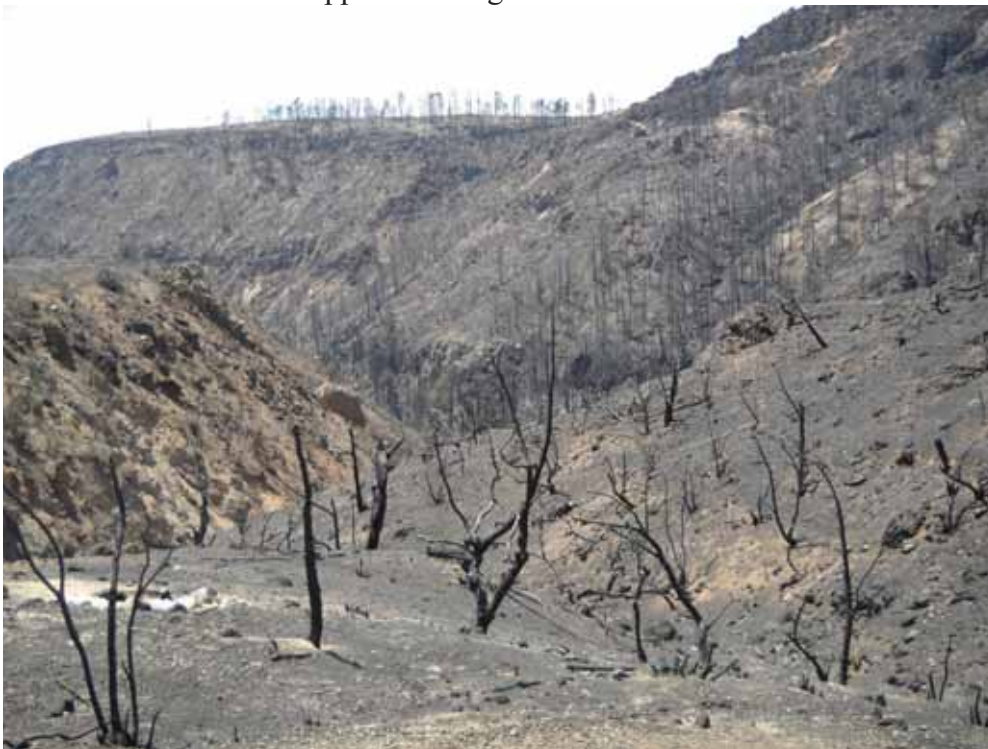
View of trail across Sanchez Mes

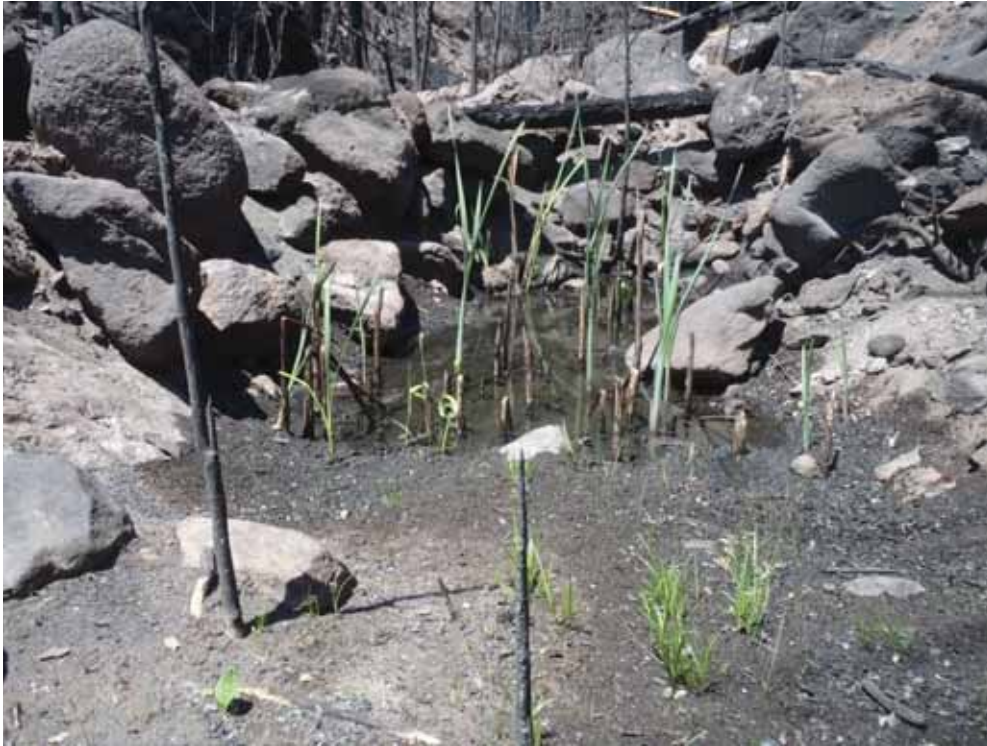
Vegetation Recovery underway at Sanchez Canyon

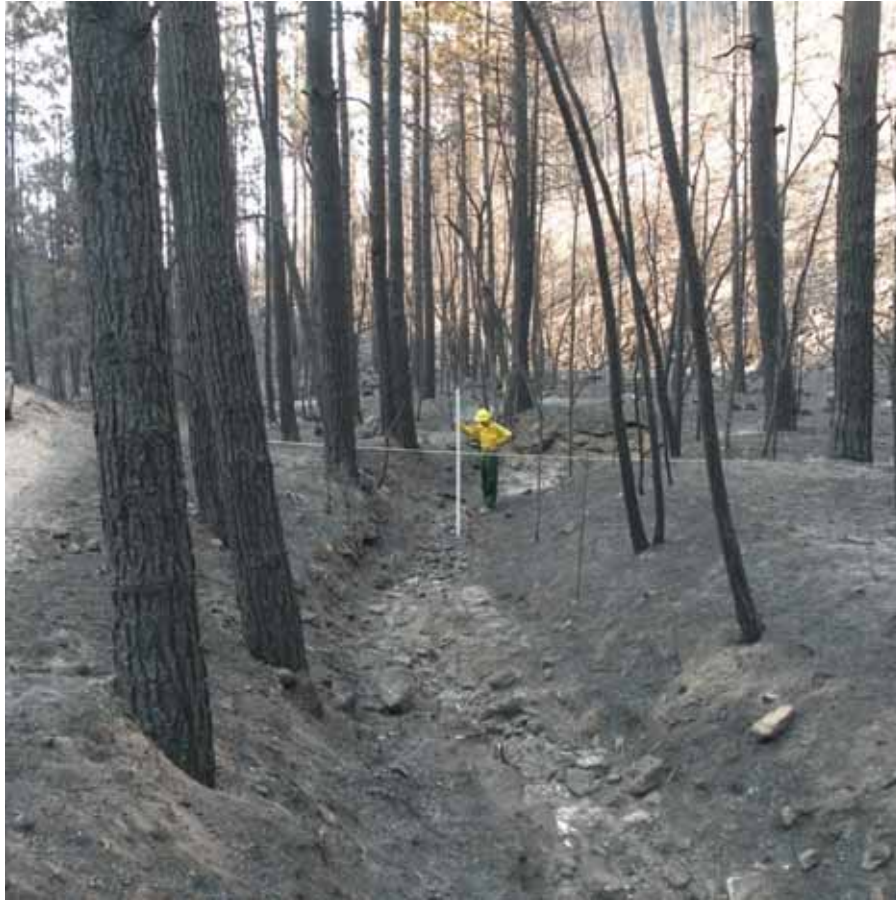
Channels with annual scour usually develop on third order or fourth order stream segments that occupy the bottom of the major canyons (7<sup>th</sup> and 6<sup>th</sup> code HUC). The typical profile includes the active channel or most recently scoured portion, in the lower half of a steep V-shape incised into a larger valley floor that is more accurately thought of as a terrace, and a floodplain in only the most extreme events.

**Figure 1.** Channel in lower Bland Canyon, July 13, 2011

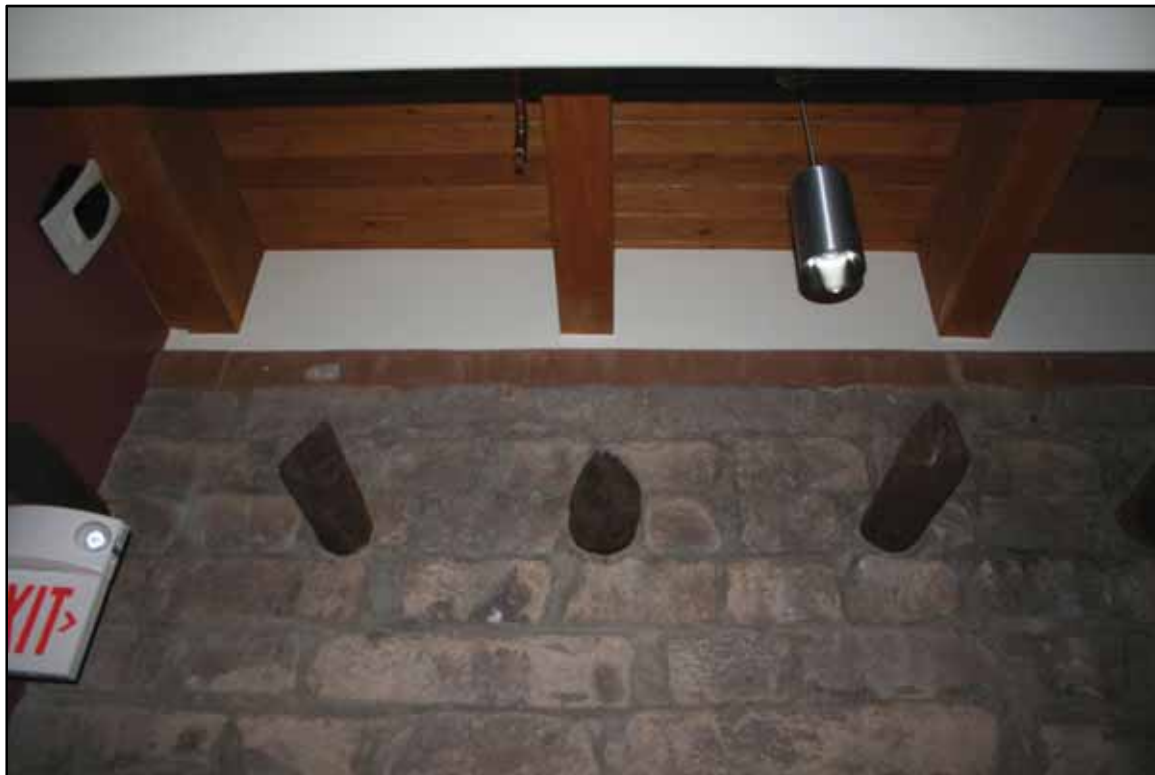
Most likely any potential movement due to potential flooding and/or soil moisture changes will be evident at points where the addition adjoins the original structure or on the taller exterior walls of the theater addition. Several photos have been included in this report to establish baseline conditions to compare any potential future movement with.

Figure 8. Northwest end of theater wall adjoining original portale wall.

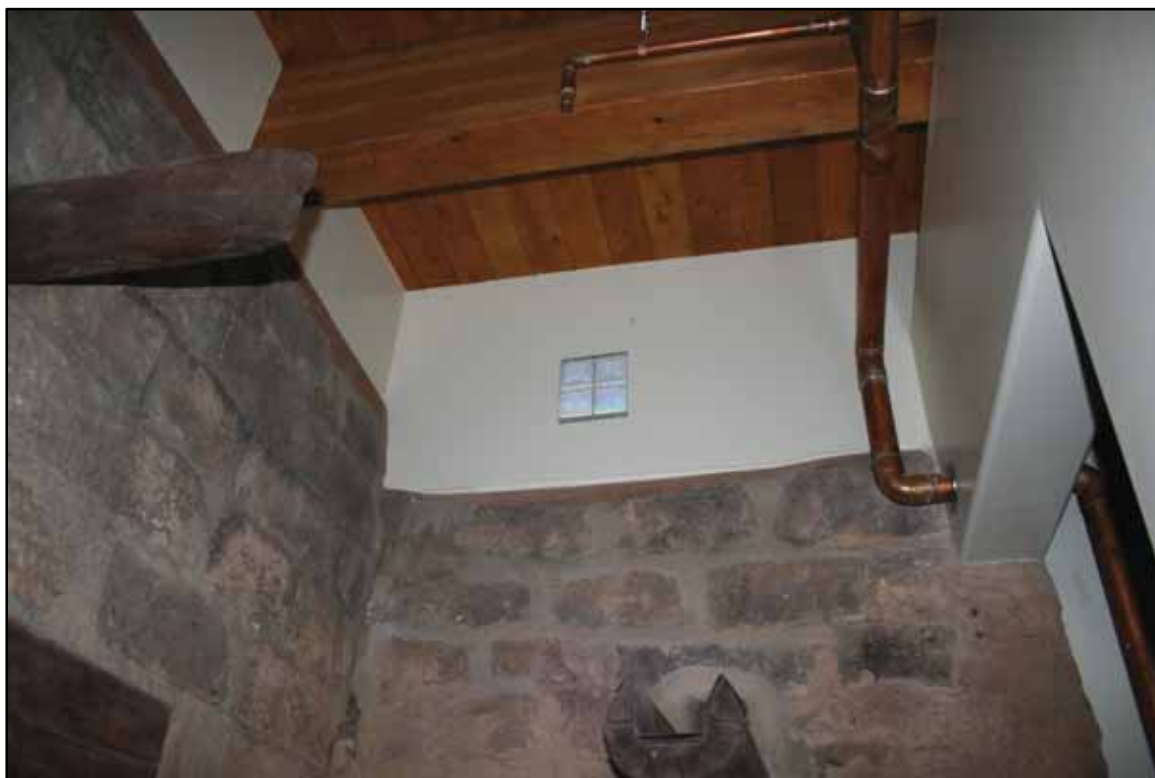
Figure 9. Southeast corner of addition.
