# **Fort Matanzas National Monument**

## **Structural Condition Assessment Report**

**October 2016**

Structural Engineers:  
Faisant Associates  
810 Light Street  
Baltimore, Maryland 21230

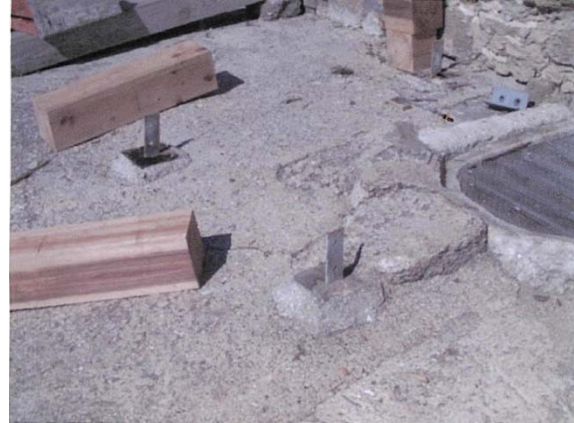
**Photo B-11:** Stair post base connection to terreplein, 1998 stair reconstruction (1998, FOMA).
