# FORMER SULLIVAN OPERA HOUSE

252-254 Main Street, McGregor, Iowa  
Predevelopment Project

**MARCH 2015**

**DOUGLAS J. STEINMETZ**  
**A R C H I T E C T**

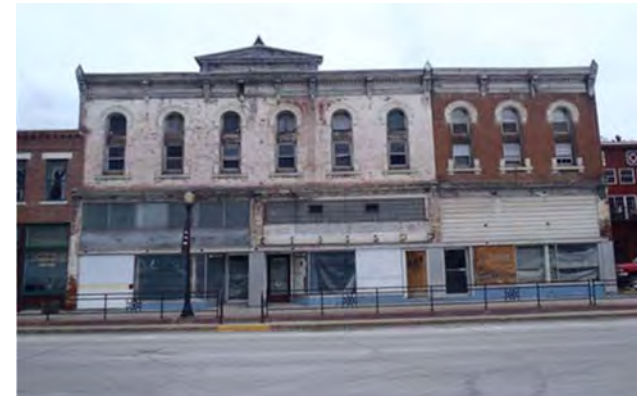
Storefront 2014

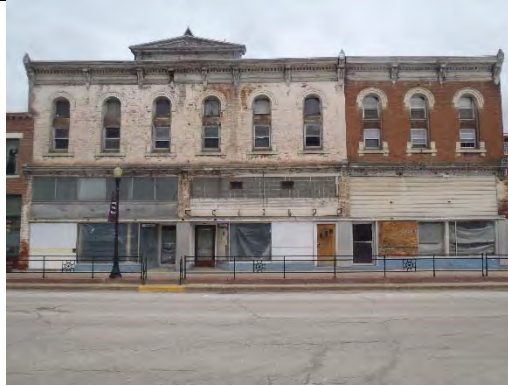
PHOTO 2: PRIMARY FAÇADE 2014

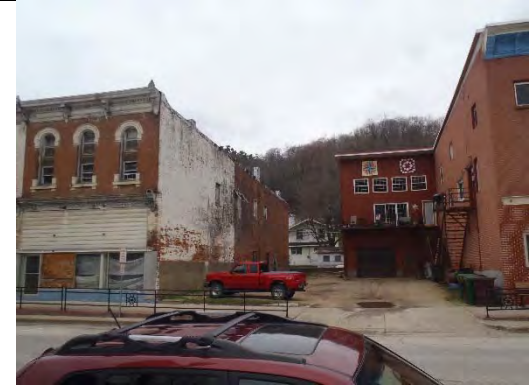
PHOTO 3: VIEW INTO LOT EAST OF BUILDING

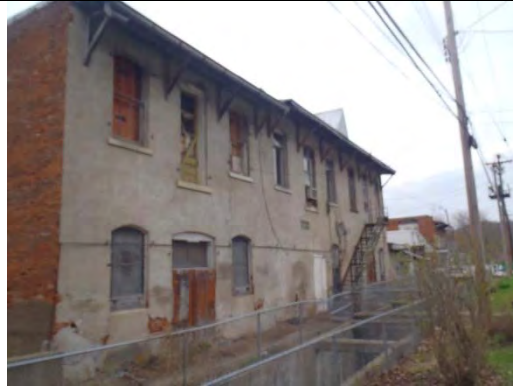
PHOTO 8: NORTH FAÇADE

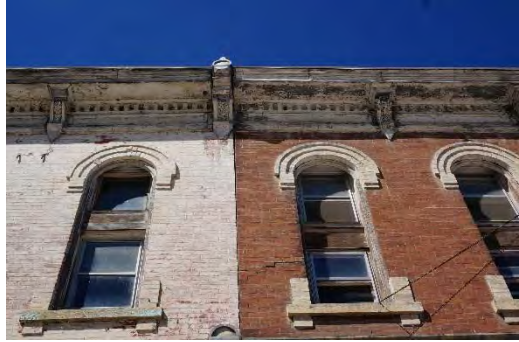
PHOTO 25: UPPER STORY-PRIMARY FACADE

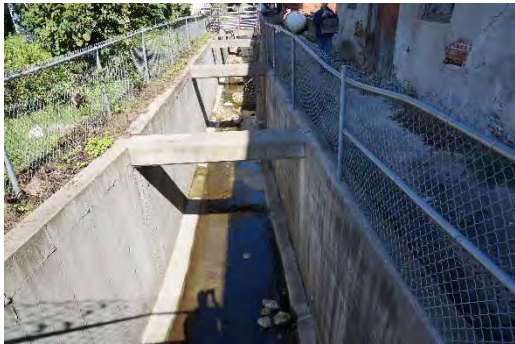
PHOTO 28: STORM SEWER NORTH OF BUILDING
