December 15, 2014

**Re:   Wichita-Sedgwick Historical Museum Building Condition Assessment and  
Maintenance Plan  
CASE Project No. 2439001**

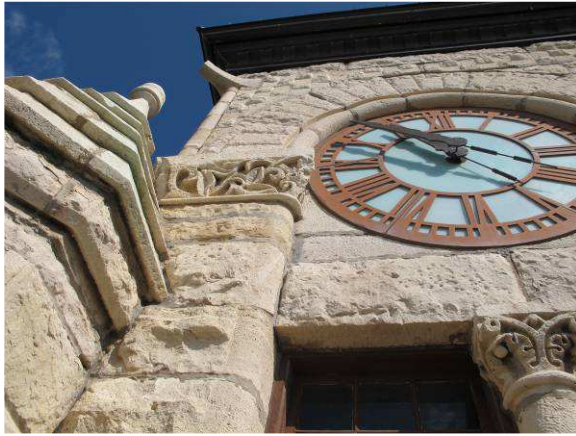
**Clock and limestone on south face**

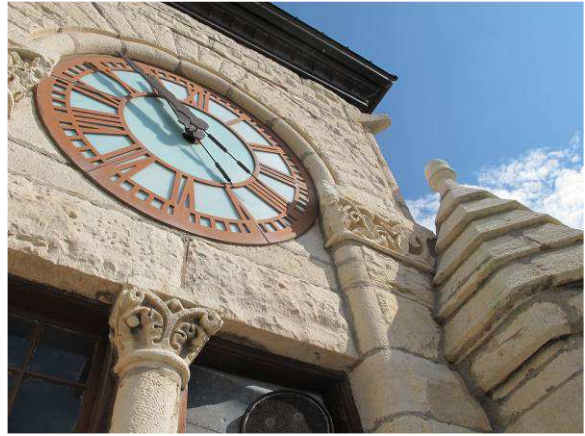
**Clock and limestone on south face**

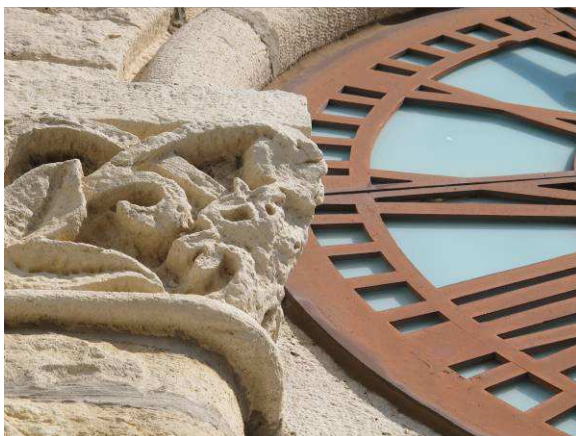
**Loss of carving detail in stone**

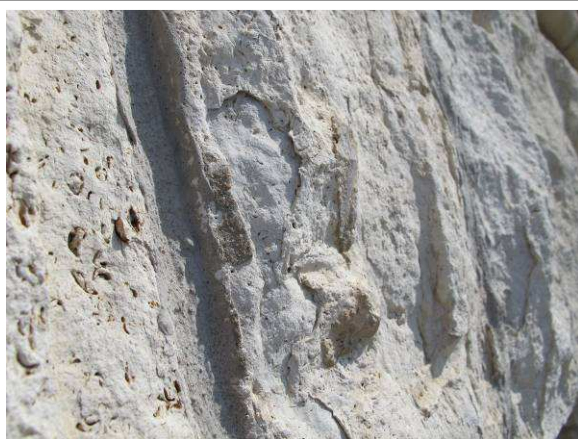
**Deteriorating limestone**

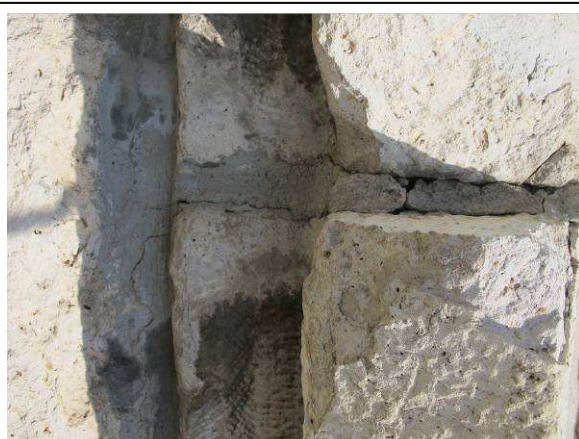
**Debonded mortar**

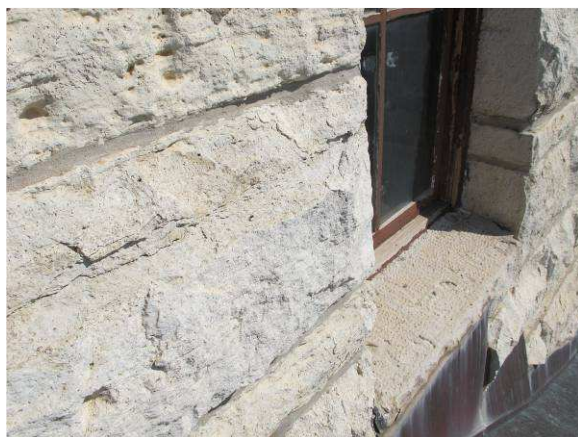
**Deteriorating limestone**

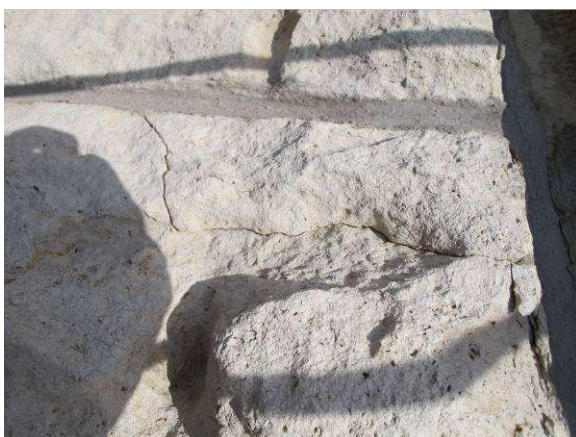
**Deteriorating stone**

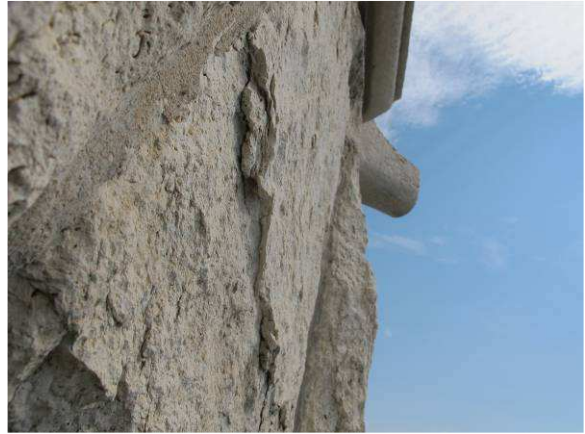
**Spalling stone**

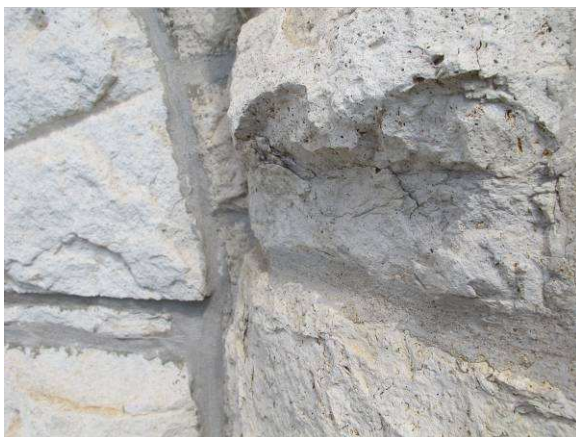
**Spalling stone**

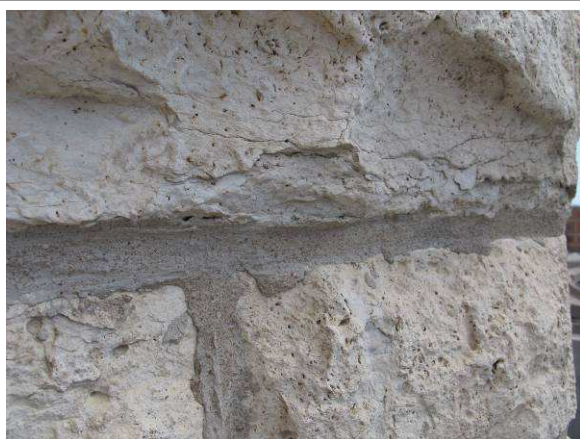
**Deteriorating limestone**

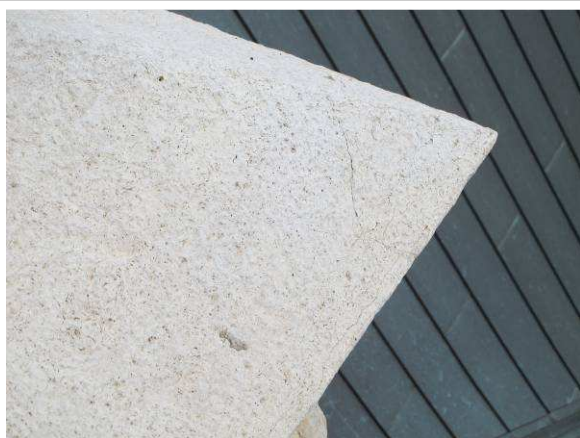
**Broken edge of stone**

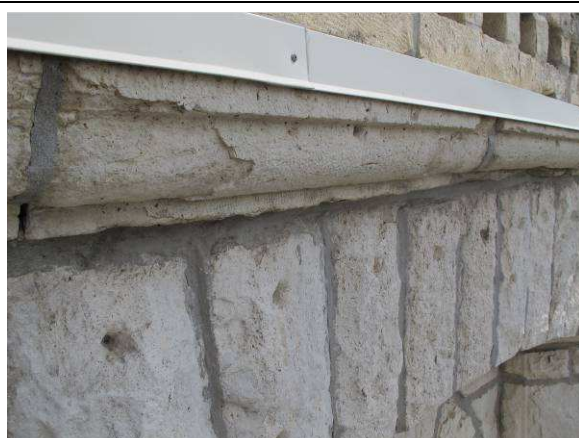
**Delaminating stone**

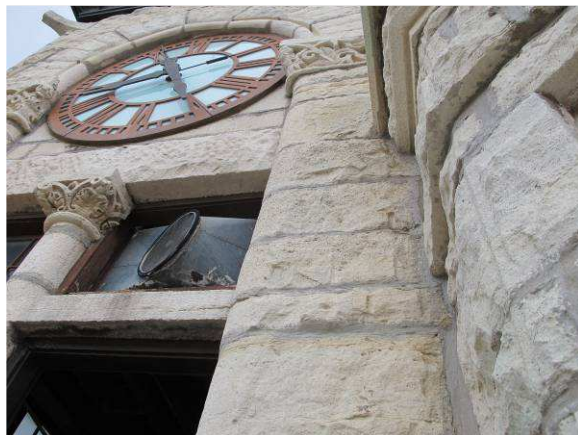
**Clock and limestone on north face**

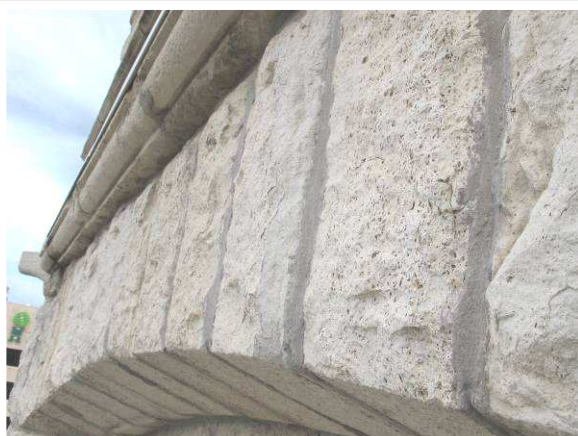
**Loss of detail above arch**

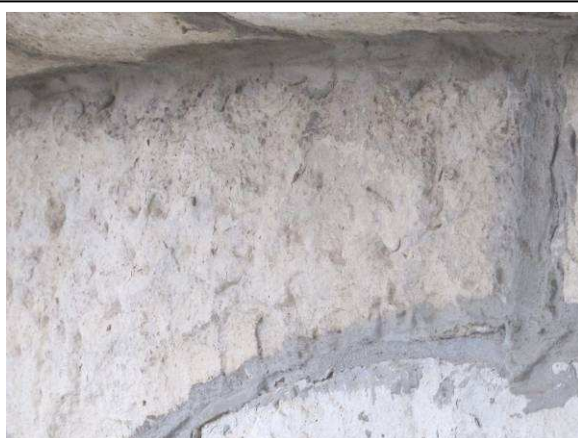
**Deteriorating mortar**

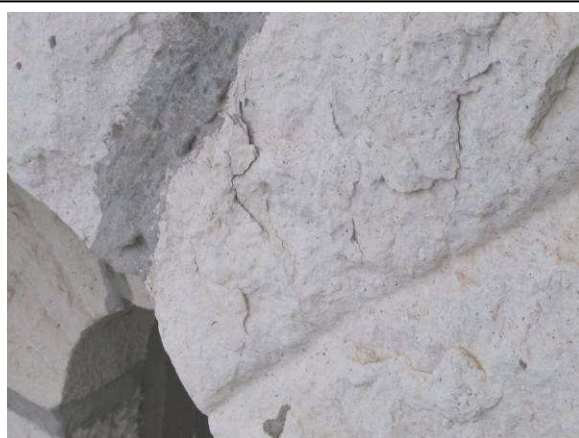
**Spalling limestone**

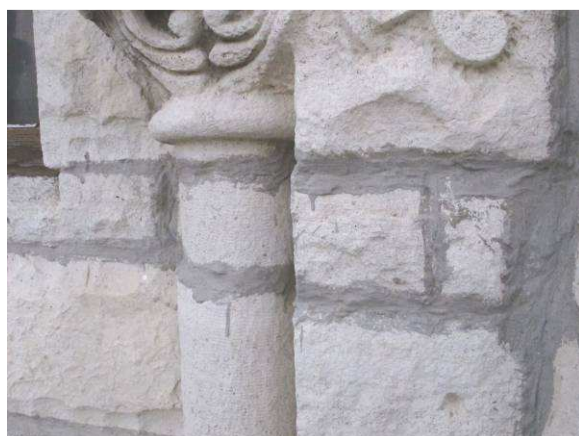
**Poor workmanship**

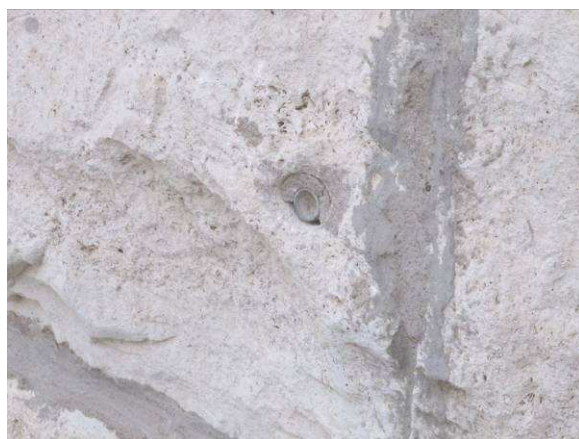
**Natural inclusion in limestone**

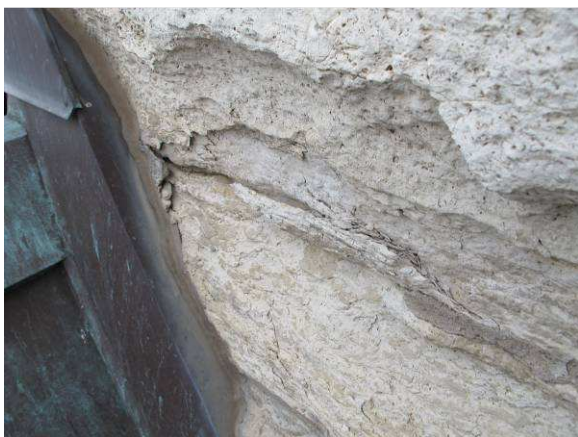
**Delaminating limestone**

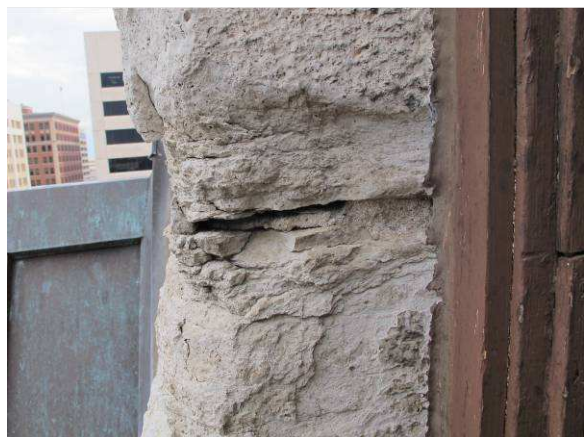
**Delaminating limestone**

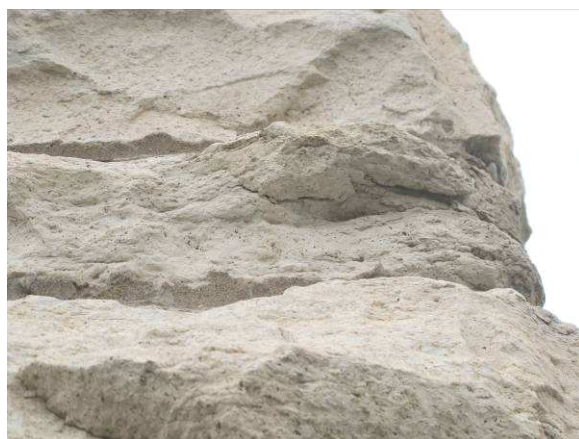
**Deteriorated limestone**

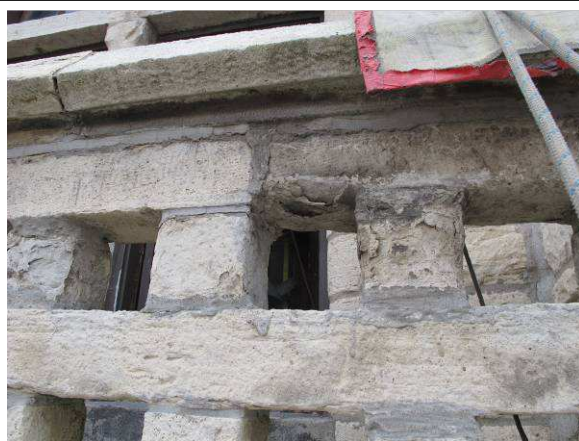
**Deteriorating balcony**

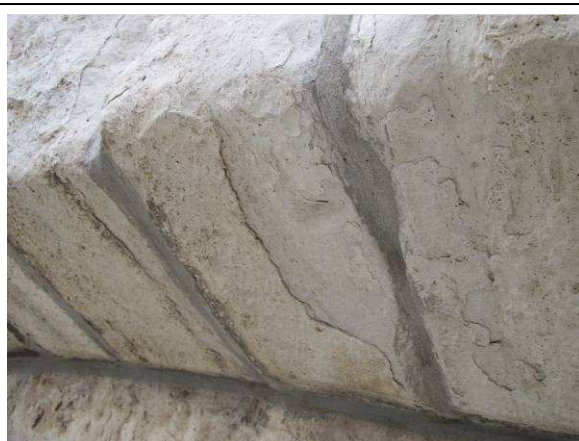
**Exfoliating limestone**

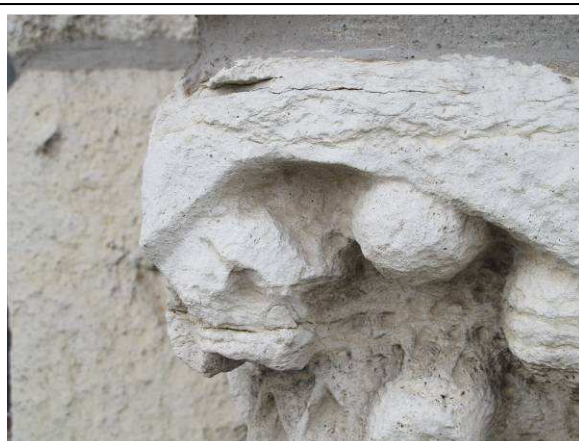
**Loss of detail in carving**

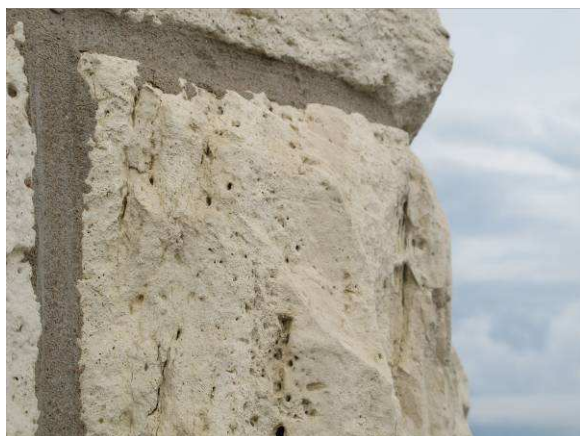
**Spalling limestone**

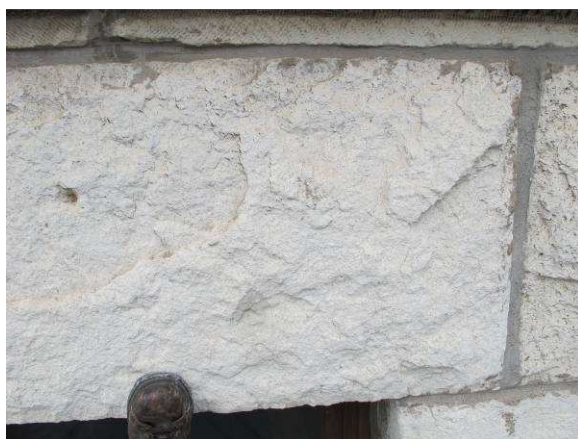
**Exfoliating limestone**

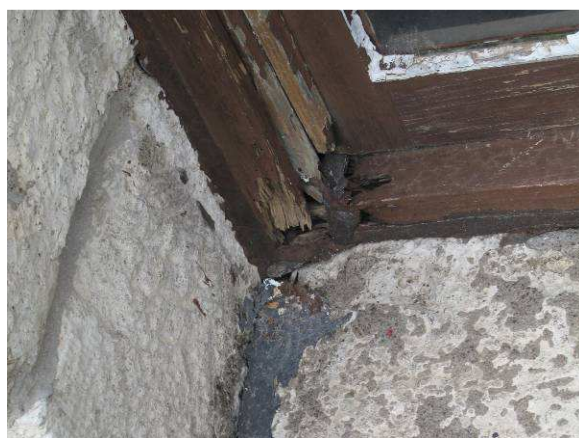
**Failed caulking**

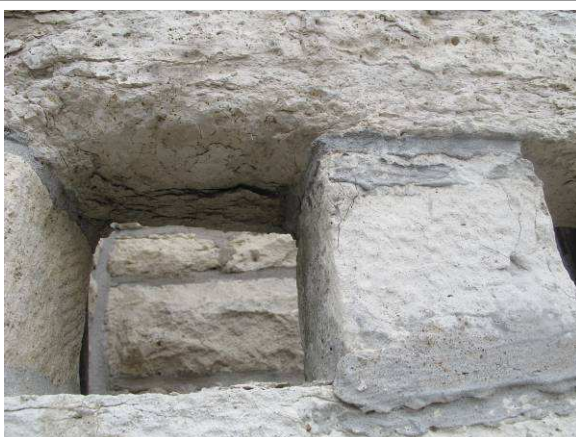
**Deteriorating limestone**

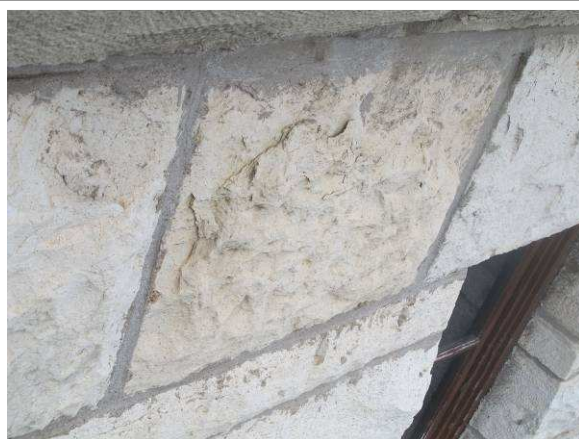
**Spalling stone**

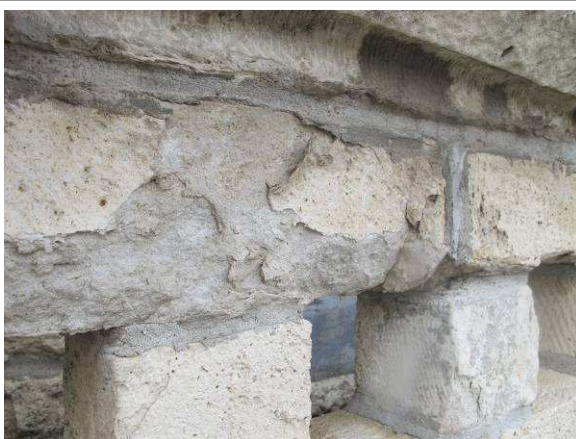
**Deteriorated limestone**

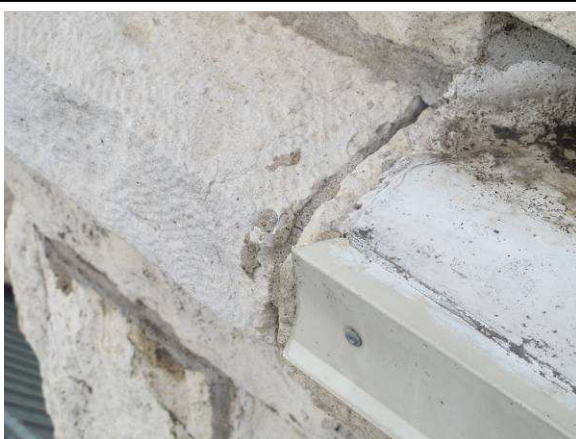
**Deteriorated stone and failed mortar joint**

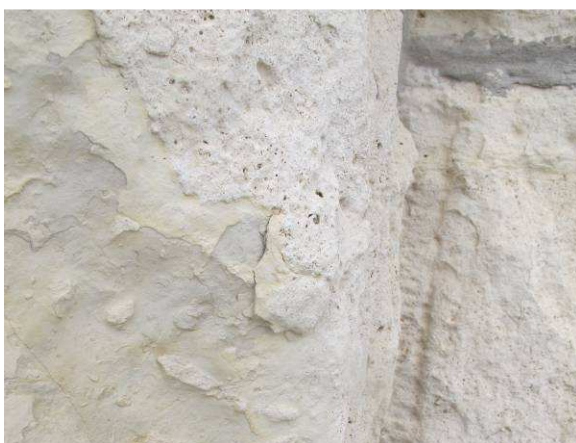
**Poor mortar installation**

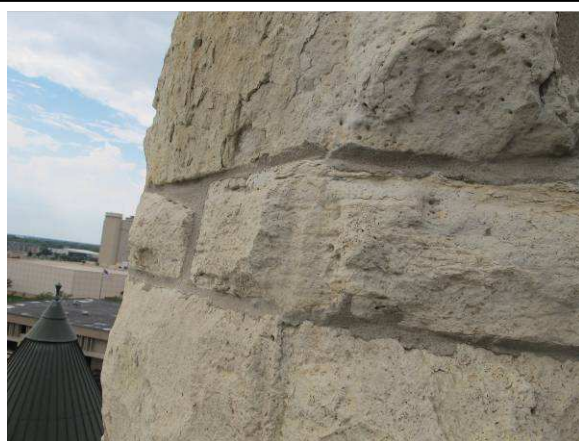
**Failed mortar**

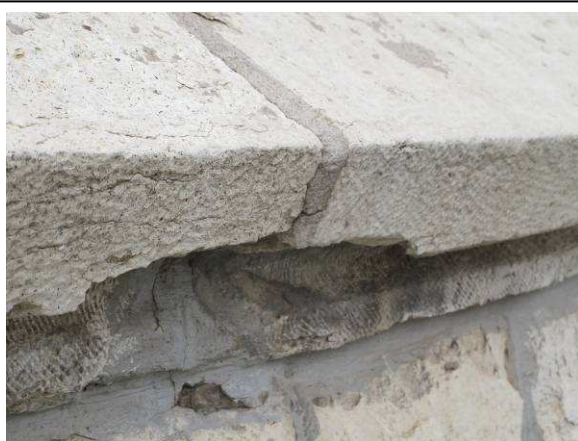
**Failing mortar installation**

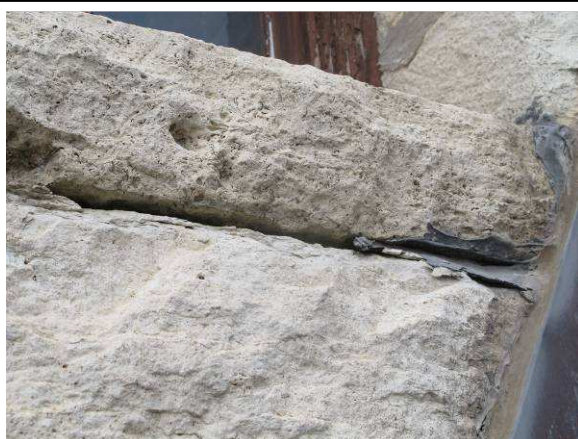
**Missing stone and mortar**

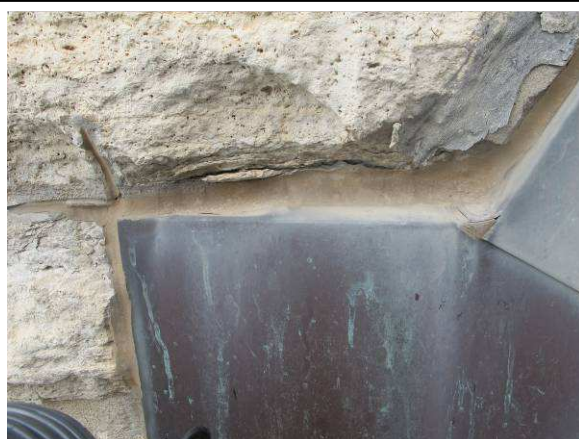
**Missing mortar**

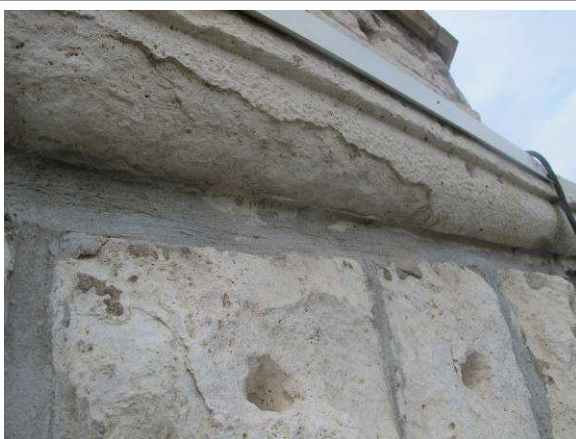
**Poor mortar installation and exfoliating stone**

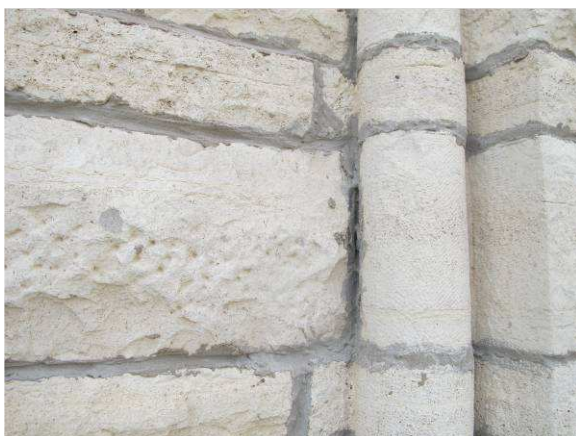
**Loss of stone detail**

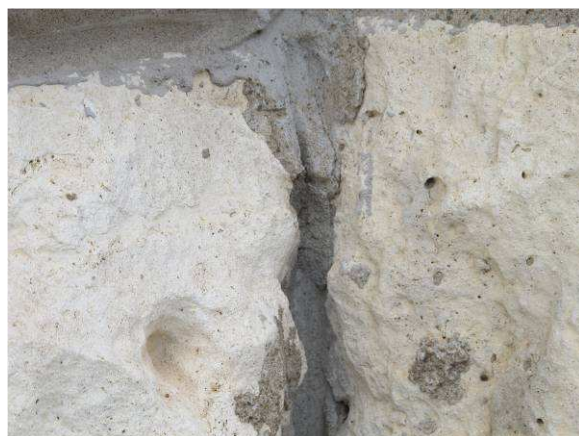
**Missing mortar**

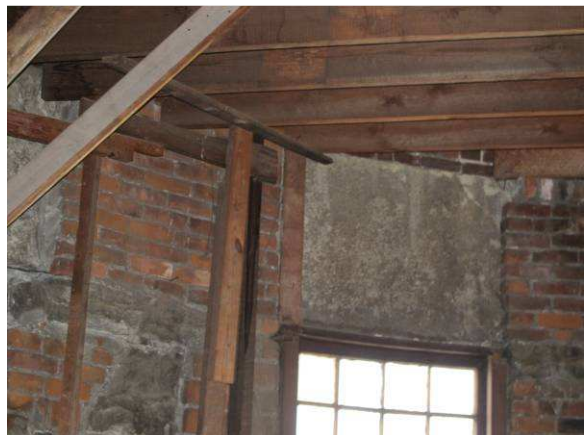
**Uncoursed mix of brick and stone**

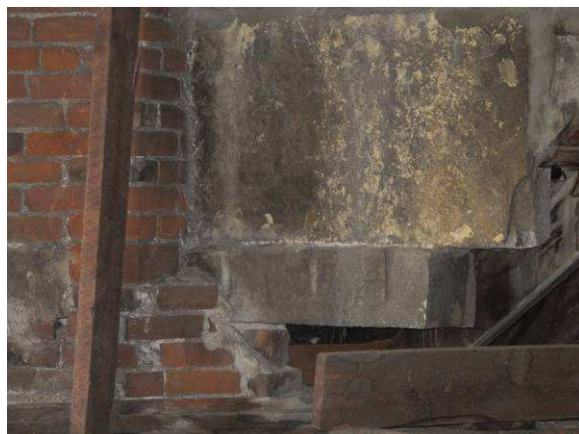
Mix of brick and stone

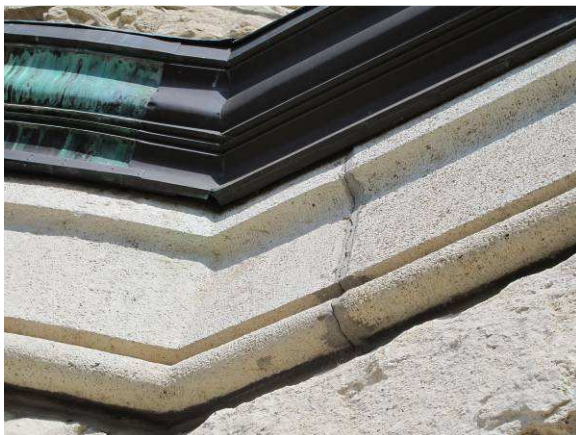
**Debonded mortar**

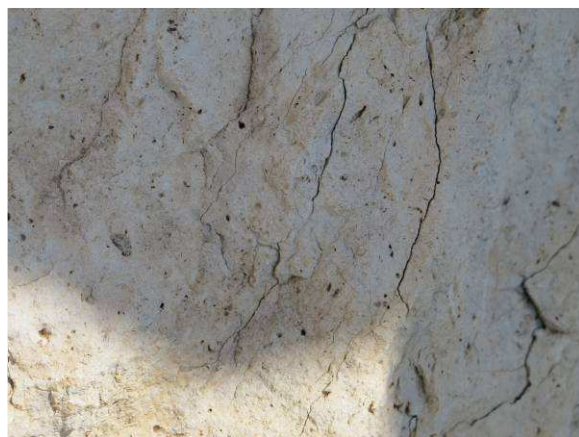
**Exfoliating stone**

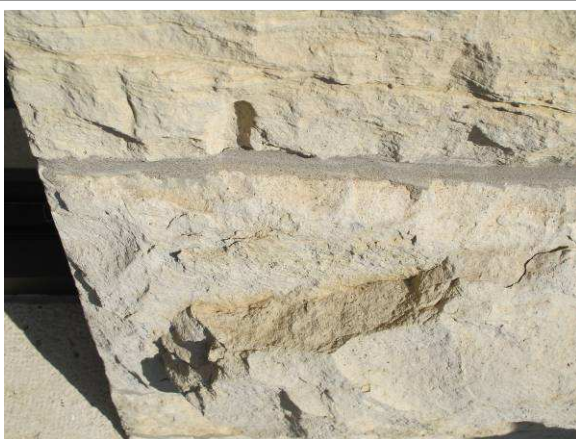
**Spalled stone**

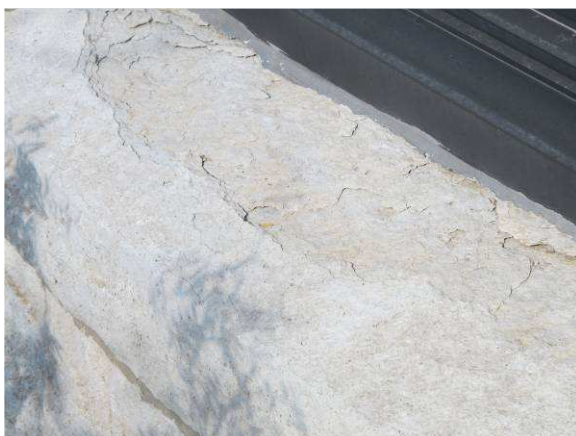
**Exfoliating stone at window ledge**

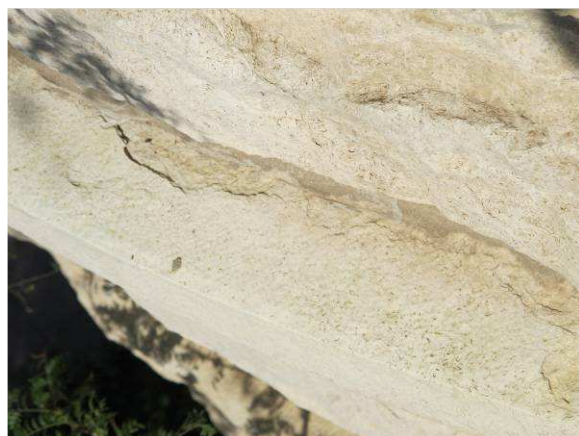
**Spalled stone**

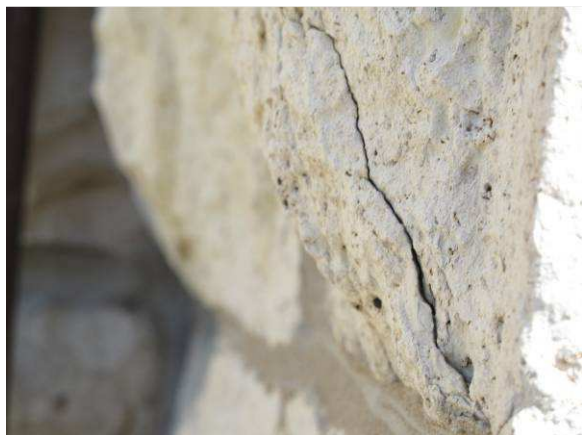
**Stone spall**

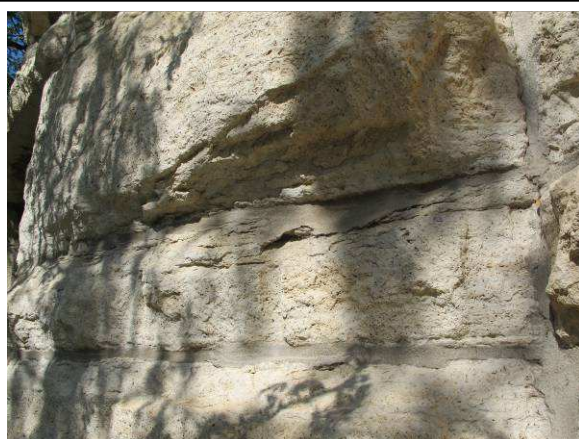
**Deteriorating limestone**

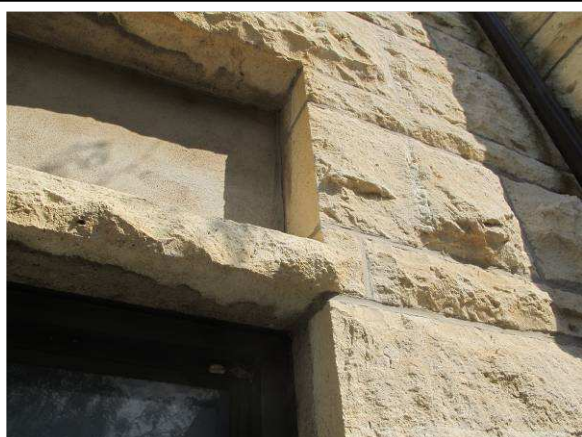
**Infill above glazed window**

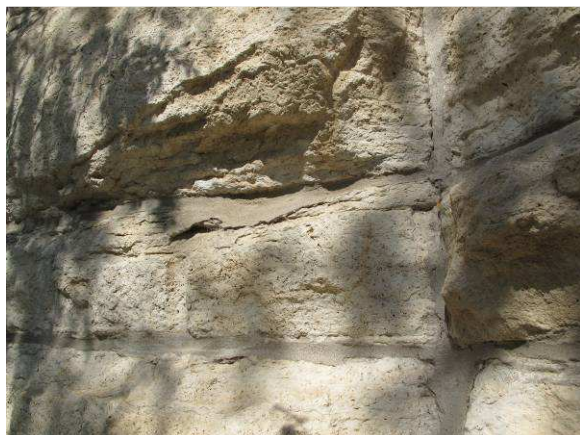
**Deteriorating limestone**

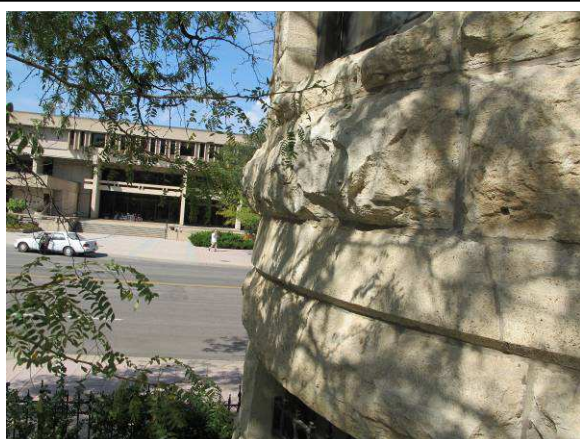
**Deteriorating stone**

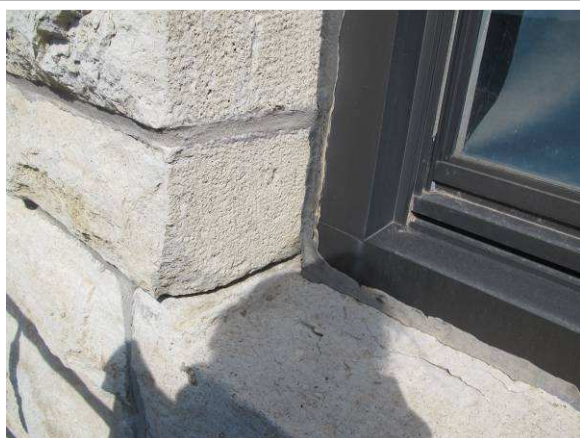
**Missing mortar**

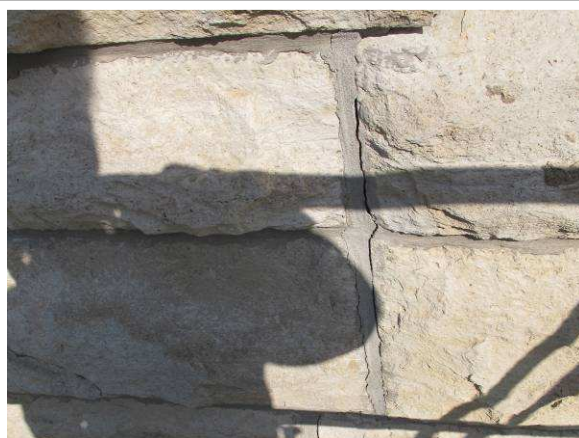
**Separated mortar**

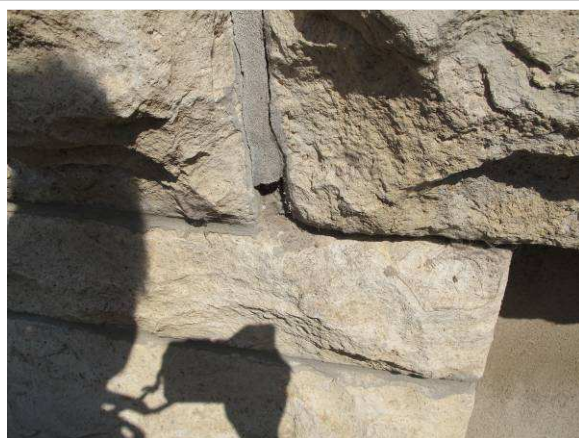
**Missing mortar**

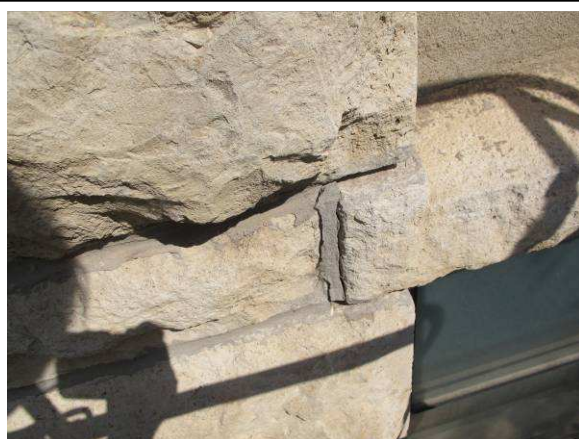
**Separated mortar**

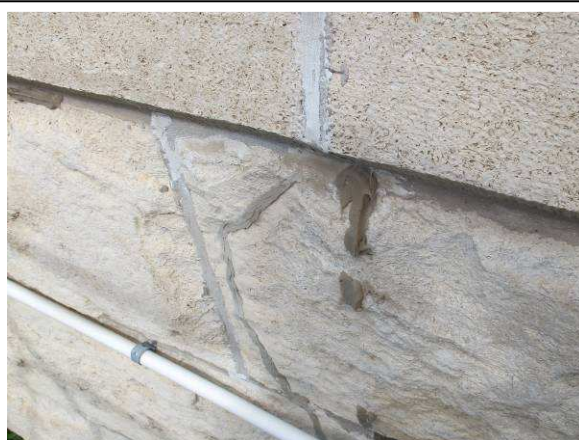
**Cracked stone**

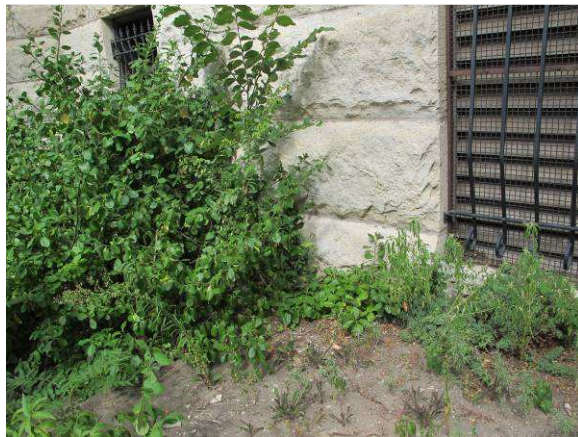
**Foliage close to building**

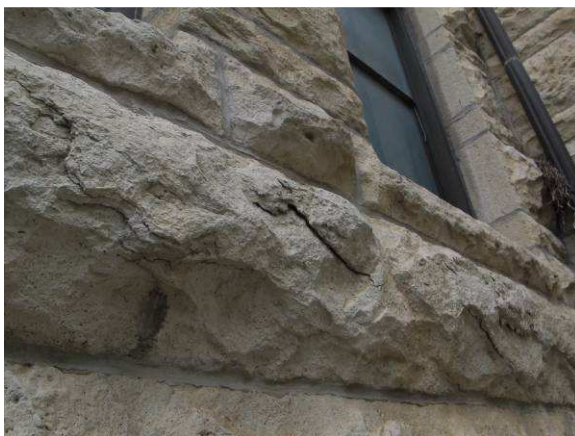
**Spalling stone**

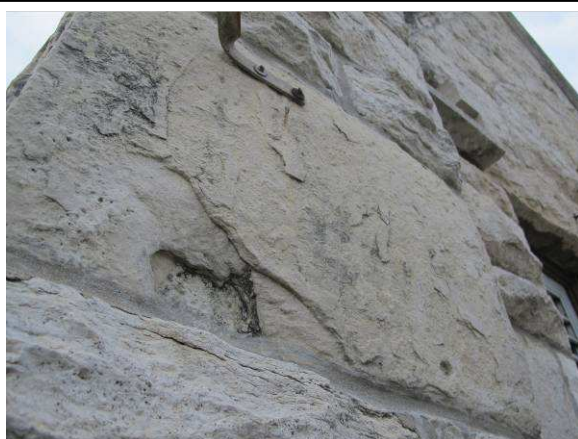
**Deteriorating stone**

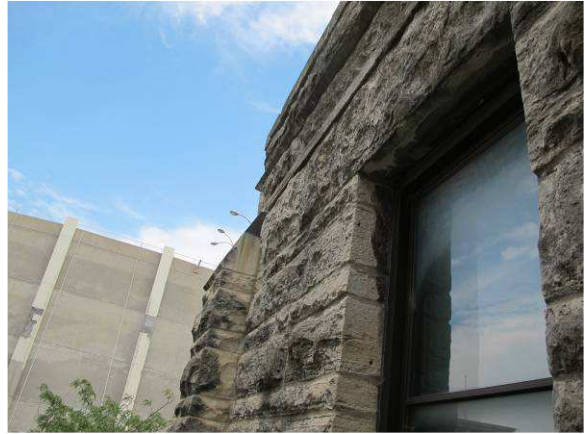
**Deposition on limestone**

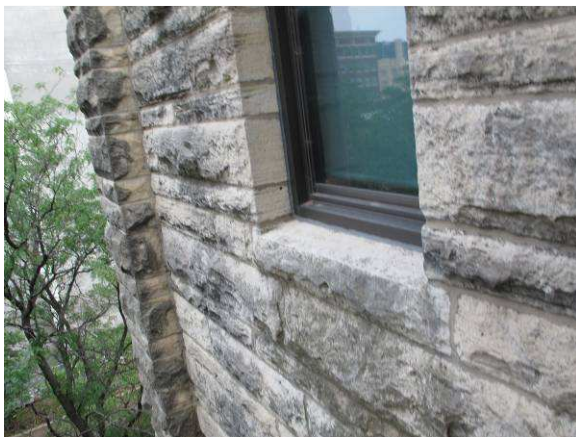
**Deposition on limestone**

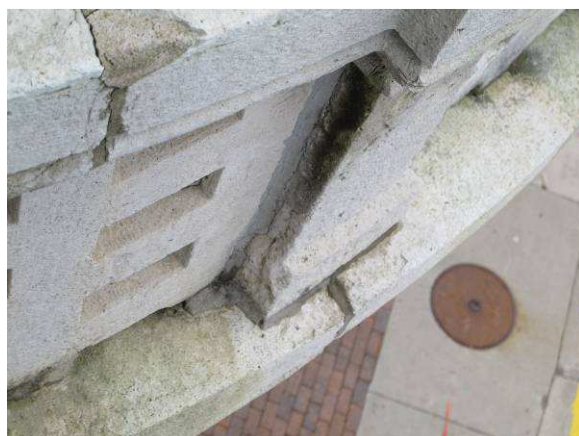
**Damaged stone**

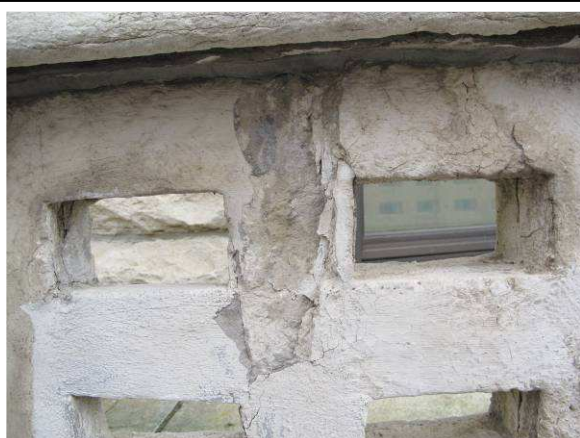
**Deteriorating stone**

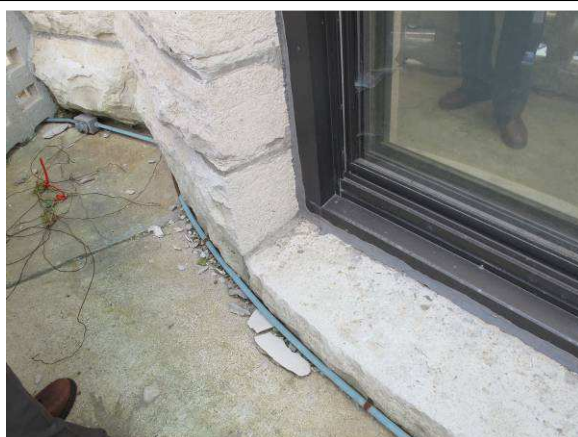
**Deteriorated stone**

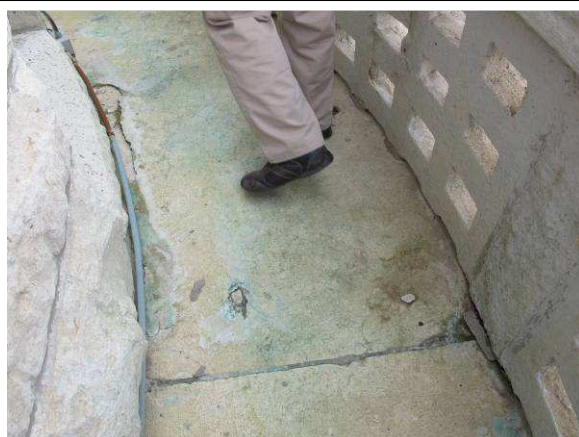
**Deteriorated stone**

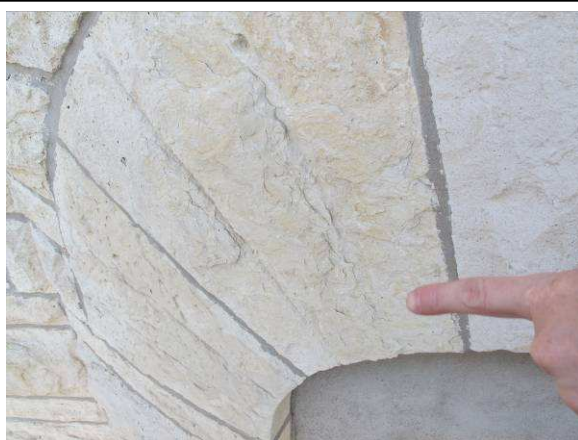
**Exfoliating stone at arch**

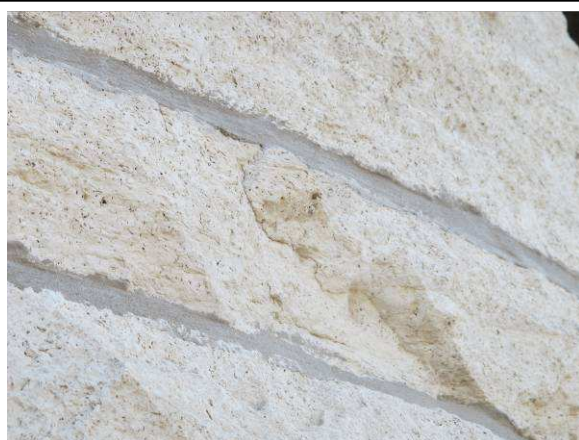
**Spalling limestone**

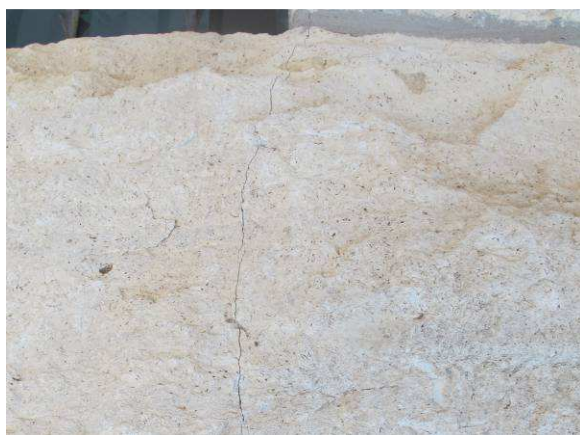
**Crack in limestone**

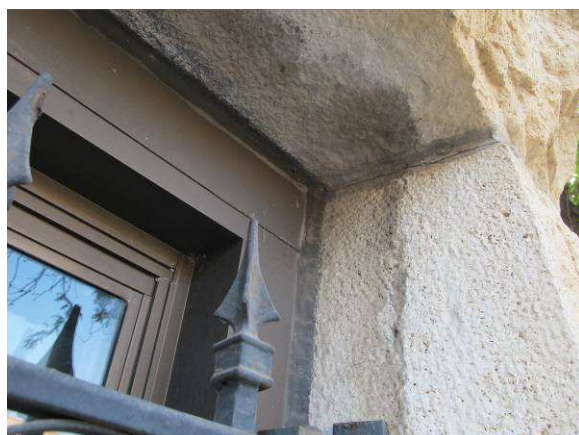
**Failing sealant**

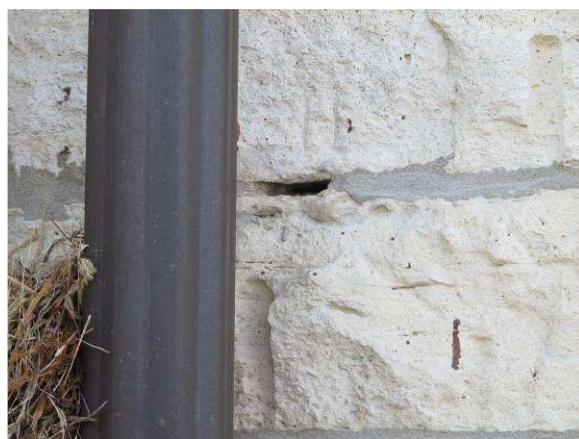
**Missing mortar**

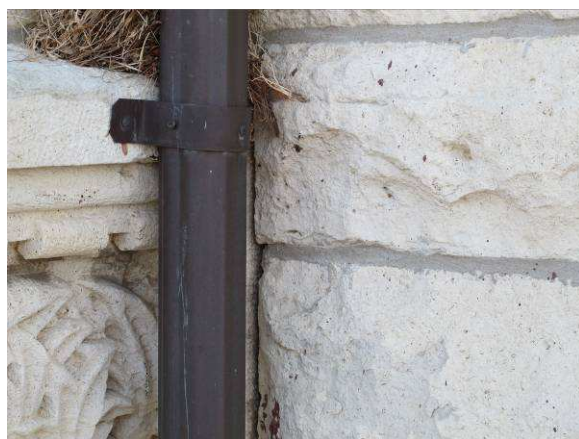
**Missing mortar**

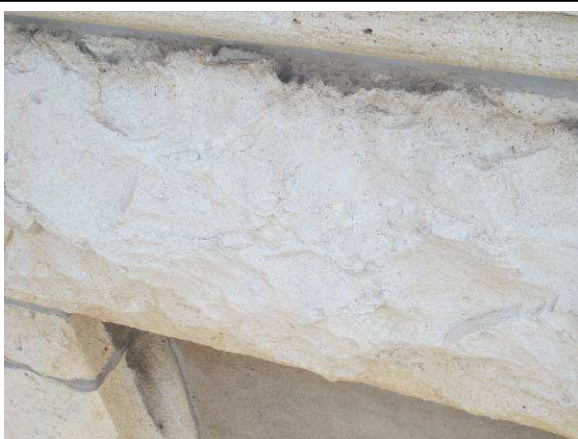
**Deteriorating stone**

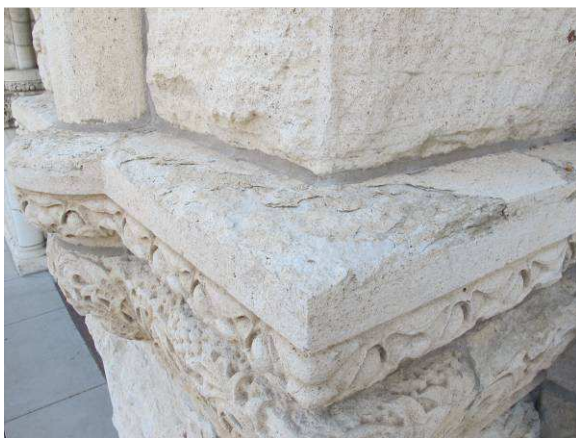
**Deteriorating stone**

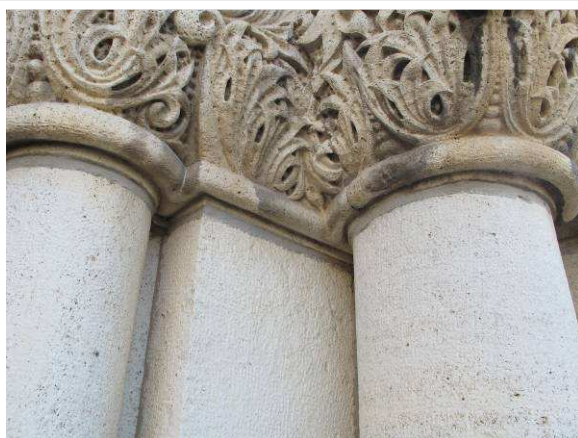
**Discoloration below carving**

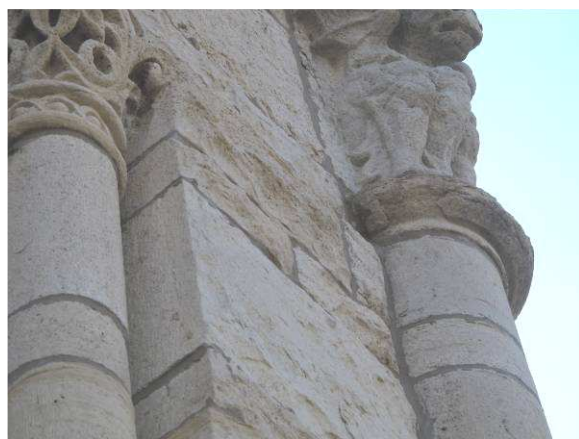
Deteriorating limestone

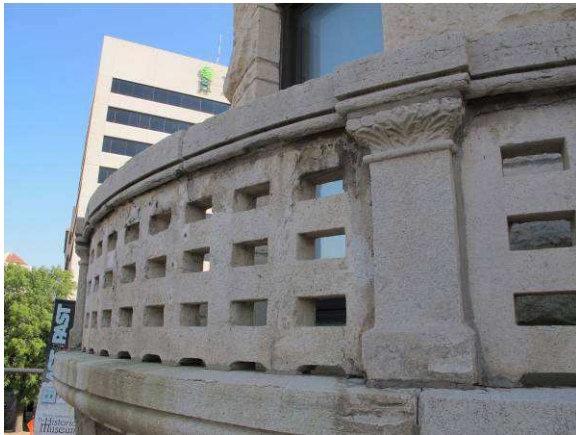
**Damaged limestone**

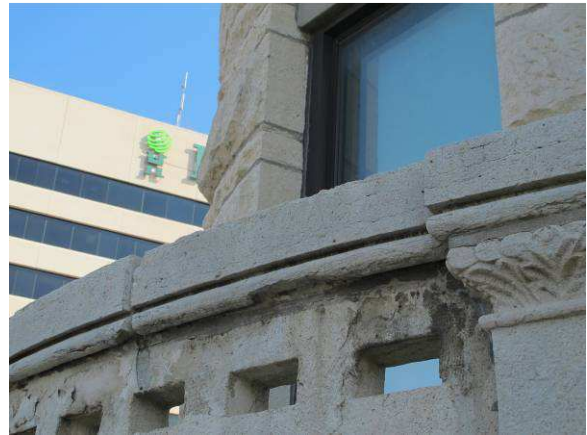
**Damaged limestone**
